## ADDENDUM NO. 1

**DATE:** June 10, 2020  
**FROM:** City of Grand Junction Purchasing Division  
**TO:** All Offerors  
**RE:** Professional Engineering Services for N. Leach Creek Bridge at 24 Road & G Road  
RFP-4802-20-DH

## MINOR BRIDGE INSPECTION REPORT

**IDENTIFICATION and LOCATION:**Structure Name: GRJM-G.0-24.01Facility Carried: G RoadFeature Intersected: Leach CreekLatitude: 39° 6' 23.0" Longitude: 108° 36' 29.0"**DESCRIPTION OF STRUCTURE:**Year Built: 1989

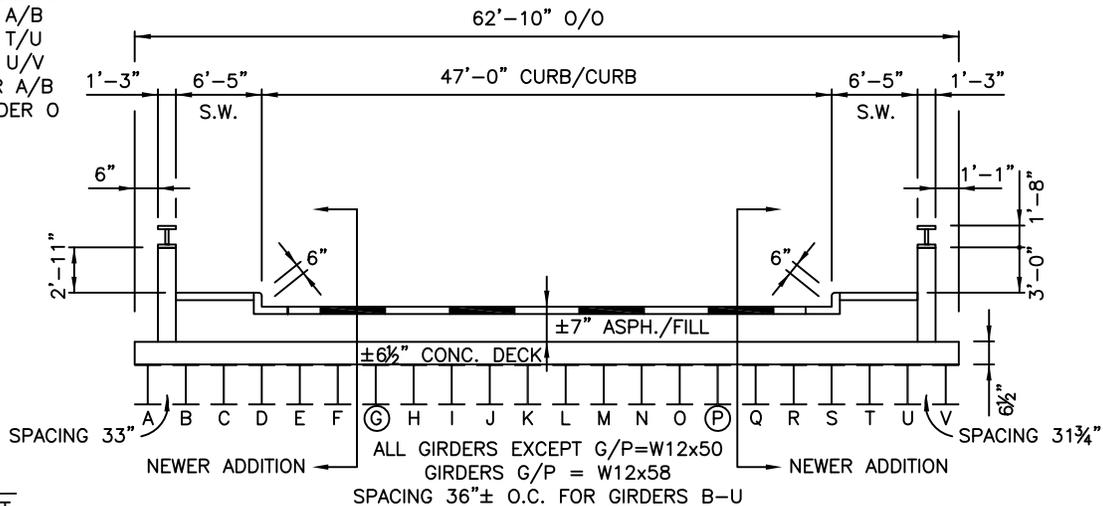
**SECTION**

2.5" BELOW GIRDER G  
 8" BET. GIRDER A/B  
 8" BET. GIRDER T/U  
 8" BET. GIRDER U/V  
 10" BET. GIRDER A/B  
 6.5" BELOW GIRDER O

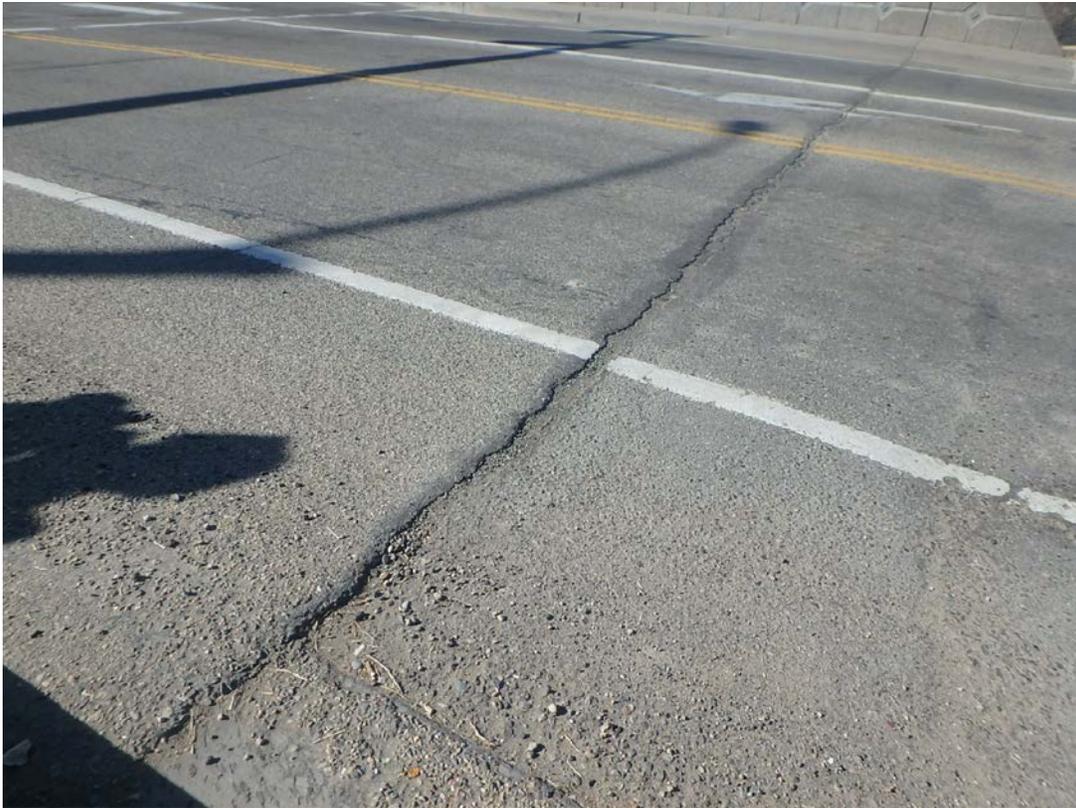
<b>CONDITION RATING</b>	<b>REMARKS</b>	
<b>58. DECK</b>	<b>7</b>	
DECK SLAB	G	7" asphalt on 6 1/2" concrete deck. Minor efflorescence between girders B and C.
WEARING SURFACE	F	Asphalt. Few discontinuous transverse cracks. Cracks over each abutment.
CURBS, SIDEWALKS, MEDIAN	G	Sidewalks on both sides. Shrinkage cracks and minor scaling. Minor undermining at southeast.
BRIDGE RAILS	G	Steel posts and rails on decorative concrete parapet. Shrinkage cracks.
DRAINS AND DRAINAGE	G	None, surface.
EXPANSION JOINTS		None.
UTILITIES	G	6 utility lines.
OTHER		
<b>59. SUPERSTRUCTURE</b>	<b>7</b>	
GIRDERS	G	(22) painted steel girders. Spotty light rusting with paint faded on girders G-P (original section). Girders G and P are W 12 x 58 and remaining girders are W 12 x 50.
BEARINGS	G	
DIAPHRAGMS AND BRACING	G	At ends.
PAINT	G	
DEFLECTIONS AND/OR VIBRATION	G	
ALIGNMENT	G	
OTHER		
<b>60. SUBSTRUCTURE</b>	<b>7</b>	
ABUTMENT WALL	F	Precast concrete panels between steel H-piles. Cracks on (2) new panels near northwest and southeast corners. Original panels have settlement, more prominent at A2.

Transverse Crack in Asphalt Typical along Top of Abutments

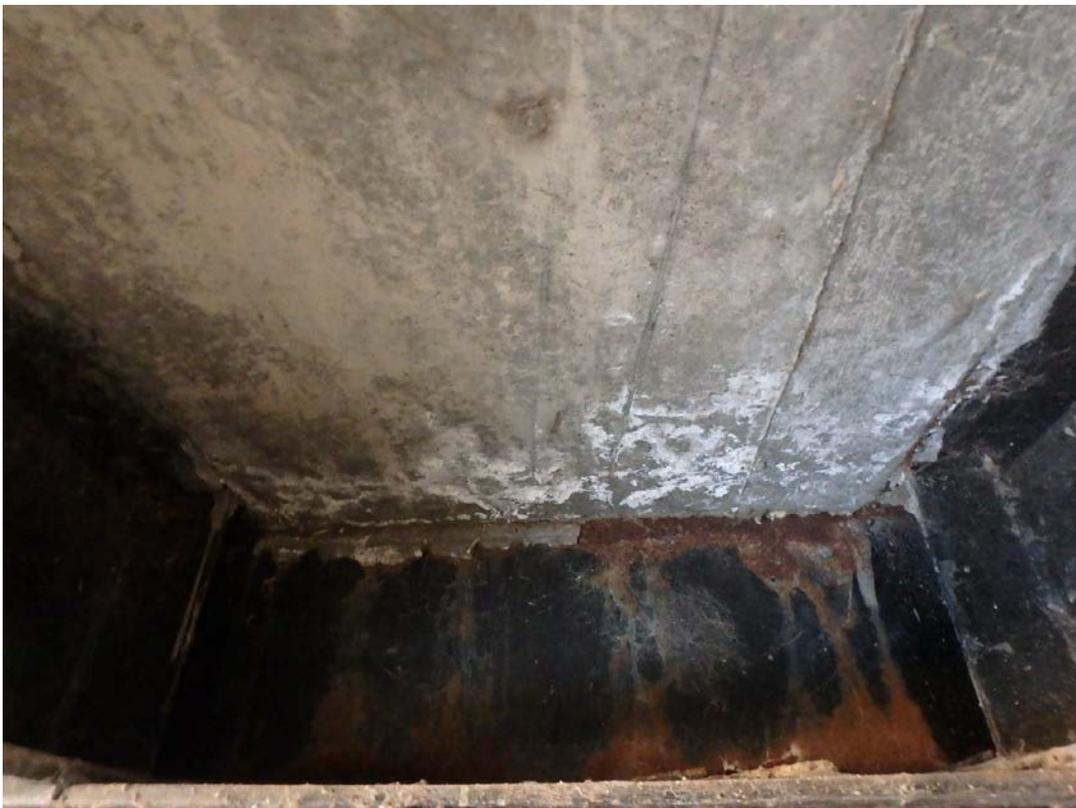
Efflorescence on Underside of Deck in Bay B at East Abutment

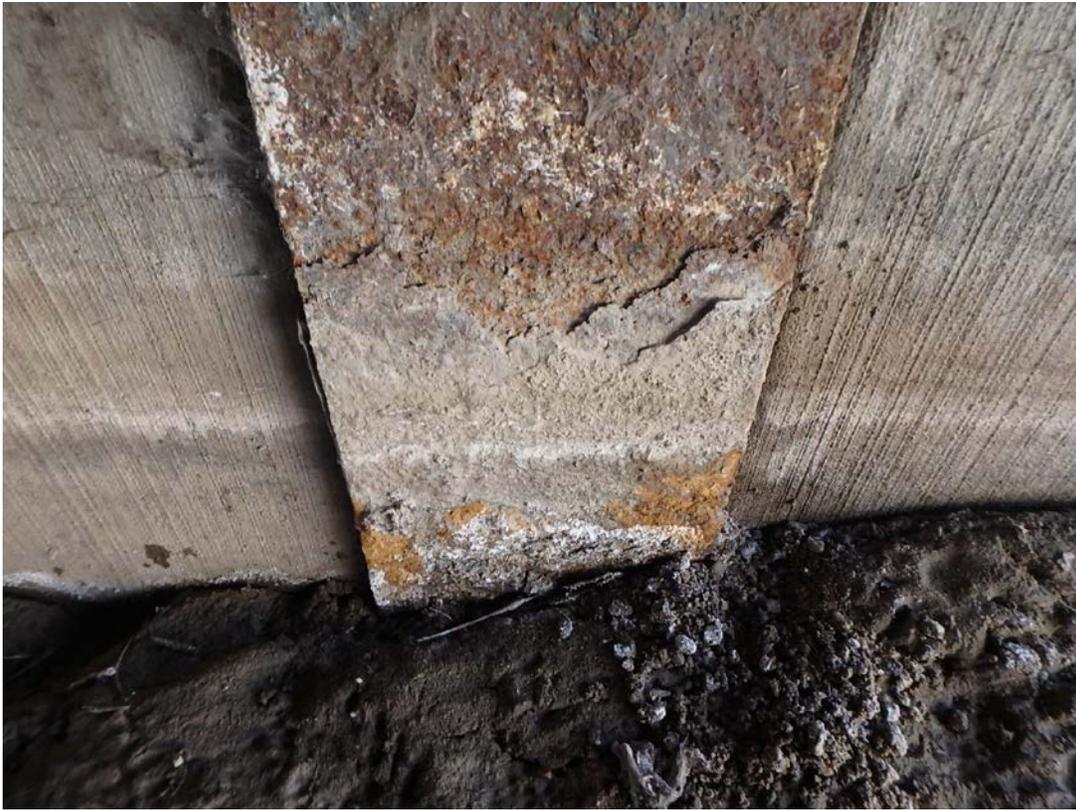
Typical Flaking Rust on Exposed Flange of Abutment Pile

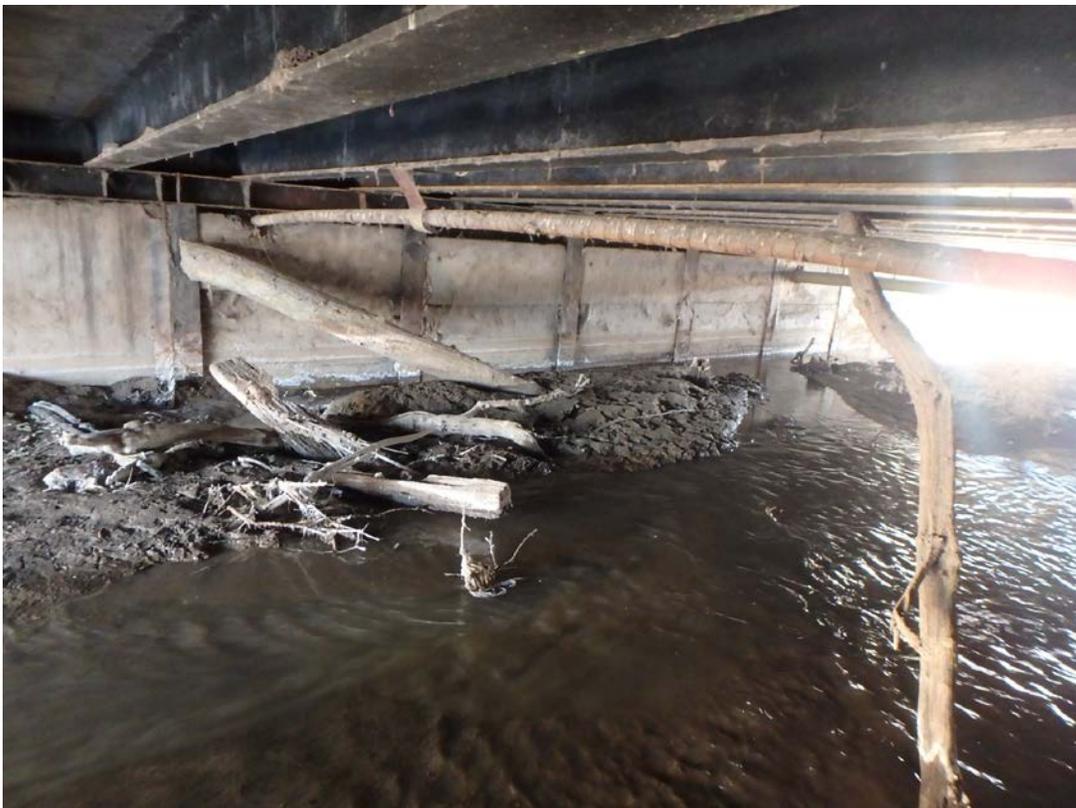
ABUTMENT BACKWALL	G	W-beam in original section but doesn't extend to new section. Not visible in new sections. Void behind and between piles near ends of old sections due to lack of backwall.
CAP AND/OR BEARING SEAT	G	8" by 8" steel H-cap with vertical stiffeners at each abutment.
PILES AND/OR COLUMNS	F	(12) 8" by 8" steel H-piles at each abutment. Flaking rust at waterline throughout.
FOUNDATIONS	G	
WINGWALLS	G	Steel H-piles with precast panels between piles. Flaking rust on piles below waterline.
EROSION AND/OR SCOUR	G	
SETTLEMENT OR DEFLECTION	G	
SLOPE PROTECTION	G	
OTHER	F	Several trees and logs caught under bridge.

CONDITION RATING	REMARKS	
<b>61. CHANNEL</b>	<b>5</b>	
ALIGNMENT	G	Straight, manmade channel.
EROSION AND/OR SCOUR	G	
CHANNEL PROTECTION	F	
WATERWAY OBSTRUCTIONS	P	Several utility lines under bridge catch debris.
ADEQUACY OF OPENING	P	Debris caught on girders.
NORMAL VELOCITY		
STREAMBED COMPOSITION		Silt.
OTHER		
<b>72. APPROACH ALIGNMENT</b>	<b>7</b>	
APPROACH GUARDRAIL		None.
SURFACING	G	Asphalt. Few longitudinal and transverse cracks.
EROSION	G	
SETTLEMENT	G	Slight bump onto bridge.
SIGNS		None.
ALIGNMENT	G	Intersection immediately west of bridge.
OTHER

Large Logs in Channel below Bridge and Resting on Girders

REASON*/ PRIORITY**	DESCRIPTION
R/C	Clean debris from beneath bridge.
R/C	Fill voids where W-beam back wall is missing.
H/C	Install approach rails that meet AASHTO/CDOT standards.

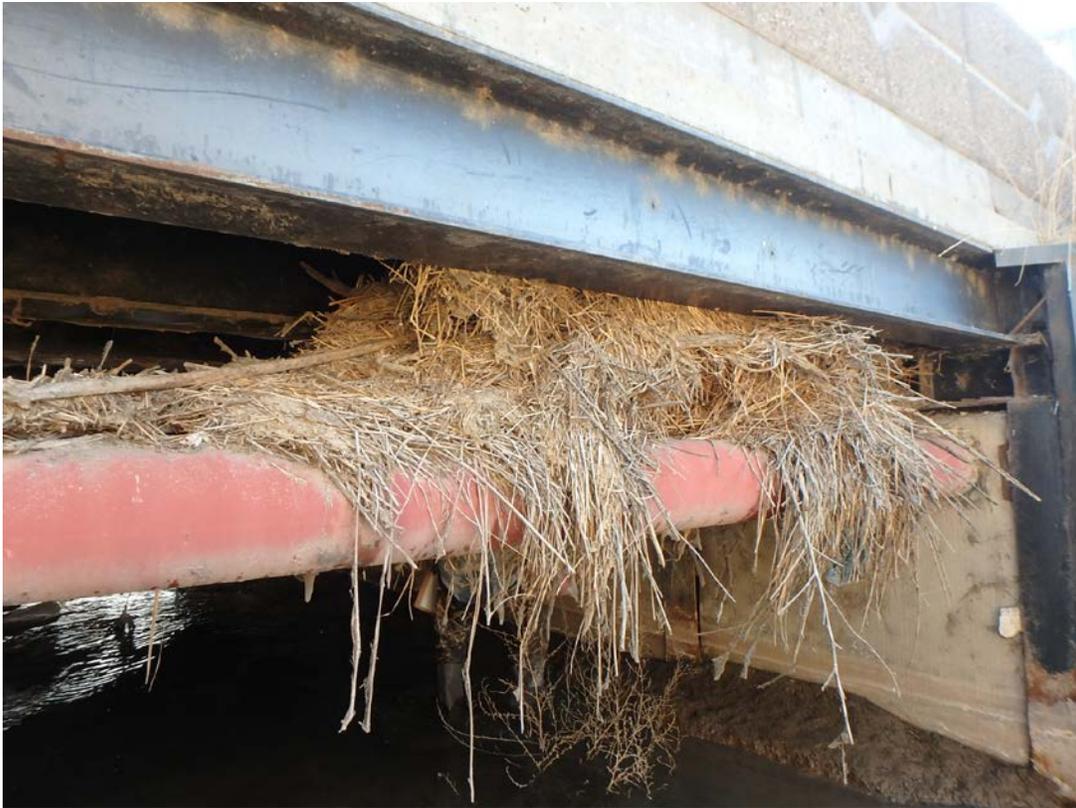
Debris Lodged above Utility at North Side of Bridge

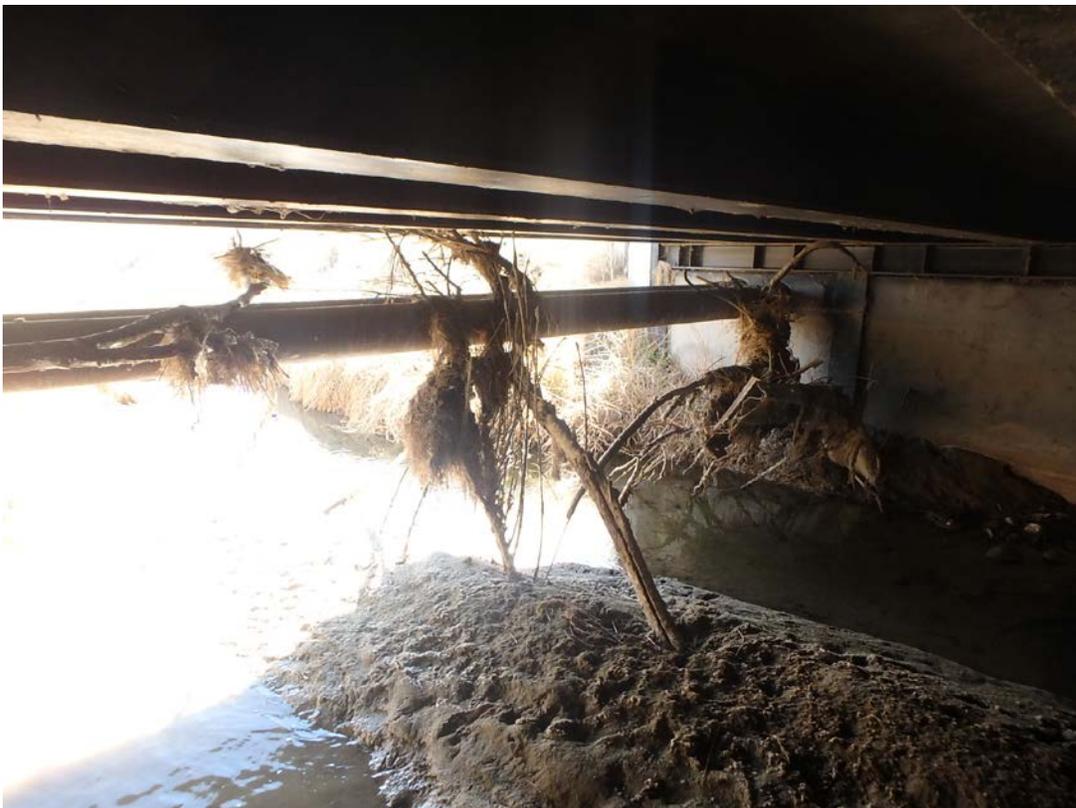
Sticks and Debris Lodged above Utilities at South Side
