ADDENDUM NO. 2

DATE: April 26, 2021
FROM: City of Grand Junction Purchasing Division
TO: All Interested Parties
RE: D Road Bridge Repair at Lewis Wash & 31 Road IFB-4909-21-SH

MINOR BRIDGE INSPECTION REPORT

IDENTIFICATION and LOCATION:Structure Name: GRJM-D.0-31.01Facility Carried: D RoadFeature Intersected: Lewis WashLatitude: 39° 3' 46.2" Longitude: 108° 28' 40.1"**DESCRIPTION OF STRUCTURE:**Year Built: Unknown

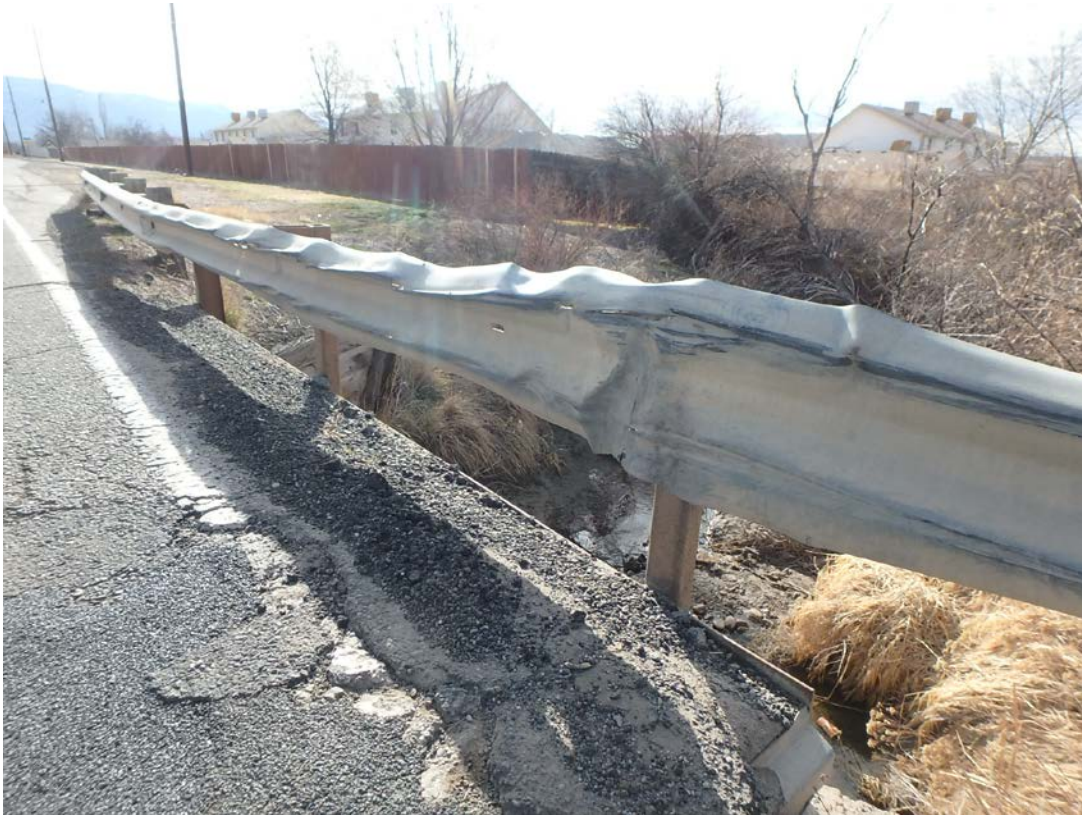
CONDITION RATING	REMARKS	
58. DECK	5	
DECK SLAB	F	Corrugated metal, corrosion at all joints.
WEARING SURFACE	F	2" to 3" Asphalt. Areas of cracks, potholes, and patches at west end.
CURBS, SIDEWALKS, MEDIAN	N/A	N/A
BRIDGE RAILS	P	Galvanized W-beam on steel posts. South side moderate impact damage.
DRAINS AND DRAINAGE	N/A	N/A
EXPANSION JOINTS	N/A	N/A
UTILITIES	F	2" steel conduit on south side, 1" PVC on north side.
OTHER

Damaged W-Beam of South Bridge Rail, Mostly at West End

REASON*/ PRIORITY**	DESCRIPTION
R/C	Secure loose decking and repave.
R/C	Patch concrete at base of abutments at north end to prevent further erosion and potential piping of the soil from behind the abutments.
H/C	Install bridge and approach rails that meet AASHTO/CDOT specifications.
R/N	Clean and paint the superstructure to retard corrosion and section loss due to leakage through the asphalt.
R/N	Stabilize both downstream slopes with angular engineered riprap.
R/N	Consideration should be given to replacing this bridge prior to spending large sums of money on maintenance and repairs because of the settlement of the abutments, deck deterioration, and poor deck geometry (too narrow).

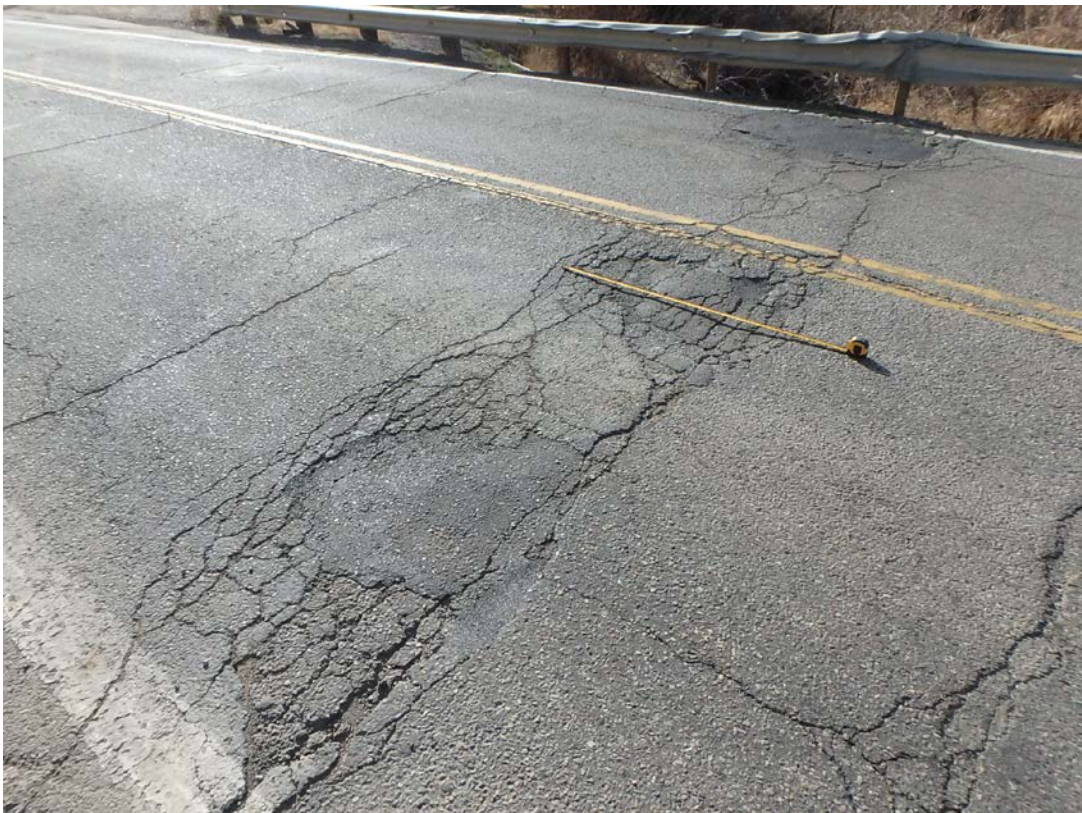
Cracked, Broken-Up Asphalt with Patched Potholes and Depressions at West End of Deck

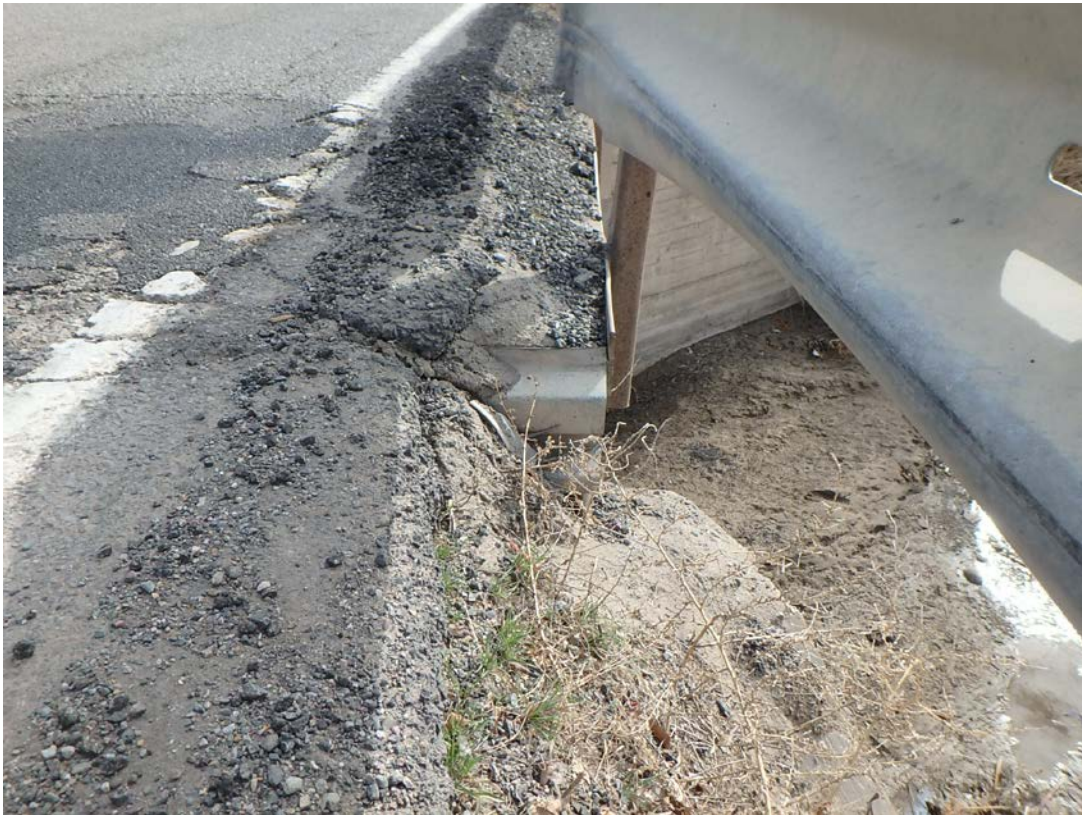
Exposed Abutment Backwall due to Erosion at Southwest Corner of Deck

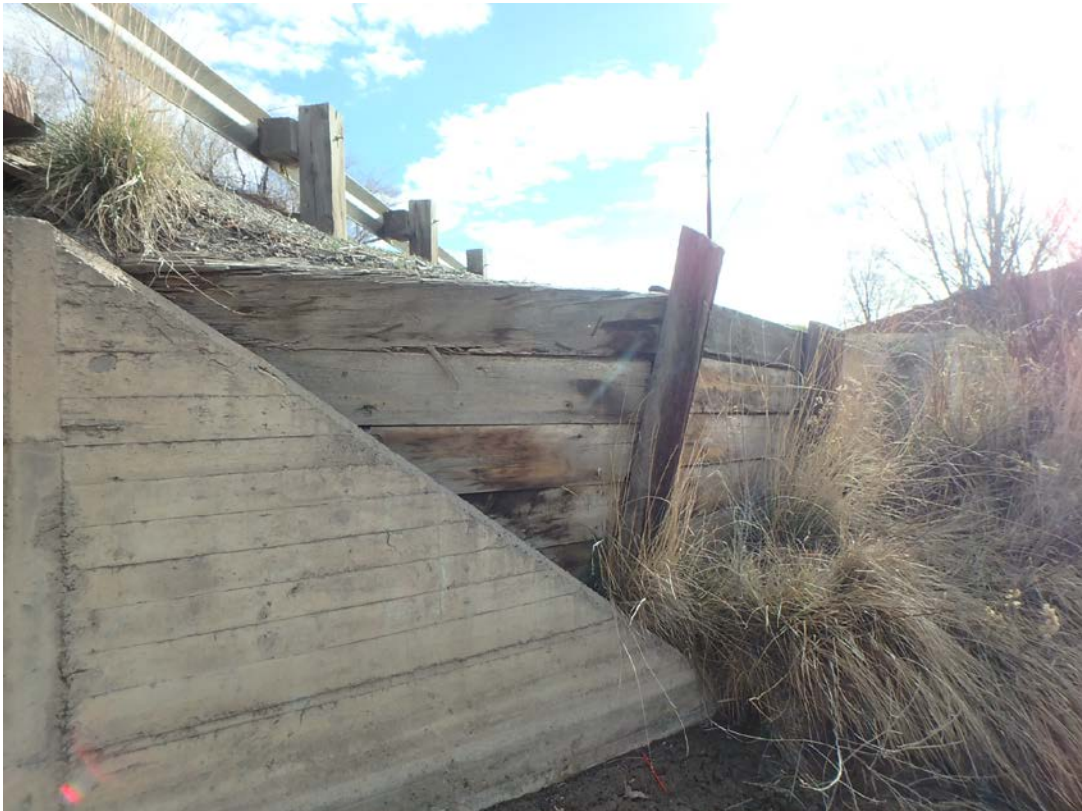
Southeast Wingwall Extension Leaning into Channel

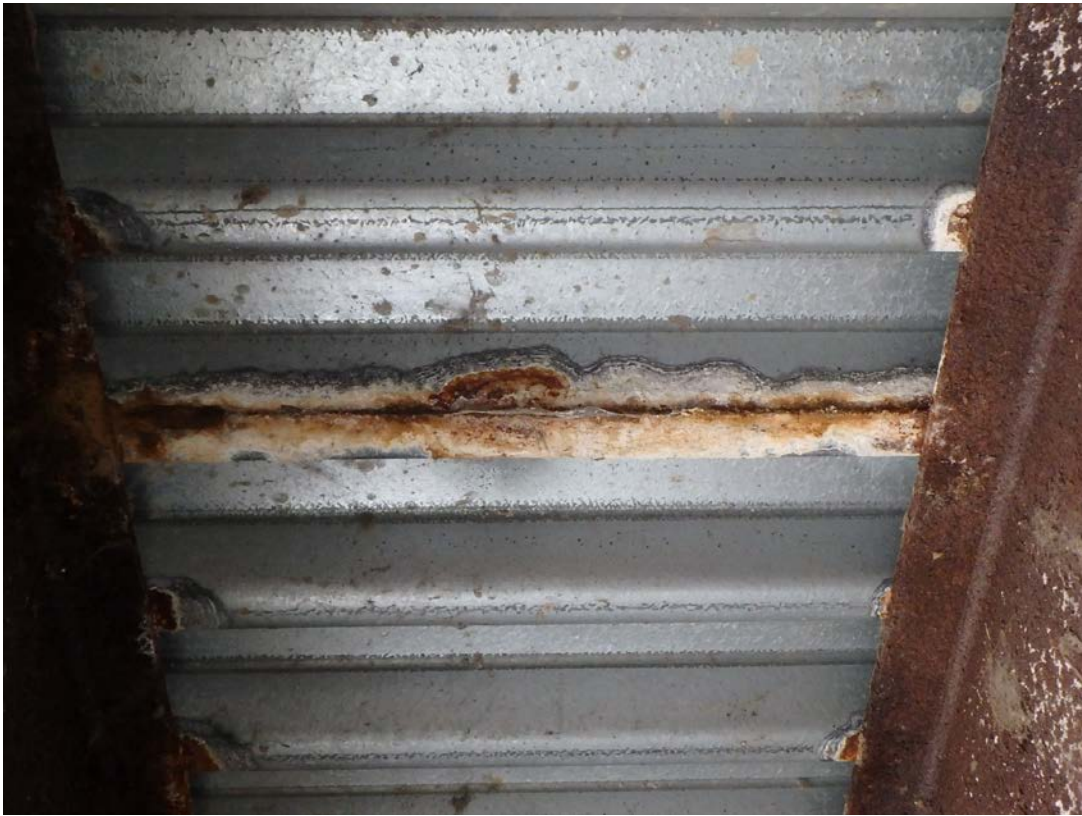
Typical Rust and Corrosion along Deck Joints and at Contact Points with Top Flanges

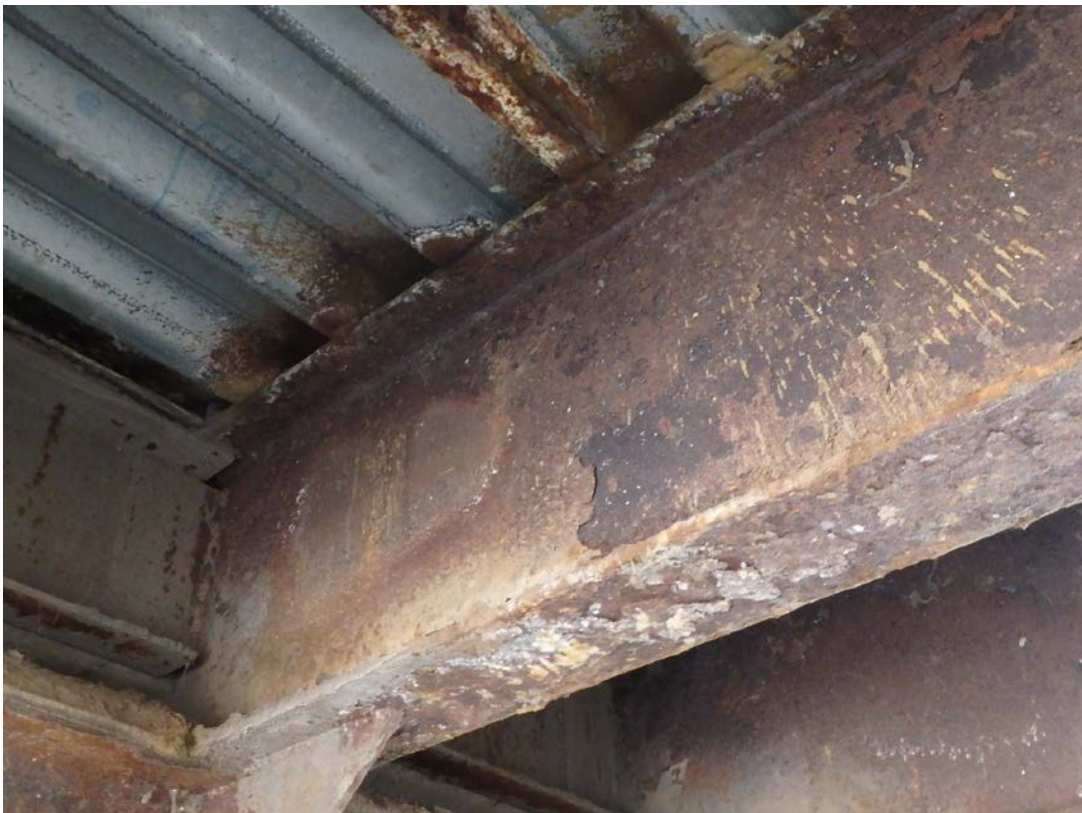
59. SUPERSTRUCTURE	6	
GIRDERS	F	Unpainted steel wide flange girders. Moderate rust, especially below leaking joints, no section loss.
BEARINGS	G	Girders welded to steel cap.
DIAPHRAGMS AND BRACING	F	Steel channels at ends.
PAINT	N/A	None.
DEFLECTIONS AND/OR VIBRATION	F	Noticeable vibration with vehicles.
ALIGNMENT	G	
OTHER

Flaking Rust Typical on Girders, Especially below Corroded Deck Joints

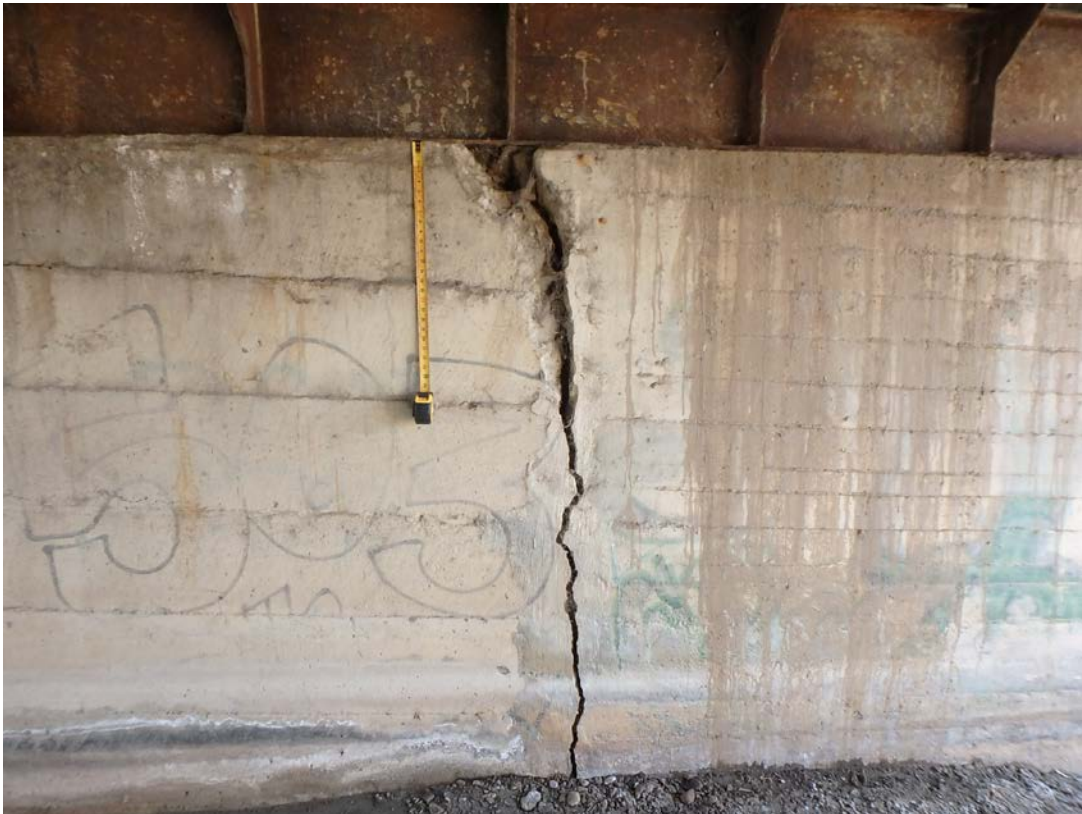
60. SUBSTRUCTURE	5	
ABUTMENT WALL	P	Both abutments have been widened in the past, vertical cracks at joint with widened section. South side settled about 3/4".
ABUTMENT BACKWALL	G	Galvanized corrugated metal.
CAP AND/OR BEARING SEAT	F	Steel wide flange bearing on concrete. Heavy rust throughout caps.
PILES AND/OR COLUMNS	N/A	N/A
FOUNDATIONS	G	
WINGWALLS	F	Concrete with timber piles and lagging extensions at south. Southeast timber is leaning about 5" in 24". North wingwalls are extensions of abutments and coincide with walls from check dam.
EROSION AND/OR SCOUR	F	1.5' concrete slab at upstream ends all exposed. Concrete footing below, exposed up to 12".
SETTLEMENT OR DEFLECTION	P	South half extension are settled approximately 3/4".
SLOPE PROTECTION	G	Concrete walls upstream, heavily vegetated downstream.
OTHER

Spalling along Vertical Crack in East Abutment

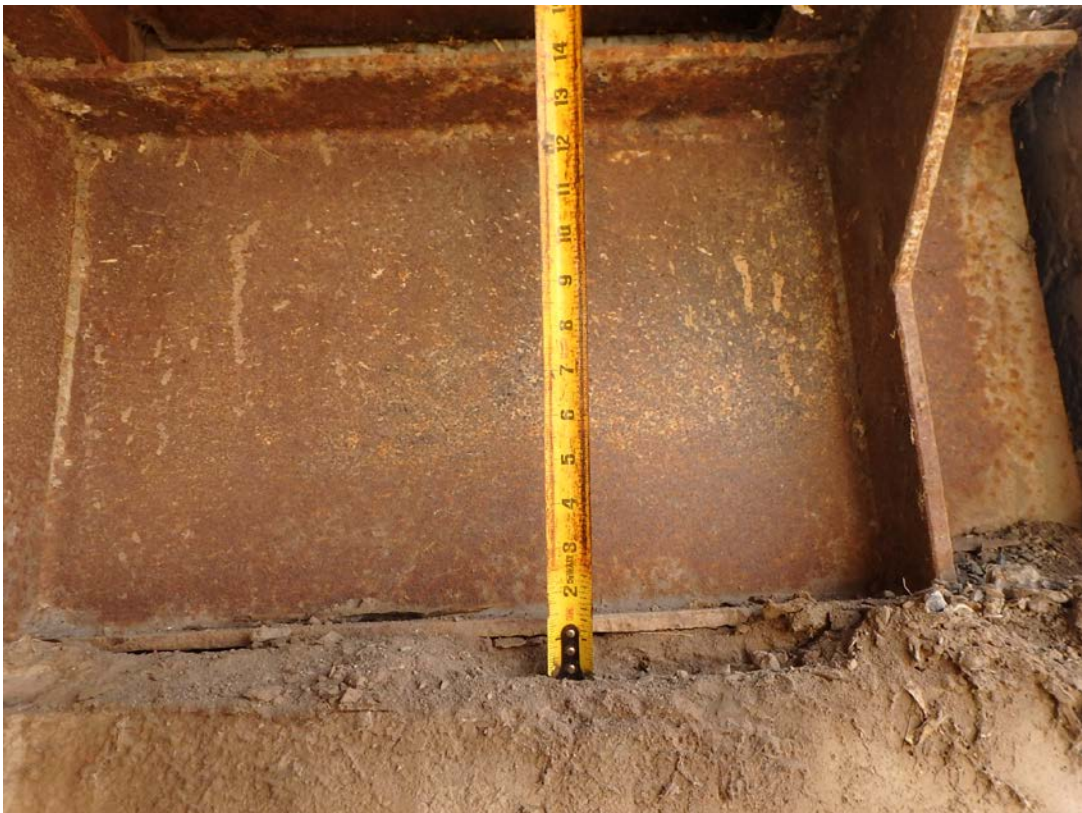
The overall condition of the bridge is FAIR. The widened sections of the abutments have settled resulting in a large cracking in each abutment and non-uniform bearing.

Gap between East Abutment Wall and Cap indicating Settling of South End of Wall

Answer: The new shims shall be made of A36 steel, with a maximum steel shim stack of 1/2" allowed. The shim shall be placed between the existing steel girders and the existing steel end wall at the (6) south-most girders, each abutment. The shims shall be welded to the girders and the end walls. The intent of the shims is to alleviate the settlement of the south side of the abutment foundation and eliminate the bump from the roadway to the bridge deck on the eastbound lane. It is unknown how much settlement has occurred at the south end of the bridge, but the attached Inspection Report shows about 3/4" settlement.

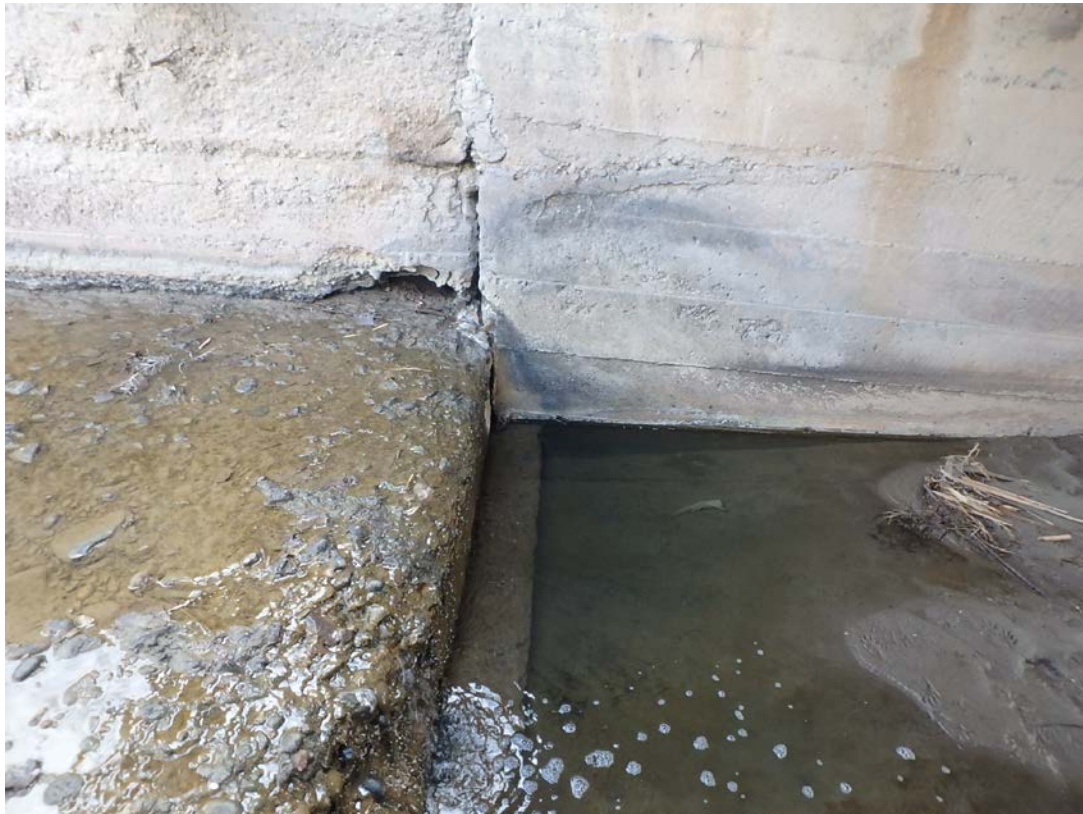
Scour Hole and Spall/Void at North End of East Abutment
