PERSIGO WASTE WATER TREATMENT PLANT Structural Condition Assessment

2145 River Road
Grand Junction, Colorado 81505

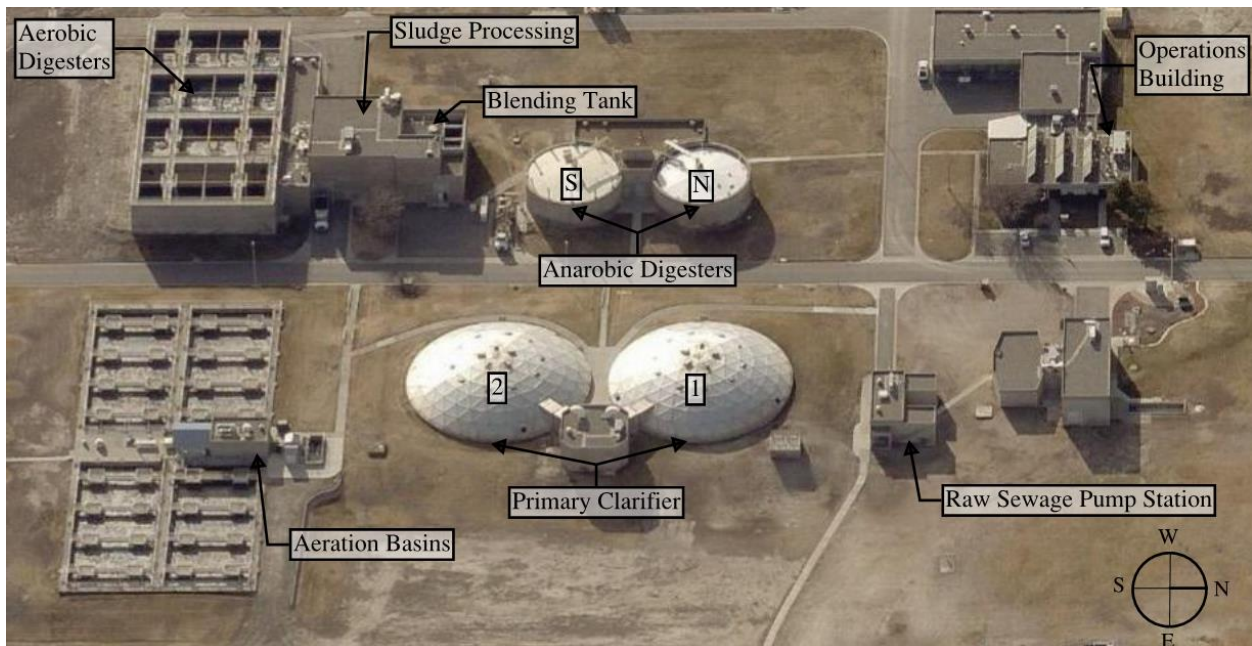
The WWTP is jointly owned by the CGJ and Mesa County, and was constructed circa 1982. The treatment plant contains structures that house a multitude of processes, including step screens, grit removal, primary clarification, primary effluent flow equalization, secondary aeration, secondary clarification, and ultraviolet disinfection. While mechanical equipment has been maintained and replaced since the plant opened in 1984, it is our understanding that the structures have remained relatively unchanged with minimal

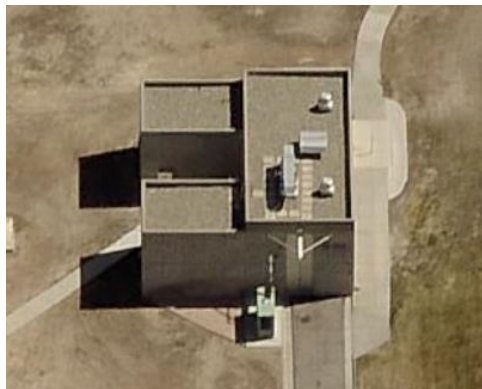
The structure consists of a conventionally reinforced 24-inch thick concrete slab foundation, with a 3-inch thick topping slab reinforced with WWR (welded wire reinforcing). The exterior face of the foundation slab is waterproofed with a continuous waterproofing that extends up the full height of the below-grade portion of the perimeter walls. The perimeter walls measure 14 inches thick and are conventionally reinforced with two mats of reinforcing. The above-grade exterior face of the perimeter walls comprises both smooth surfaced concrete, in addition to an upper band of ribbed concrete. A single stairwell at the east end of the structure provides access down to the pump room. The roof of the elevated structure is steel framed.

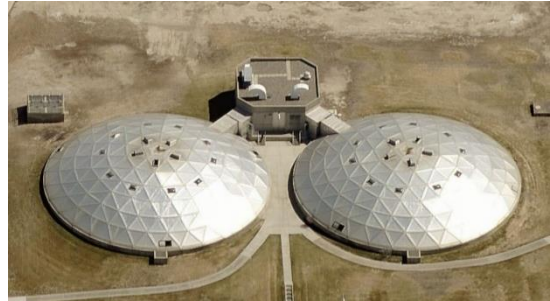
2.2.3. Aeration Basin

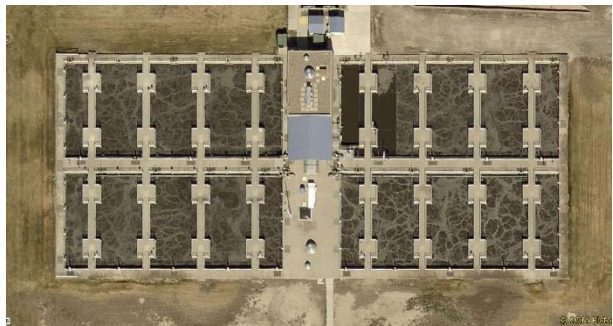
The aeration basin is rectangular in plan, and measures approximately 123 feet in the north-south direction, and 275 feet in the east-west direction. The aeration basin blower room is situated at the center of the structure (oriented in the north-south direction), and is approximately 30 feet in width. The basin walls extend approximately two feet above grade, and approximately nineteen feet below grade. To the east and west of the basin blower room, the structure is split equally in the east-west direction by interior basin baffle walls, such that four individual open-air basins are present. Elevated concrete catwalks with post-installed guardrails are present at-grade that provide pedestrian access above the basins below. A single-story basin control room is present at the north end of the structure, above the blower room.

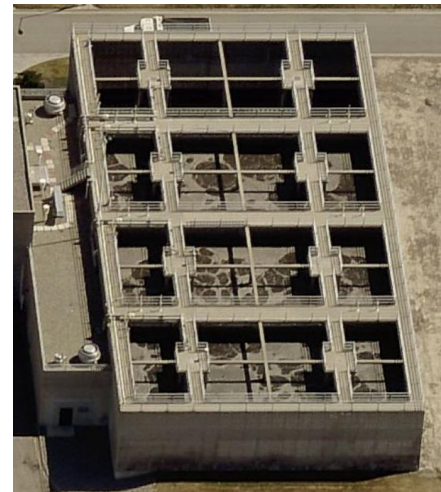
2.2.5. Sludge Processing Unit

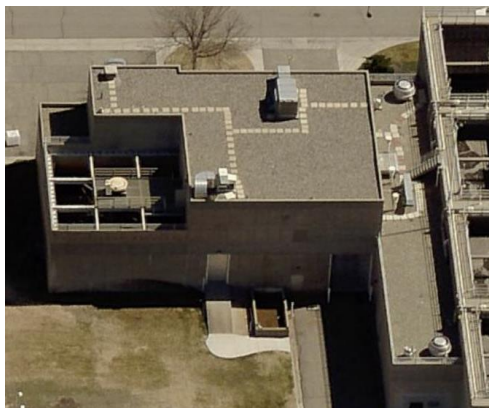
The structure of the sludge processing unit primarily consists of a 6-inch thick concrete slab foundation reinforced with WWR, with a conventionally reinforced 8-inch thick concrete slab at the blending tank. The perimeter walls primarily consist of conventionally reinforced 14-inch thick concrete with two mats of reinforcing. The exterior face of the perimeter walls comprises both smooth surfaced concrete, in addition to intermittent bands of ribbed concrete. We understand that the roof of the blending tank originally consisted of a conventionally reinforced 8-inch thick slab/lid, which was replaced approximately twenty years ago with open air structural steel framing. At that time, the north and west exterior walls of the tank were reportedly lined with shotcrete.

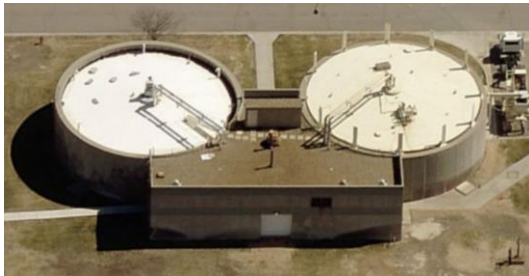
The roofs are of two different vintages, with the south digester roof (included with our assessment) constructed of radial space trusses welded together from mild steel. The steel lid comprises the horizontal walking surface above the trusses, in addition to an approximately 6-foot deep “rim skirt” at the perimeter of the lid, which extends down into the digesters. The lid bears on concrete corbels within the digester for support.

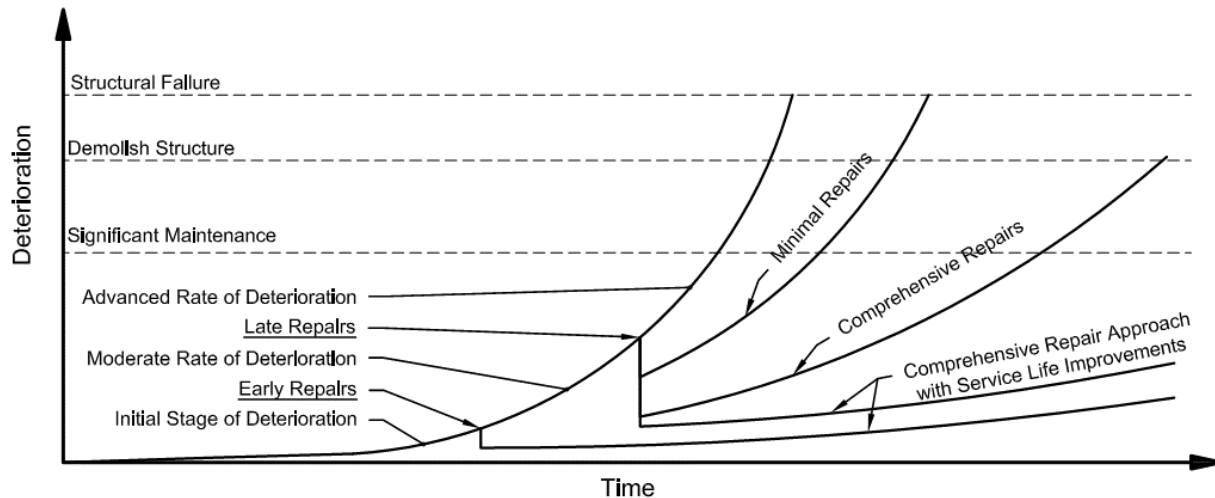
Adapted from Figure 19-2 of Chrest, Antony P., et. al. *Parking Structures: Planning, Design, Construction, Maintenance, and Repair*, 3rd Edition.

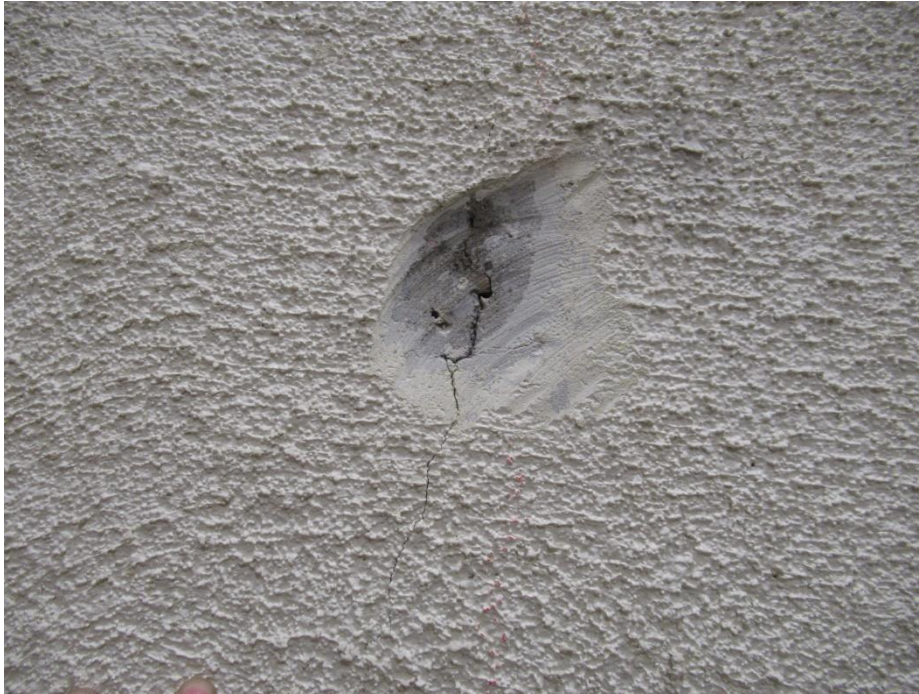
Figure 1. Typical coating installation at interior wall surfaces

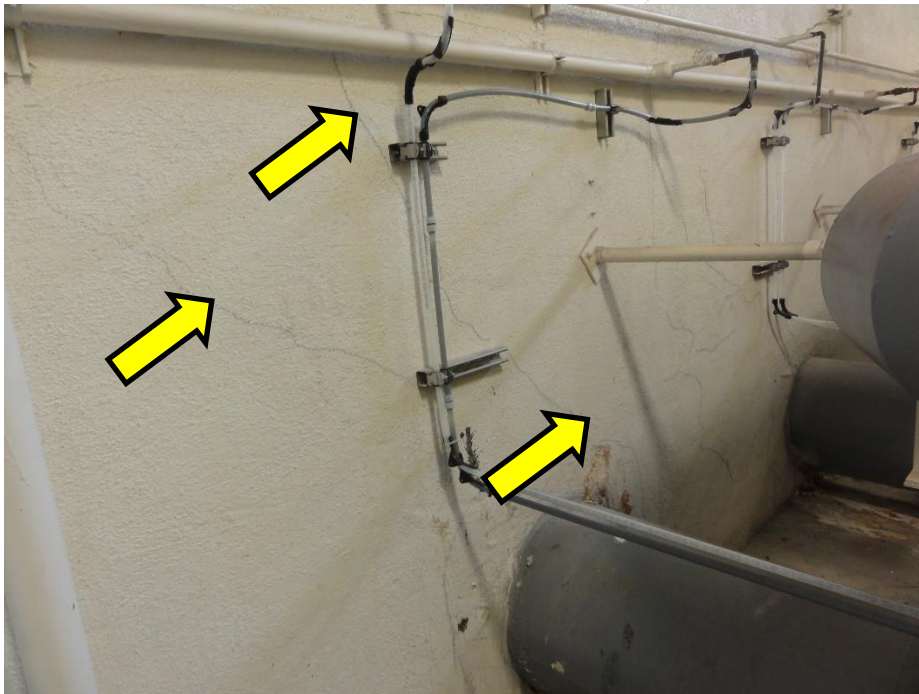
Figure 2. Noted cracks at the Raw Sewage Pump Station perimeter wall (demising wall between the pump room and the wet well), traced in blue

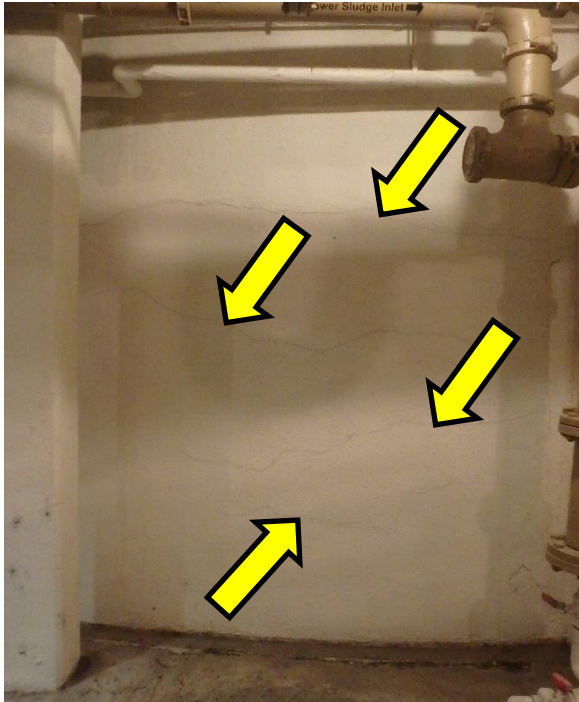
Figure 3. Noted cracks at the Anaerobic Digester interior wall, traced in blue

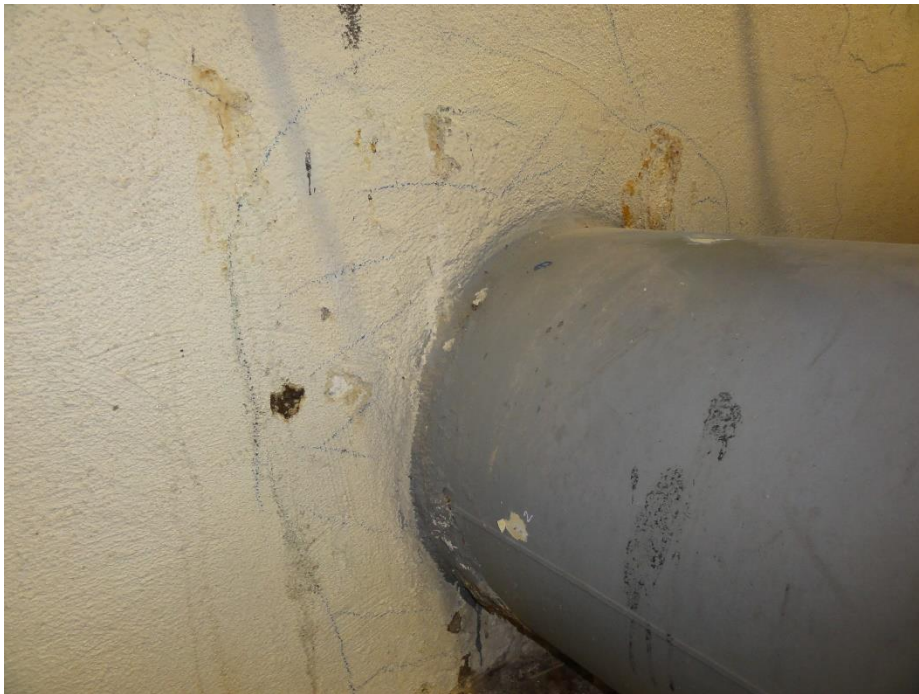
Figure 4. Sounded delaminated coating adjacent to inlet pipe

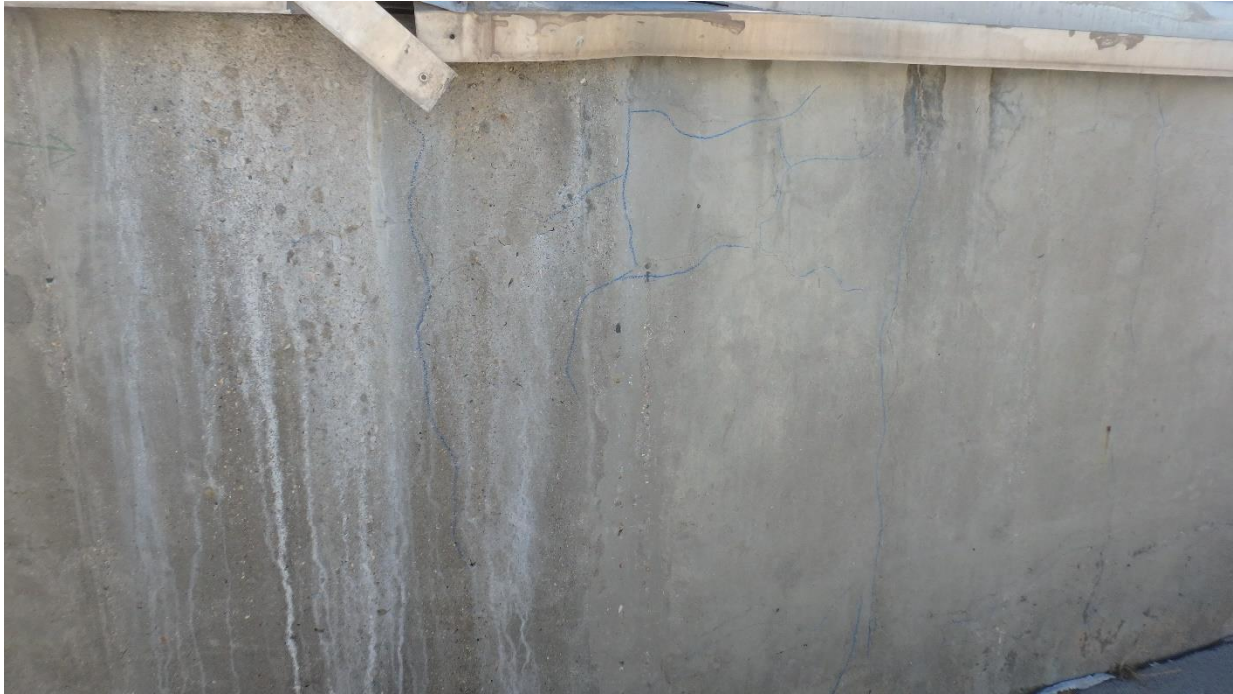
Figure 5. Map patterned cracking at exterior of Primary Clarifier walls

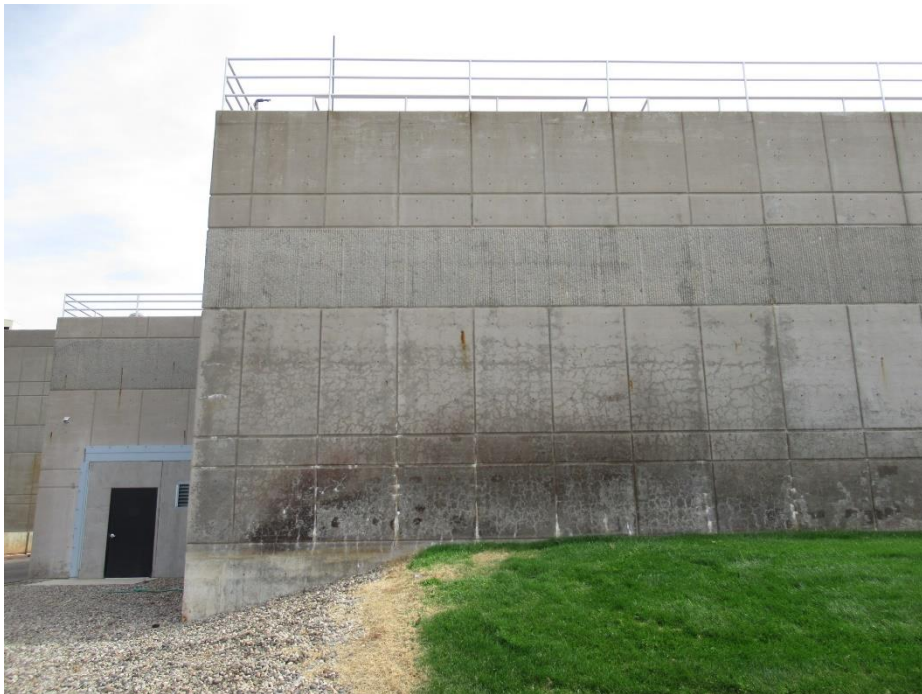
Figure 6. Map patterned cracking at lower half of Aerobic Digester perimeter walls

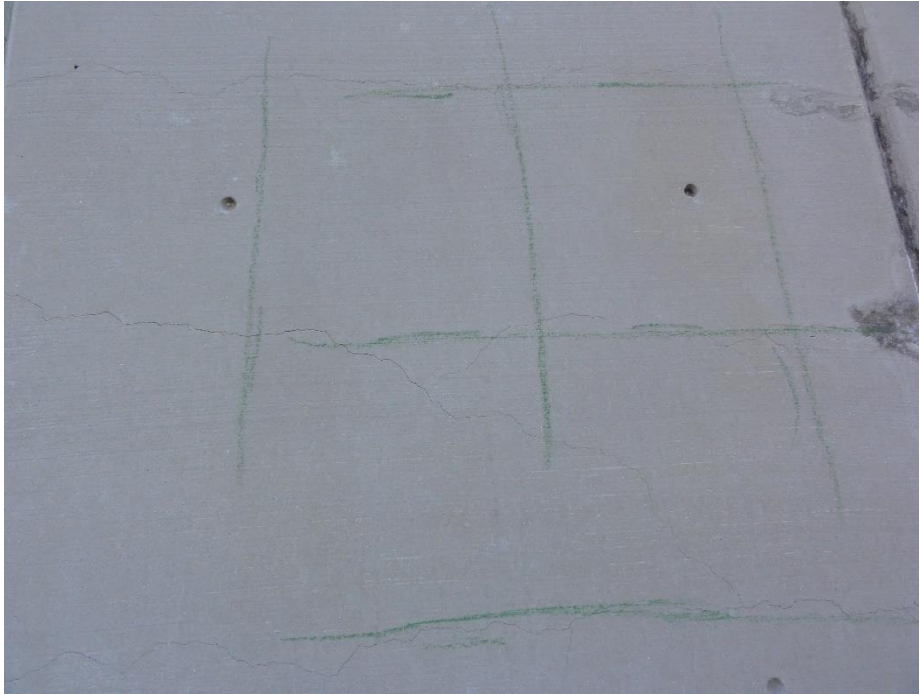
Figure 7. Typical longitudinal and transverse cracking, aligning with locations of embedded reinforcing (reinforcing traced in green)

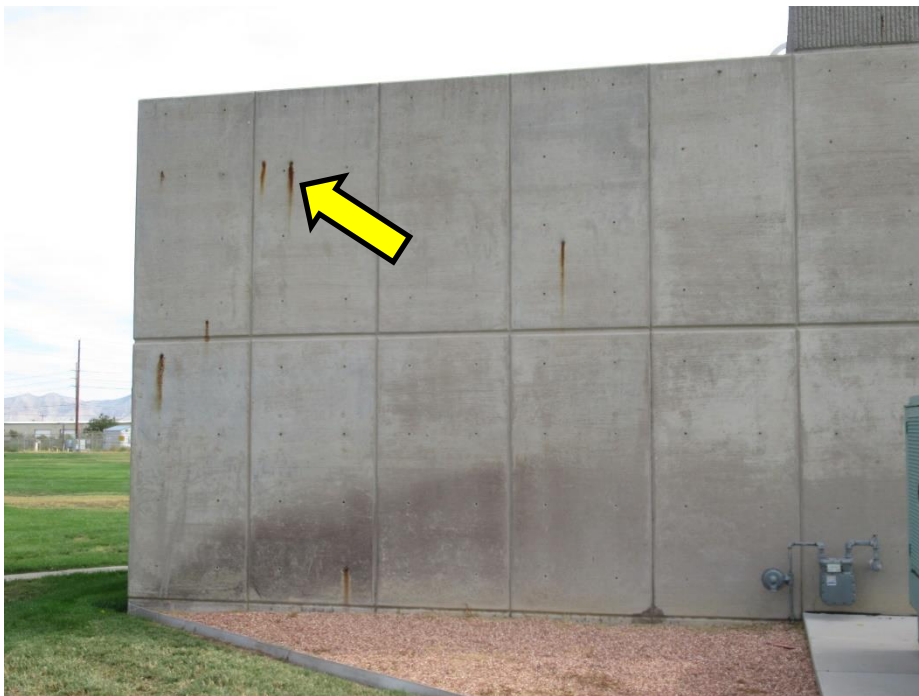
Figure 8. Typical and isolated corrosion staining at aggregate particles

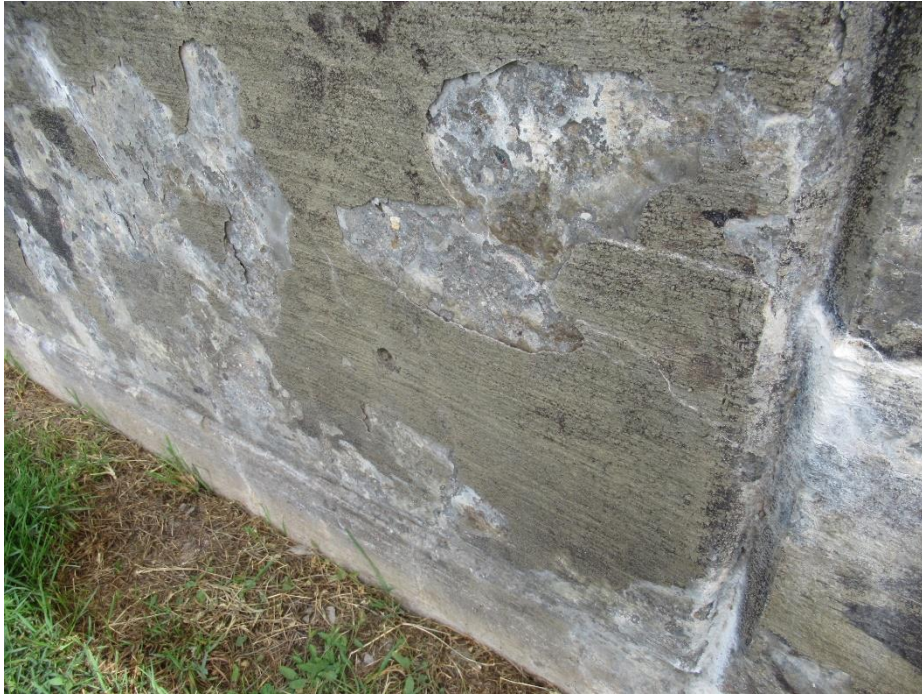
Figure 9. Flaking of surface applied purge coat at Aerobic Digester perimeter wall

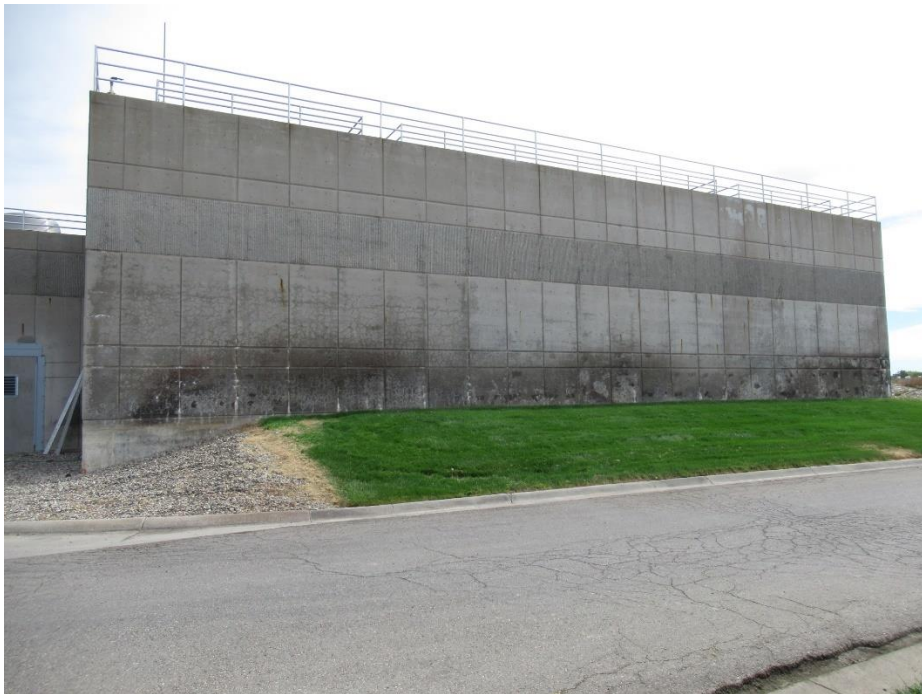
Figure 10. Typical surface staining at base of wall, adjacent to landscaping irrigation

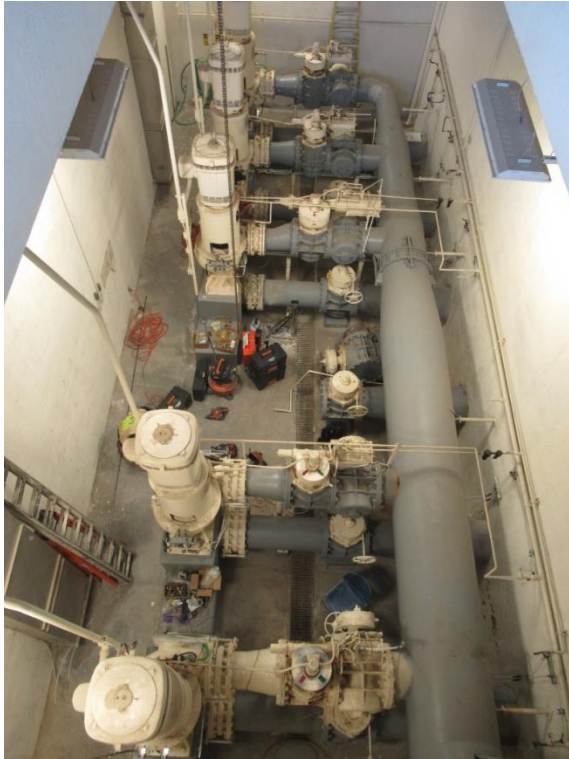
Figure 11. Overall view of the pump slab room, as viewed from the ground floor slab

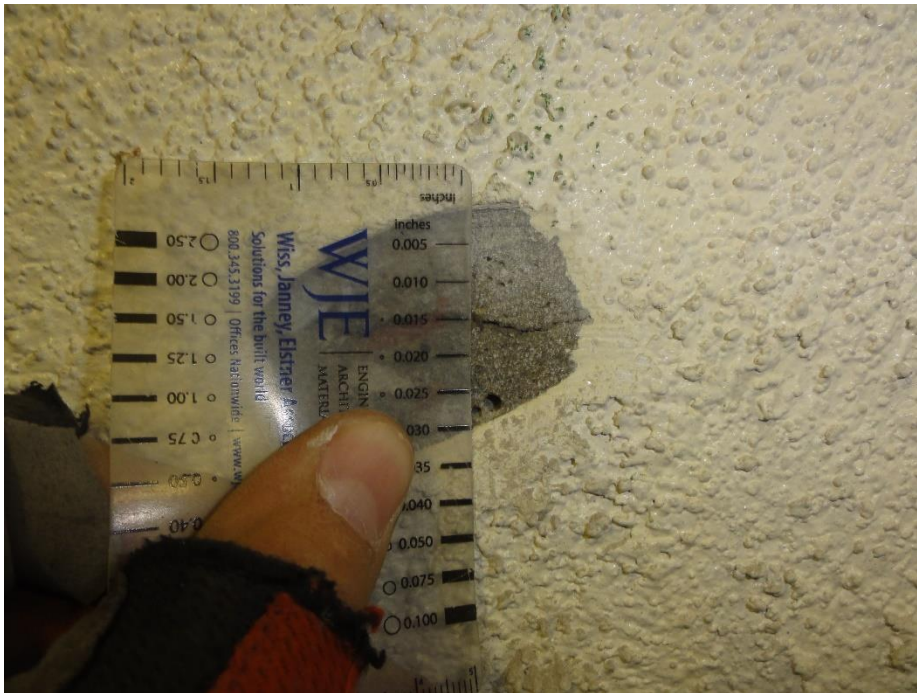
Figure 12. 15 mil crack observed in concrete substrate, that had not yet propagated through the wall coating

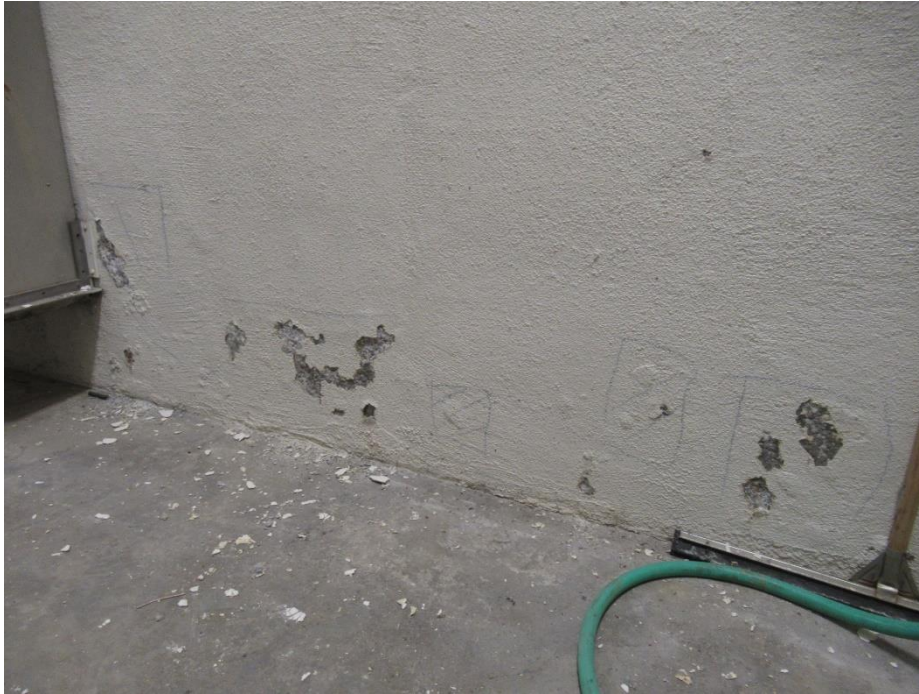
Figure 13. Coating delaminations at the base of the interior walls

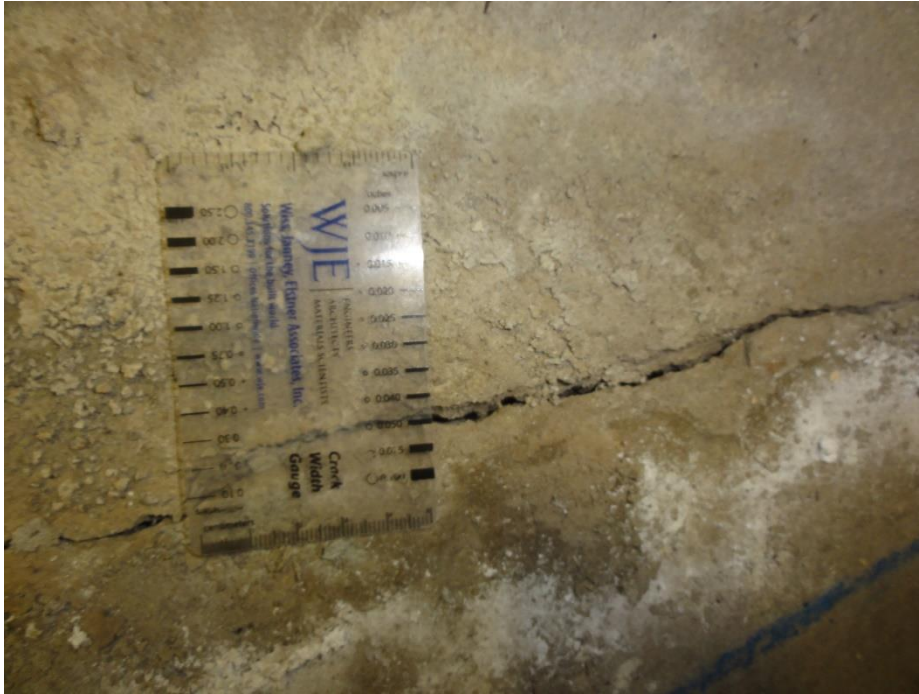
Figure 15. Measurement of a crack at the topping slab of the pump room

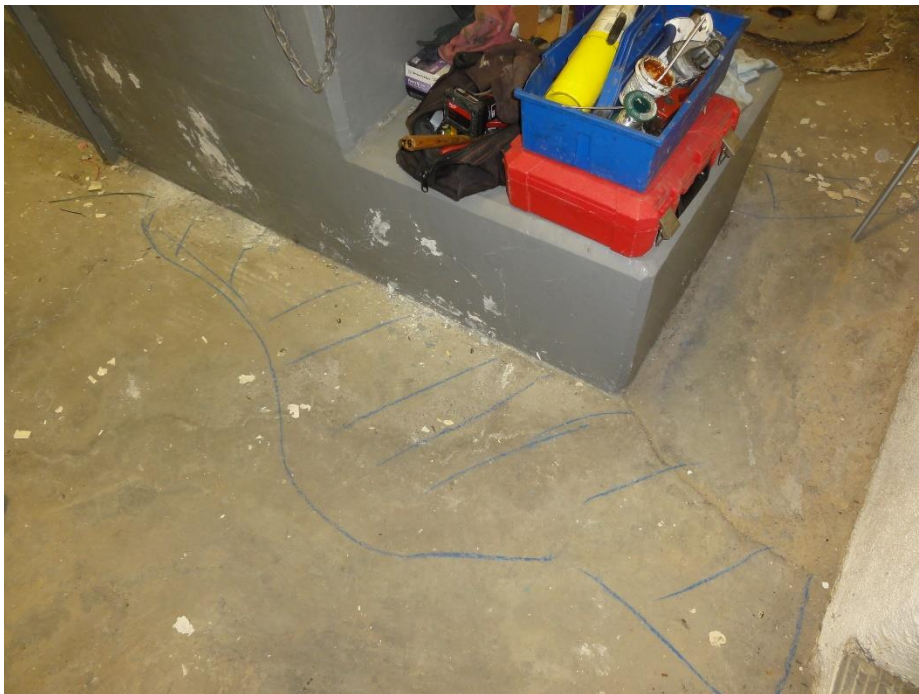
Figure 16. Noted delamination, adjacent to a pipe support pedestal, highlighted in blue

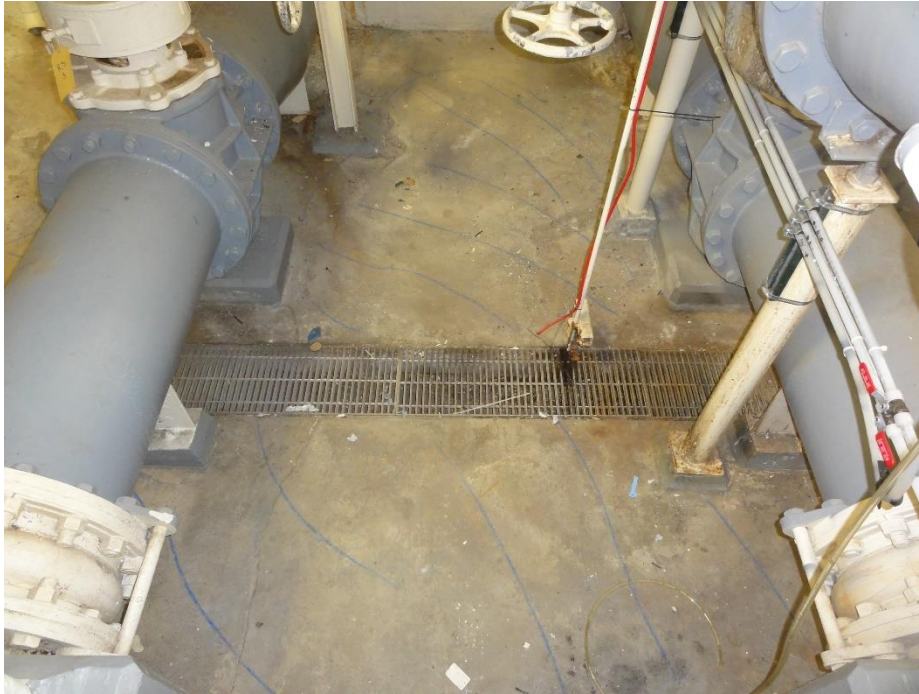
Figure 17. Noted delamination, adjacent to the central trench drain, highlighted in blue

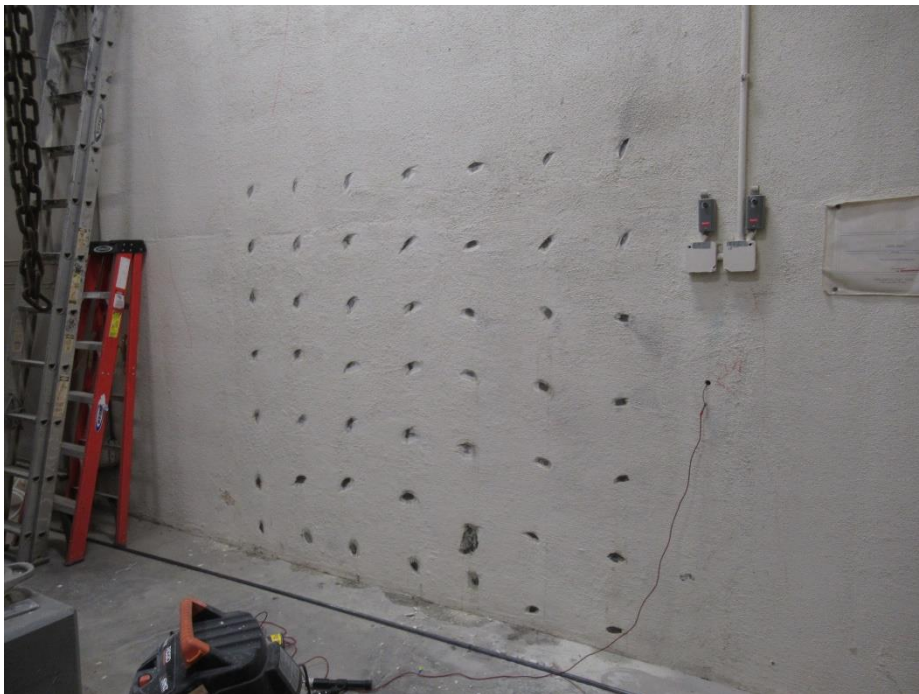
Figure 18. Overall view of HCP testing at south elevation wall

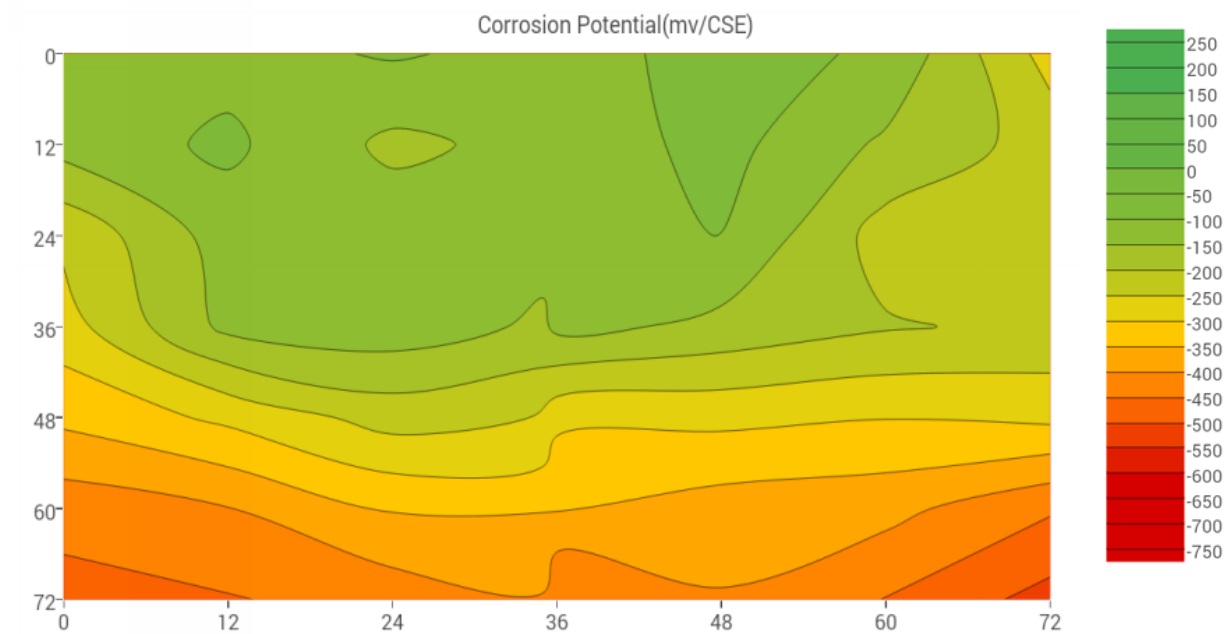
Figure 20. Half-cell potential data at the south elevation interior foundation wall (shown in Figure 18). The color scale is in mV and the reference electrode is a CSE

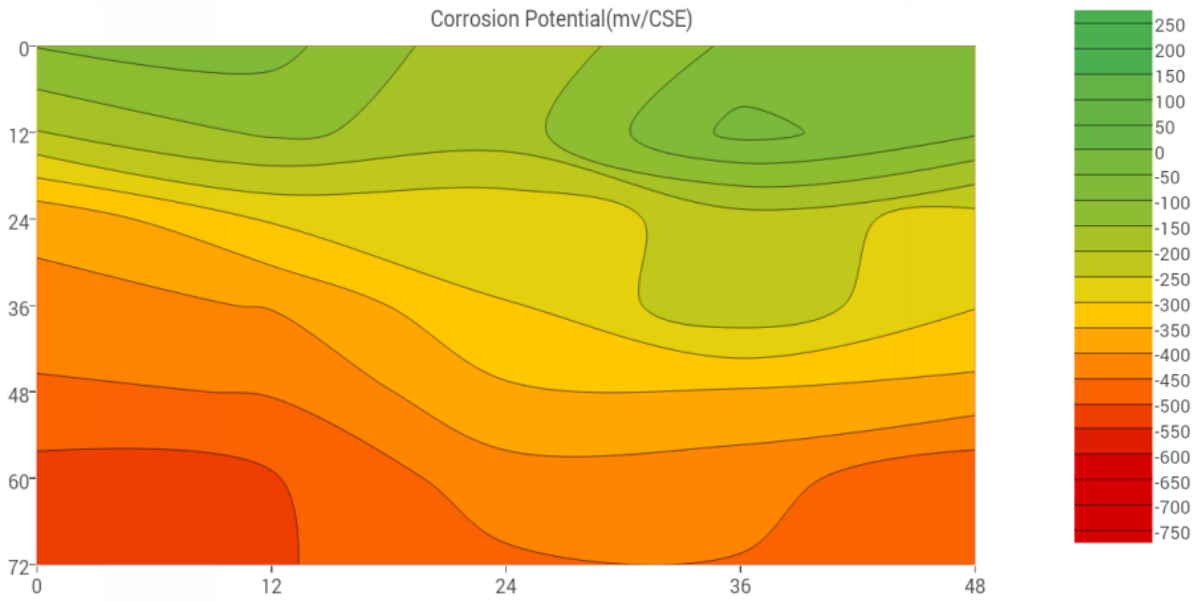
Figure 21. Half-cell potential data at the north elevation interior foundation wall (shown in Figure 19). The color scale is in mV and the reference electrode is a CSE

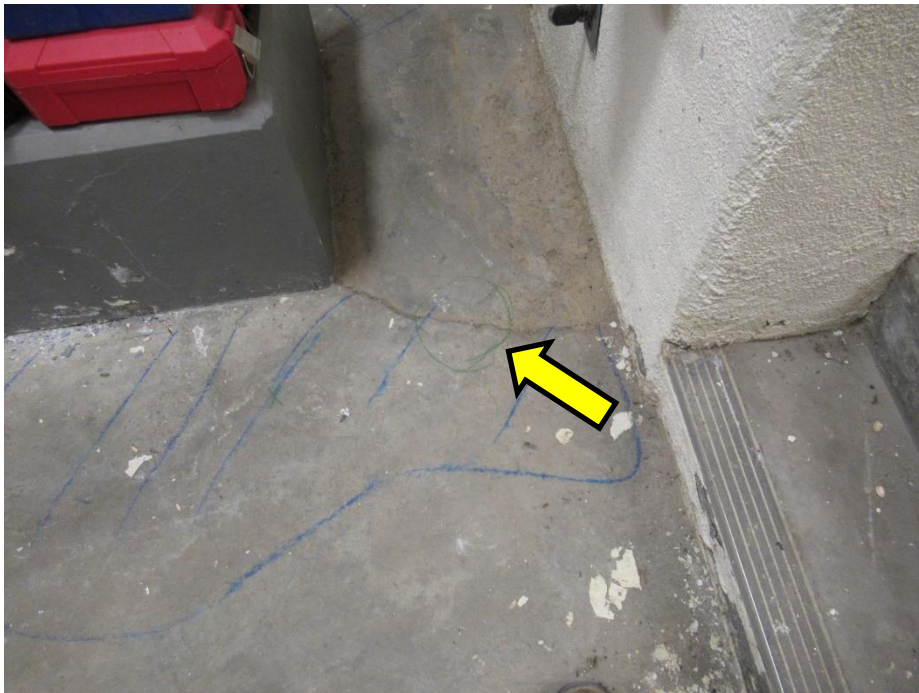
Figure 22. Core location through topping slab crack

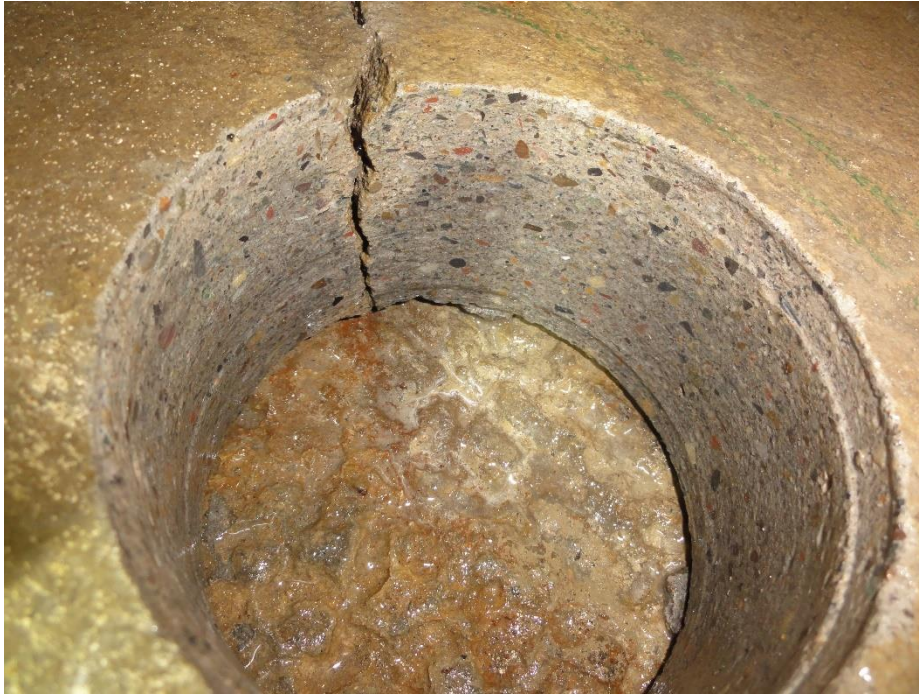
Figure 23. Topside of structural slab present after removal of topping slab. Note that the topping slab crack does not continue into the structural slab below.

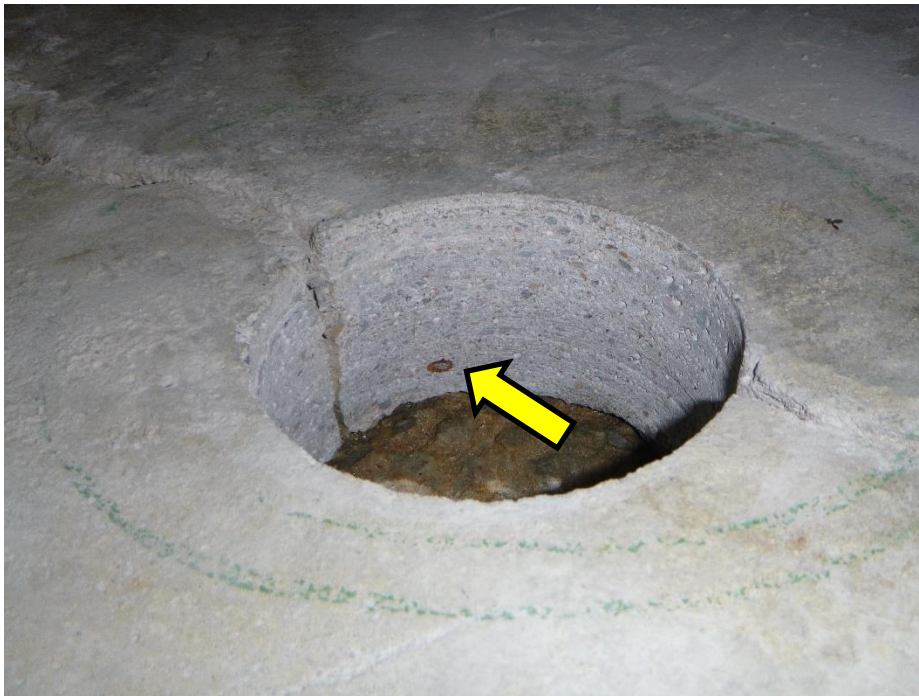
Figure 24. WWR observed near the bottom surface of the extracted core

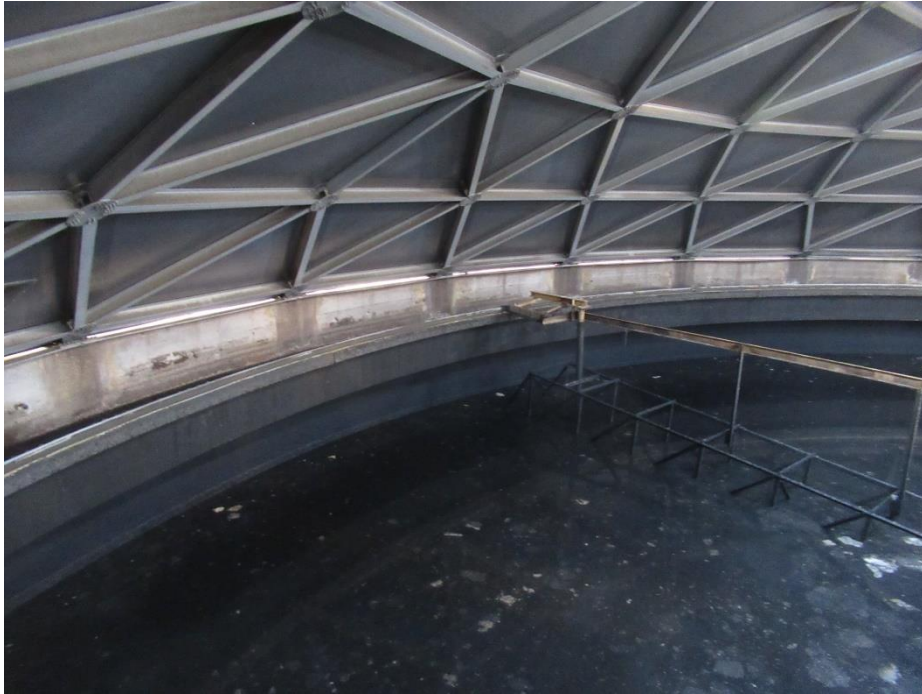
Figure 25. Overall view of the interior of the primary clarifier

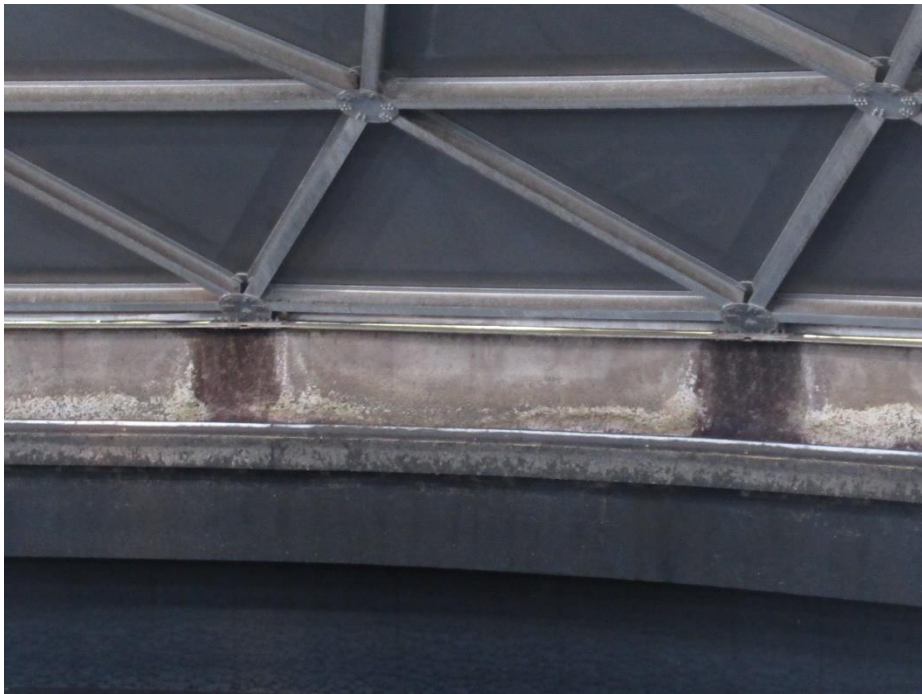
Figure 26. Moisture staining present beneath roof attachment locations

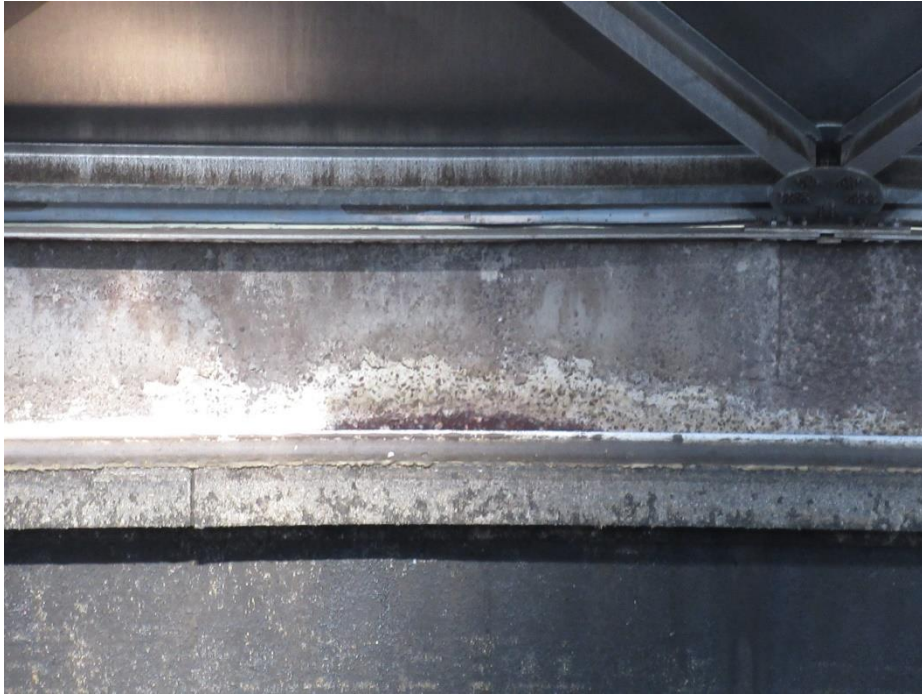
Figure 27. Paste erosion within the effluent trough

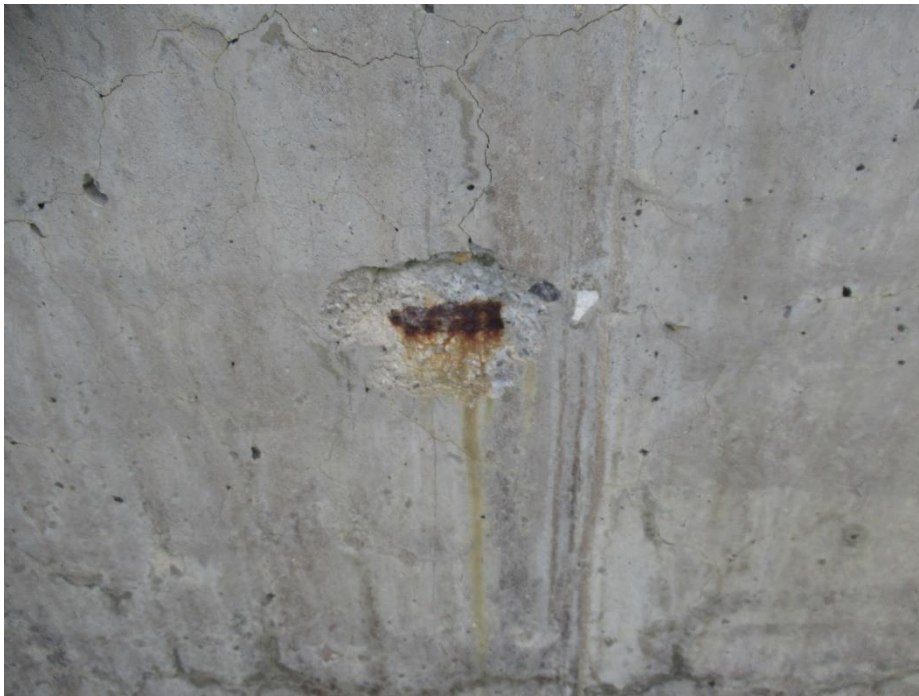
Figure 30. Isolated exposed and corroded reinforcing bar

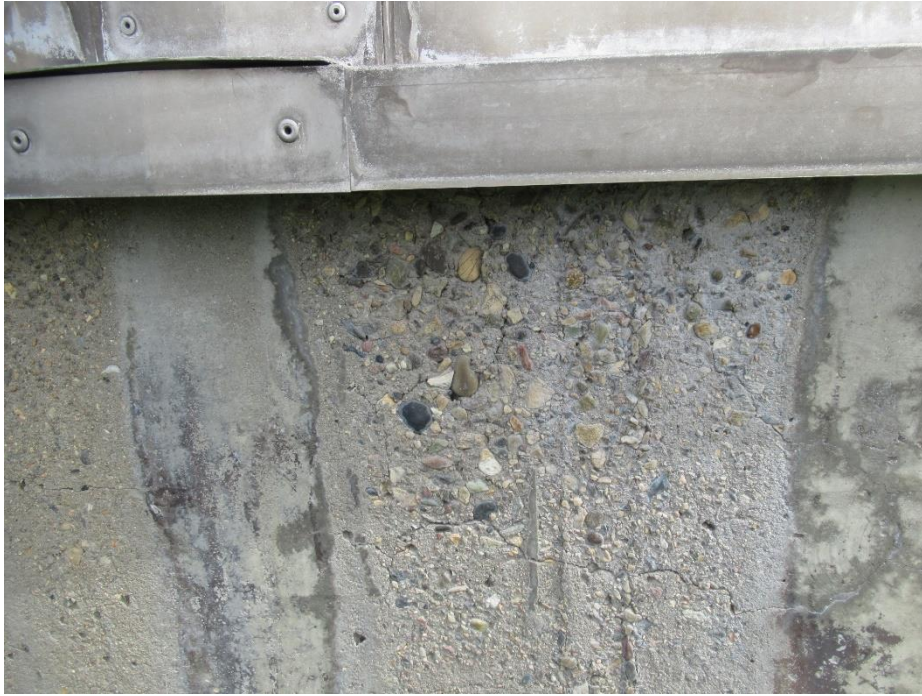
Figure 31. Paste erosion at exterior of clarifier walls

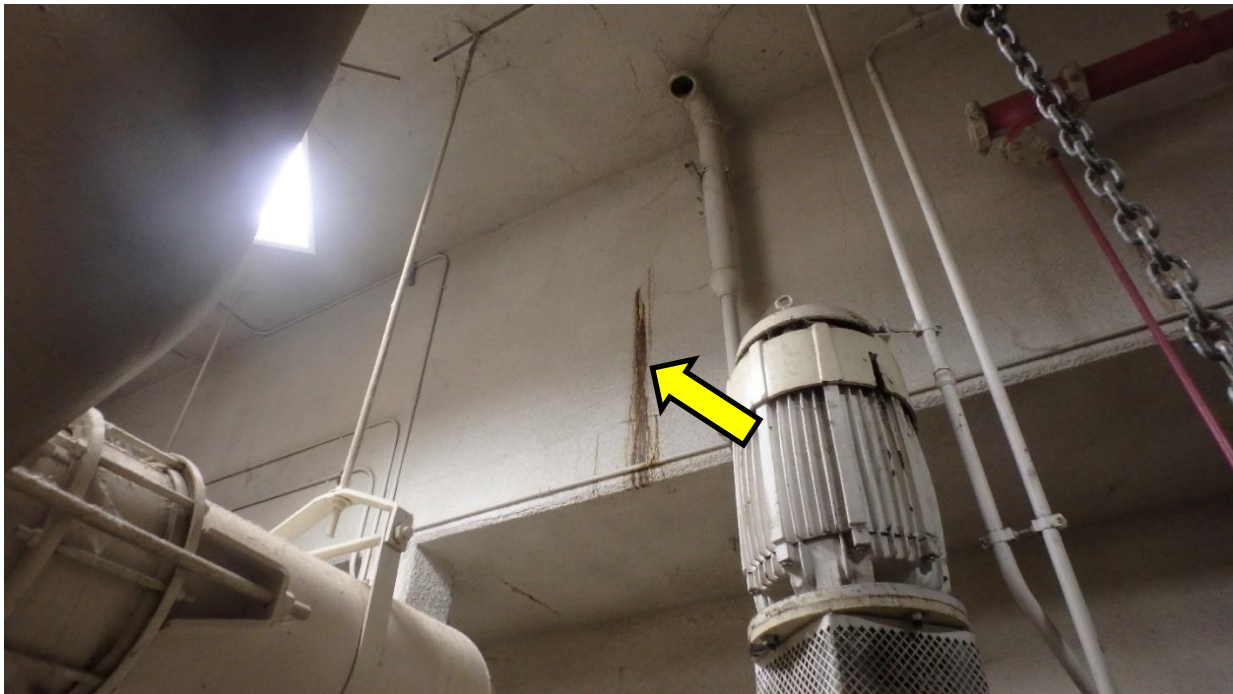
Figure 34. Staining at elevated trough

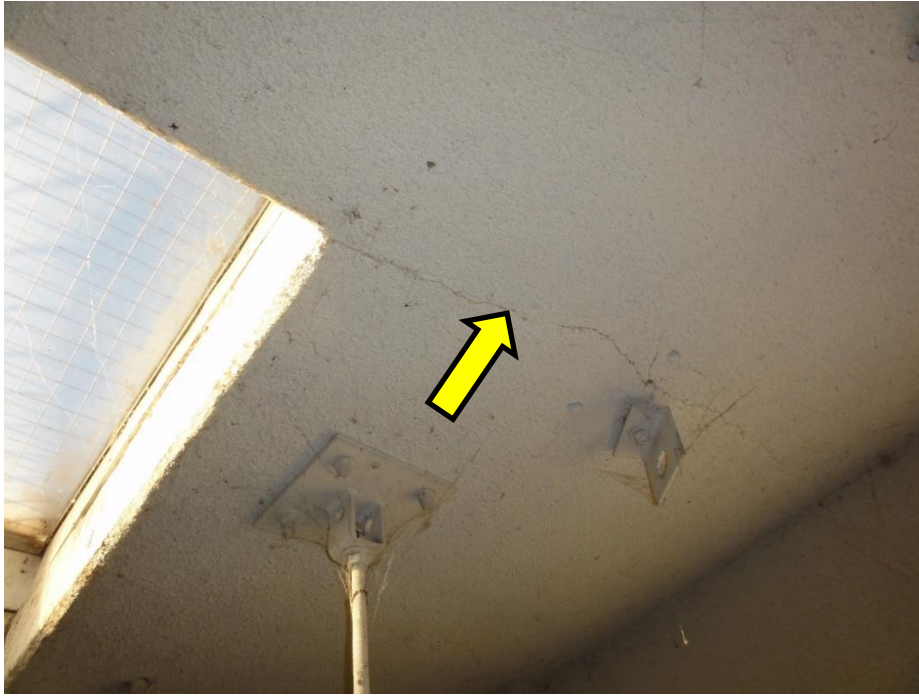
Figure 35. Re-entrant corner cracking at blower room skylight, as observed on the soffit of the ground floor slab
