PERSIGO WASTE WATER TREATMENT PLANT Structural Condition Assessment

2145 River Road
Grand Junction, Colorado 81505

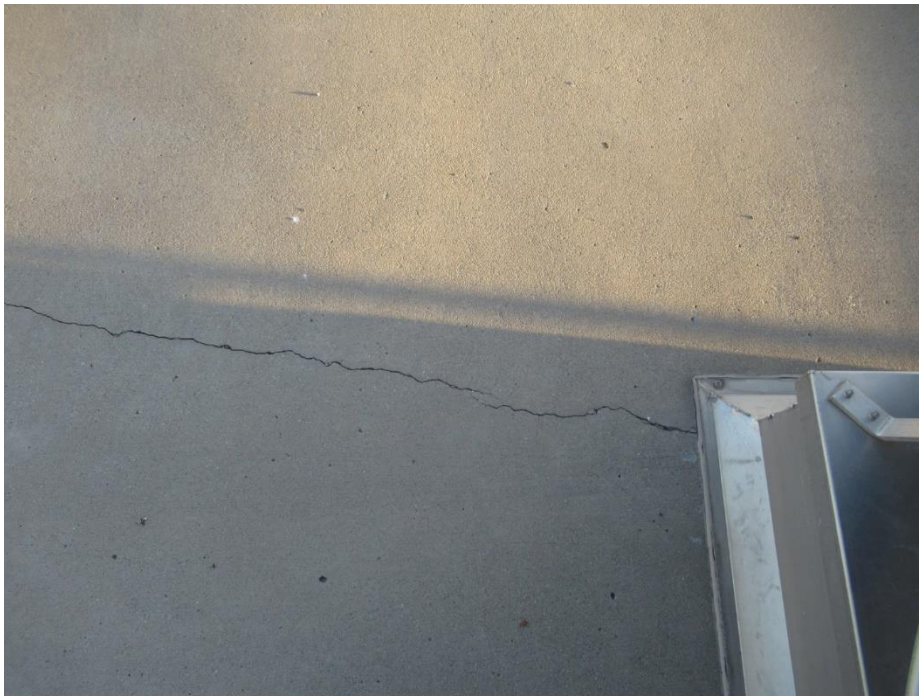
Figure 36. Re-entrant corner cracking at blower room skylight, as observed on the top surface of the ground floor slab

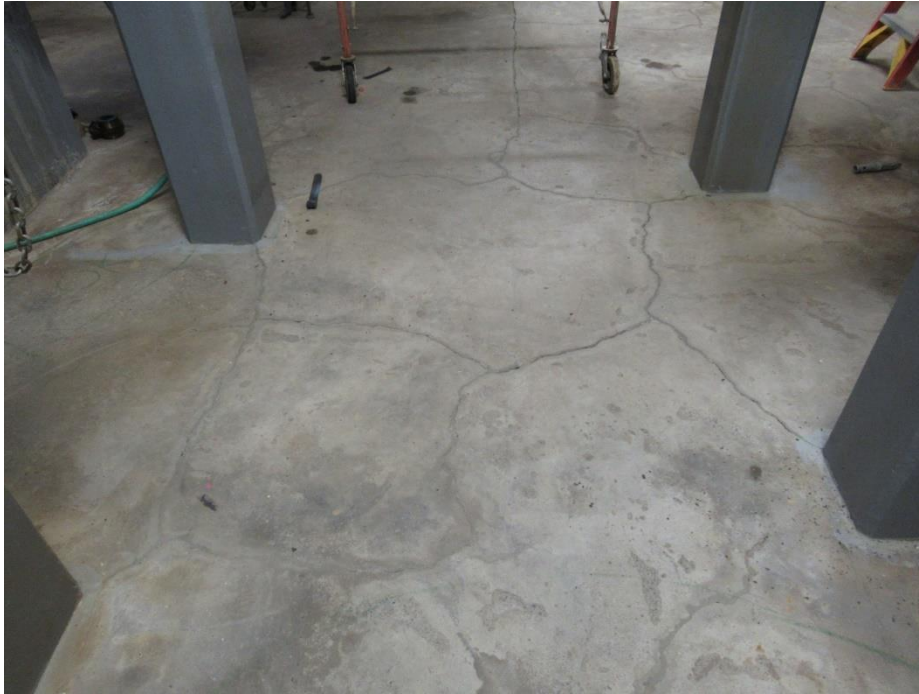
Figure 37. Typical topping slab cracking

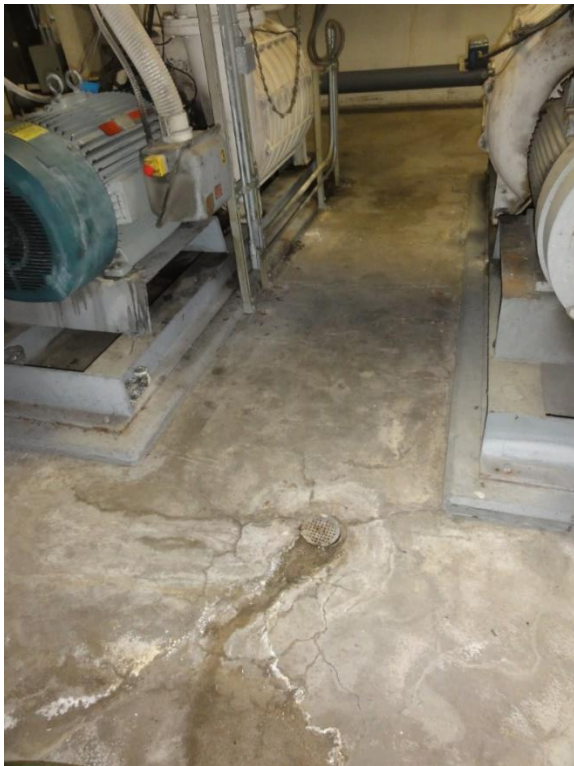
Figure 38. Evidence of ponding water at existing floor drain

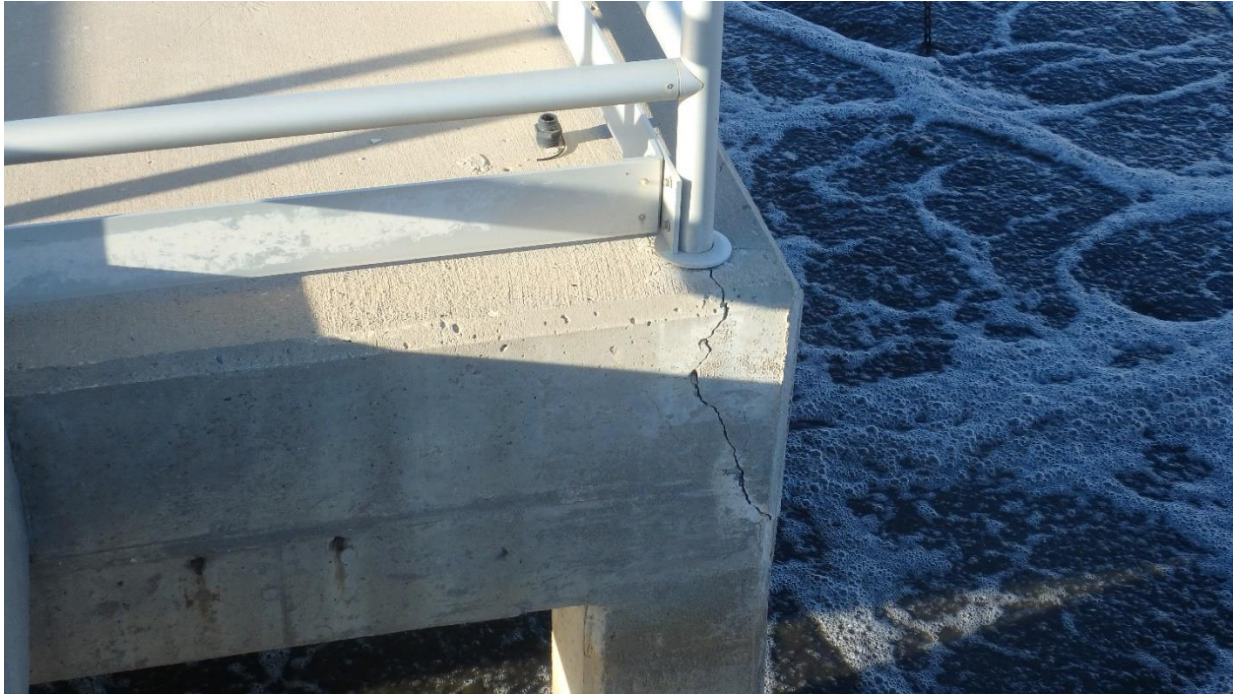
Figure 39. Incipient spall at guardrail post embed

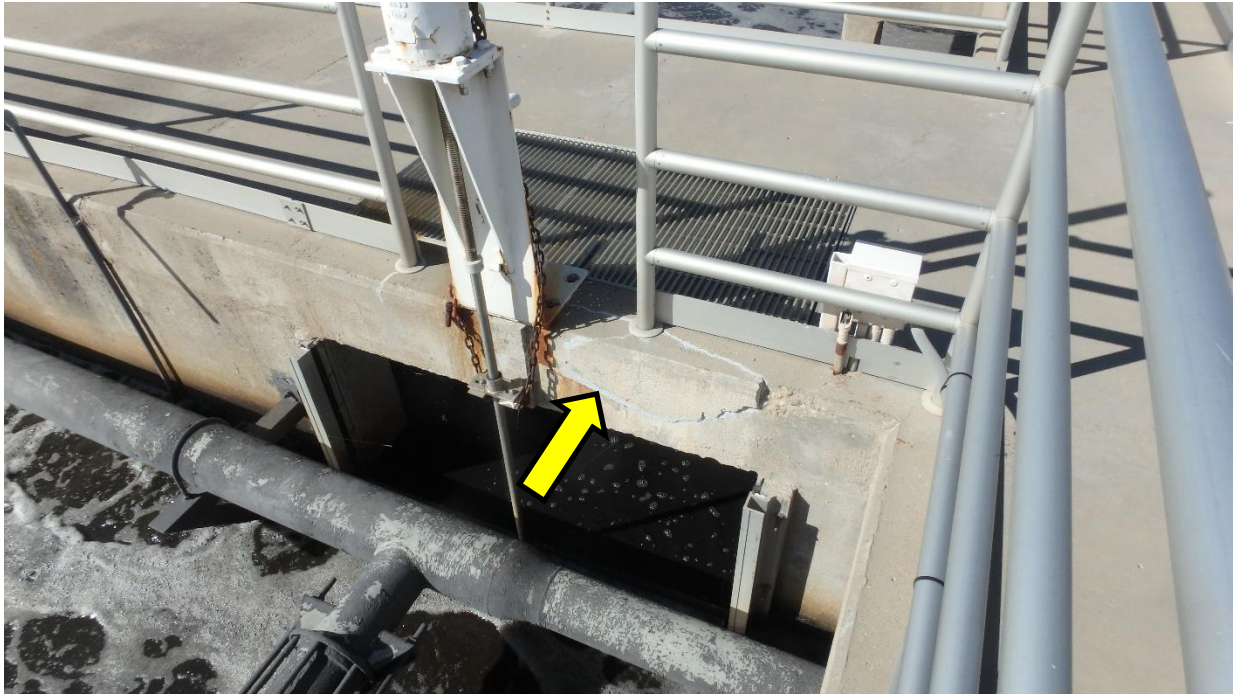
Figure 40. Previously installed sealant at incipient spall location

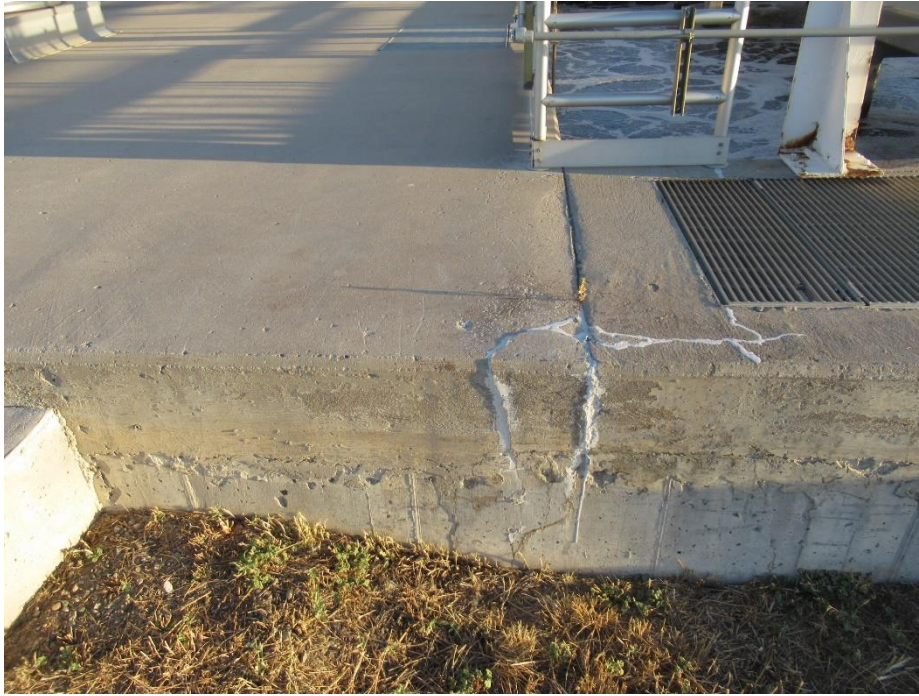
Figure 41. Previously installed sealant at incipient spall location

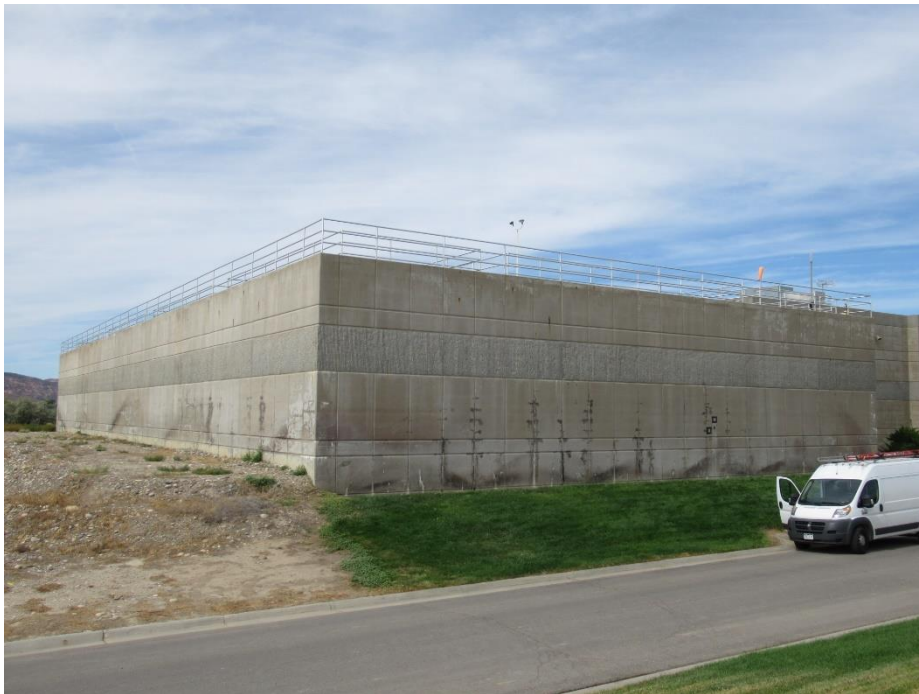
Figure 42. Overall view of the east elevation of the Aerobic Digester

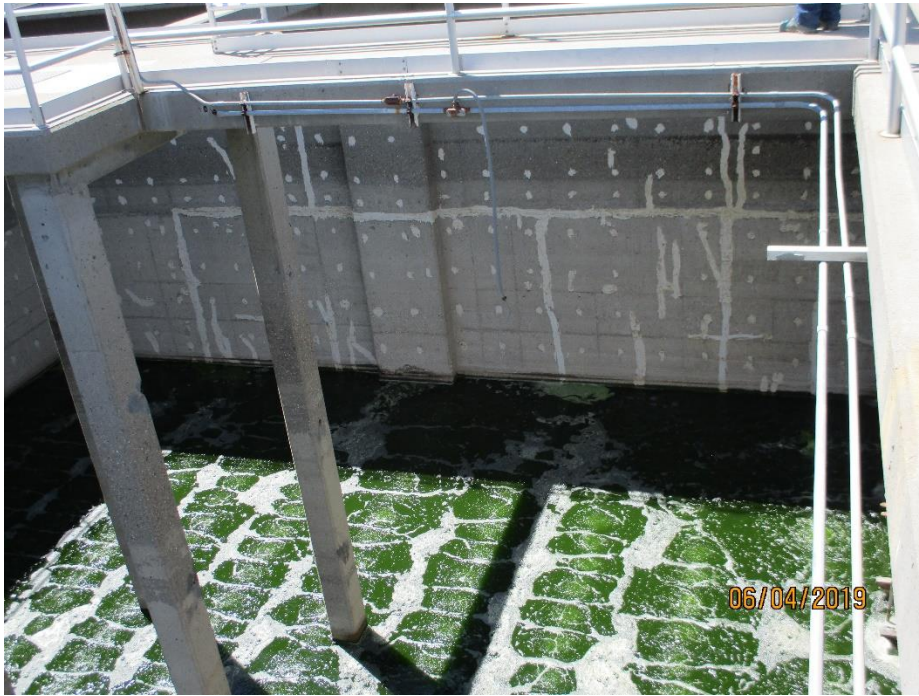
Figure 45. Previous crack repair attempt at the digester basin walls

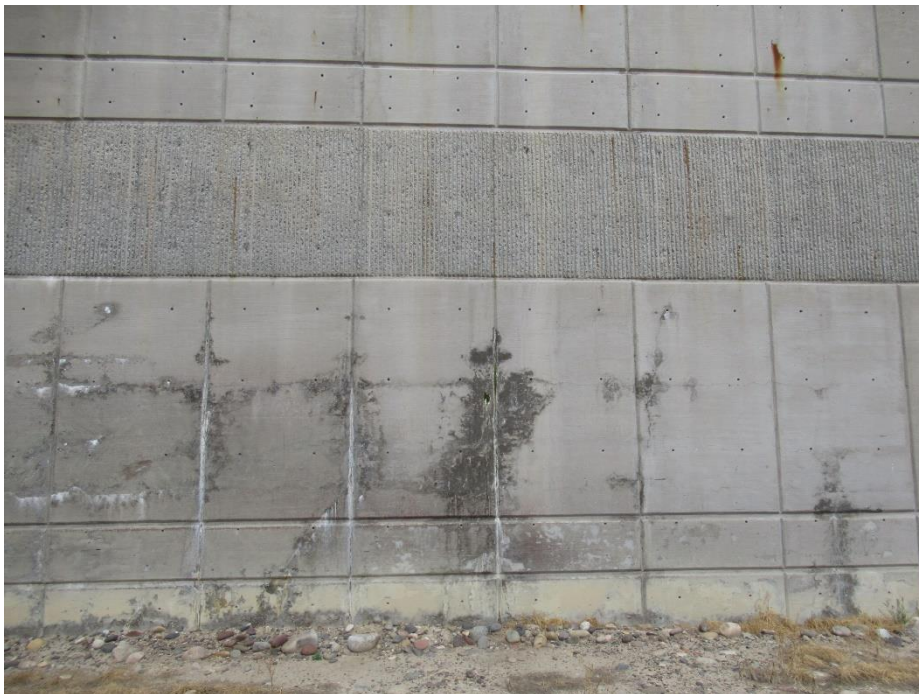
Figure 46. Evidence of moisture intrusion and efflorescence staining at reveal joints

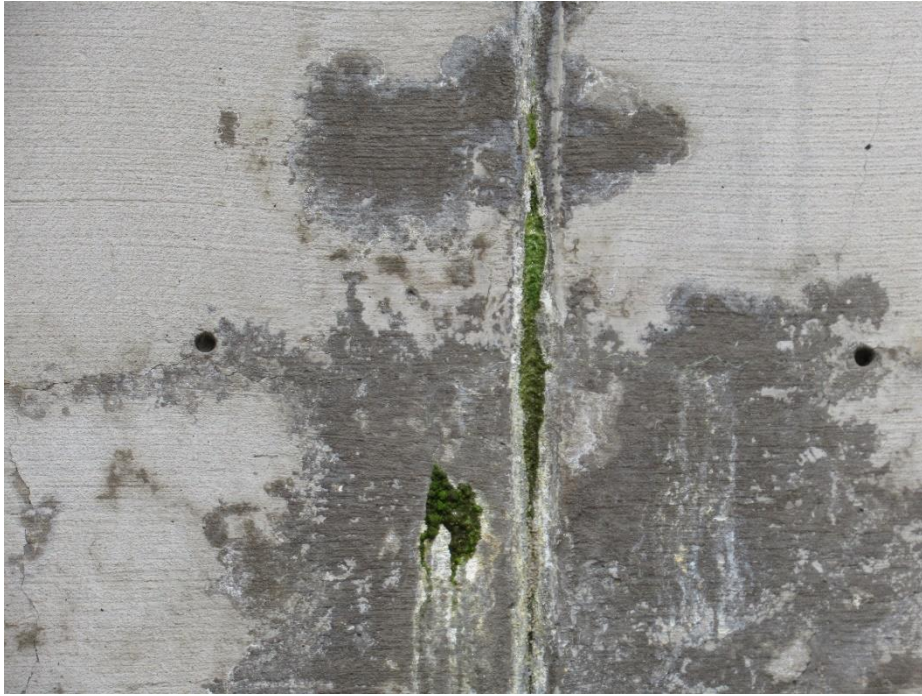
Figure 47. Evidence of moisture intrusion and potential organic growth staining at reveal joint

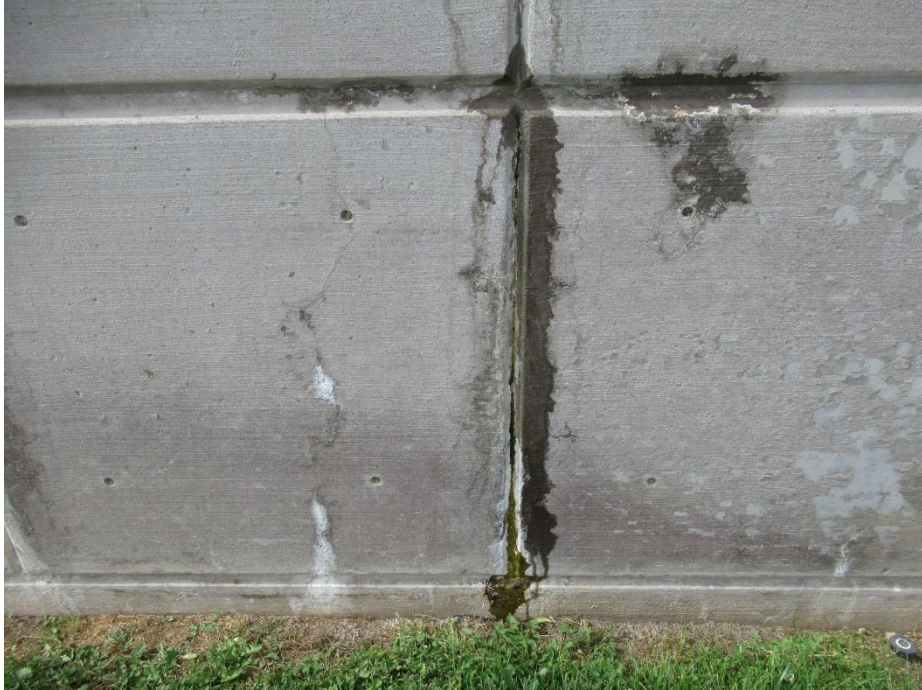
Figure 48. Actively leaking crack within reveal joint

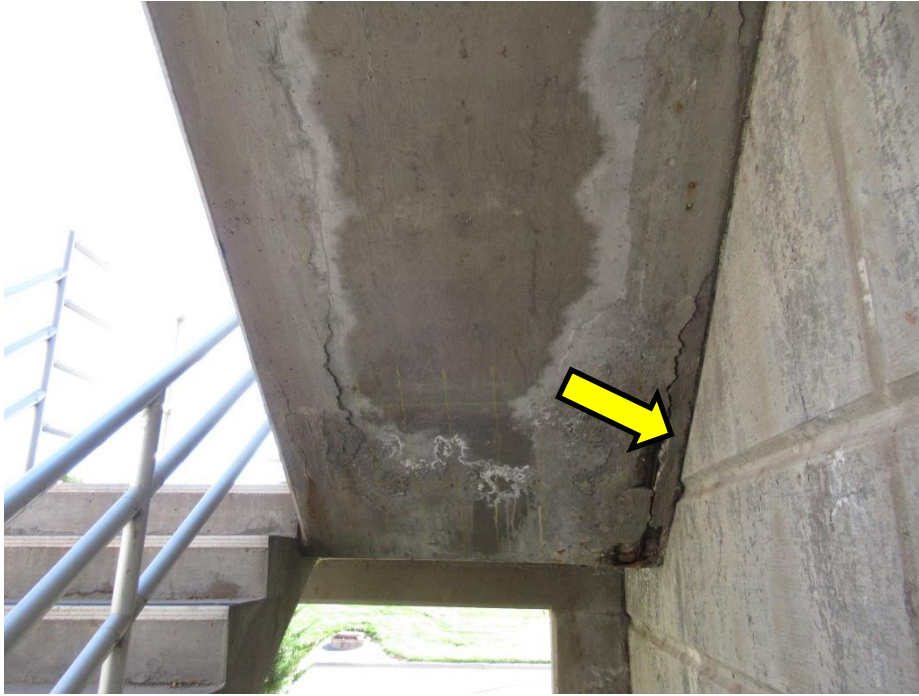
Figure 49. Overall view of the soffit of the ground level stairwell, with noted cracking, spalls, and exposed corroded reinforcing

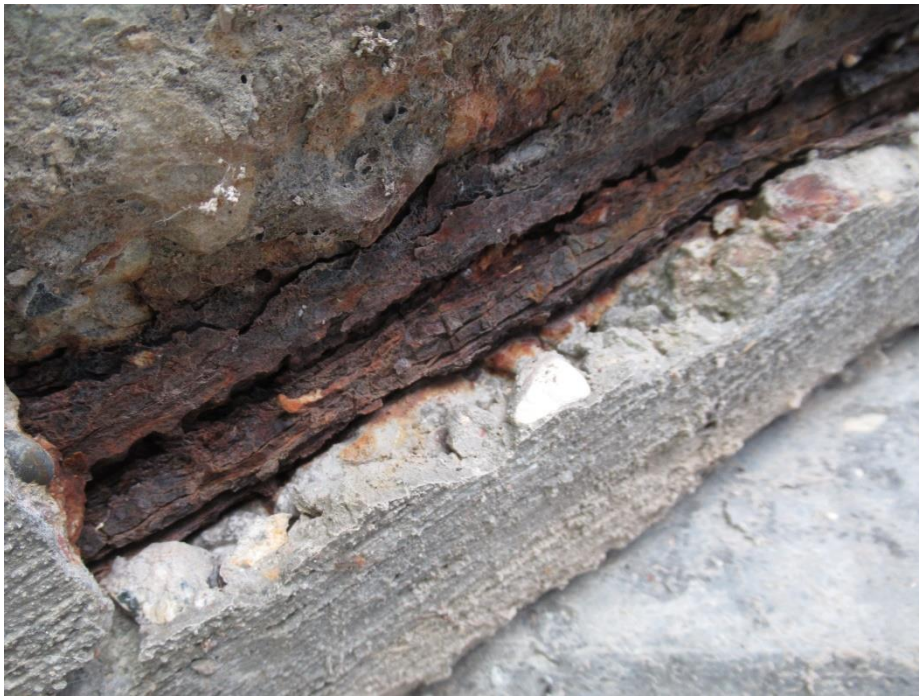
Figure 50. Up-close view of exposed corroded reinforcing at the soffit of the ground level stairs

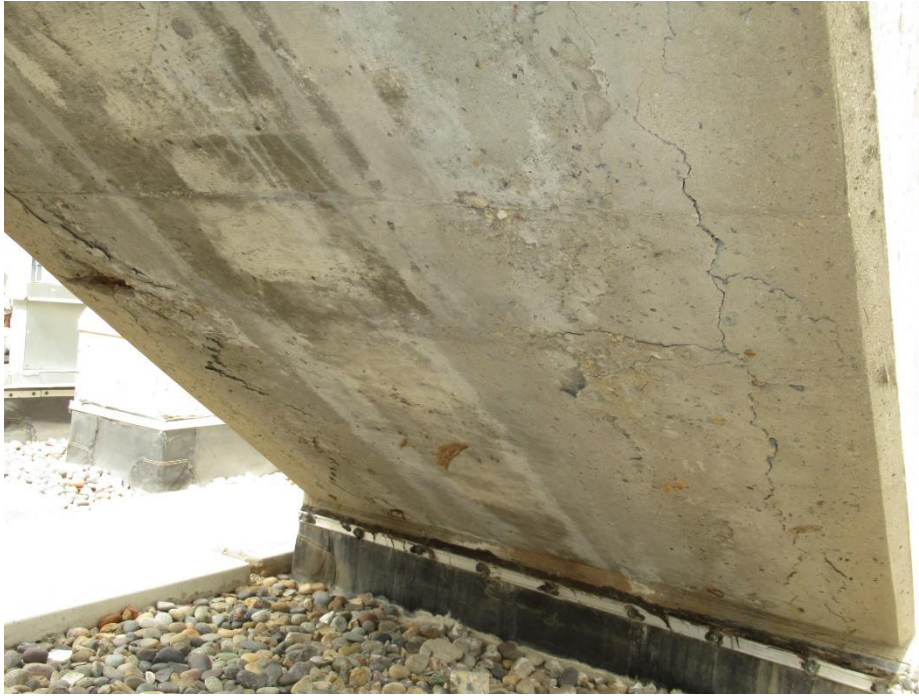
Figure 51. Overall view of the soffit of the roof level stairwell, with noted cracking and spalls

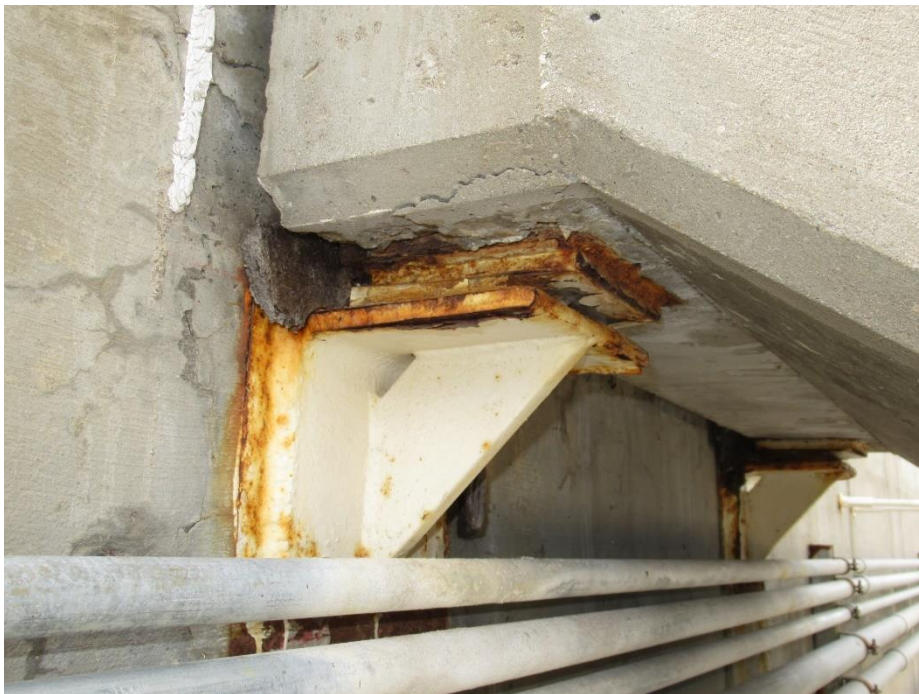
Figure 52. Surface corrosion on the upper support bearing angles and plates for the roof level stairwell

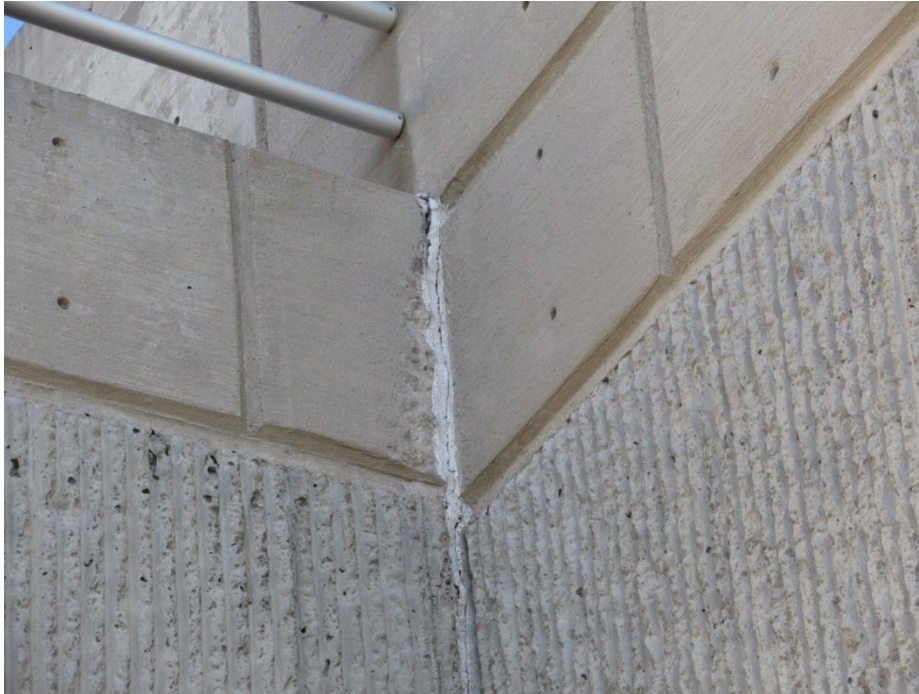
Figure 53. Failed sealant joint between Aerobic Digester and Sludge Processing Unit

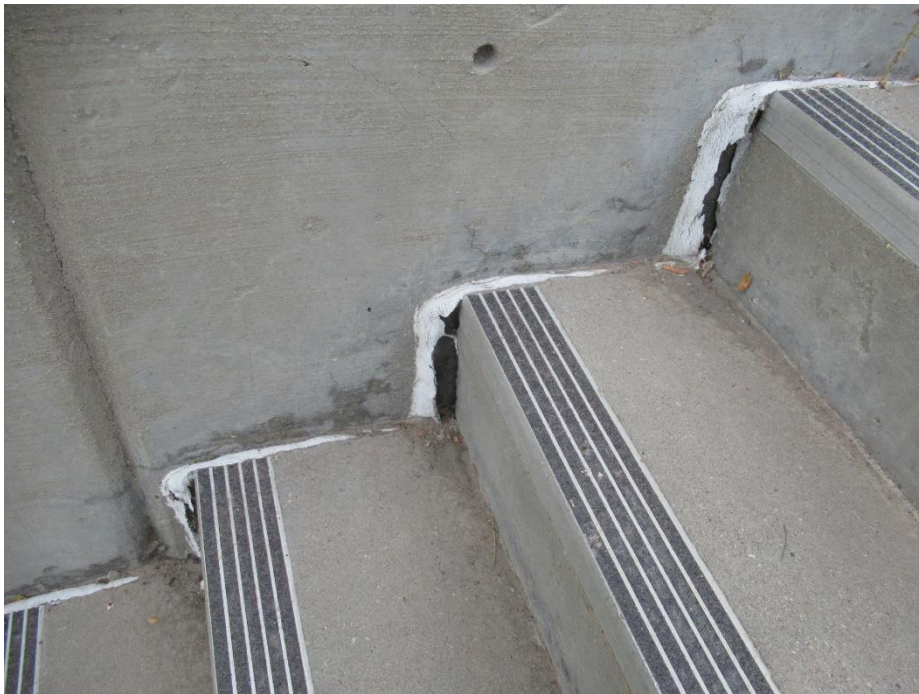
Figure 54. Sealant joint between the ground level stairs and the adjacent building face that had failed and was no longer in contact with both substrate surfaces

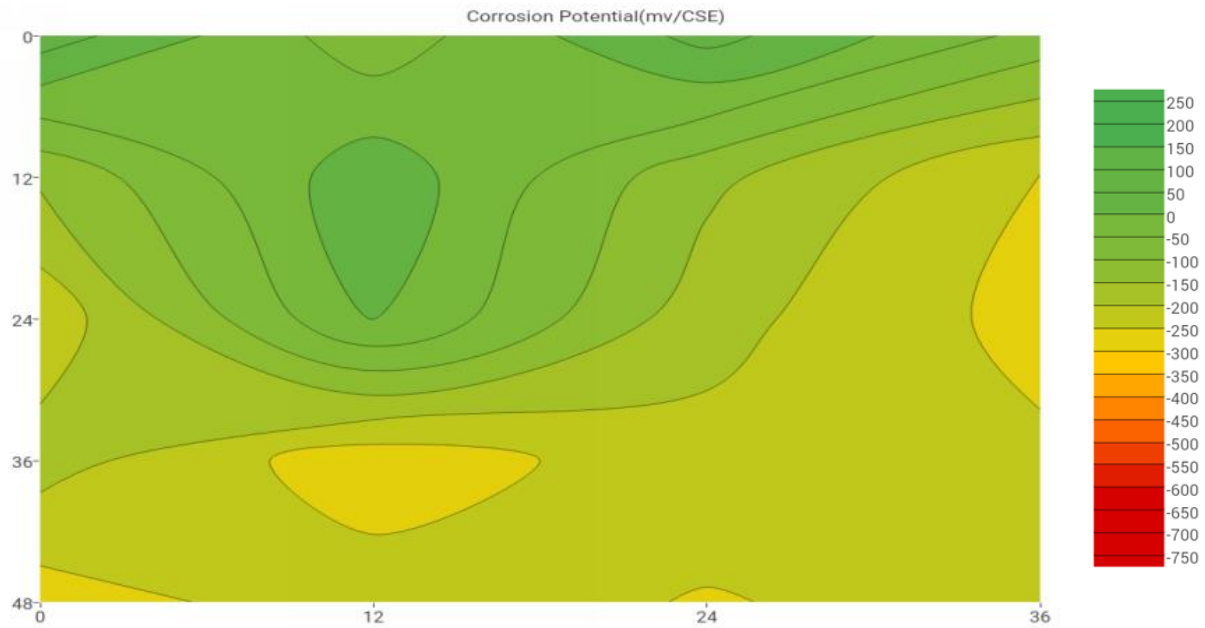
Figure 55. Half-cell potential data at the soffit of the aerobic digester stairwell (shown in Figure 49). The color scale is in mV and the reference electrode is a CSE

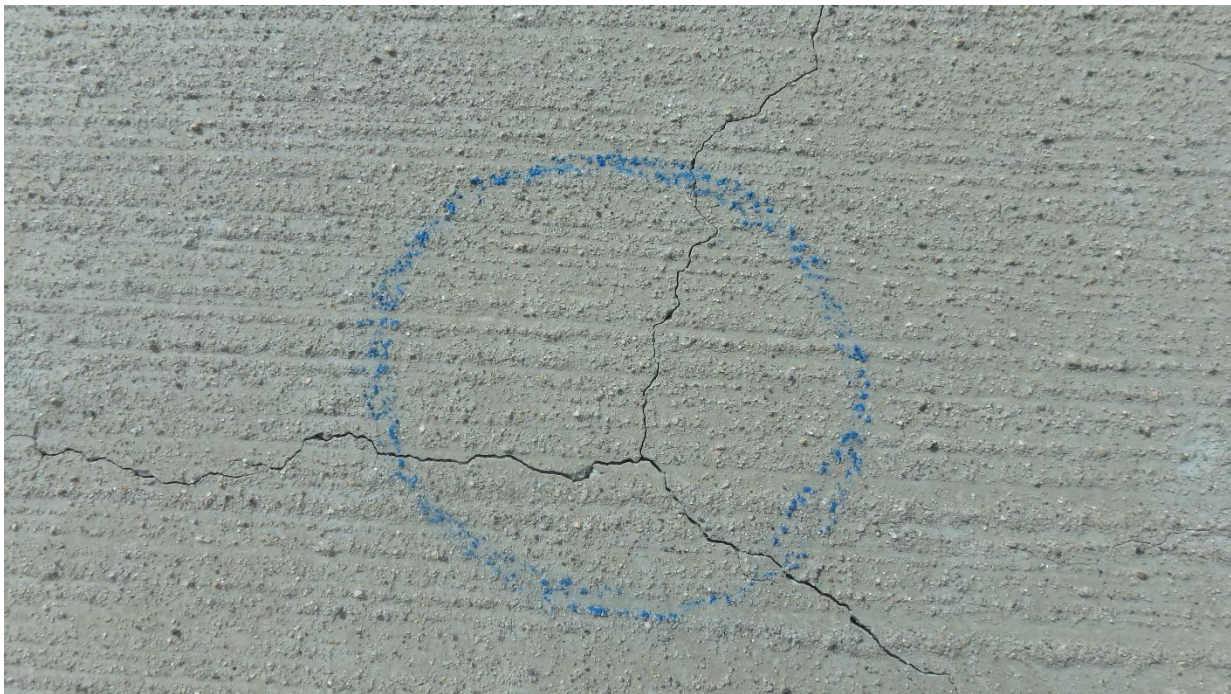
Figure 58. Core sample location at east elevation wall, intersecting multiple surface cracks

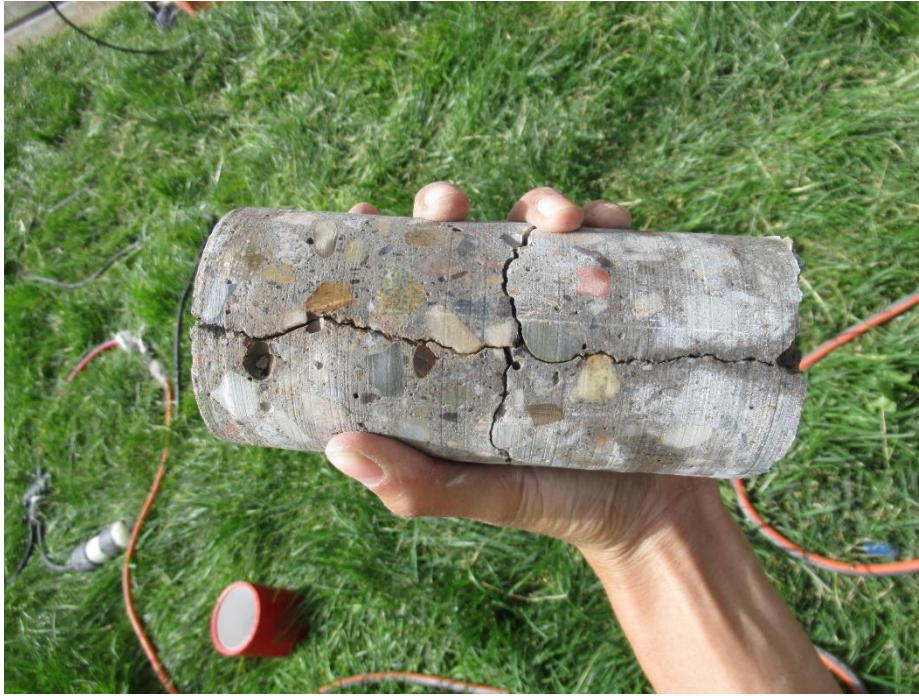
Figure 59. Partial-depth core sample obtained from area documented in Figure 58

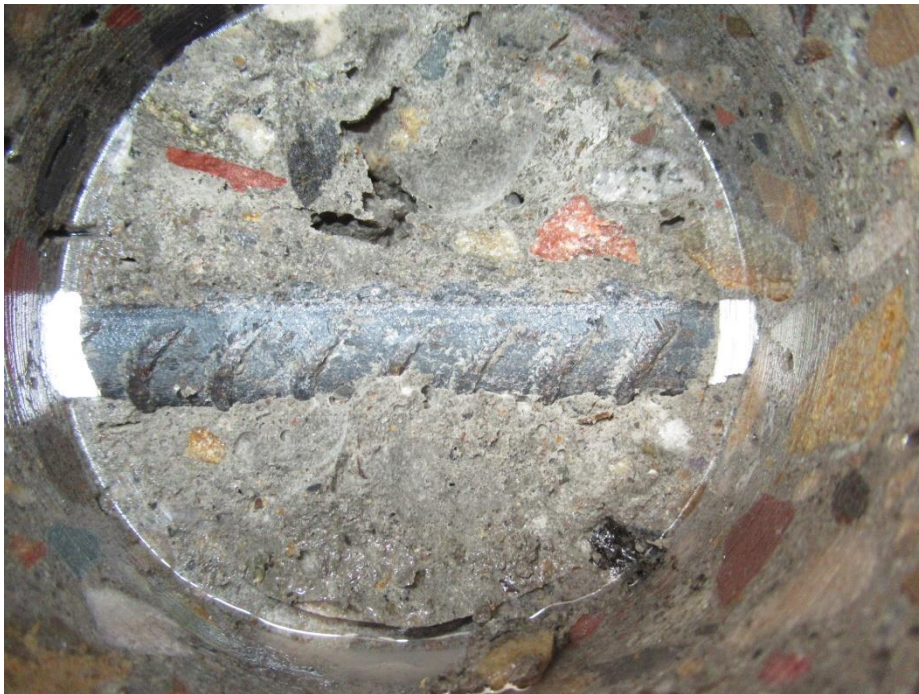
Figure 60. Exposed embedded reinforcing bar, with little to no surface corrosion present

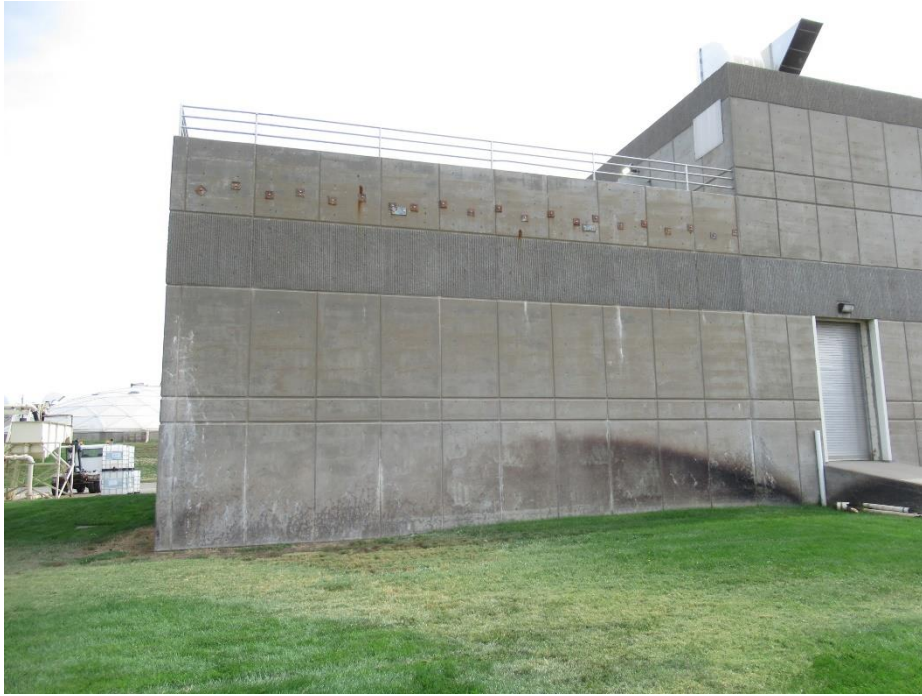
Figure 61. Overall view of the northwest corner of the Sludge Processing Unit

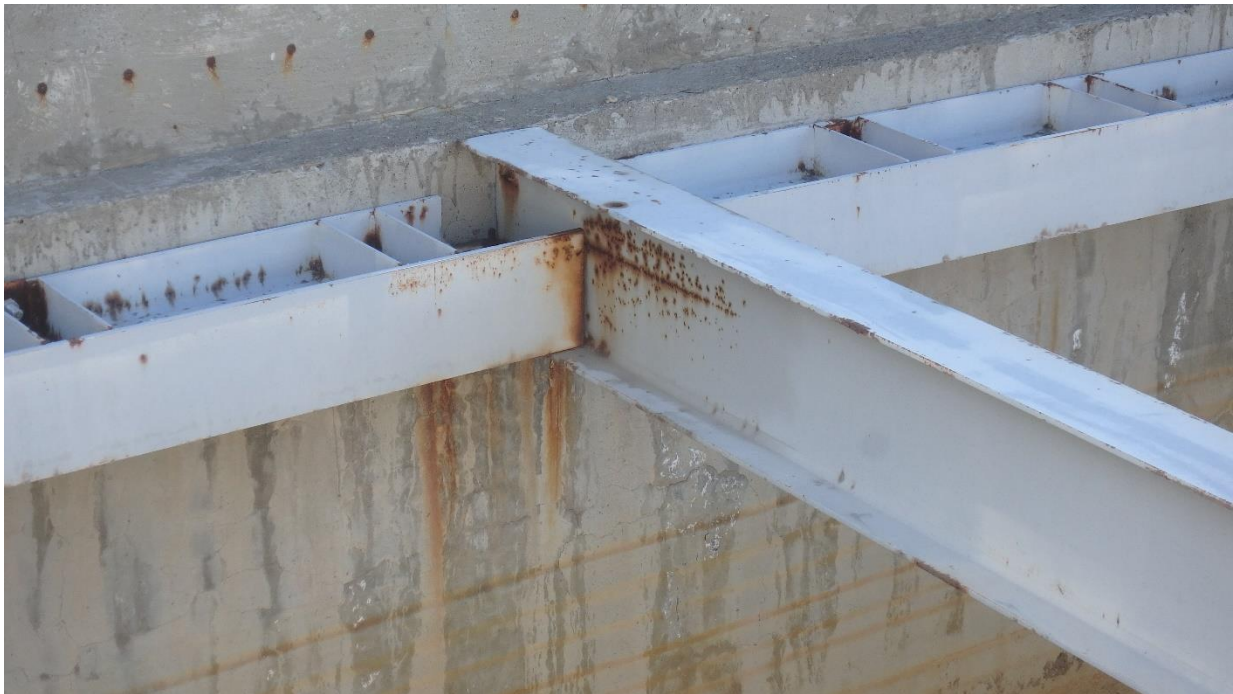
Figure 64. Surface corrosion on coated framing members

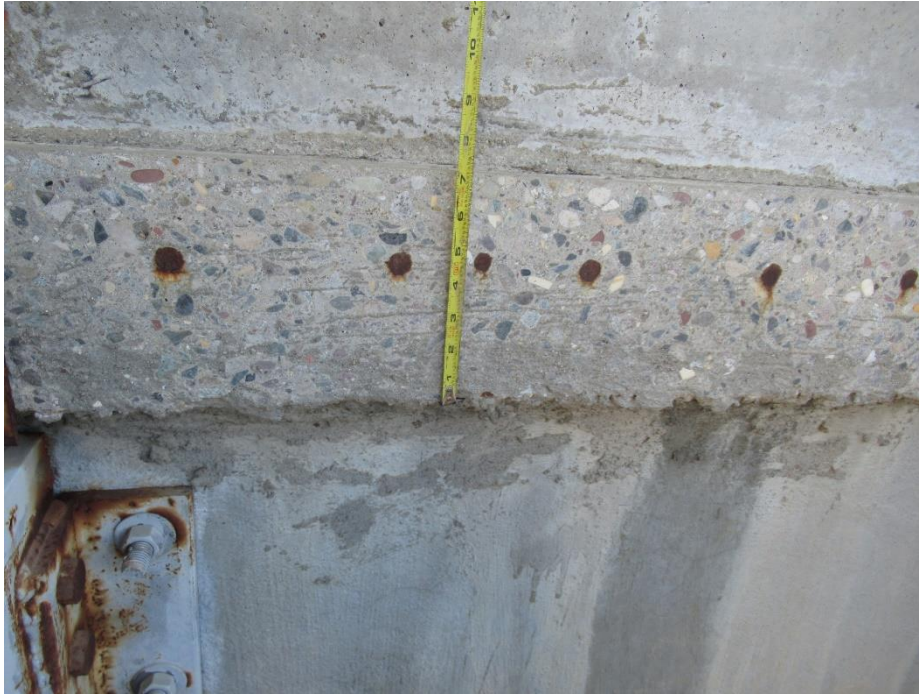
Figure 65. Surface corrosion on previously sawcut reinforcing, which was abandoned when concrete lid/roof was removed

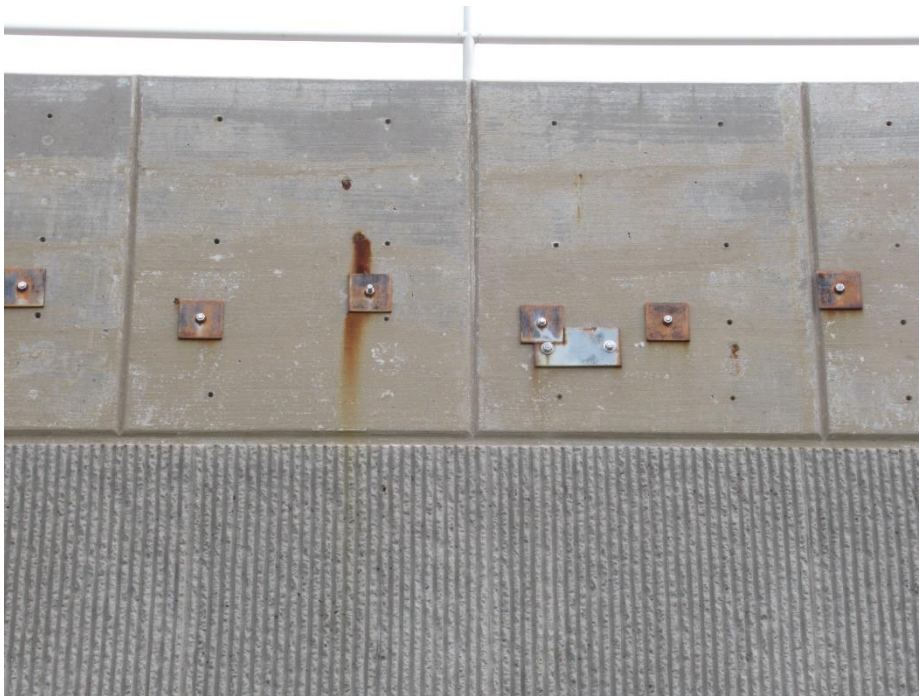
Figure 66. Corrosion of plate washers, as viewed from the exterior of the blending tank walls

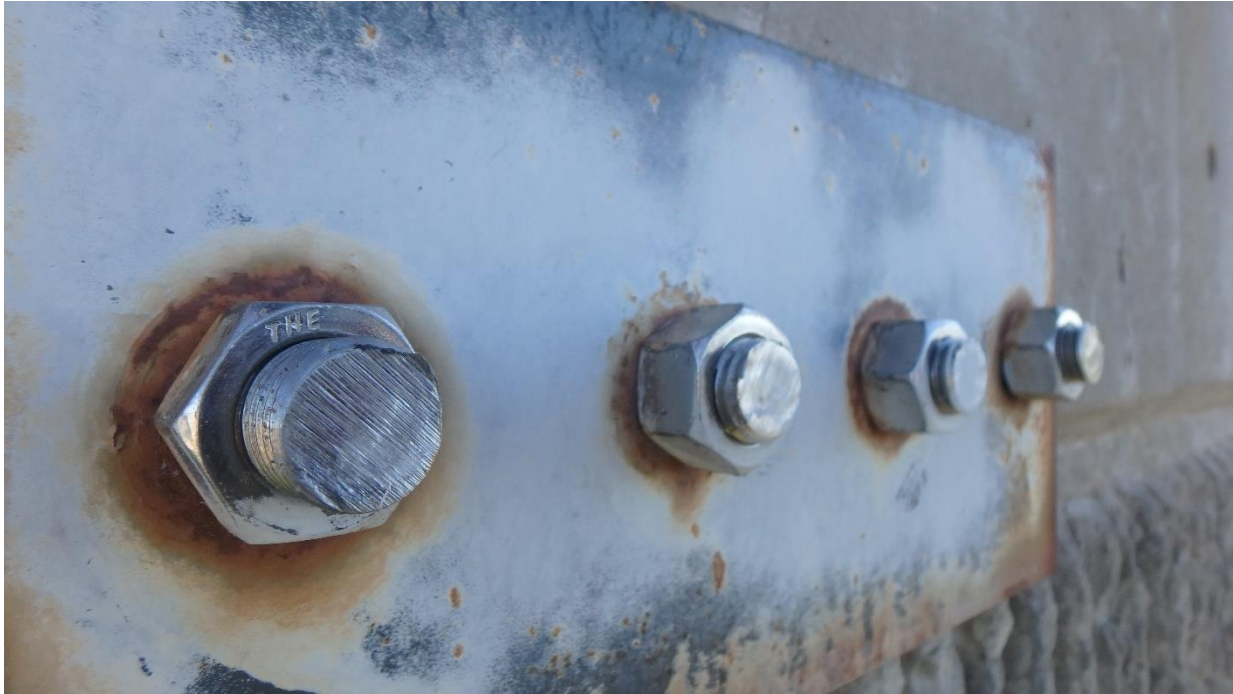
Figure 67. Corrosion of plate washers adjacent to bolt attachments, as viewed from the exterior of the blending tank walls

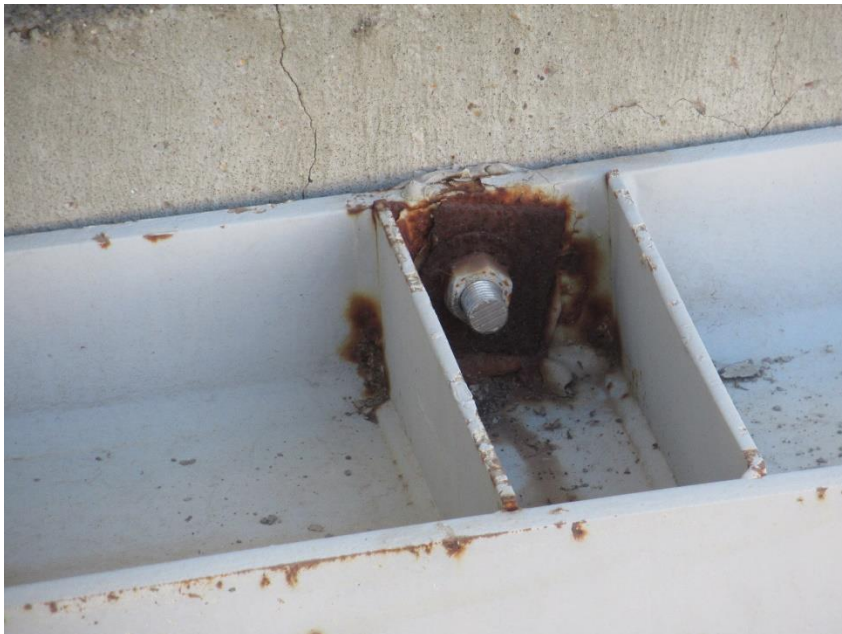
Figure 68. Corrosion of plate washers adjacent to bolt attachments, as viewed from the interior of the blending tank walls

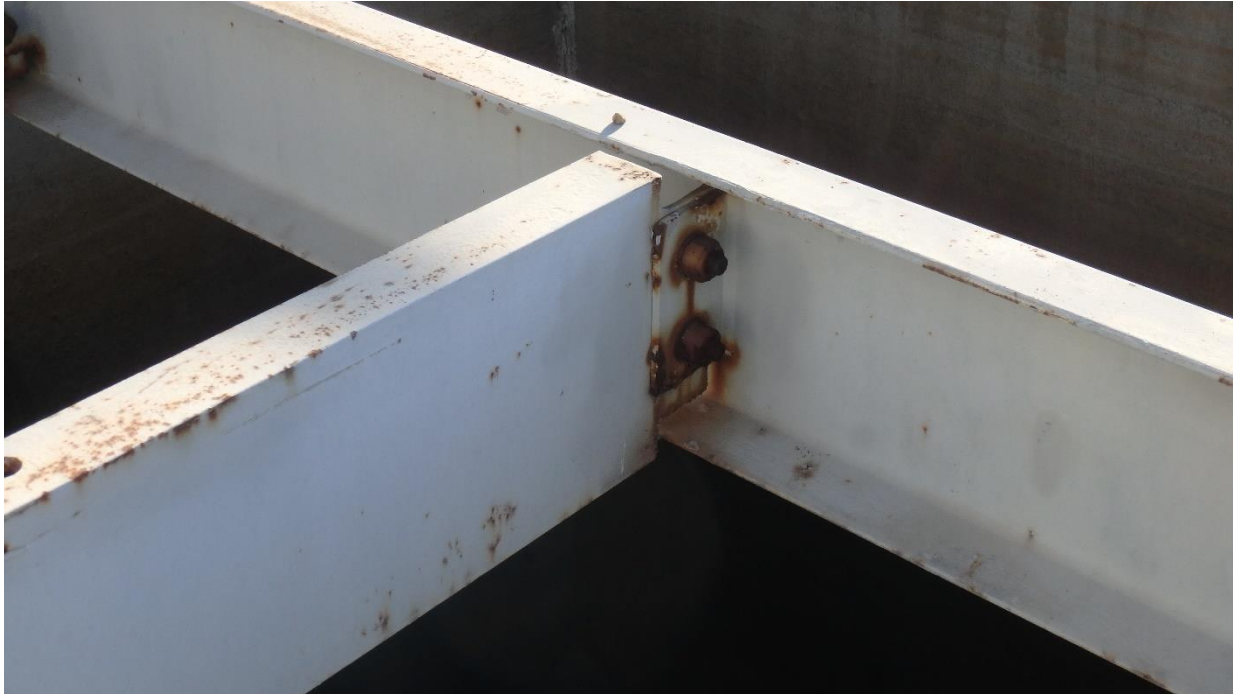
Figure 69. Corrosion on bolted connection for the interior framing support

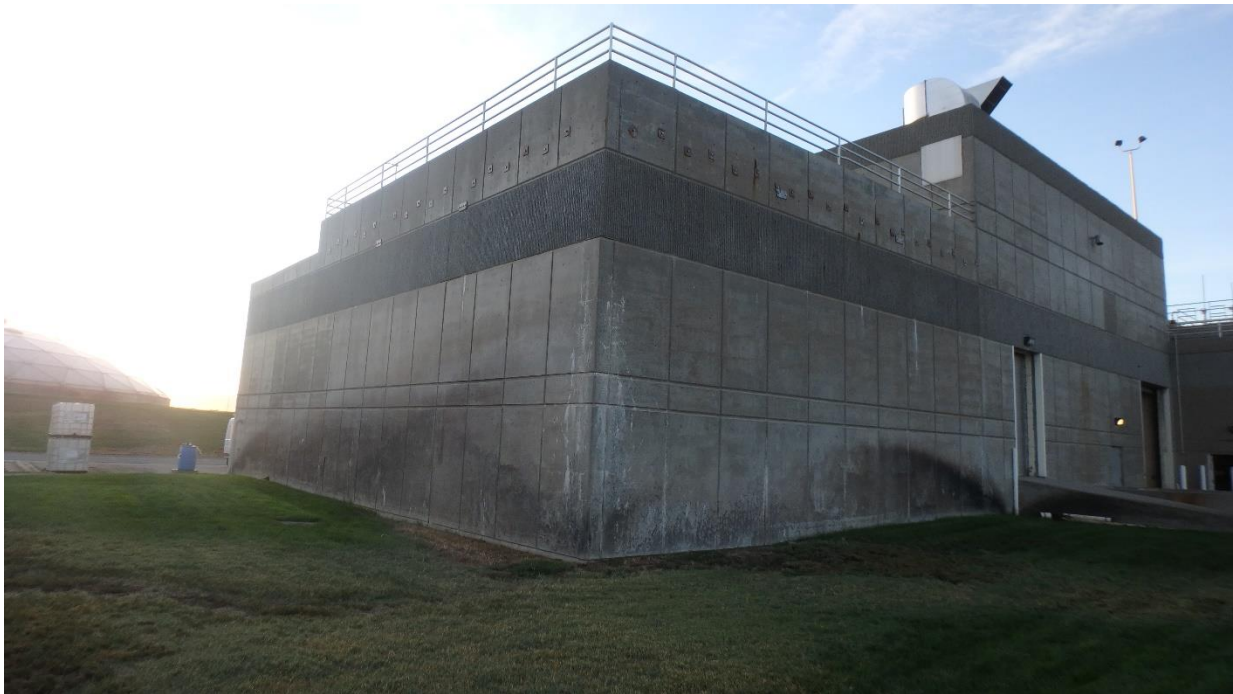
Figure 70. Noted efflorescence and staining at northwest corner of blending tank

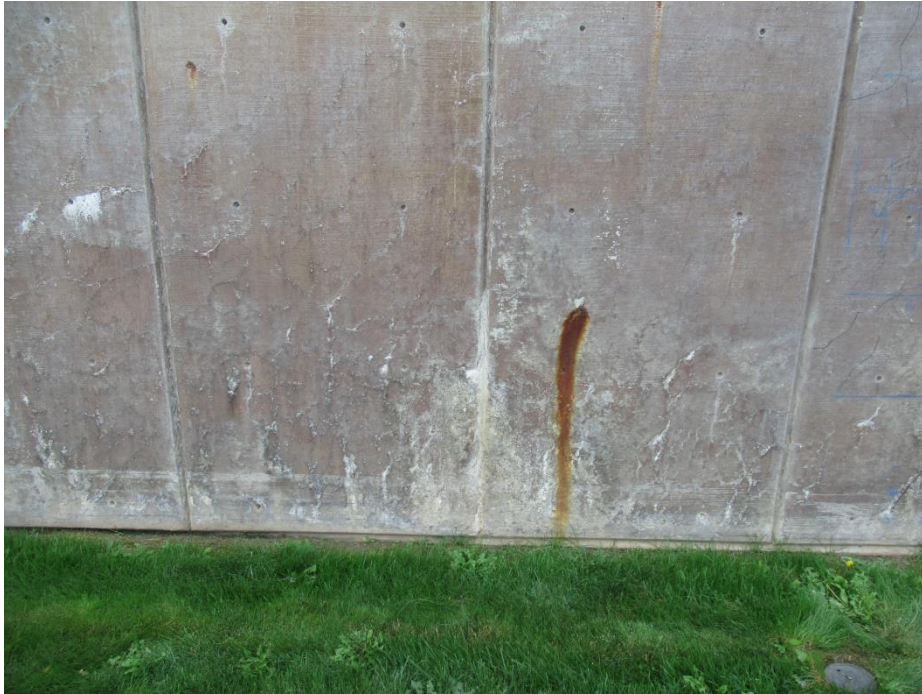
Figure 71. Noted efflorescence at panel reveal joint

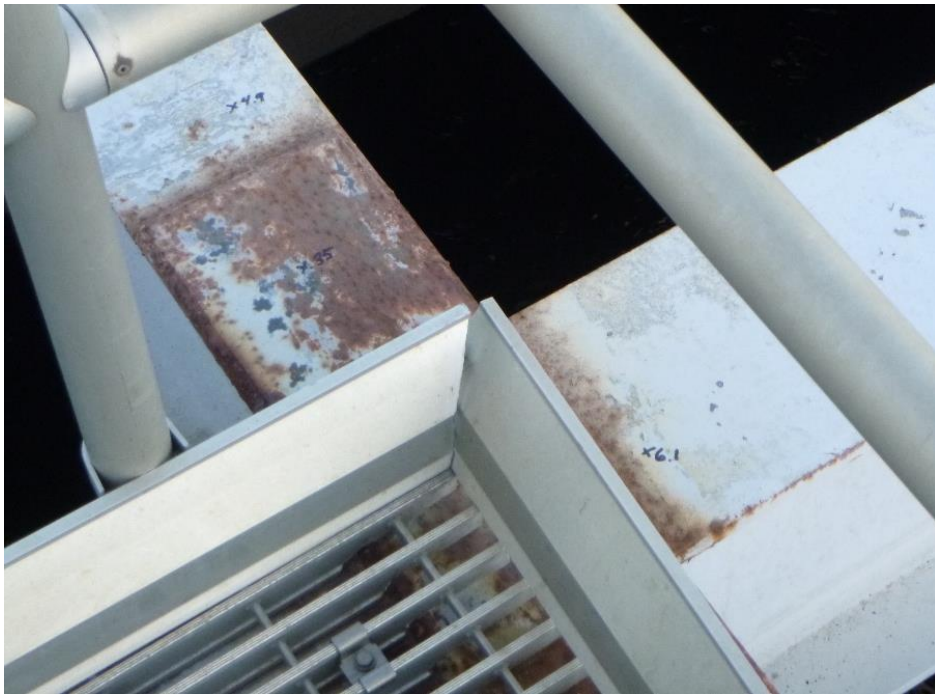
Figure 72. Coating thickness correlated to corrosion distress, note black coating thickness measurements in mils

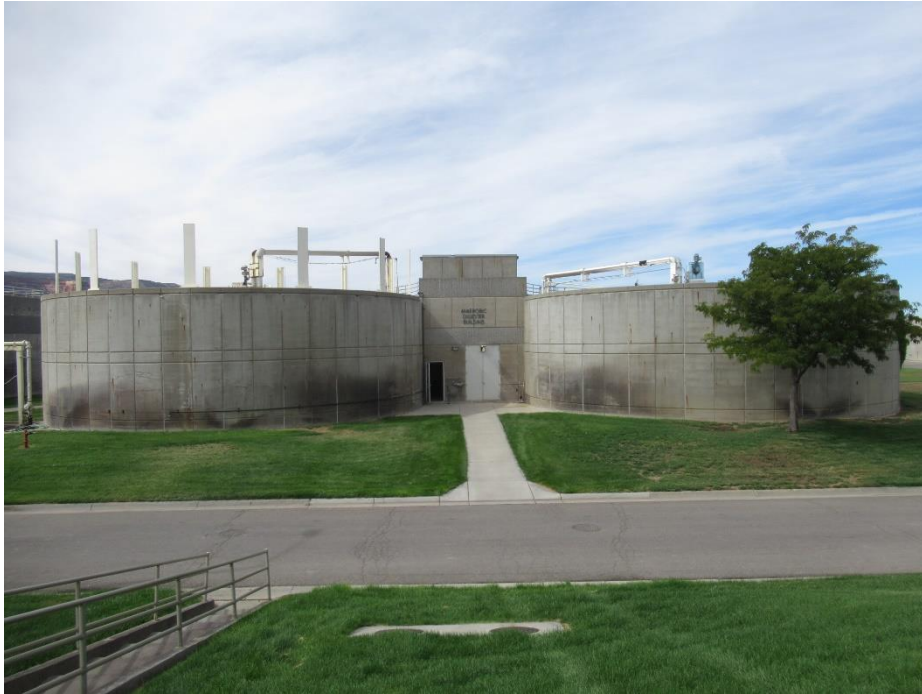
Figure 73. Overall view of the east elevation of the Anaerobic Digesters, with the Anaerobic Digester Building situated in the center
