PERSIGO WASTE WATER TREATMENT PLANT Structural Condition Assessment

2145 River Road
Grand Junction, Colorado 81505

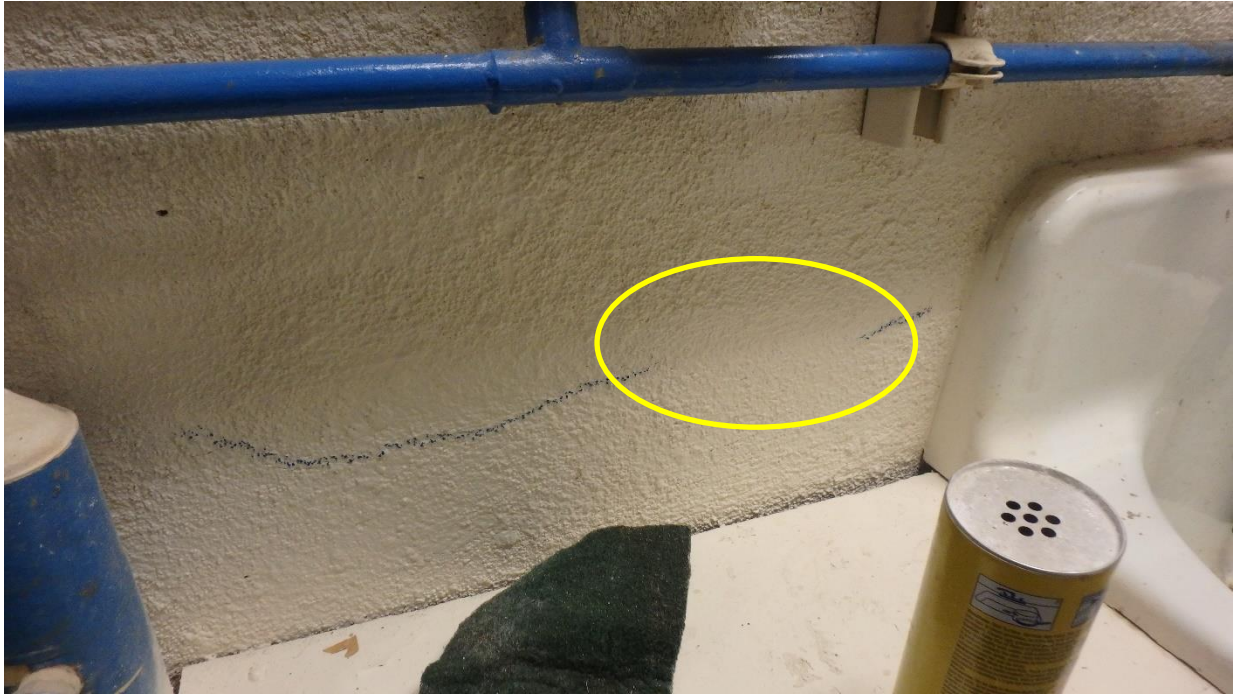
Figure 75. Previous coating repair location at the south digester interior wall

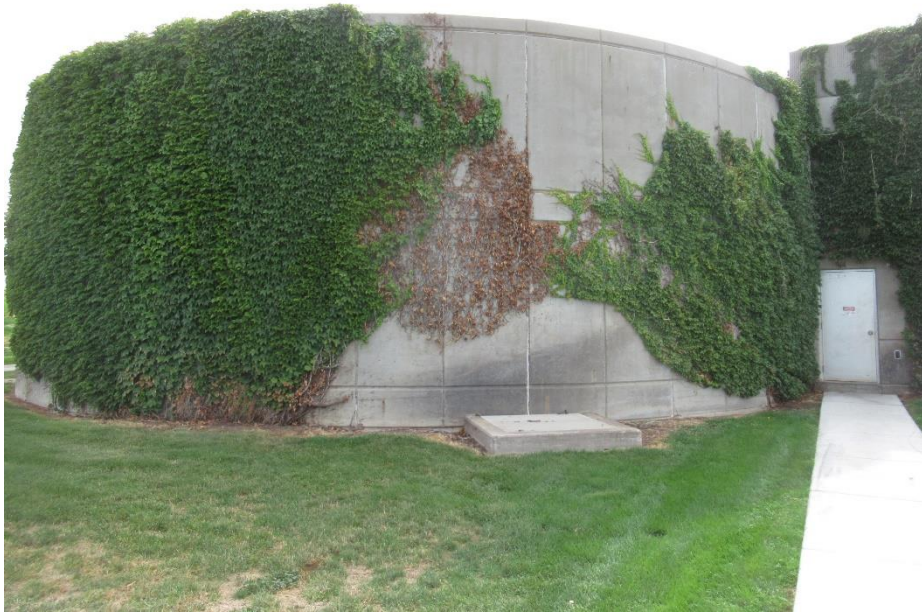
Figure 76. Plant growth on north digester exterior

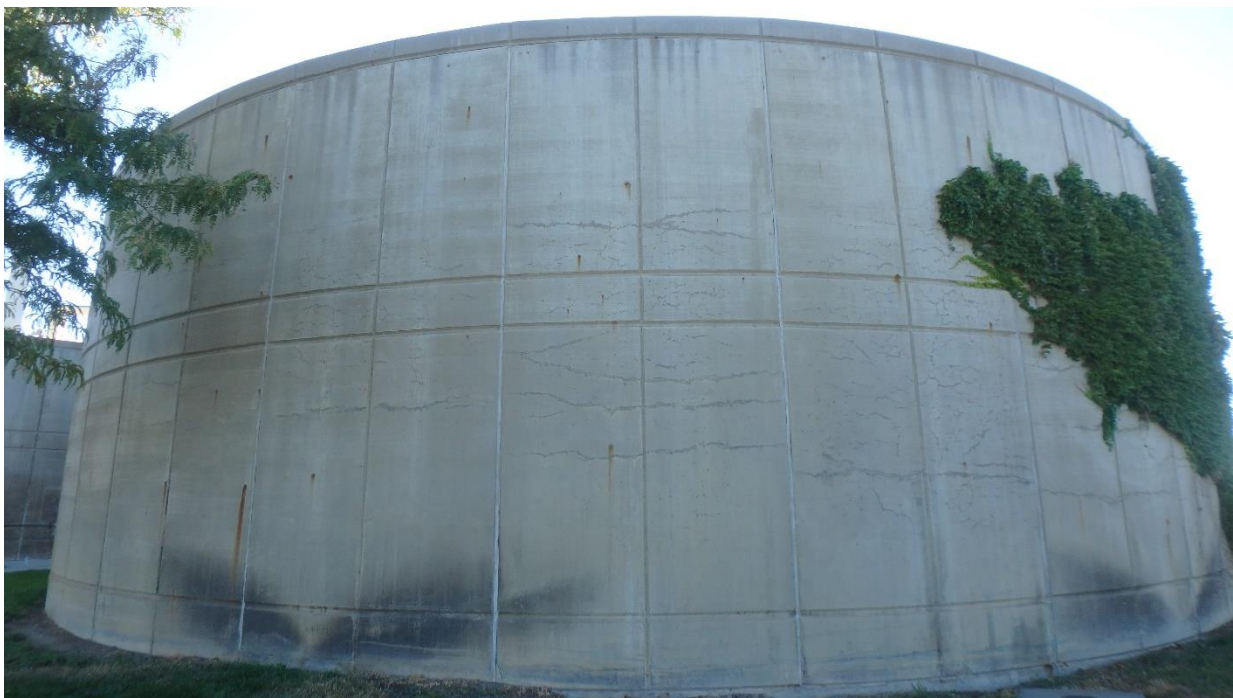
Figure 79. Transverse cracking observed on multiple panels

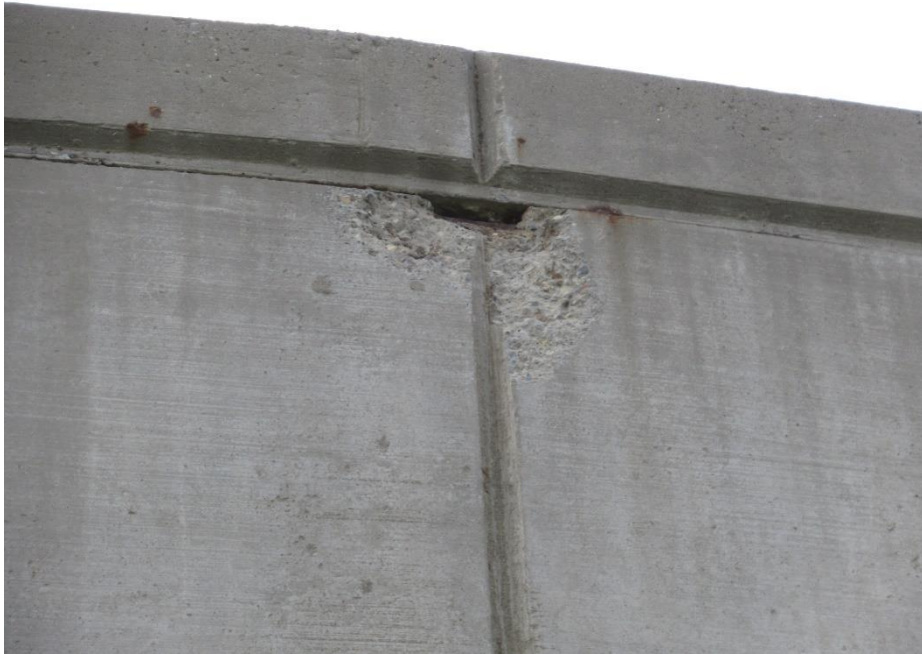
Figure 80. Spalled concrete at upper corner of exterior panel

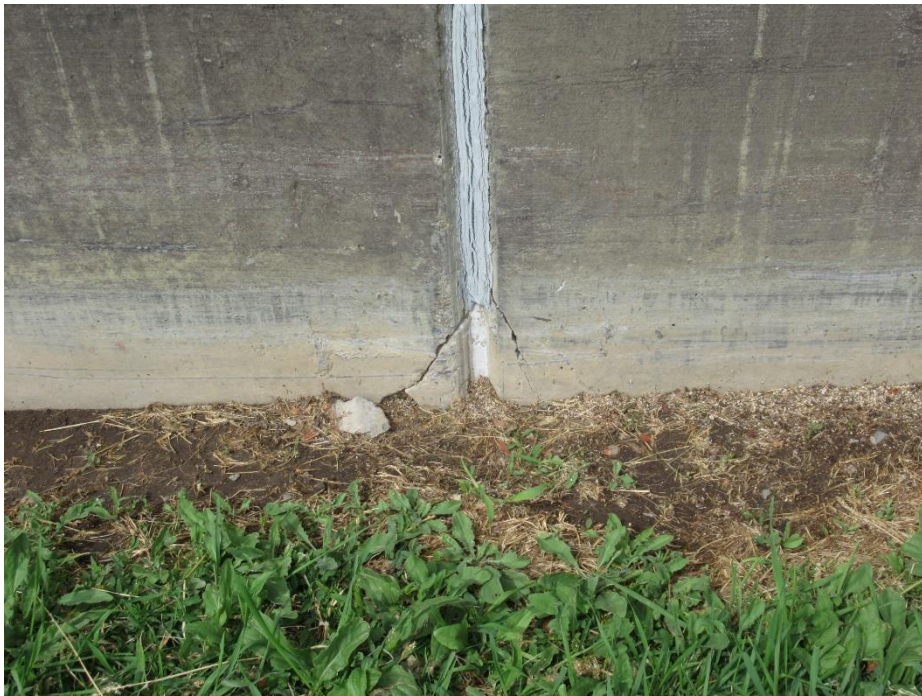
Figure 81. Spalled concrete at lower corner of exterior panel

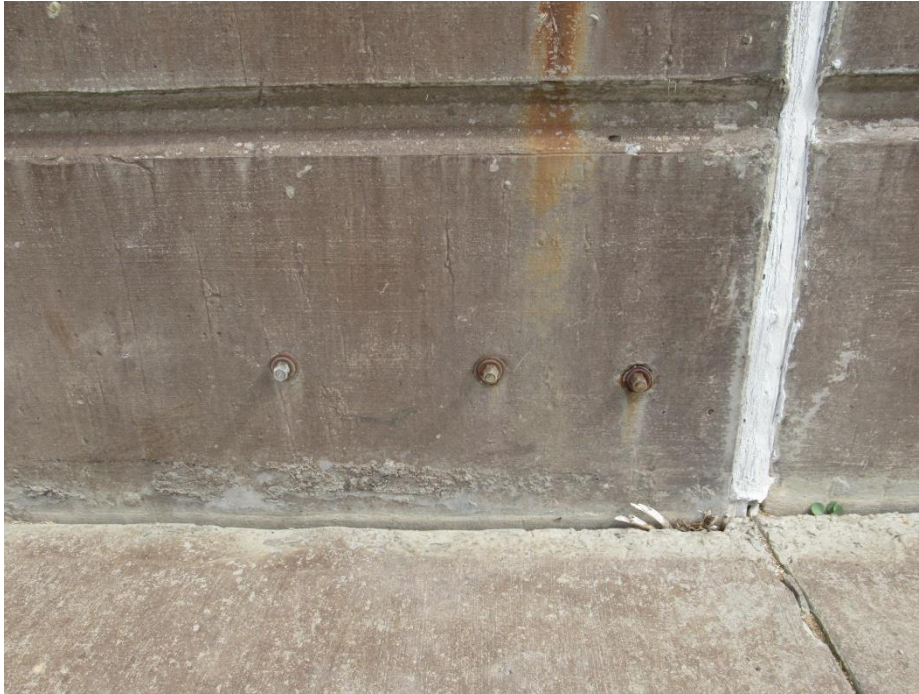
Figure 82. Supplemental attachment bolts at one panel at the south digester

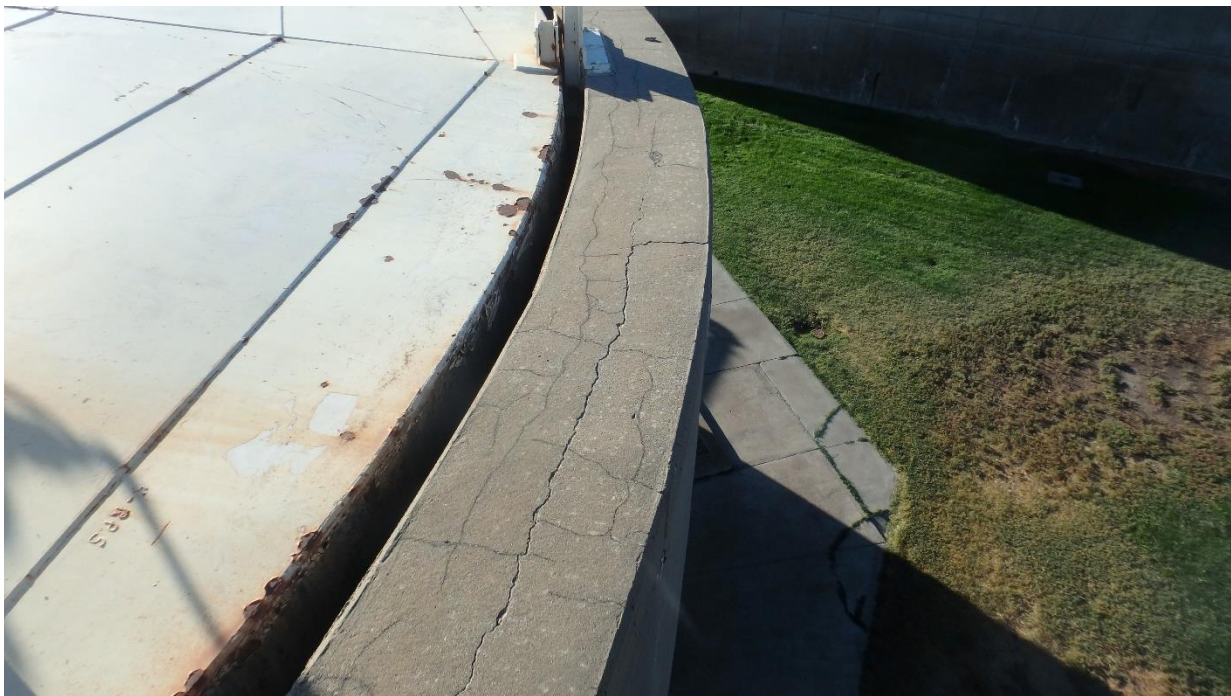
Figure 83. Longitudinal crack at the centerline of the concrete coping cap

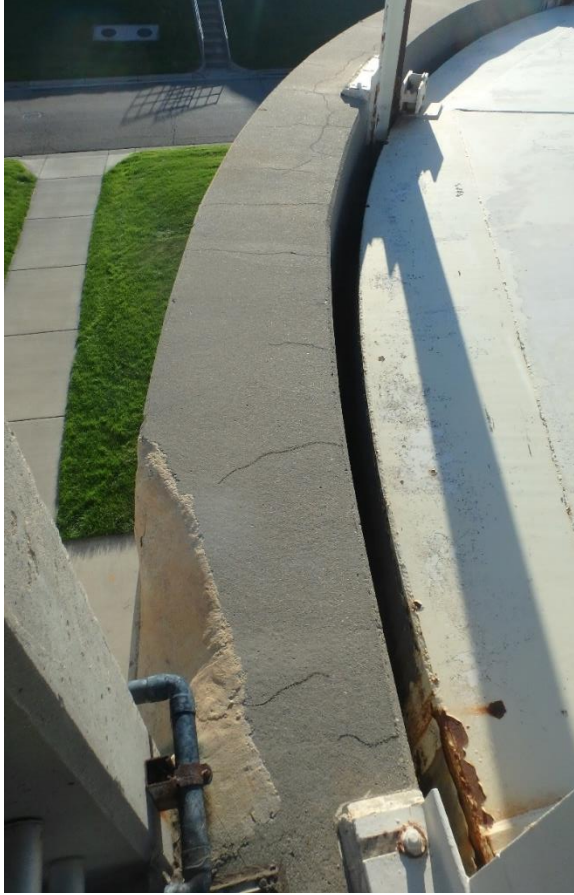
Figure 84. Transverse cracking at the concrete coping cap

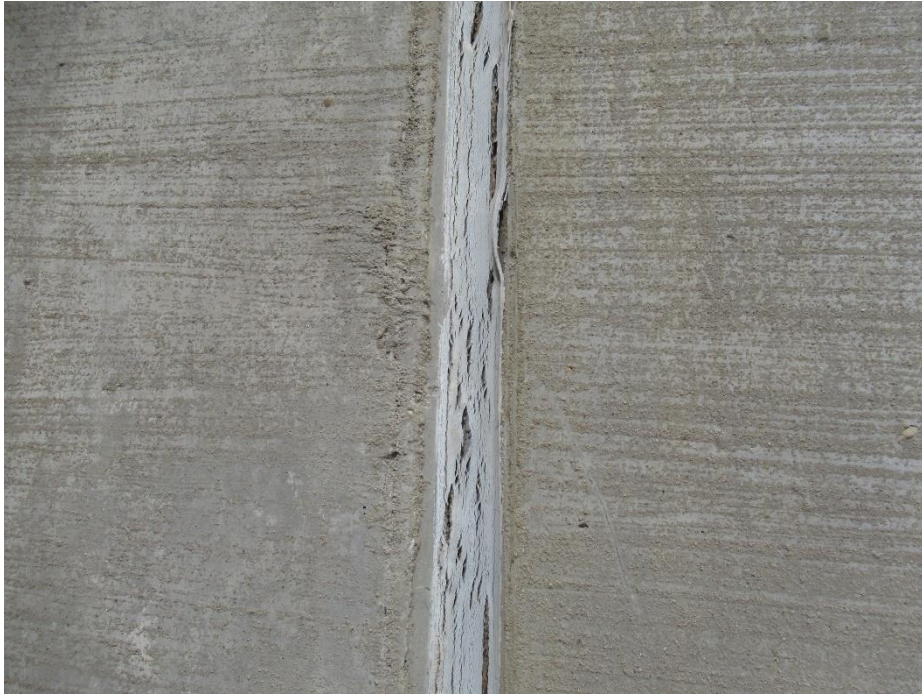
Figure 85. Sealant joint that had failed in both adhesion and cohesion

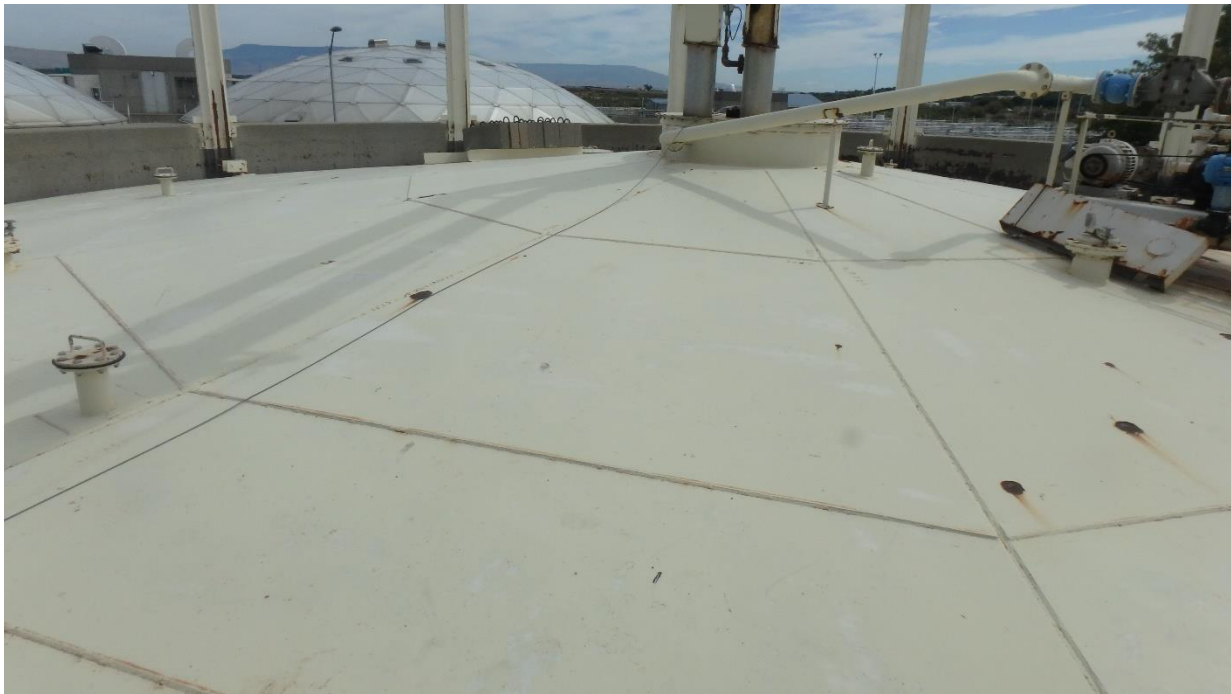
Figure 86. Overall view of the coating on the top surface of the south digester lid
