March 5, 2024

Mark Ritterbush
Water Services Manager
City of Grand Junction

Re: Juniata Reservoir – Alternatives Review for Repair Options

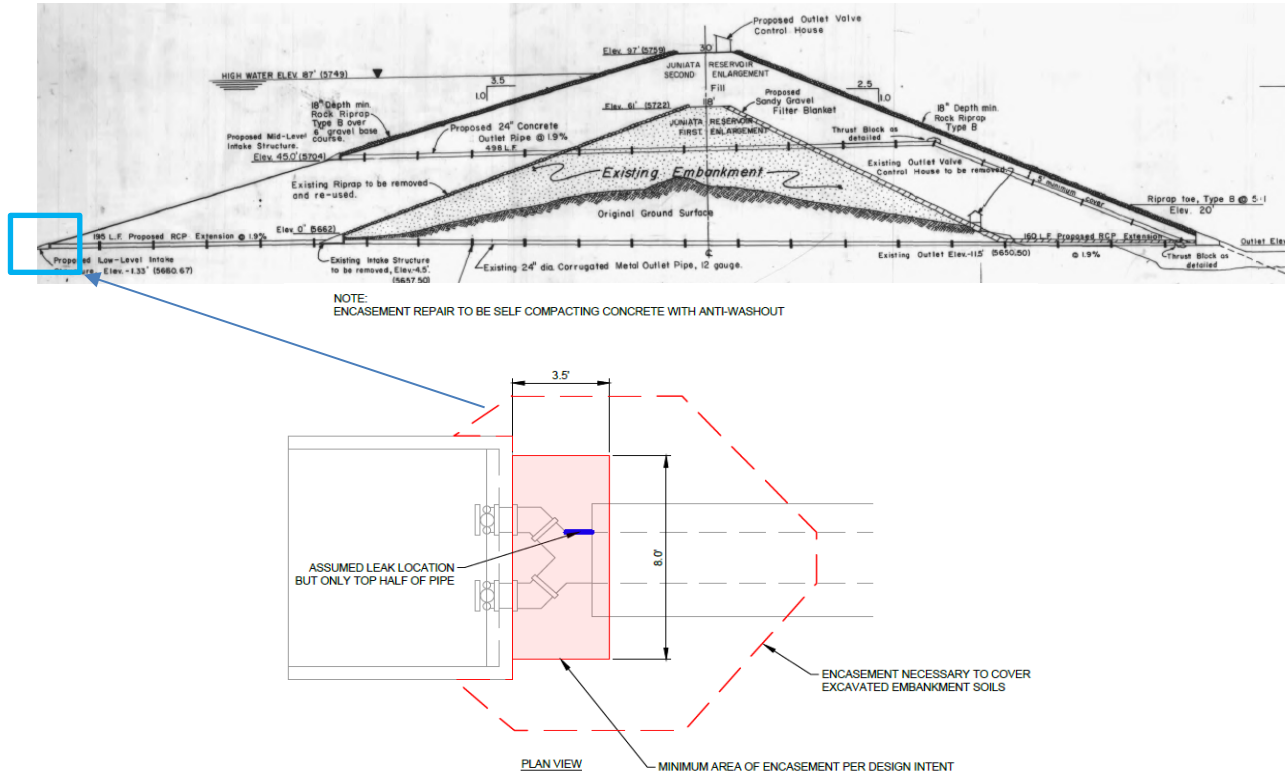
With this direction and following the December 8 call, Ayres developed a concept sketch of an underwater repair option that involved encasing the leaking section of pipe in concrete. In summary, this conceptual design would involve removal of existing soil around the existing intake and placement of concrete in the red shaded area shown on the next page.

4. The contractor would then remove the soils around the low level inlet and encase the wye (similar to the figure on previous page) with concrete.
5. A pair of new air lines from the low level outlet would be trenched into the riprap and encased in concrete all the way up to the maximum reservoir pool. Existing hydraulic lines would also be encased in that concrete. If the City desired to save money, the hydraulic and air lines could be just excavated into the embankment and covered with soil and then riprap (perhaps saving \$100,000 to \$150,000 in price).

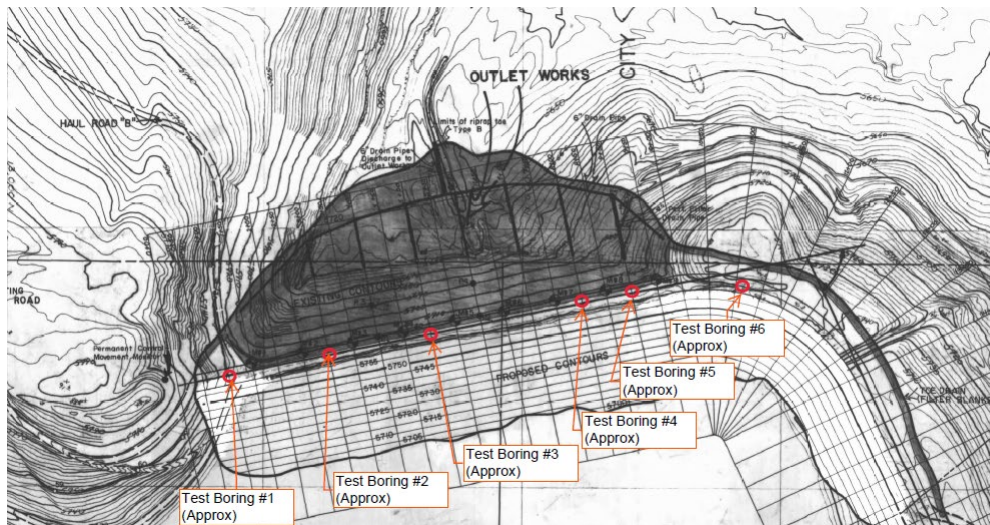
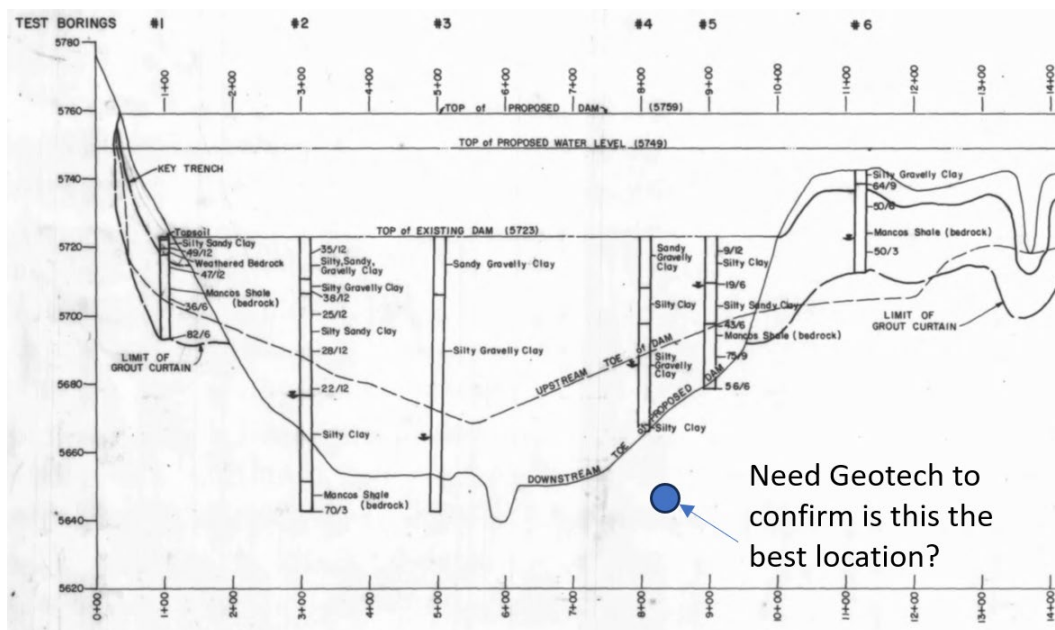
Borings from 1978 Plans

- Ayres asked about options to go through the bedrock formation that was left and right and under the embankment. Noting the curvature of the outlet stream, Ayres pondered if a new bedrock tunnel from reservoir to downstream stream could be done between Test Borings #4 and #6 as shown in the below image. Lithos suggested that the Mancos Shale formation can be tunneled through, either with directional boring or tunnel boring machine, but in either case more geotechnical exploration would be needed to confirm the local site conditions were acceptable and to also figure out if secondary grouting would be necessary. Lithos noted that test boring data does not currently go much deeper than the top of foundation bedrock, and new borings would be needed wherever the new outlet was planned.

- Lithos suggested that if the City was interested in exploring a new low level outlet pipe through the bedrock, a feasibility study should be conducted. There are generally two options for tunneling – a tunnel boring machine and directional boring. Both have pros and cons, as listed below.
