MEMORANDUM

To: Randi Kim, Mark Ritterbush and Slade Connell - City of Grand Junction
CC: Jason Ward - Design Review Engineer
John Hunyadi - Chief, Dam Safety Branch
From: Jackie Blumberg - Dam Safety Engineer
Date: March 20, 2023
Dam Name: Juniata
DAMID: 420128
Subject: Low Level Outlet File Review

Juniata Dam is a high hazard structure located at 38.967457° latitude, -108.285497° longitude in Mesa County, Colorado. The dam was constructed circa 1940 and subsequently enlarged in 1954 and 1978. Additional construction affecting the outlet occurred in 1987, followed by minor projects in 2002, 2019 and 2021. The low level outlet is known to be a bifurcated system, equipped with two identical upstream gates. The dam is presently 98-feet high and stores 7281 acre-feet at the spillway crest. Recent attempts to inspect the low level outlet have revealed a leak into the conduit, prohibiting rover entry and meaningful video capture. The source of the leak is unknown but it is posited to be originating from the upstream end. This memorandum presents a summary of the low level outlet following review of the digital archive with the intent to aid future inspection and discussion.

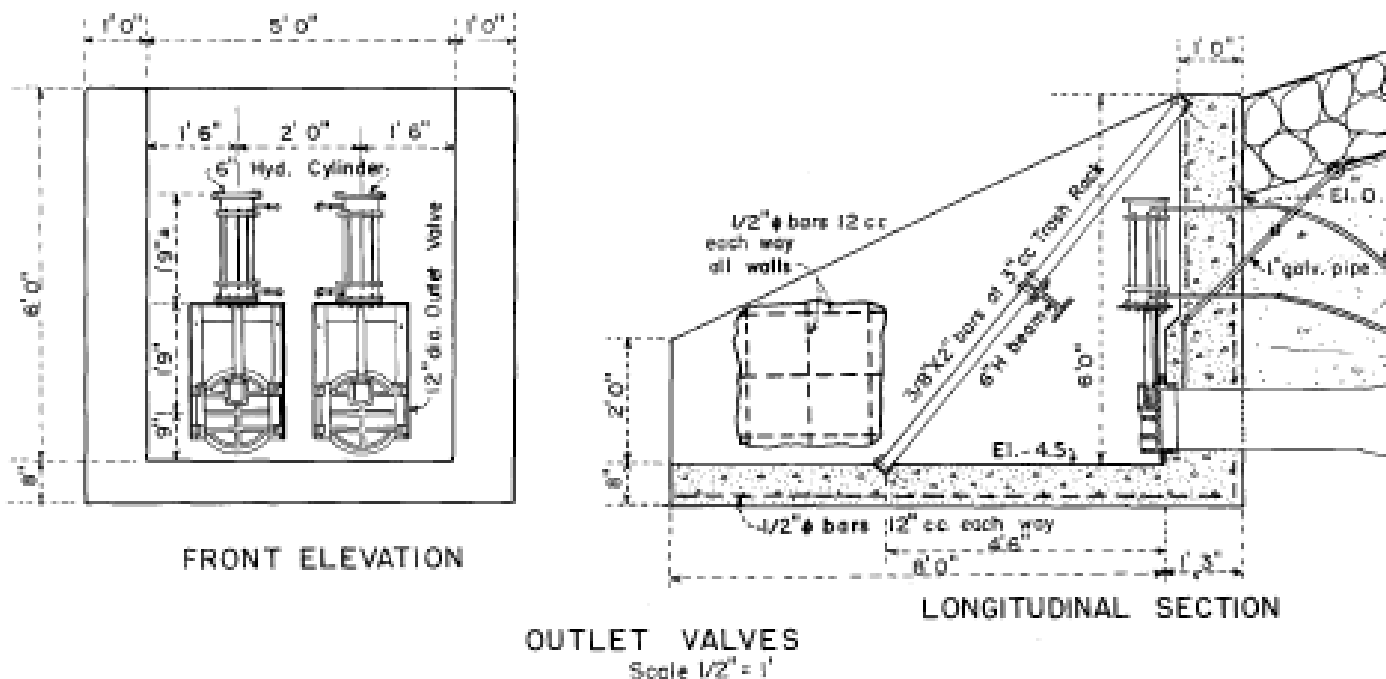
1954 intake details show air vent connection to conduit is encased by the concrete headwall.

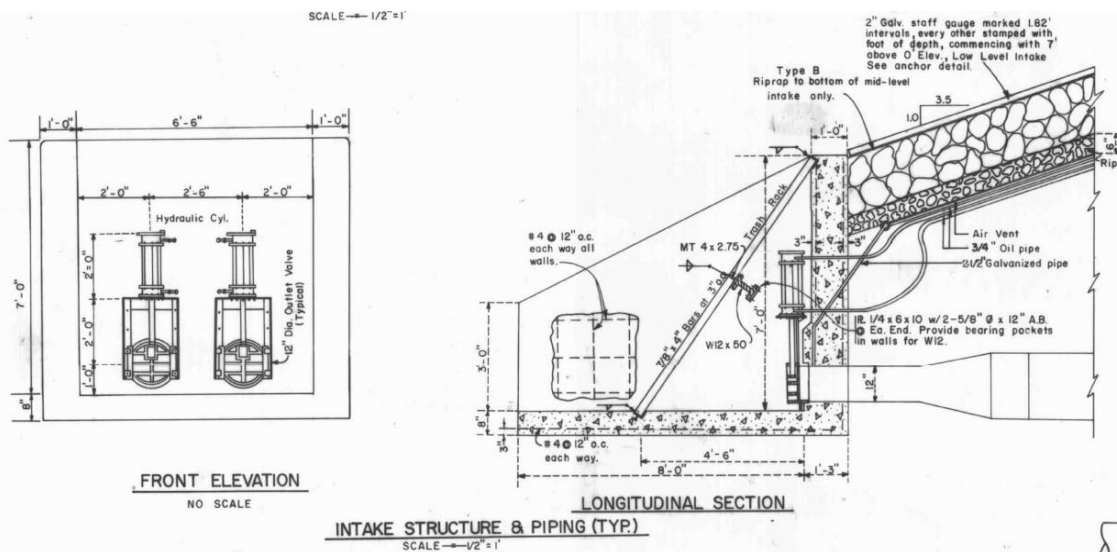
1978 raise shows a nearly identical intake detail, one where the air vent connection to the conduit is encased by the concrete headwall. The plans show the 24-inch dia. bell and spigot RCP transitioning to 12-inch ductile iron (the original bifurcated inlet and gates). Although the detail is nearly identical, the intake structure is entirely rebuilt to accommodate the second dam raise and attendant outlet extension.

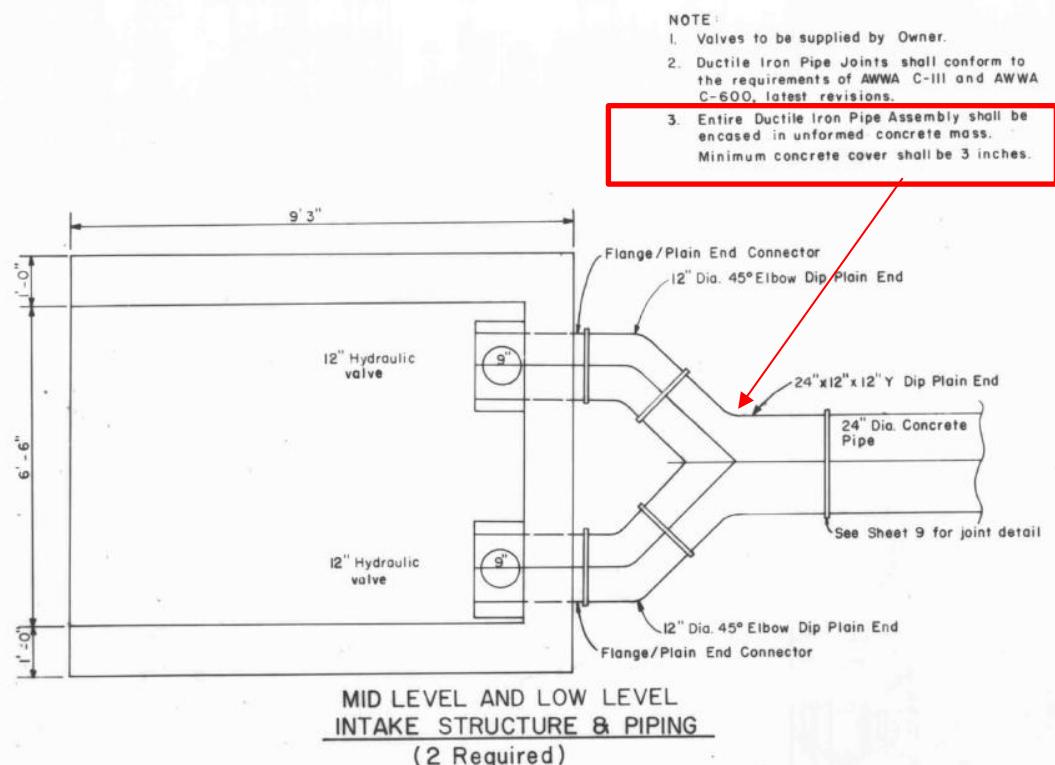
The existing CMP segment remains in place and is extended by RCP at upstream (195-feet) and downstream ends (160-feet). Notes on plans state, "Existing CMP to be excavated to first joint, cleaned, banded and extended to the limits noted with RCP". The plans also show the ductile iron bifurcated intake to be encased in unformed concrete.

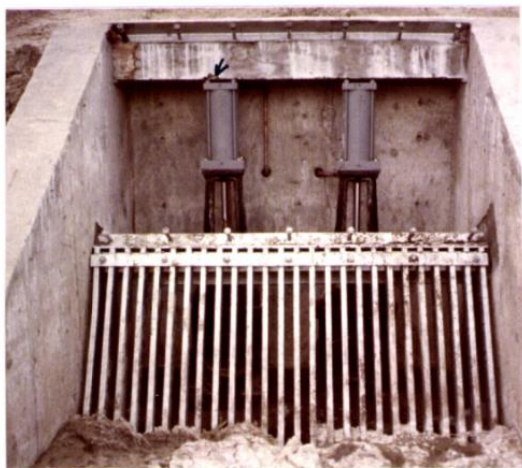
Construction inspection on April 17, 1979 revealed pockets associated with the grouted beam at the intake for both upper and lower level gates. The Contractor indicated the pocket was due to soil within the forms and not poor quality concrete.

LOW LEVEL GATES
← POCKET CAUSED BY DIRT IN FORMS

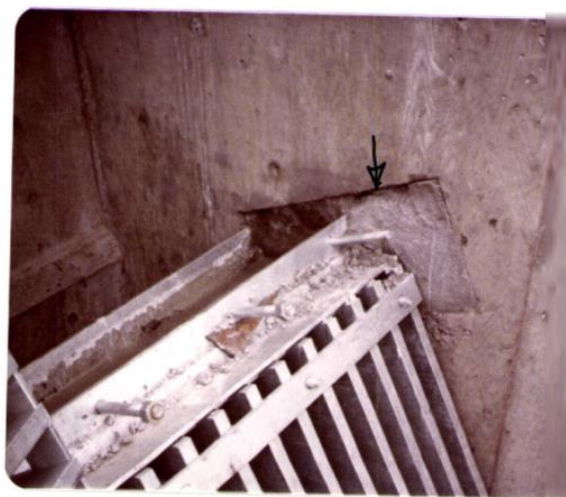
POORLY GROUTED BEAM POCKET
ON UPPER LEVEL INTAKE.

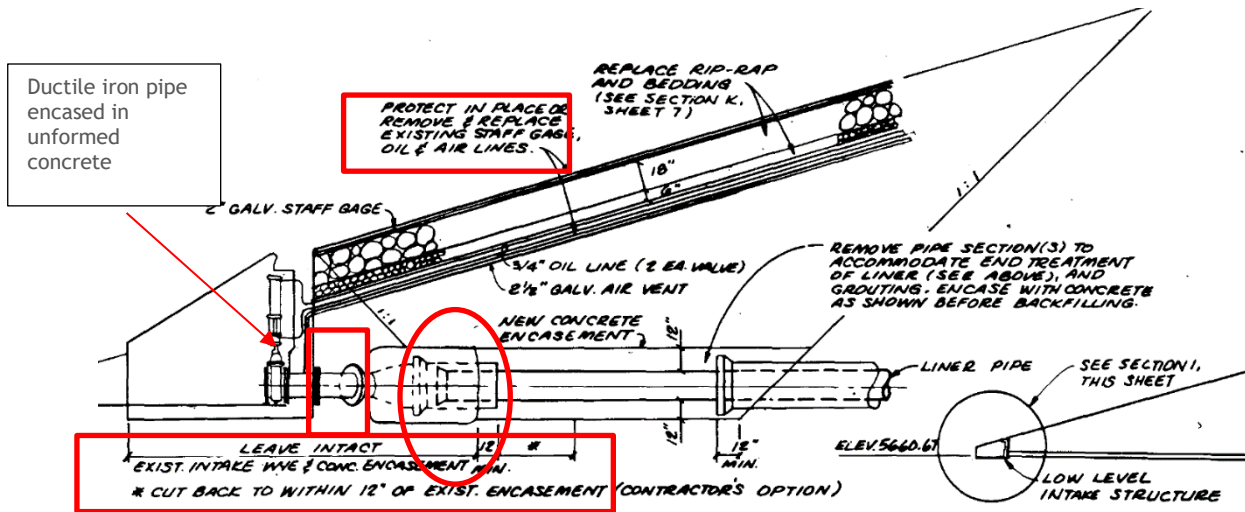
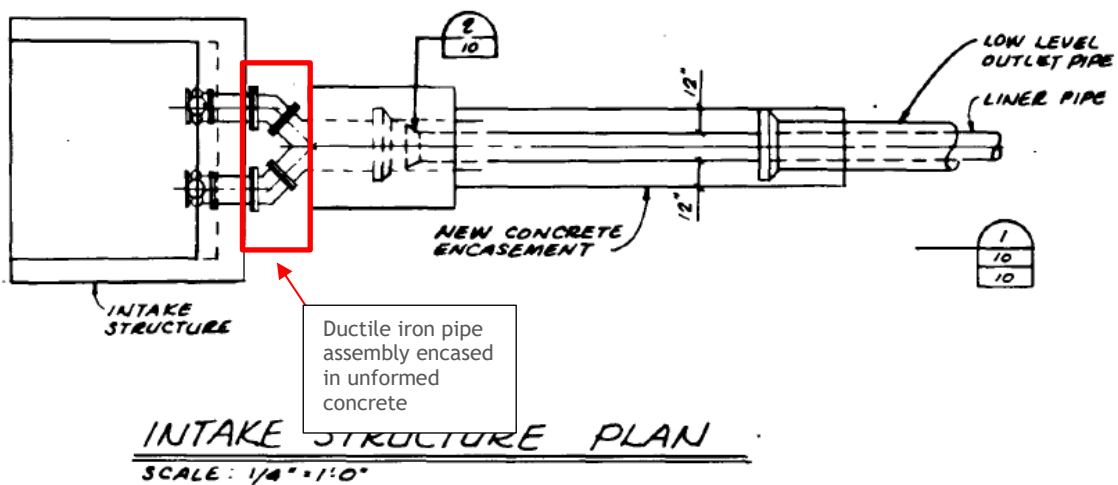
1987 details are shown below for the HDPE sliplining work. The existing concrete headwall at the intake to remain in place. Ductile iron bifurcated segment (encased in unformed concrete) also to remain in place. Refer to end of this memorandum for 1986 video inspection discussion that prompted the work. Structural calculations showing load resistance were provided.

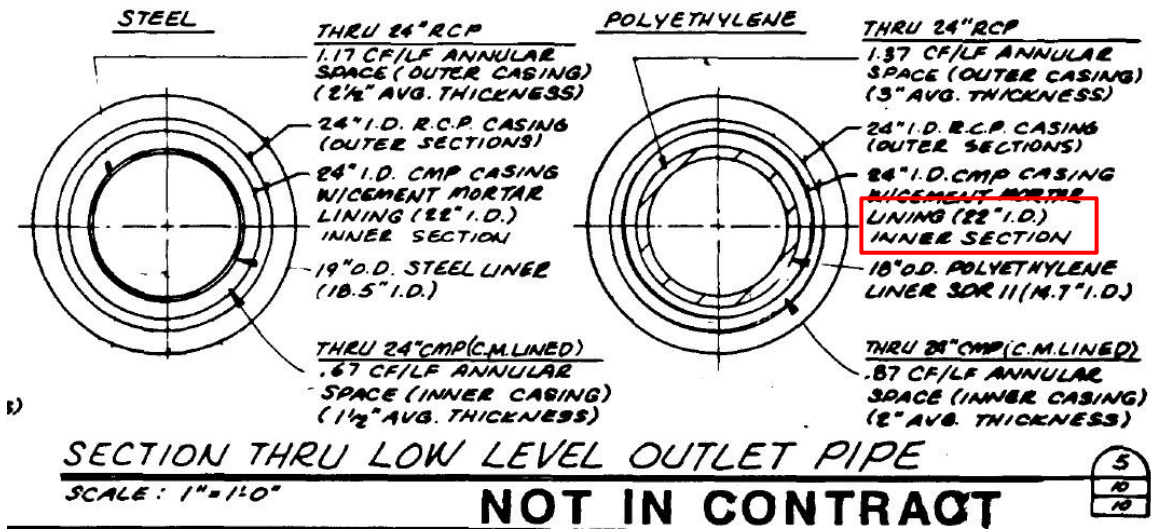
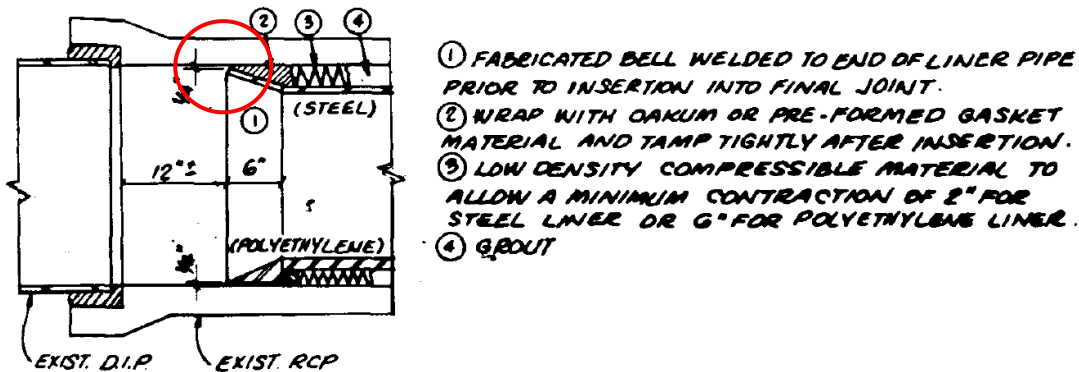
Below shows the section view for pipe lining. Ultimately, HDPE was selected as the liner pipe that would be pulled through the host pipe and the annular space grouted. Based on construction drawings,

the segment through the longitudinal center of the dam would be comprised of (extending outward from center): HDPE (14.7-inch ID/18-inch OD), grout, cement mortar (22-inch ID), CMP (24-inch) with asbestos coating (assuming host pipe is intact). The extended end segments would be: HDPE (18-inch ID), grout, RCP (24-inch), discrete concrete encasement at ends (appears as 48-inch OD on plans, assuming host pipe is intact).

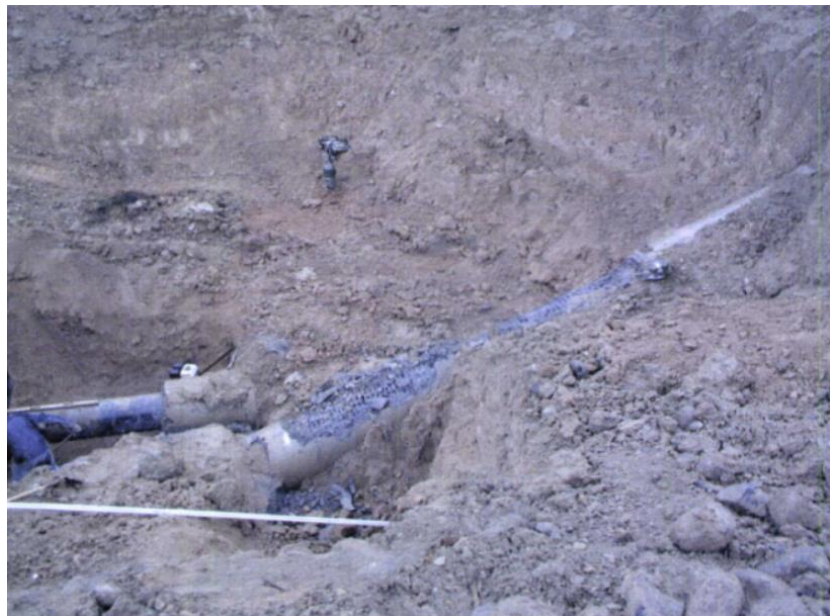
2002 excavation pictures revealed that the crown of the RCP was indeed broken in some places.

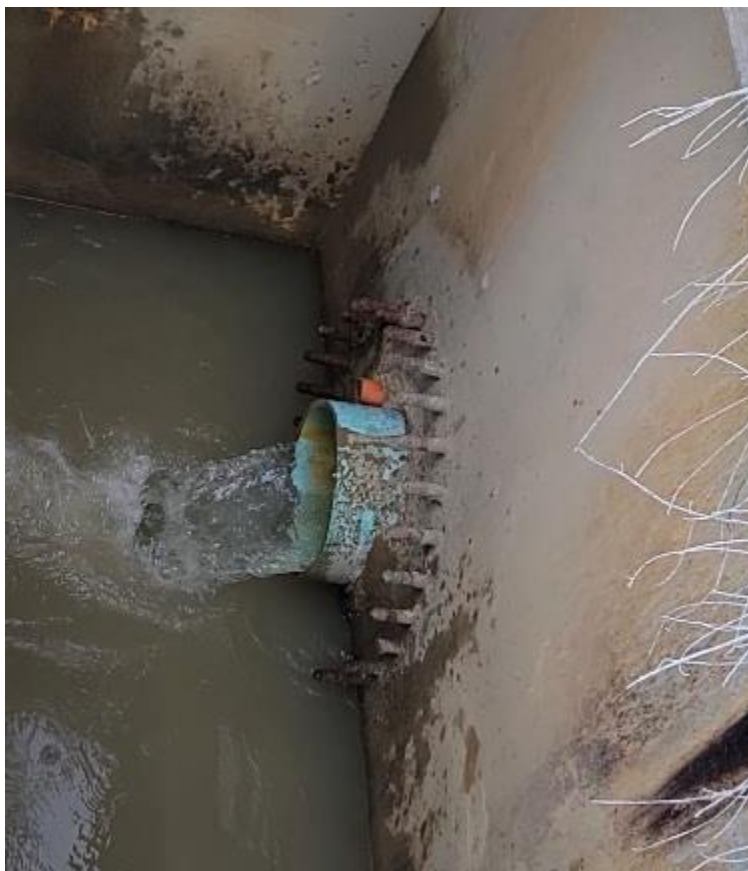
A site visit was conducted on November 28, 2022, to determine if the low level conduit could be video inspected with the pipe conveying water. The DSE and City staff decided it would not be feasible due to the volume of water exiting the pipe. The pipe conveyed a notable flow of clear water (image below). Sediments from within the impact basin mixed with flows exiting the pipe, causing the basin water to be visually cloudy, but flows exiting the pipe were noted to be clear. The DSE and City staff observed that the volumetric flow rate exiting the low level conduit appeared greater than would be expected from a 2.5-inch diameter air vent. Reservoir storage was high as pressure reservoirs from on top of the Grand Mesa were released into Juniata for the winter. However, a staff gauge reading was not collected the day of the site visit.

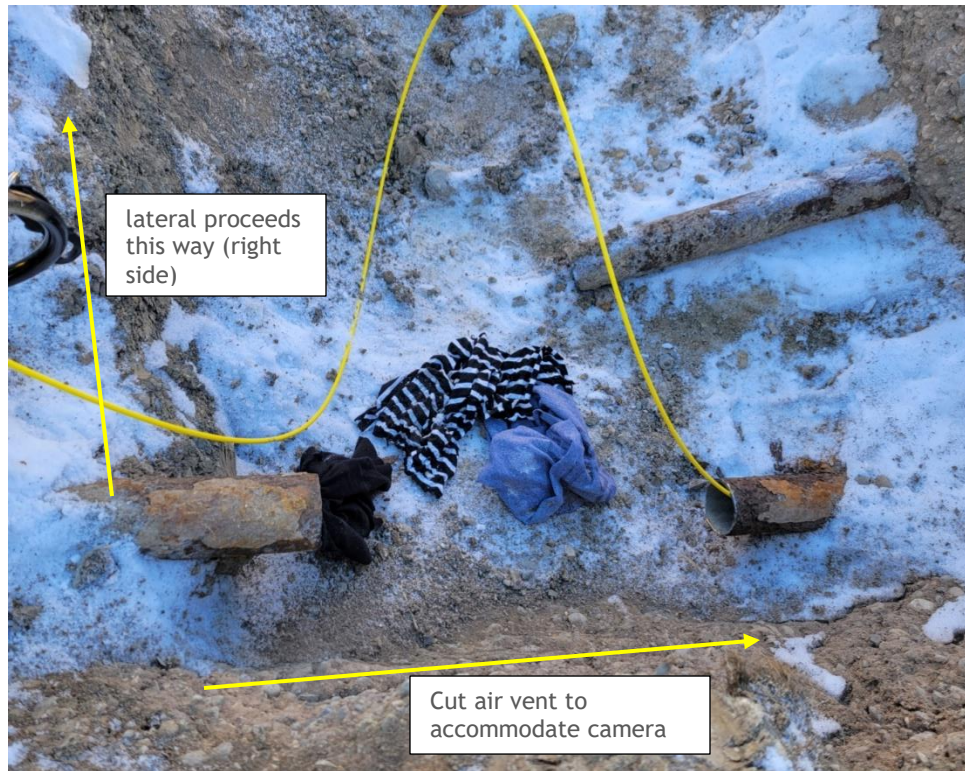
The City located and cut the low-level air vent just below a 90-degree lateral on the crest of the dam, on the reservoir side of the control shed, to accommodate the small camera. City staff stated the air vent alignment contained at least four, and possibly up to six 90-degree bends. The camera encountered water within the vent pipe at about the same level as the reservoir, indicating a break. Further, the camera revealed minor deposition but otherwise acceptable condition of pipe and joints until it reached a 90-degree that it could not surmount at about 150-feet. The downstream valve had been open for about an hour before the camera inspection and the City staff were surprised the air vent had not drained.

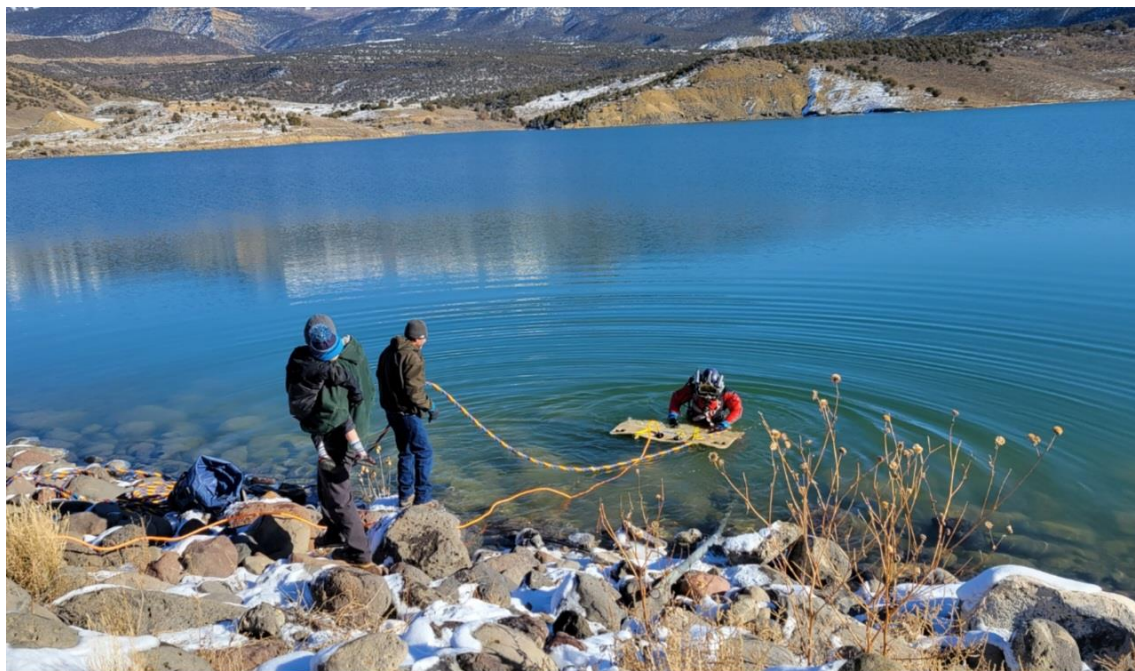
The dive inspection proceeded generally the same as for MDS. Potable Divers could not visually see the gate, flange, trash rack or intake structure, rather, the inspection was done by feel. The diver noted no pull or other sign of intake of flow around the gate but did report he heard a sound like ice popping or microphone static on the right side of the structure. The sound became more pronounced when he placed his head very near the right side of the concrete. No spalling of concrete was detected when the diver felt the intake structure.

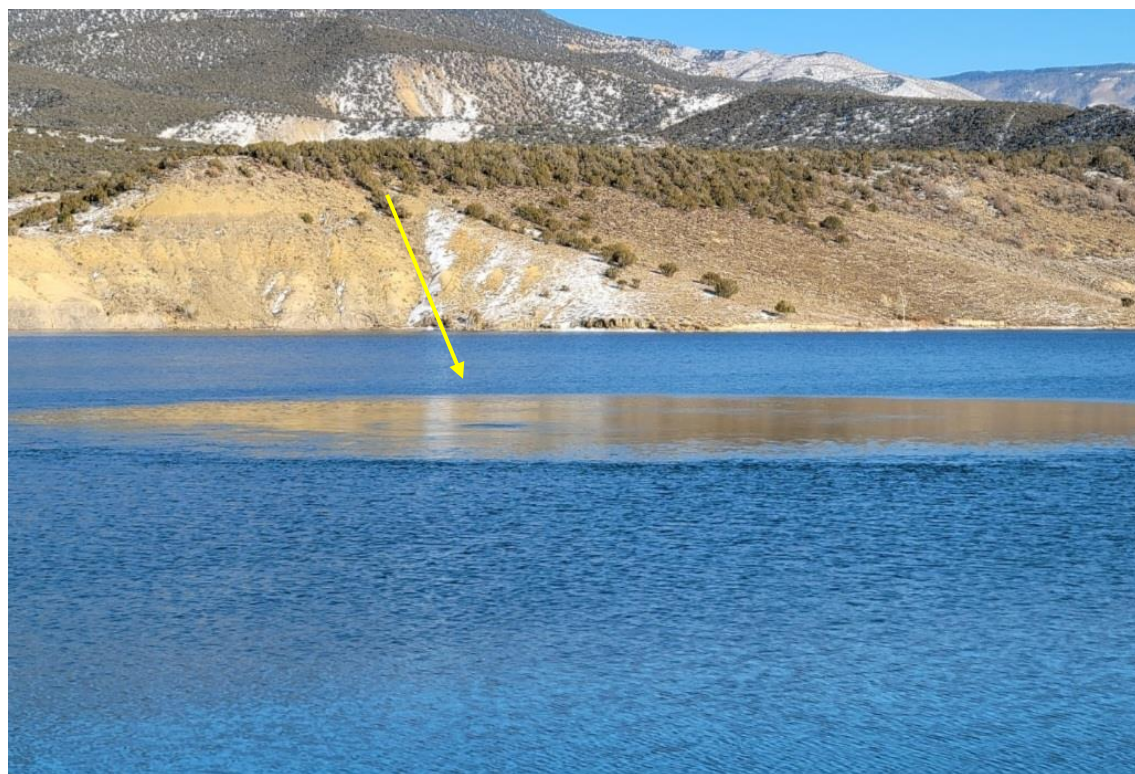
At the conclusion of the dive inspection, City staff closed the downstream valve. Water was expunged through the air vent on the top of the control shed and later through the cut section on the crest. Interestingly, air bubbles were seen out in the reservoir, at the approximate location of the intake structure, which would support a break in the air vent line.

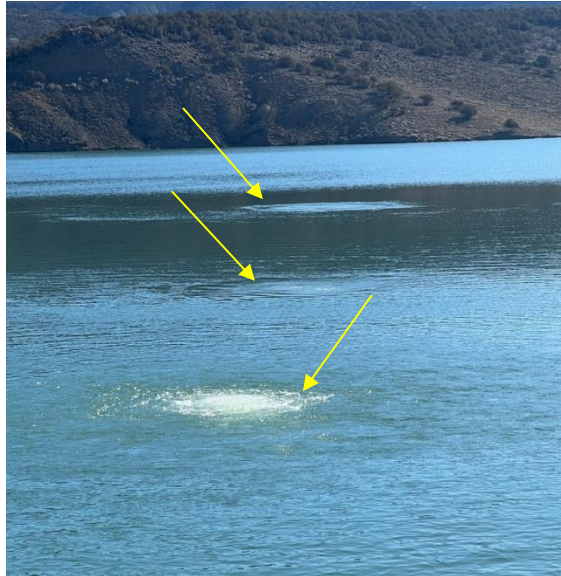
Applying pressurized air within the line on March 30, 2023, revealed two additional breaks in the galvanized line, occurring between the upstream intake structure and the crest.

Moving forward, the City plans to replace the galvanized line. Following replacement, the low-level outlet may be video inspected as normal. The City will maintain the low-level outlet valve in a closed configuration until repairs can be made.
