# ENGINEER'S INSPECTION REPORT

OFFICE OF THE STATE ENGINEER - DIVISION OF WATER RESOURCES - DAM SAFETY BRANCH

DAM NAME: JUNIATA T: 120S R: 0970W S: 31 COUNTY: MESA DATE OF INSPECTION: 5/22/2023  
DAM ID: 420128 YRComp: 1979 DAM HEIGHT(FT): 98.3 SPILLWAY WIDTH(FT): 30.0 PREVIOUS INSPECTION: 5/6/2022  
CLASS: High hazard DAM LENGTH(FT): 2000.0 SPILLWAY CAPACITY(CFS): 1000.0 NORMAL STORAGE (AF): 7281.0  
DIV: 4 WD: 42 CRESTWIDTH(FT): 30.0 FREEBOARD (FT): 5.2 SURFACE AREA(AC): 150.0  
EAP: 3/5/2019 CRESTELEV(FT): 5759.8 DRAINAGE AREA (AC.): 1350.0 OUTLET INSPECTED: 7/24/2017

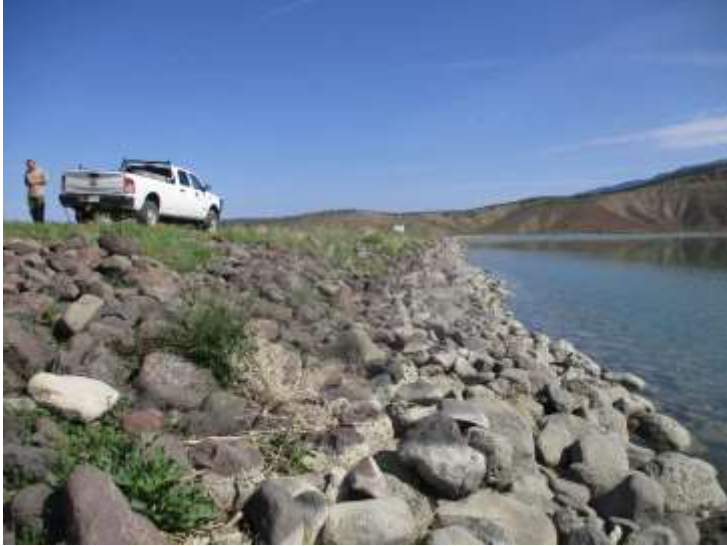
Changes: none observed. No signs of distress noted. Slopes appears stable, with good riprap coverage.

*Looking across the upstream slope toward the right abutment.*

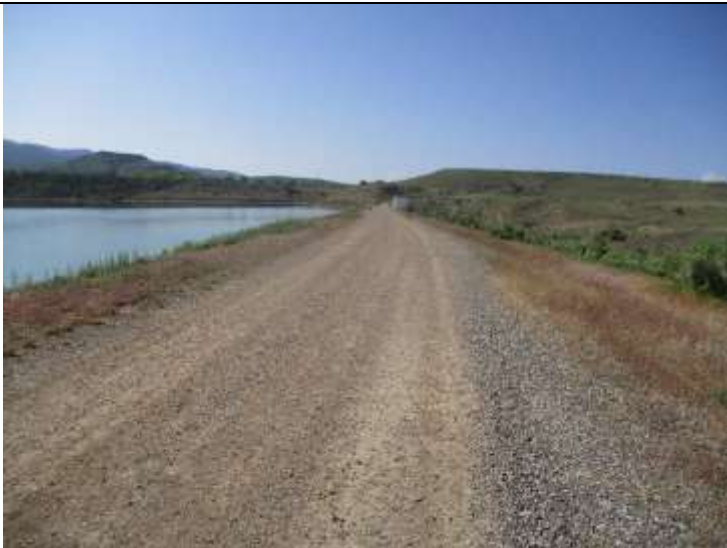
Changes: crest appears generally unchanged from previous inspection; exhibits good grade, alignment and gravel cover. No signs of distress observed.

*View of the crest from the right side.*

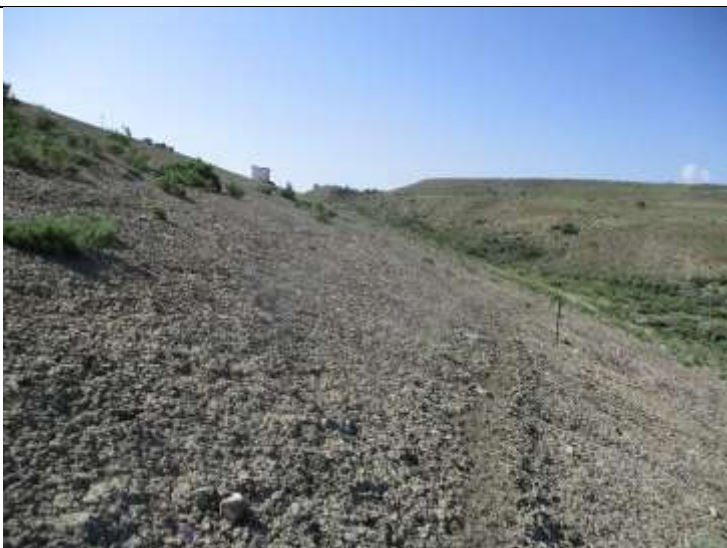
Changes: none observed. Slope appears stable and generally consistent with previous inspection.

*Looking across the downstream slope from the right side.*

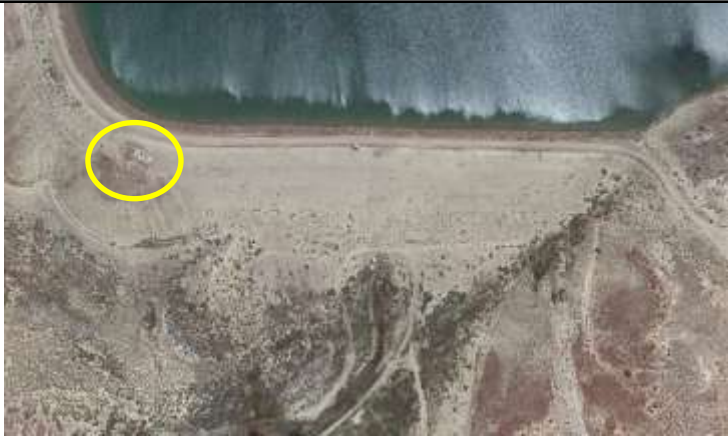
(31, 32) Staked seepage areas high on the right side downstream embankment exhibited moist soils and alkali salts, but no flowing or standing water. Willow shoots establishing in the area should be removed. Seepage appears when reservoir levels exceed the elevation of the original spillway.

*Google imagery showing downstream slope. Seepage area identified.*

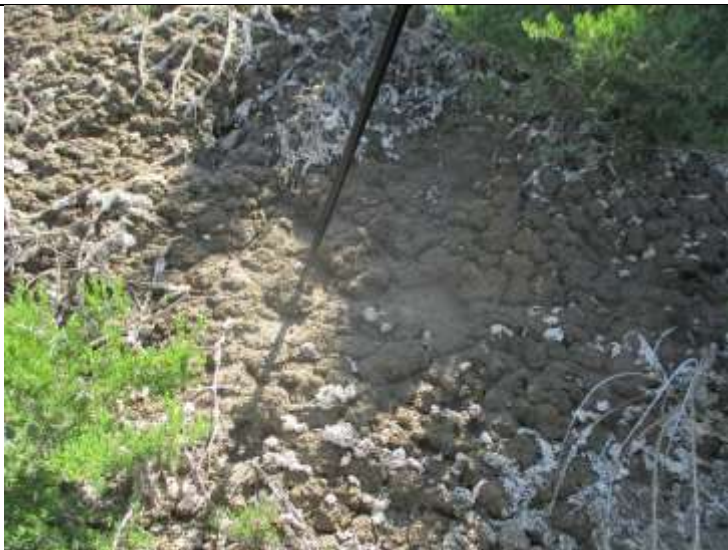
*Seepage area, marked by moist soils and alkali salts. Recommend to visually observe as reservoir levels continue to rise.*

Actions: visually inspect the staked seepage area high on the right side downstream embankment for changes in seepage rate or clarity, as the reservoir fills.

**(63) We discussed clearing the brush that has established on different aspects of your dam. Please also remove the willow shoots that are beginning to establish in the staked seepage area, high on the right side downstream slope.**

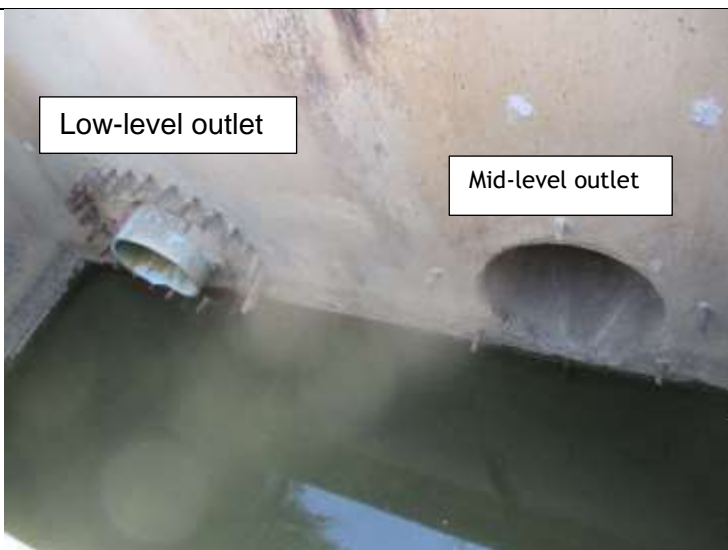
**Juniata is equipped with a mid- and low-level outlet.**

*Mid- and low-level outlet terminal ends.*

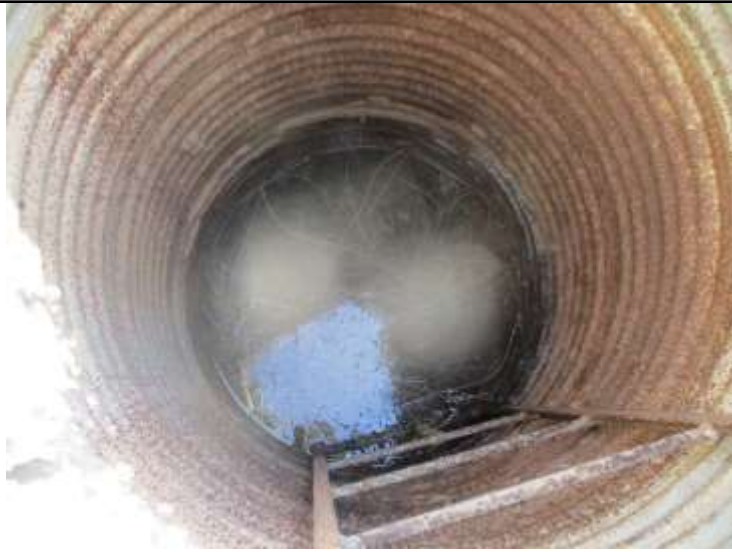
(39) Blue PVC toe drain collects from VCP system that is visible at the bottom of the manhole on the right side of the access road. The drain was submerged at the time of the inspection.

*VCP runs through bottom of manhole.*

**5/18/2019 - Remove roots from drain VCP visible in manhole to allow free flow of water ONGOING AS NEEDED**

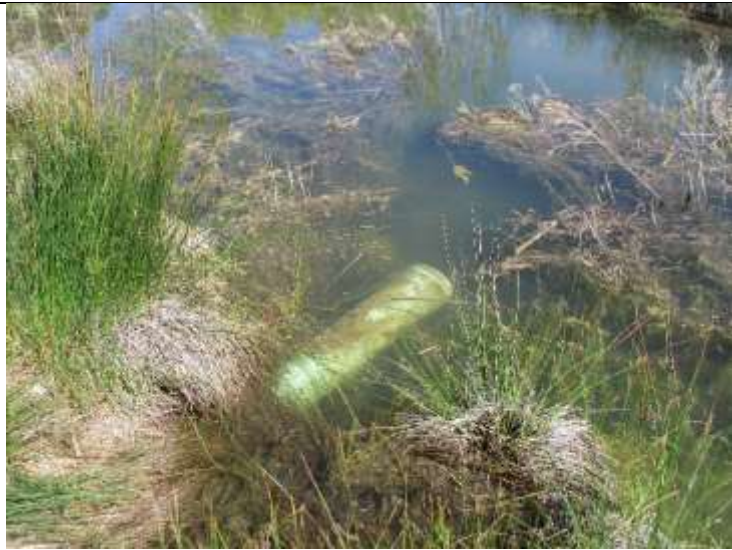
*Submerged toe drain.*

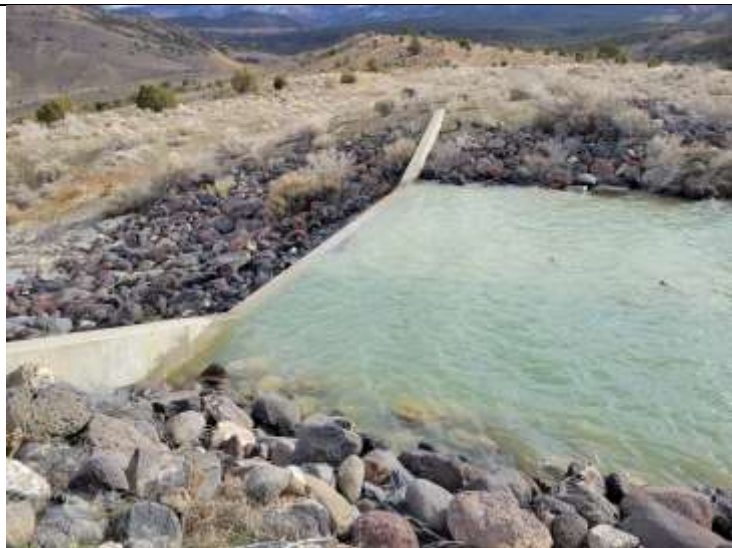
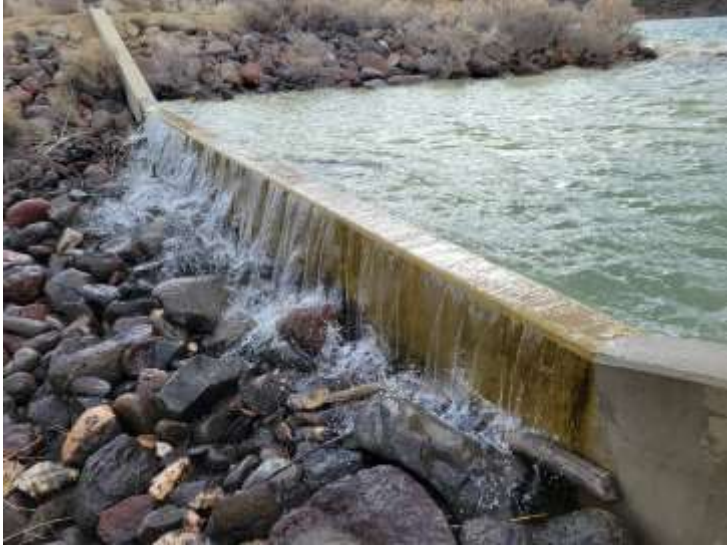
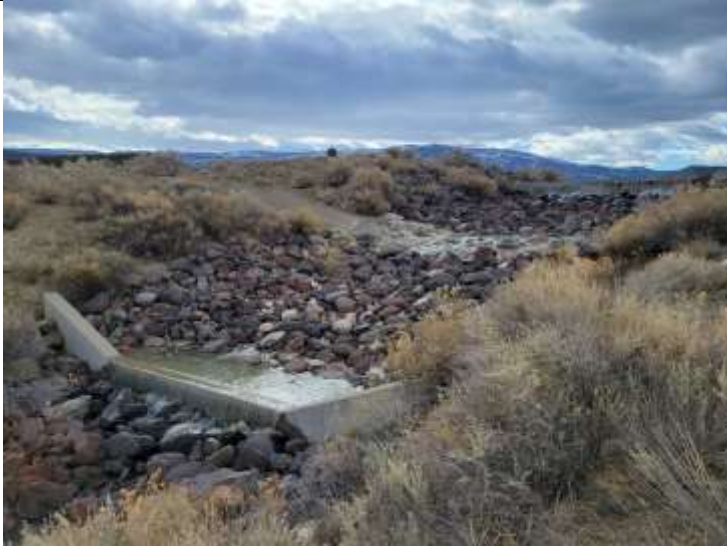
**Spillway activation observed during site visit on 6Mar2023. Control weir, riprap channel and grouted riprap channel sections all appear to be functioning as intended.**

*Spillway activation photo taken 6Mar2023.*

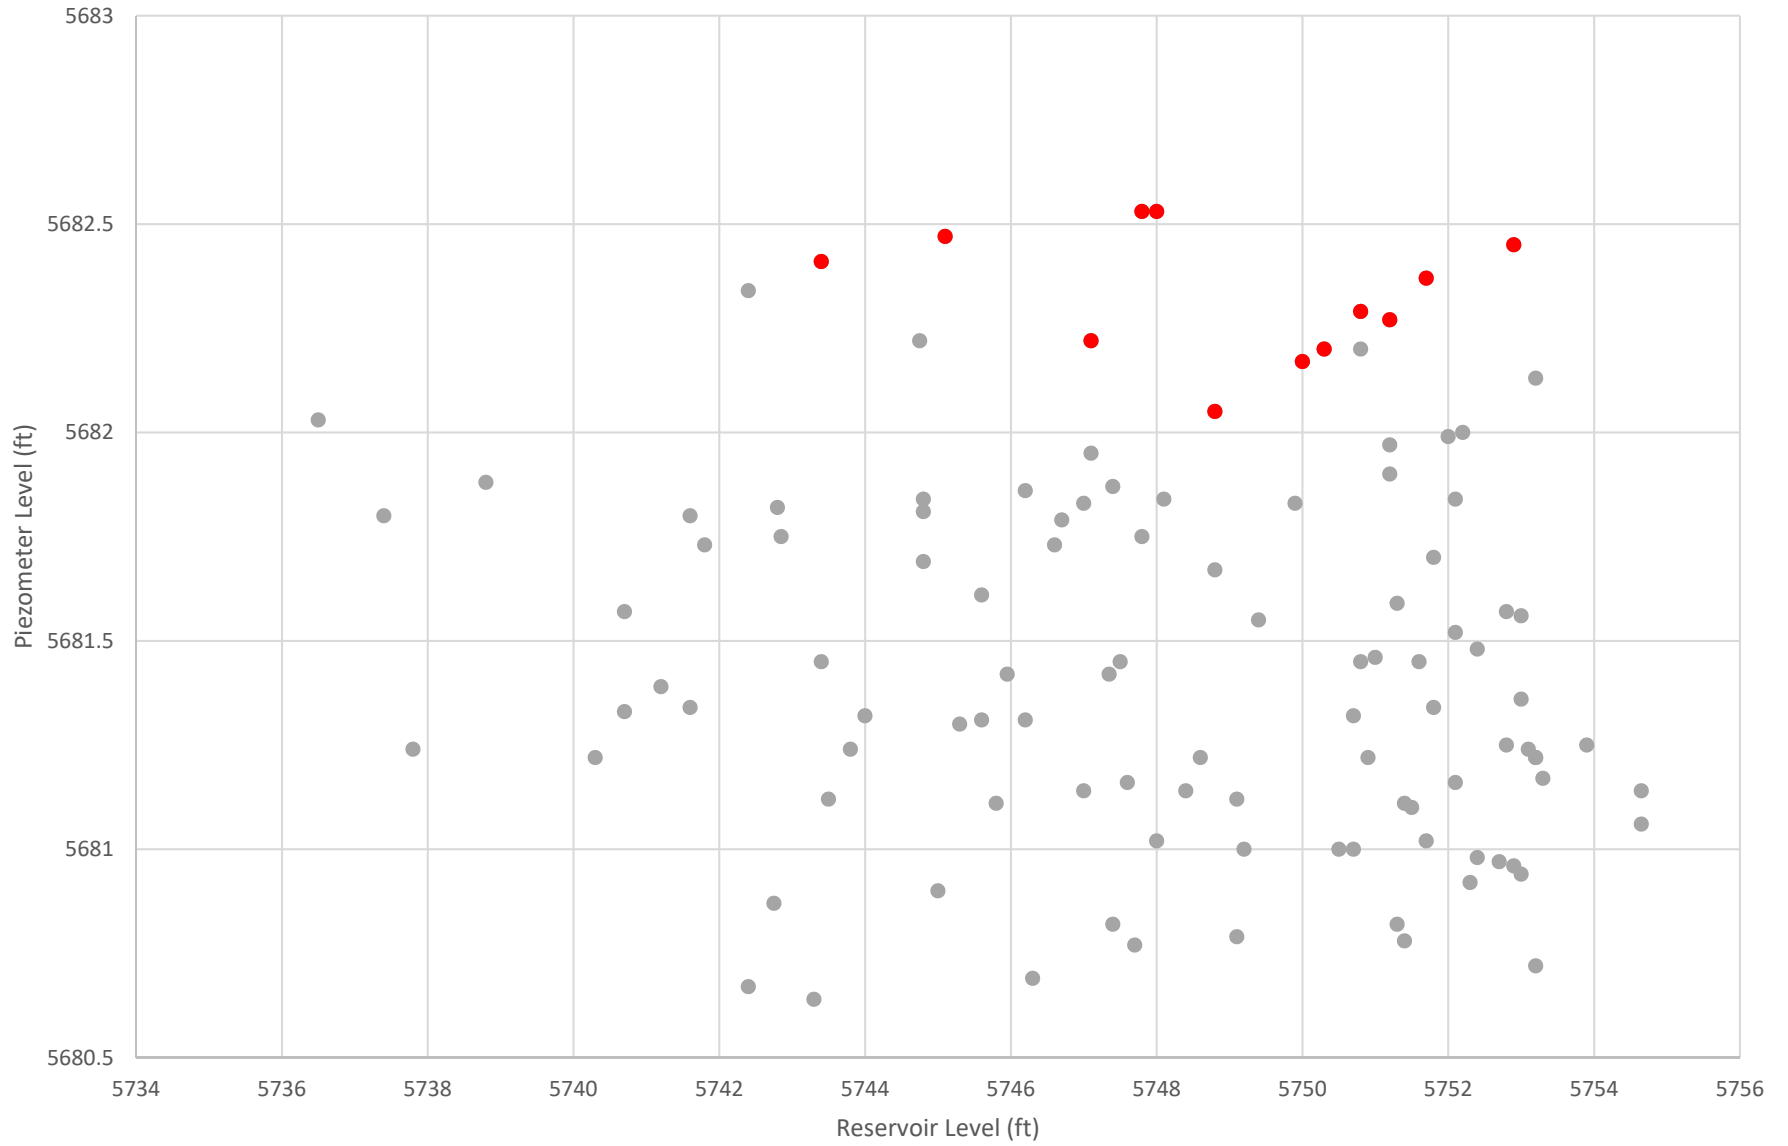
● PZ-3 (TMid) ● 2022

**PZ-3 reading a little high but within expected range, PZ-5B and PZ-6A reading low but within expected range (were reported as low last season also). Toe drain reading low but within reasonable range (see attached monitoring plots).**
