Asbestos Building Materials Inspection Services

Client: The City of Grand Junction, 250 N. 5th Street, Grand Junction,
CO 81501

Project Site: 649 25 Road, Grand Junction, CO 81506

Inspection Date: January 4, 2024

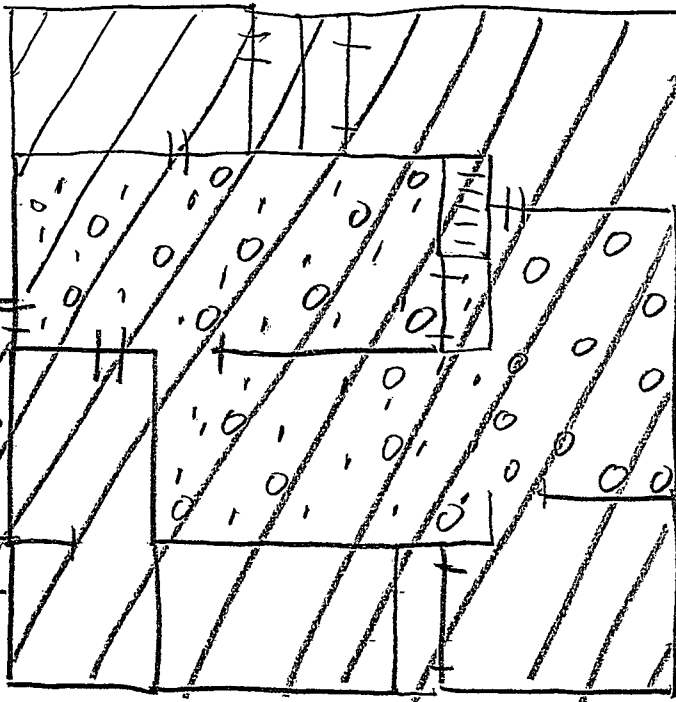
ACM Locations Diagram

ACM Siding → Ground Floor

Shingles and
Black Tar
Impreg. Felts
(entire exterior)

▨ ACM: Plaster,
Gypsum Board
and Celotex
Wall and
Ceiling Panels
(all walls/ceilings)

◻◻◻◻ ACM Ceiling Tiles

◻◻◻◻ ACM Vinyl Floor Tile/mastic

★ ACM Window Glazing (NE and E windows)

The prior listed ACBMs are regulated by the State of Colorado and the EPA and must be handled, removed and disposed of by a State of Colorado licensed asbestos abatement contractor (General Abatement Certificate holder) in accordance with Colorado State Regulation #8 prior to building demolition.
