Asbestos Sampling Report

**333 West Ave Building A
Grand Junction, CO 81501**

GJ 061623 Waste

Waste Office

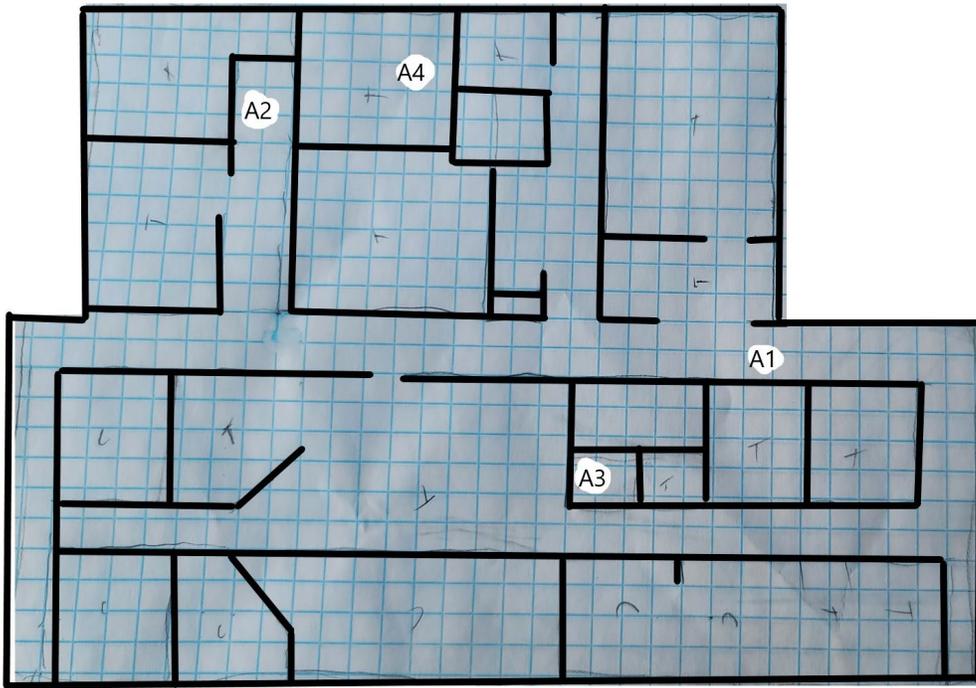
Sampling Locations

- Vinyl Floor Tile and Mastic

No asbestos was detected in any of the samples taken.
