866-789-3483

City of Grand Junction Field Report

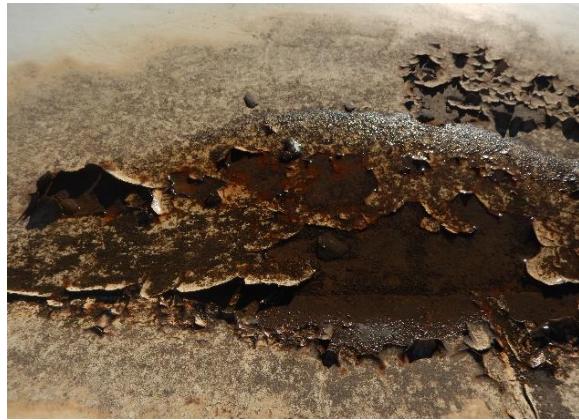
Conclusion/Discrepancies: Roof coating is slightly oxidized. There are numerous areas of low spots along the roof panel weld seams. Roof has low spots allowing water to pool causing delamination of the coating in a few areas. Recommend touching up these areas before the delamination becomes worse.

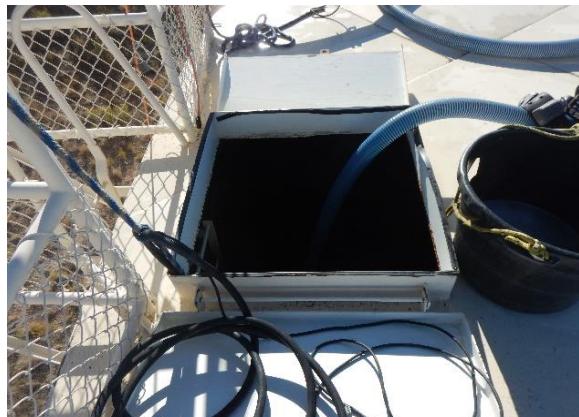
Satisfactory	Y	<input checked="" type="checkbox"/>	N	<input type="checkbox"/>	
Coating					
Corrosion	Y	<input type="checkbox"/>	N	<input checked="" type="checkbox"/>	<input type="checkbox"/>
Proper Design	Y	<input checked="" type="checkbox"/>	N	<input type="checkbox"/>	<input type="checkbox"/>
Locked	Y	<input checked="" type="checkbox"/>	N	<input type="checkbox"/>	<input type="checkbox"/>
Gasket	Y	<input checked="" type="checkbox"/>	N	<input type="checkbox"/>	<input type="checkbox"/>
Hinge					
Hatch Size	3	FT	X	3	FT
Conclusion/Discrepancies	Both the access hatch and gasket are in good condition.

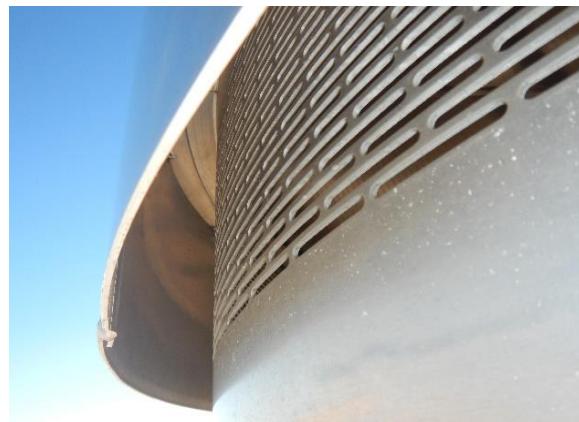
Satisfactory	Y	<input checked="" type="checkbox"/>	N	<input type="checkbox"/>	
Coating	Aluminum				
Corrosion	%	Y	<input type="checkbox"/>	N	<input checked="" type="checkbox"/>
Proper Design	Y	<input checked="" type="checkbox"/>	N	<input type="checkbox"/>	<input type="checkbox"/>
Screens	Y	<input checked="" type="checkbox"/>	N	<input type="checkbox"/>	<input type="checkbox"/>
Sealed Edges & Seams	Y	<input checked="" type="checkbox"/>	N	<input type="checkbox"/>	<input type="checkbox"/>
Cap/Cover	Y	<input checked="" type="checkbox"/>	N	<input type="checkbox"/>	<input type="checkbox"/>
Conclusion/Discrepancies	Both the vent and screen are in good condition.

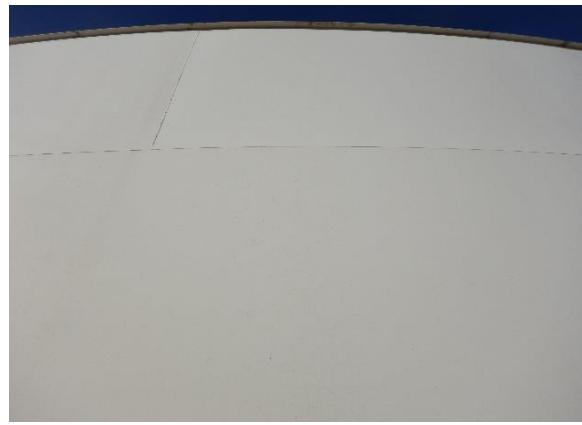
Rings	
Chime	Good condition
2nd Weld Ring	Good condition
3rd Weld Ring	Good condition
4th Weld Ring	
5th Weld Ring	
Ring(s)	4 in all
Wall to Roof Seam	Good condition
Coating	
Satisfactory	Y <input checked="" type="checkbox"/> N <input type="checkbox"/>
Oxidized	Y <input checked="" type="checkbox"/> N <input type="checkbox"/>
Pitting	Y <input checked="" type="checkbox"/> N <input checked="" type="checkbox"/>
Delamination	Y <input checked="" type="checkbox"/> N <input checked="" type="checkbox"/>
Corrosion	Y <input checked="" type="checkbox"/> N <input checked="" type="checkbox"/>
Conclusion/Discrepancies	Shell coating is slightly oxidized no other issues noted.

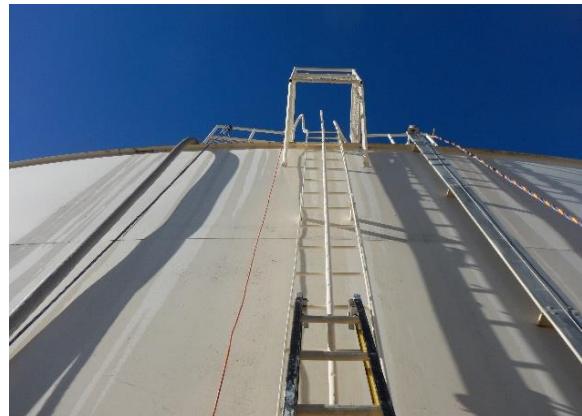
Construction	Coated steel
Satisfactory	Y <input checked="" type="checkbox"/> N <input type="checkbox"/>
Coating	
Satisfactory	Y <input checked="" type="checkbox"/> N <input type="checkbox"/>
Oxidized	Y <input checked="" type="checkbox"/> N <input type="checkbox"/>
Pitting	Y <input checked="" type="checkbox"/> N <input checked="" type="checkbox"/>
Delamination	Y <input checked="" type="checkbox"/> N <input checked="" type="checkbox"/>
Corrosion	% Y <input checked="" type="checkbox"/> N <input checked="" type="checkbox"/>
Welds/Joints	Good condition
Supports	Good condition
Safety Cage/Climb	Y <input checked="" type="checkbox"/> N <input type="checkbox"/>
Conclusion/Discrepancies	Slight oxidation was noted. Ladder is in good condition and safe for use.

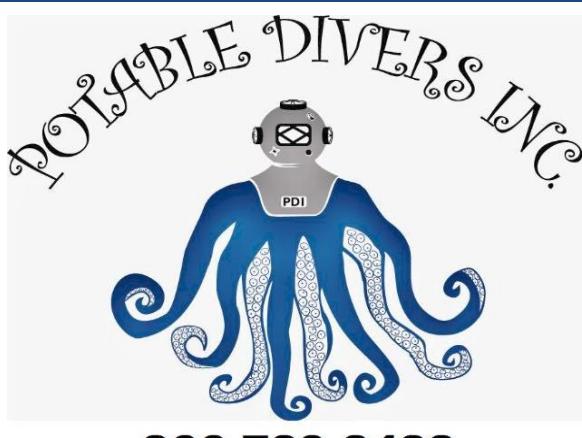
Coating	
Satisfactory	Y <input type="checkbox"/> N <input type="checkbox"/>
Oxidized	Y <input type="checkbox"/> N <input type="checkbox"/>
Pitting	Y <input type="checkbox"/> N <input type="checkbox"/>
Delamination	Y <input type="checkbox"/> N <input type="checkbox"/>
Corrosion	% Y <input type="checkbox"/> N <input type="checkbox"/>
Welds/Joints	
Supports	
Screens	Y <input type="checkbox"/> N <input type="checkbox"/>
Attachments	
Foundation	
Conclusion/Discrepancies	Internal

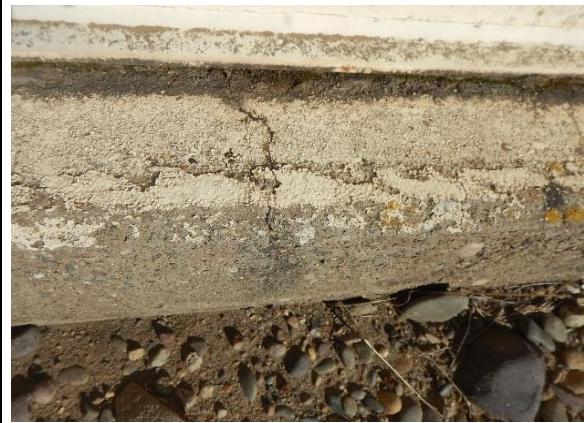
Satisfactory	Y	X	N	
Cracking	Y	X	N	
Spalling	Y		N	X
Exposed Aggregate	Y		N	X
Erosion Undermining	Y		N	X

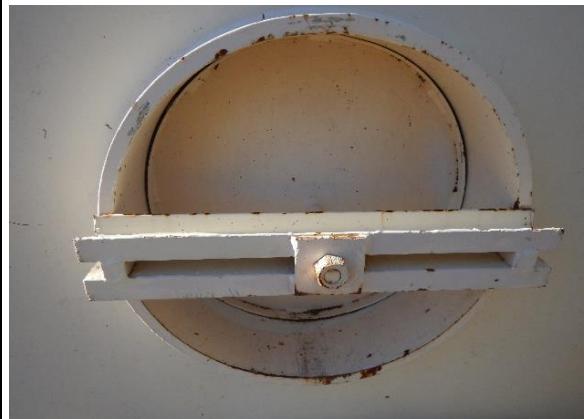
MANUAL LEVEL INDICATOR

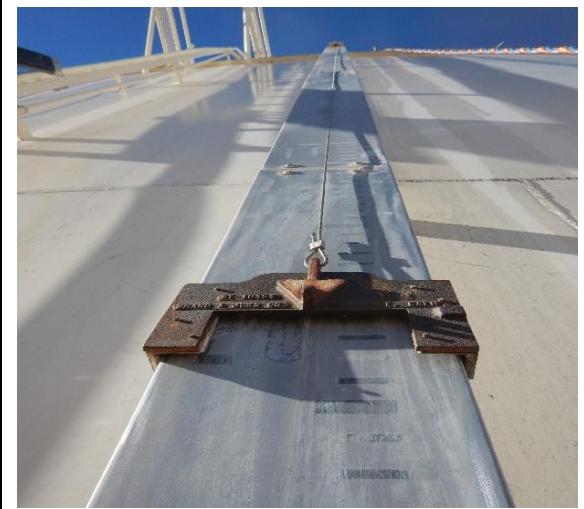
Conclusion/Discrepancies: No issues noted.

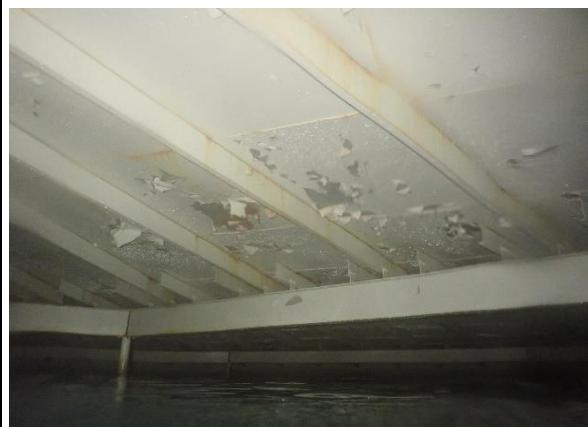
Conclusion/Discrepancies: Corrosion was noted where the roof panels rest on top of the trusses
 Coating is delaminating from the roof panels exposing the undercoat.

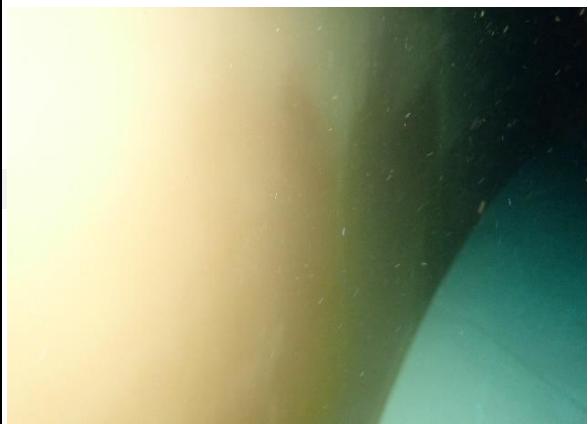
Coating			
Satisfactory	Y	<input checked="" type="checkbox"/>	N <input type="checkbox"/>
Blistering	Y	<input type="checkbox"/>	N <input checked="" type="checkbox"/>
Cracking	Y	<input type="checkbox"/>	N <input checked="" type="checkbox"/>
Peeling	Y	<input type="checkbox"/>	N <input checked="" type="checkbox"/>
Holidays	Y	<input type="checkbox"/>	N <input checked="" type="checkbox"/>
Pitting	Y	<input type="checkbox"/>	N <input checked="" type="checkbox"/>
Corrosion	5%	<input checked="" type="checkbox"/>	N <input type="checkbox"/>
Seams/Welds	Good-fair condition		
Rings			
Chime	Good condition		
2nd Weld Ring	Good condition		
3rd Weld Ring	Good condition		
4th Weld Ring			
5th Weld Ring			
Ring(s)	4 in all		
Wall to Roof Seam	Good-fair condition		
Baffle/Support Walls	None		
Conclusion/Discrepancies:	Minor corrosion where the shell and roof meet in the corner weld.

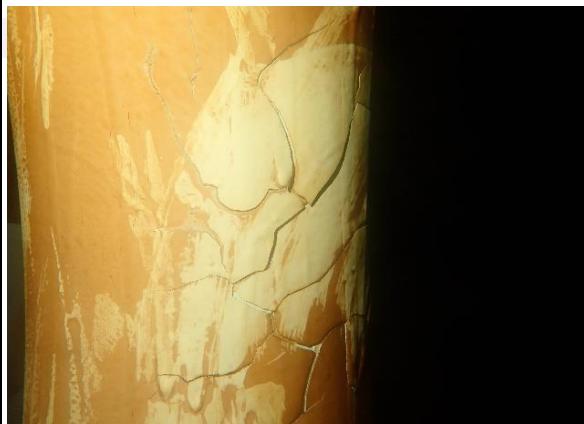
Conclusion/Discrepancies: A few of the columns have extensive cracking and delamination of the coating.

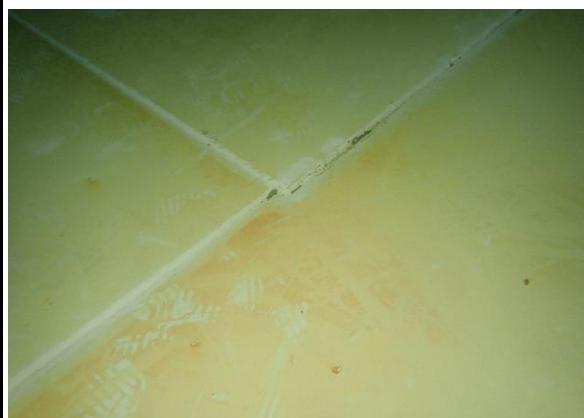
Conclusion/Discrepancies: Floor and coating are in good condition. No issues noted.

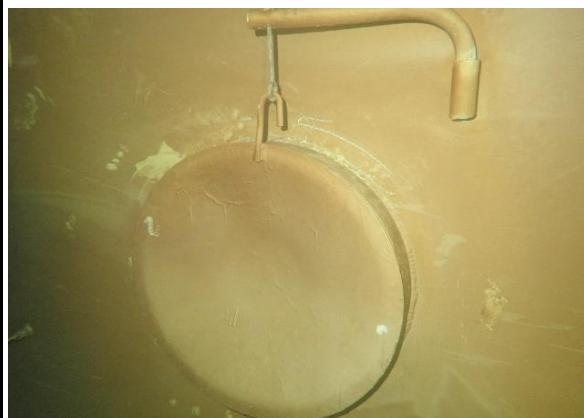
Conclusion/Discrepancies: No issues noted.

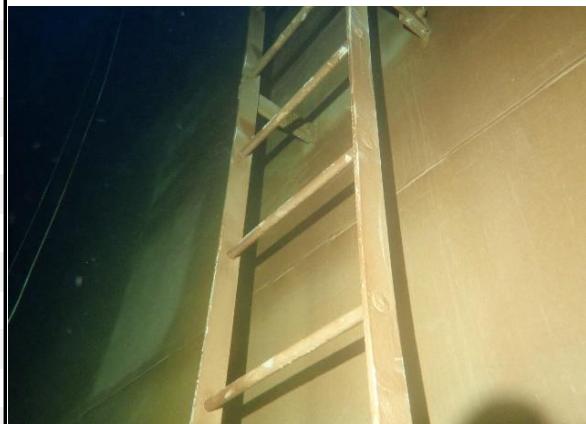
Conclusion/Discrepancies: Ladder is in good condition and safe for use.

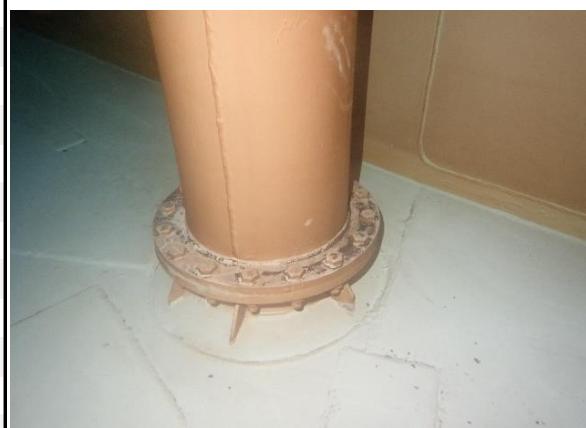
MANUAL LEVEL INDICATOR

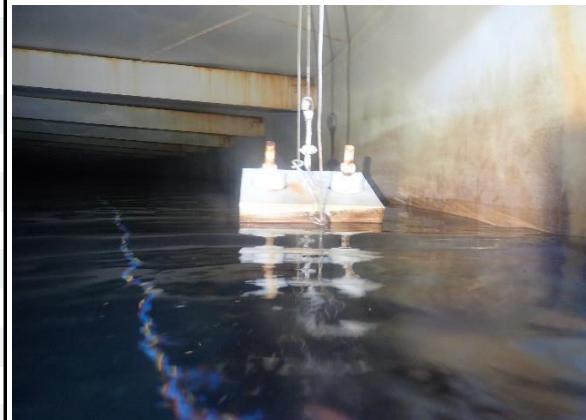
Conclusion/Discrepancies: Minor corrosion on the hardware.

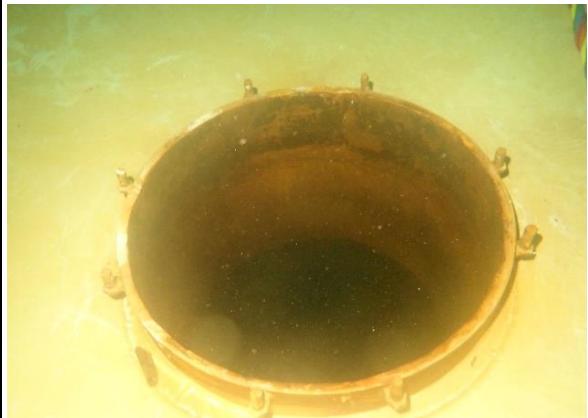
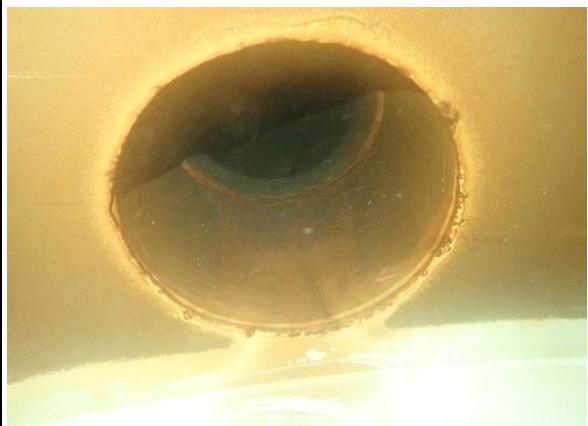
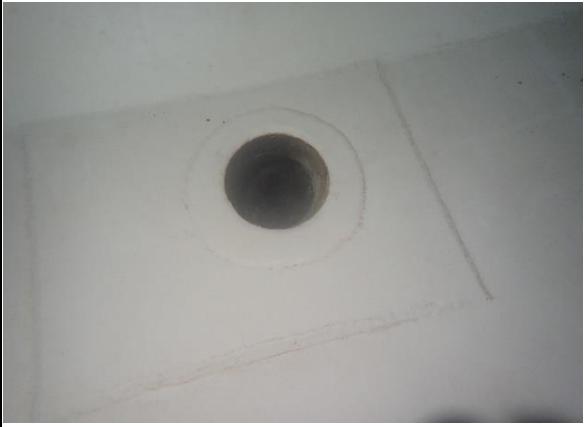
Conclusion/Discrepancies: Minor corrosion in
interior of the drain pipe.
