TANK BOTTOM INSPECTION REPORT

**City of Grand Junction
South 4.0 MG Water Storage Tank
170' Diameter**

**Water Treatment Plant
Grand Junction, Colorado**

Inspection Completion Date: November 20, 2025

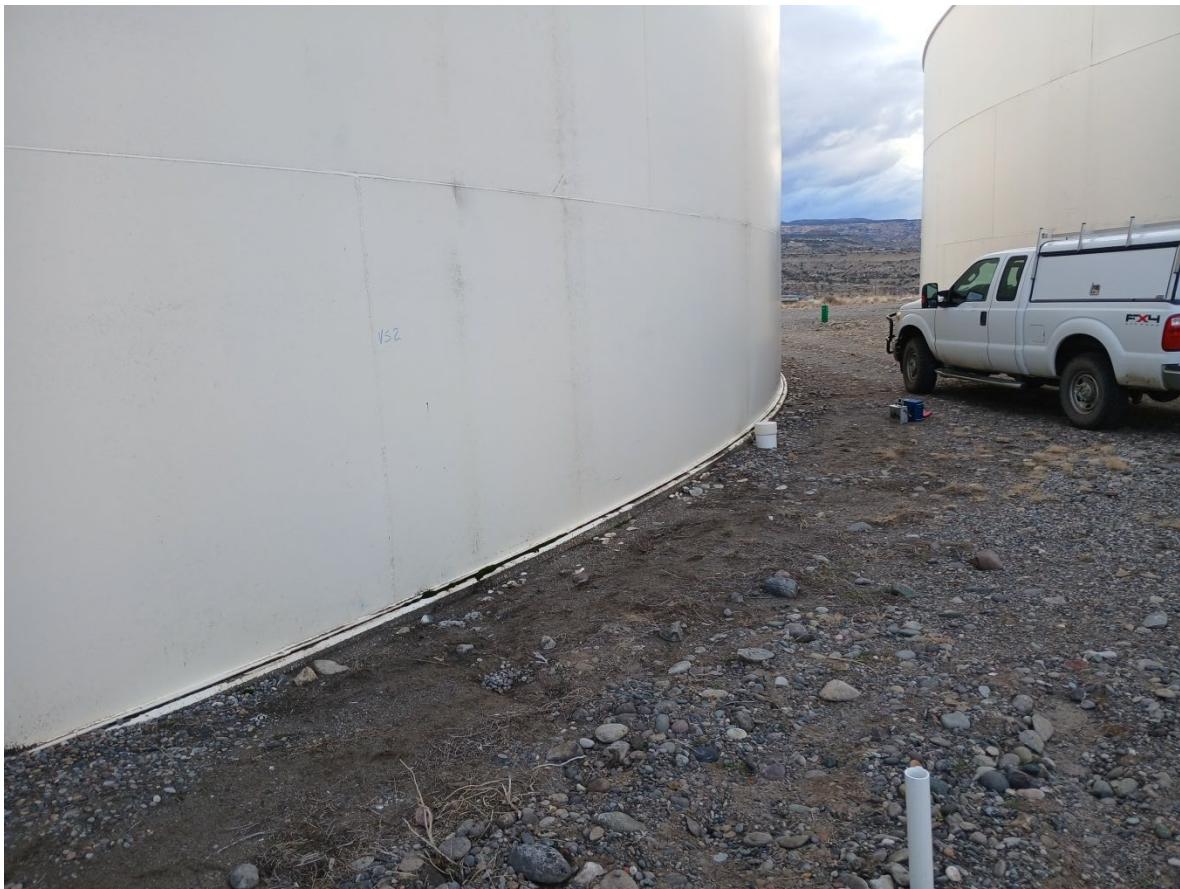
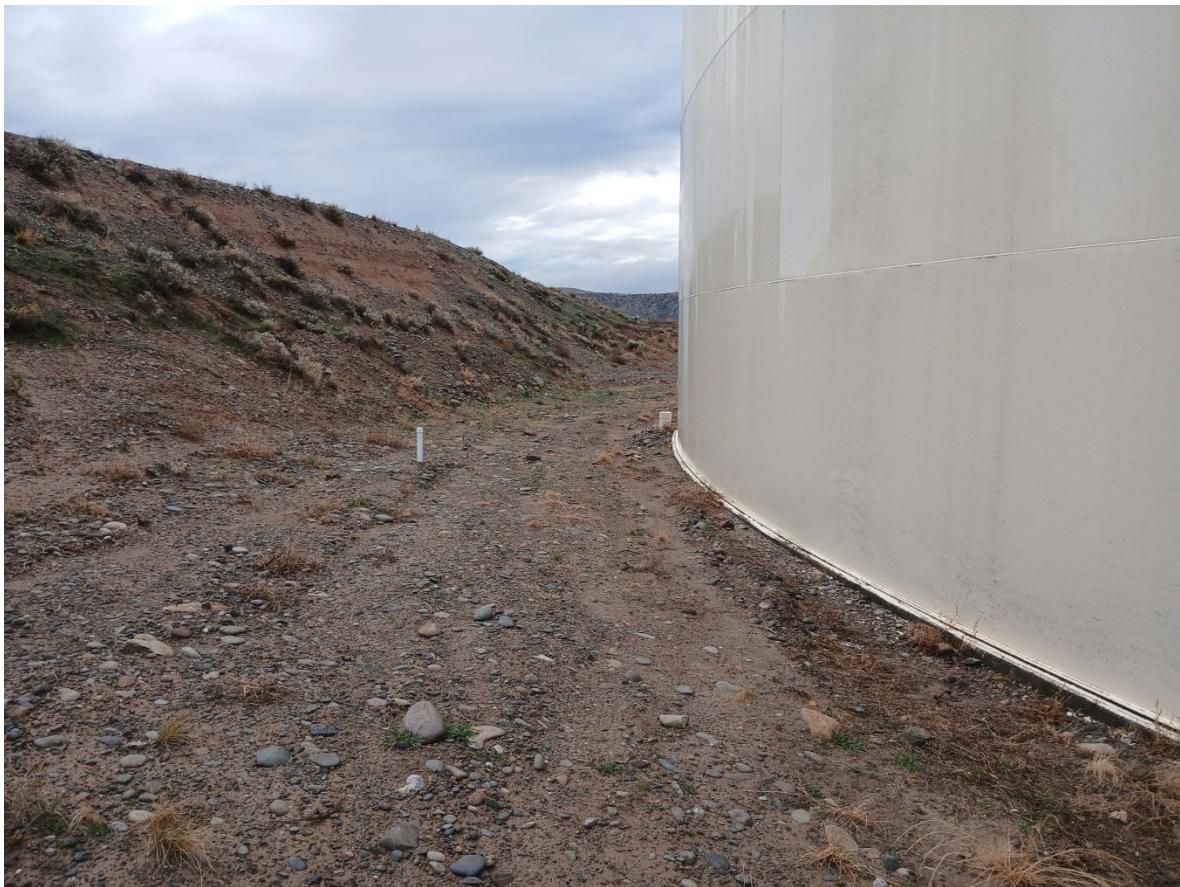
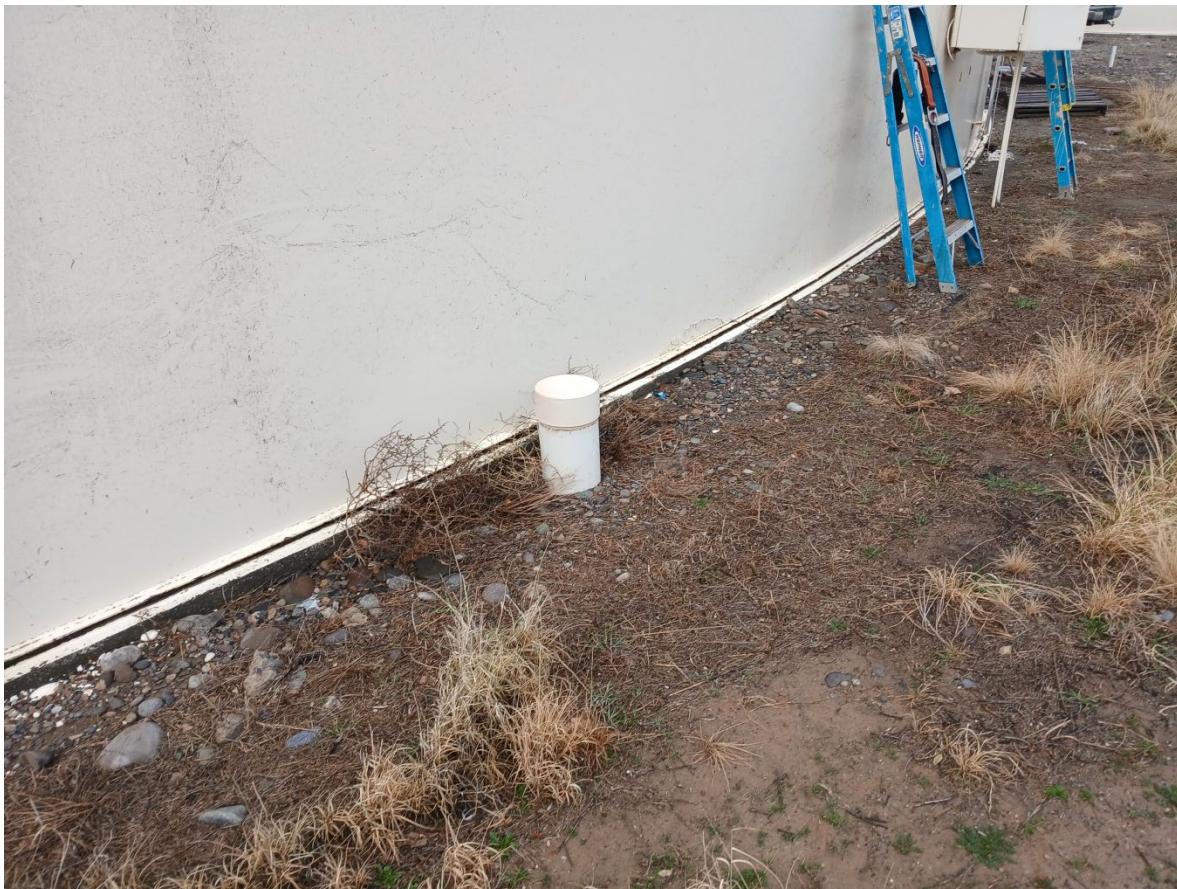
- On the external side of the tank, the bottom plate projection was visually inspected. There are significant gaps between the concrete ring wall and the bottom plate projection. The most significant gaps are on the West side of the tank where mud jacking was completed around the sump. The air gap is up to 1 $\frac{1}{4}$ ". The current condition allows water to migrate under the bottom. There are widely scattered areas of hairline cracks in the concrete ring wall. The surrounding grade is higher than the concrete ring wall at a few locations. See photos 07 through 17.

Photo 07. Tank support configuration and surrounding grade

Photo 08. Tank support configuration and surrounding grade

Photo 09. Tank support configuration and surrounding grade

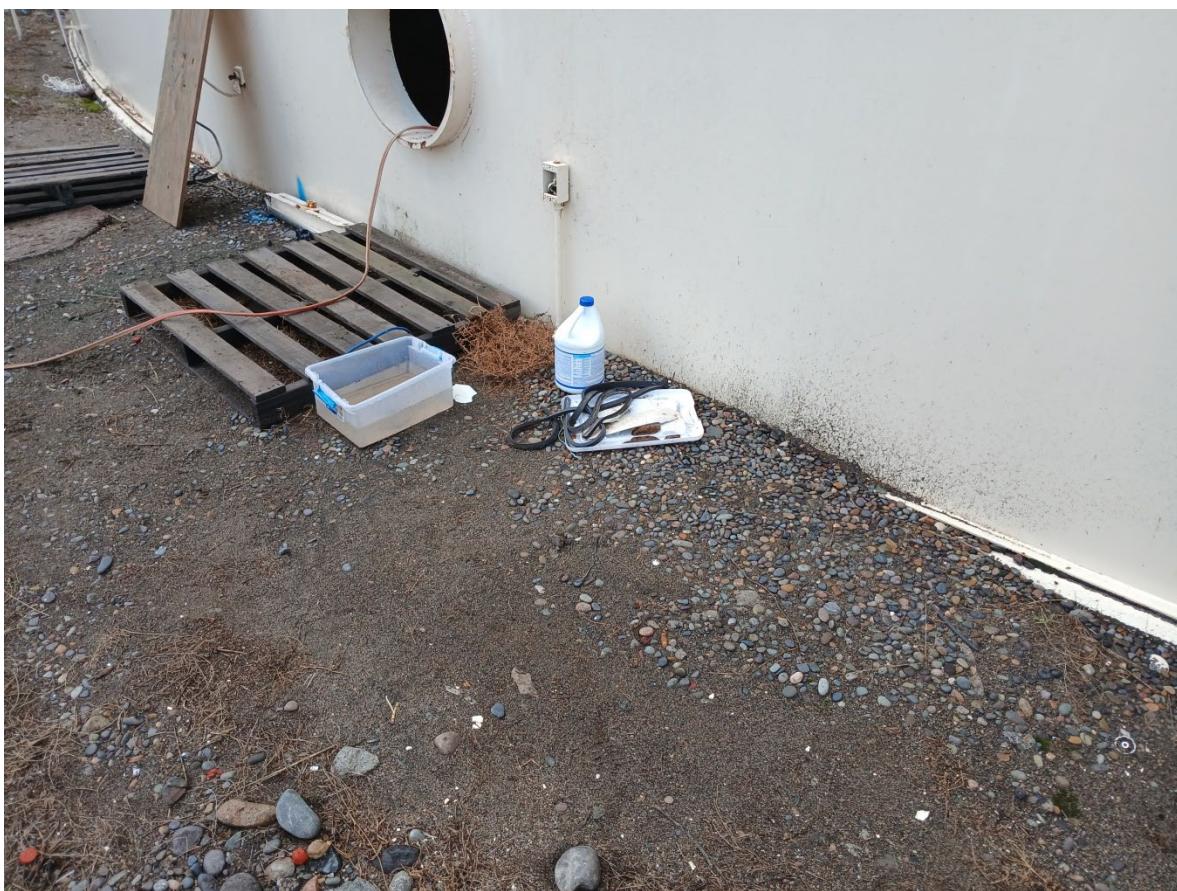
Photo 10. Surrounding grade higher than bottom plate projection

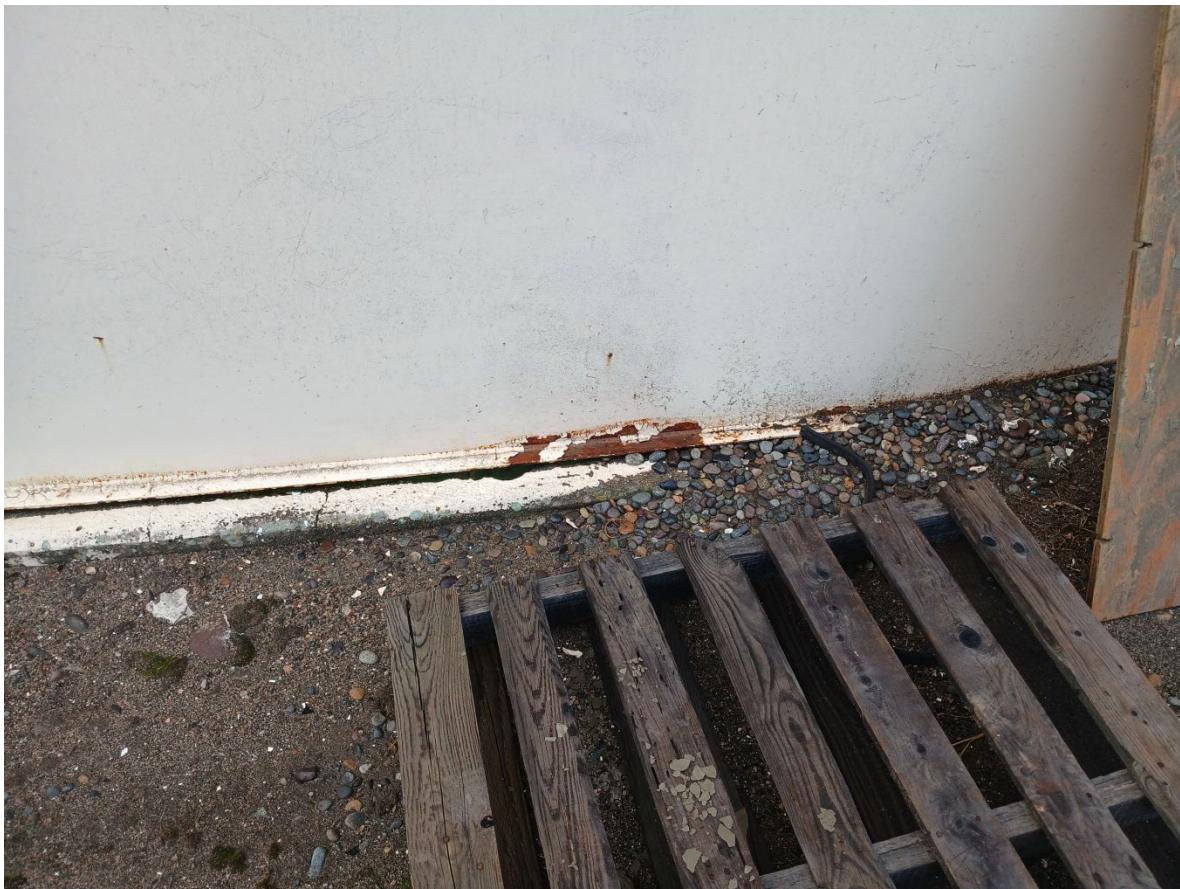
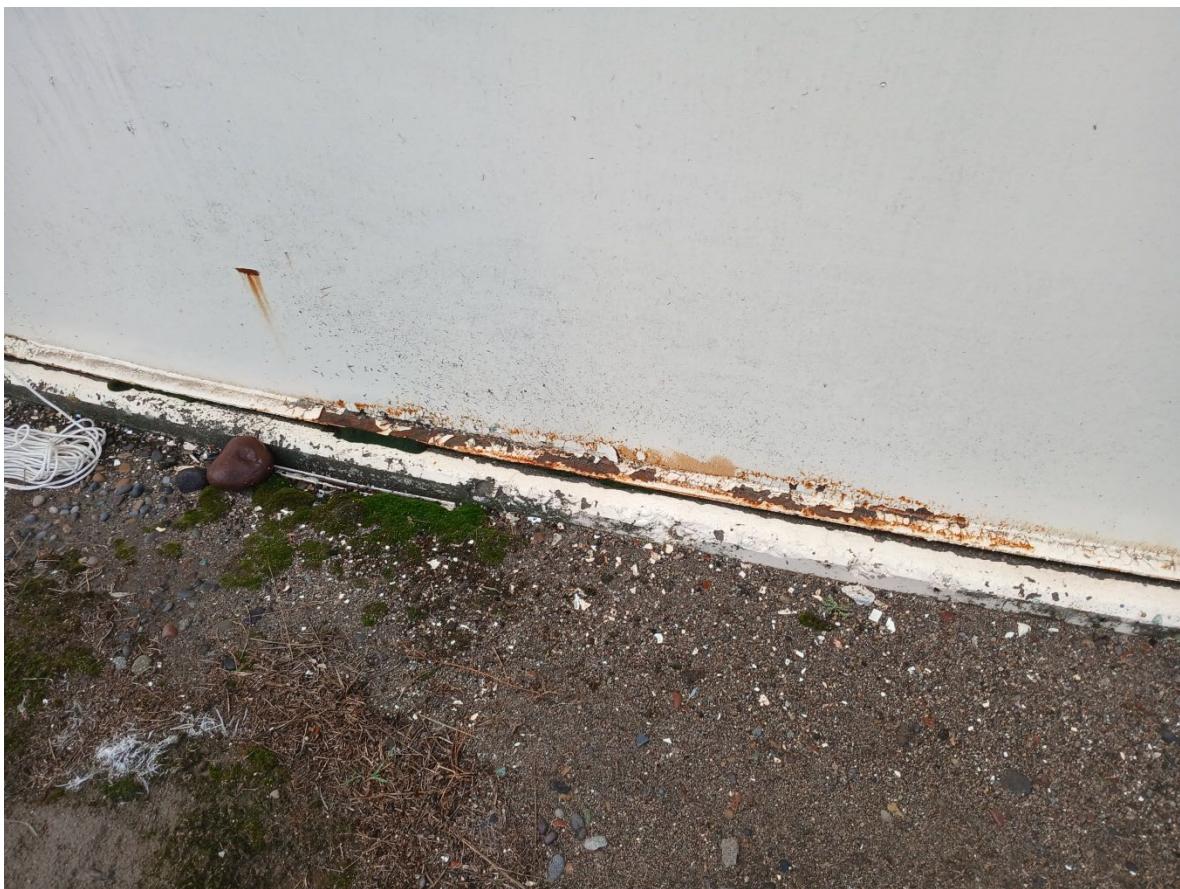
Photo 11. Area of paint failure with rust at bottom plate projection

Photo 12. Area of paint failure with rust at bottom plate projection

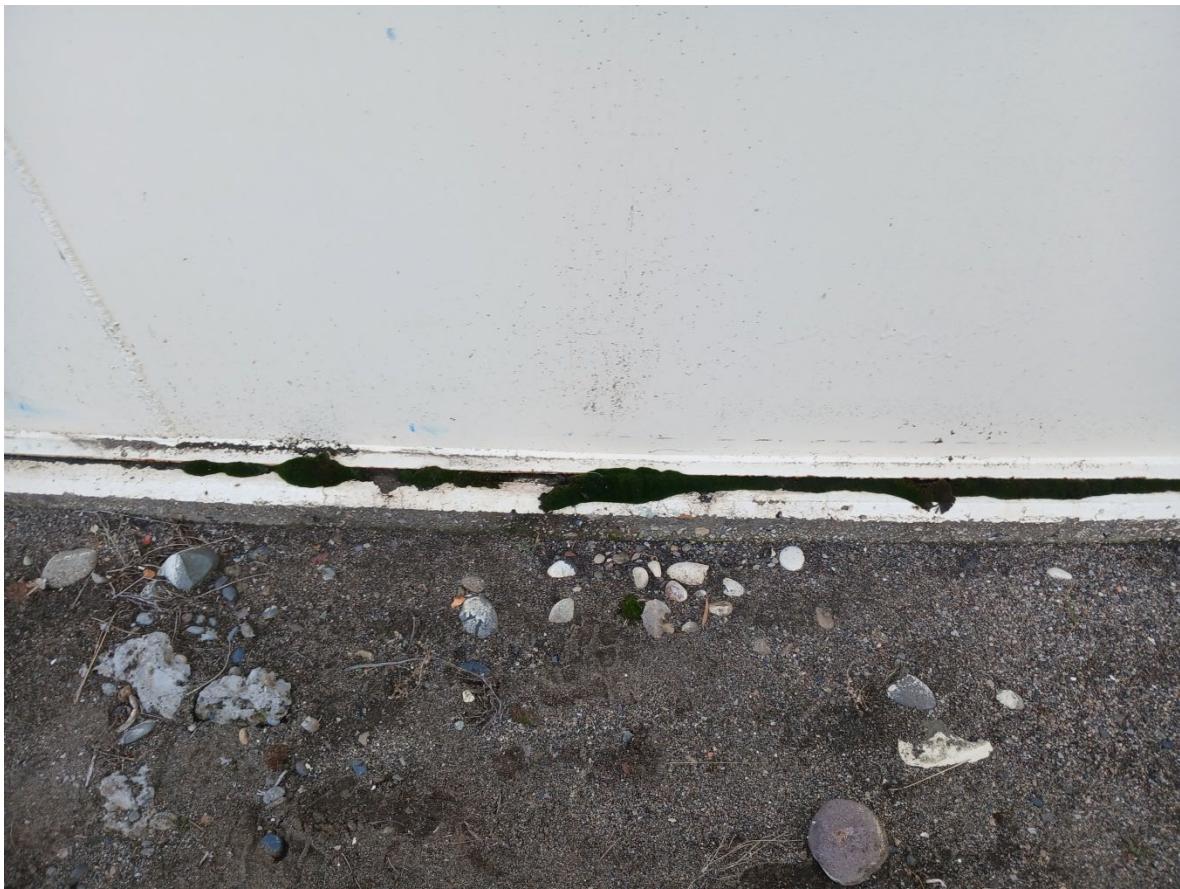
Photo 13. Moss growing between concrete ring wall and bottom plate projection

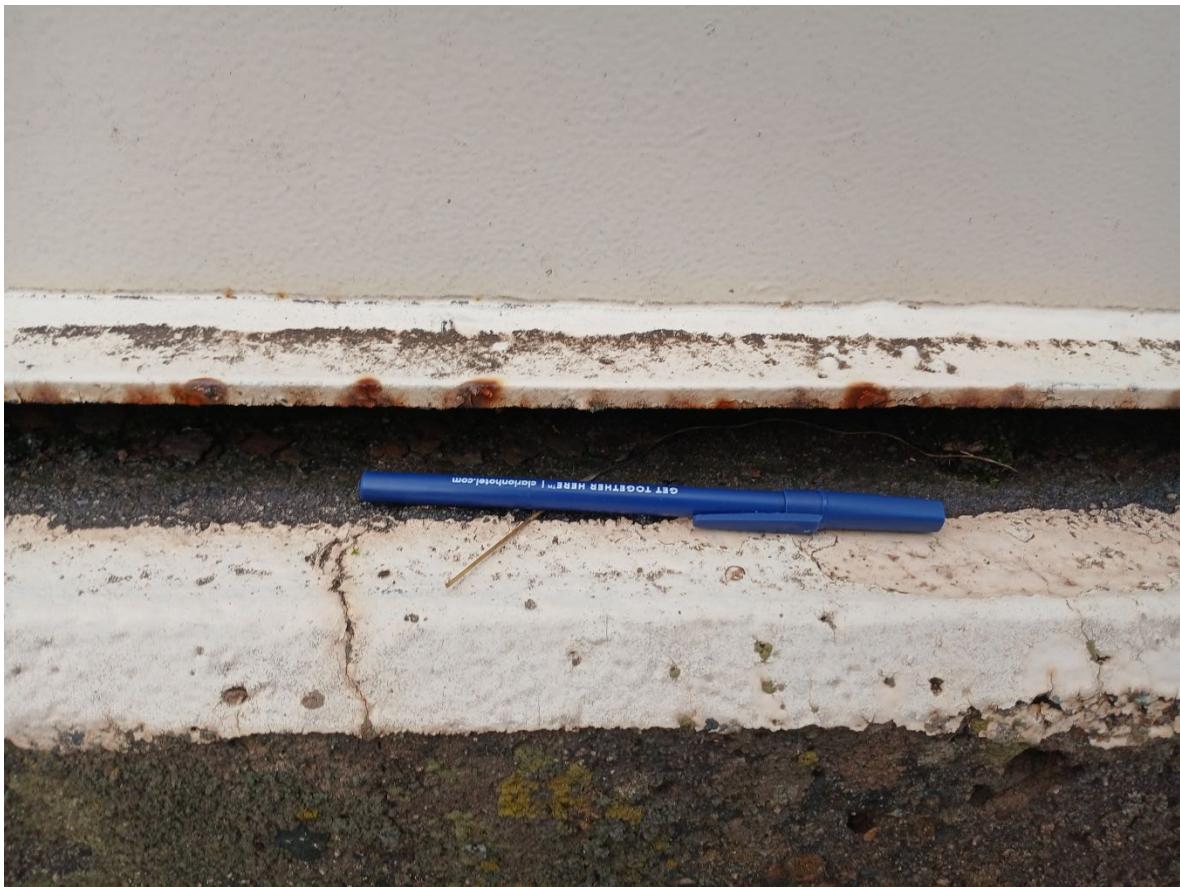
Photo 14. Air gap between concrete ring wall and bottom plate projection

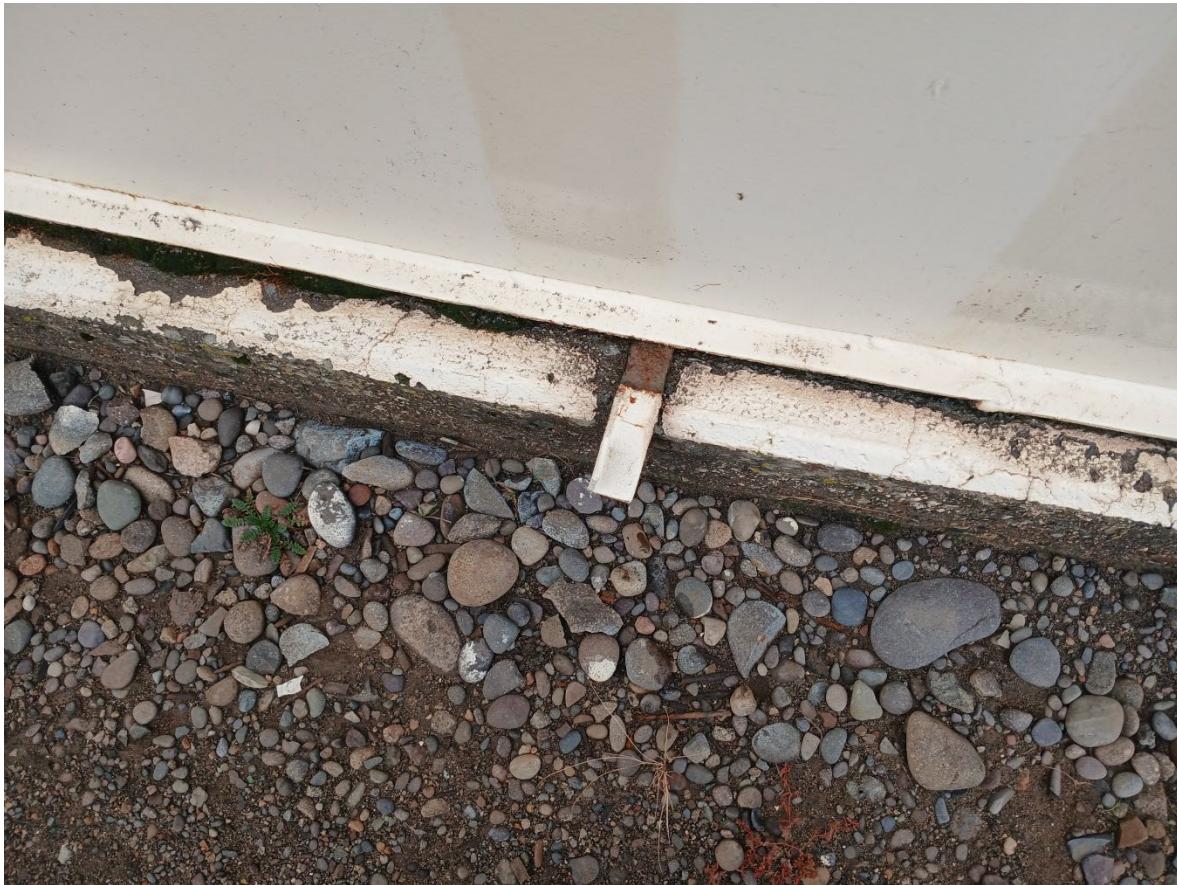
Photo 16. As found corroded piece of flat steel bar between concrete ring wall and bottom

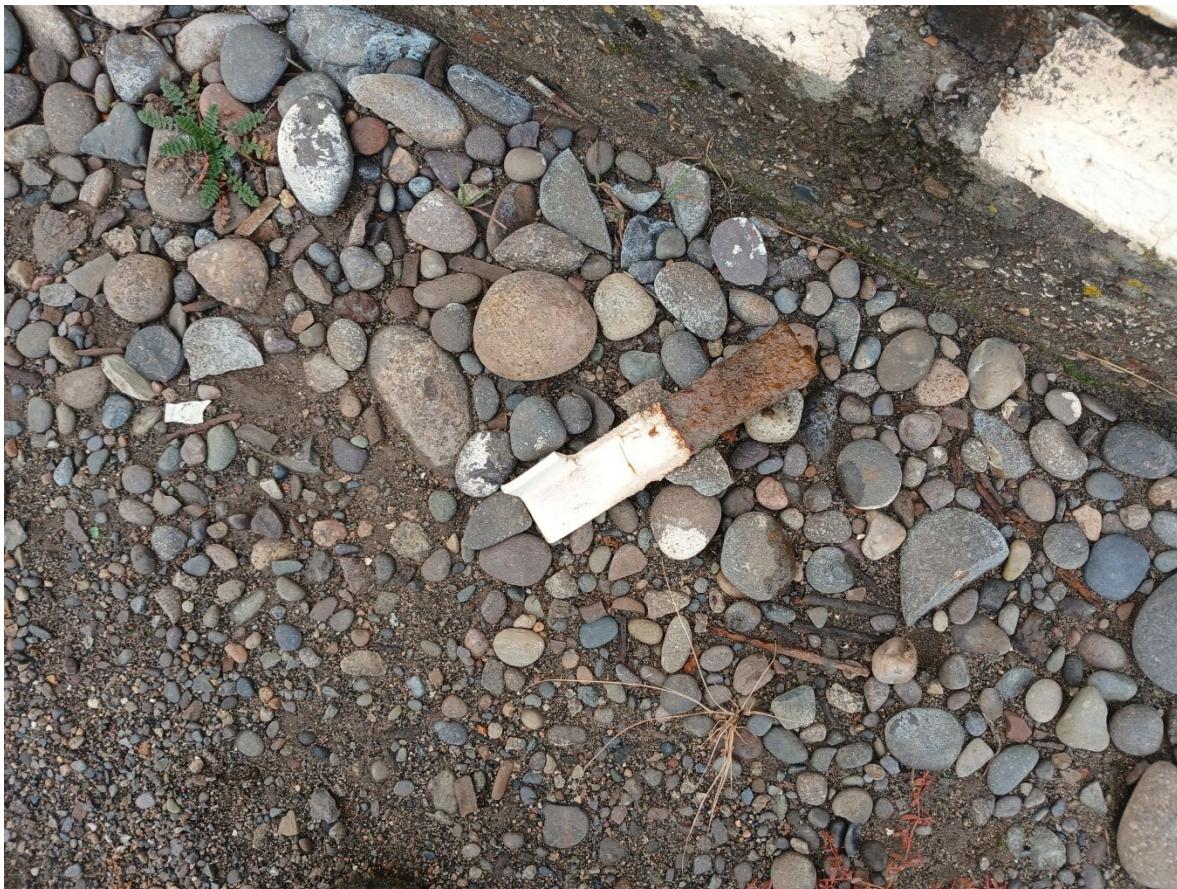
Photo 17. Corroded piece of flat steel bar between concrete ring wall and bottom

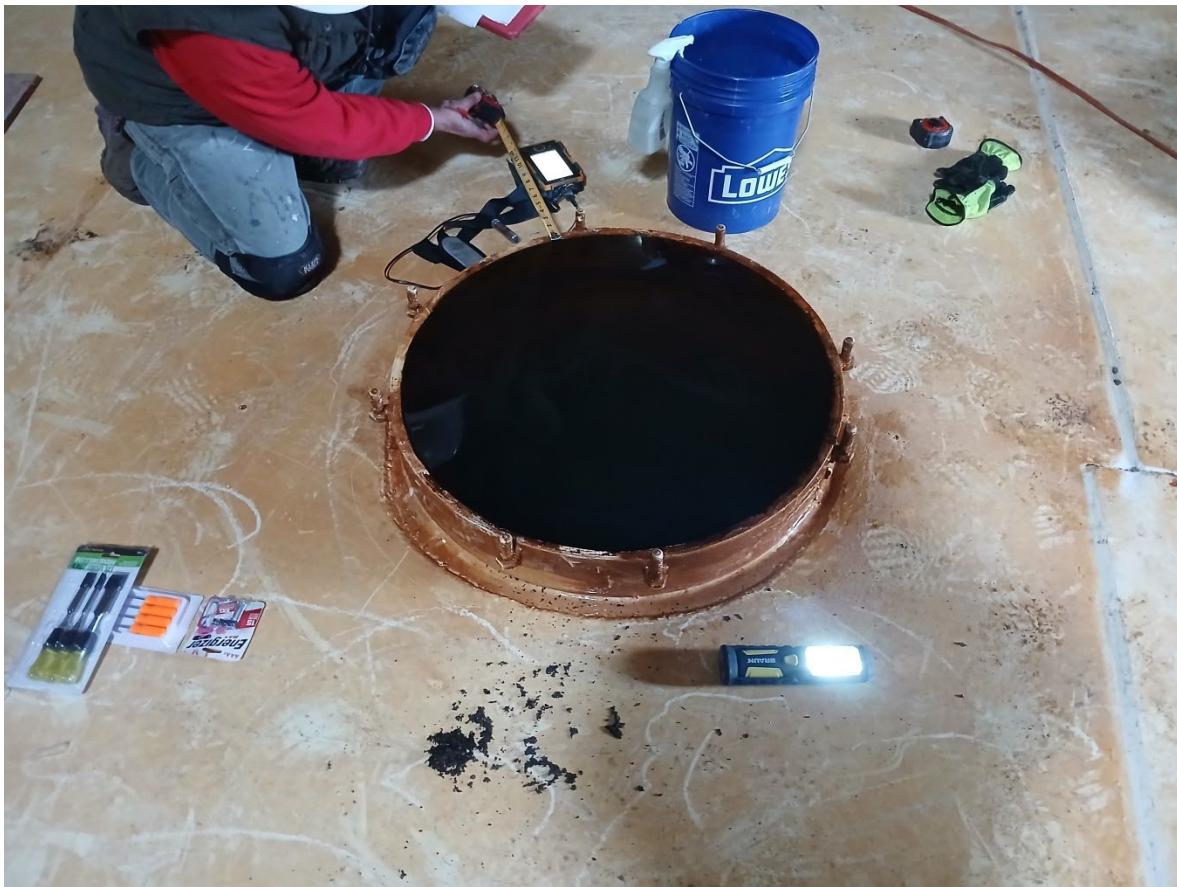
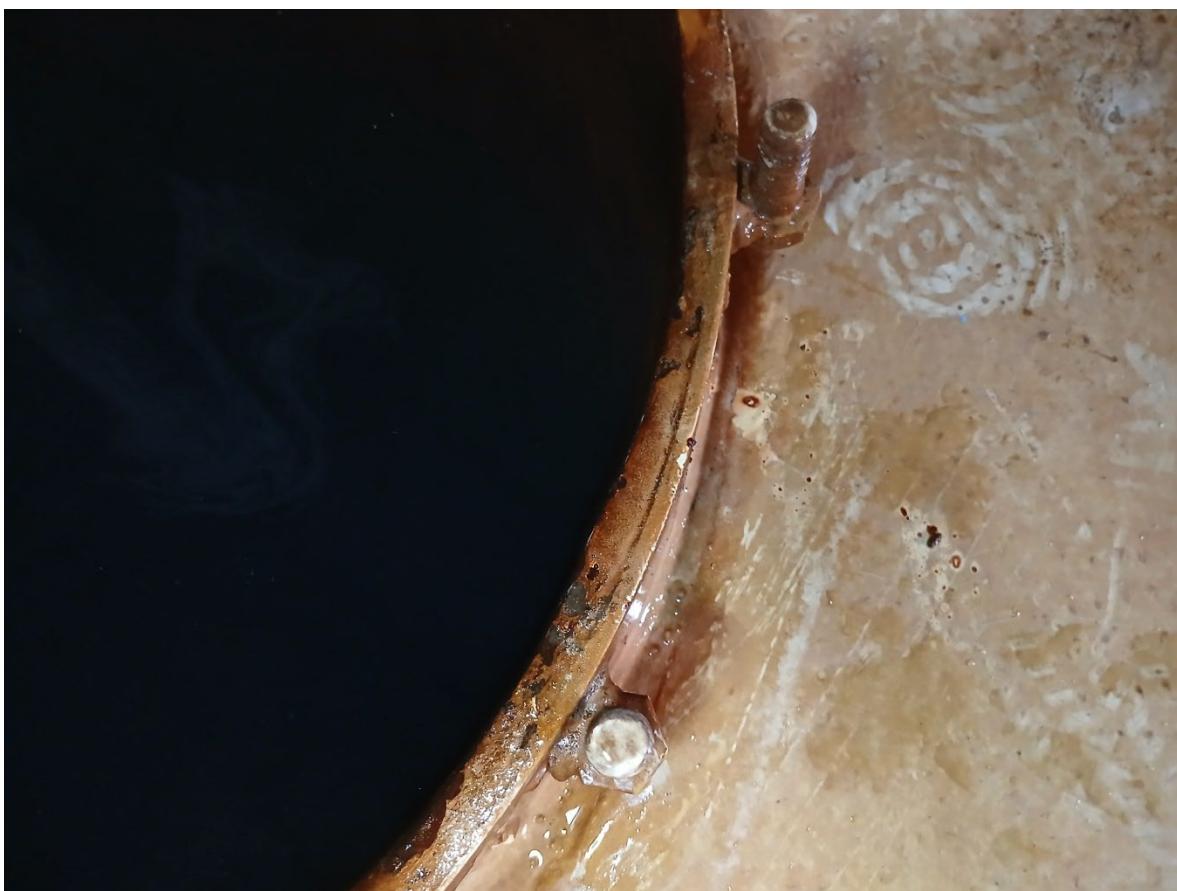
- There is a 30" bottom inlet on bottom plate 16 with underside reinforcement. The pipe was full of water with a steel silt ring. There is a non-metallic internal liner visible at the edge of the silt ring. See photos 27 and 28. No obvious issue was observed with this connection.

Photo 27. 30" bottom inlet pipe configuration with silt stop and water inside

Photo 28. 30" bottom inlet pipe configuration with silt stop and water inside

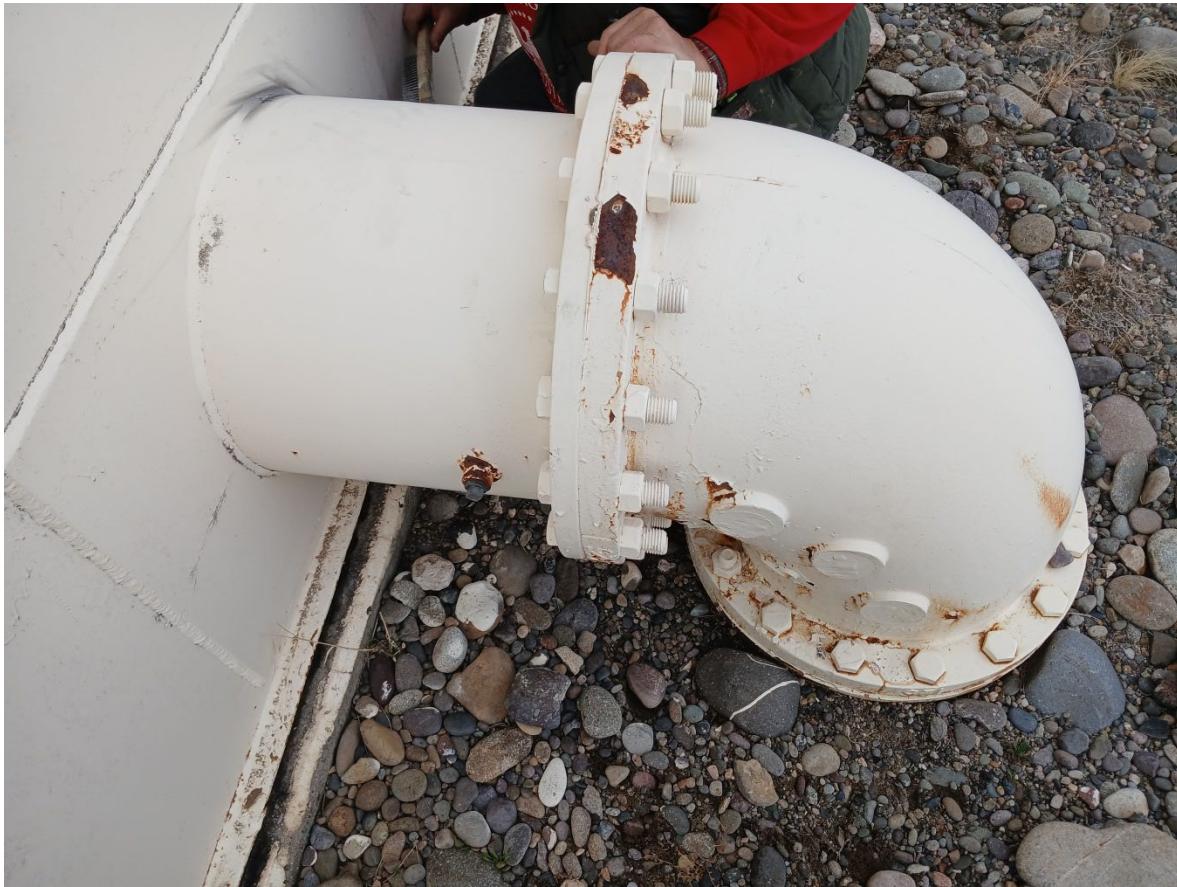
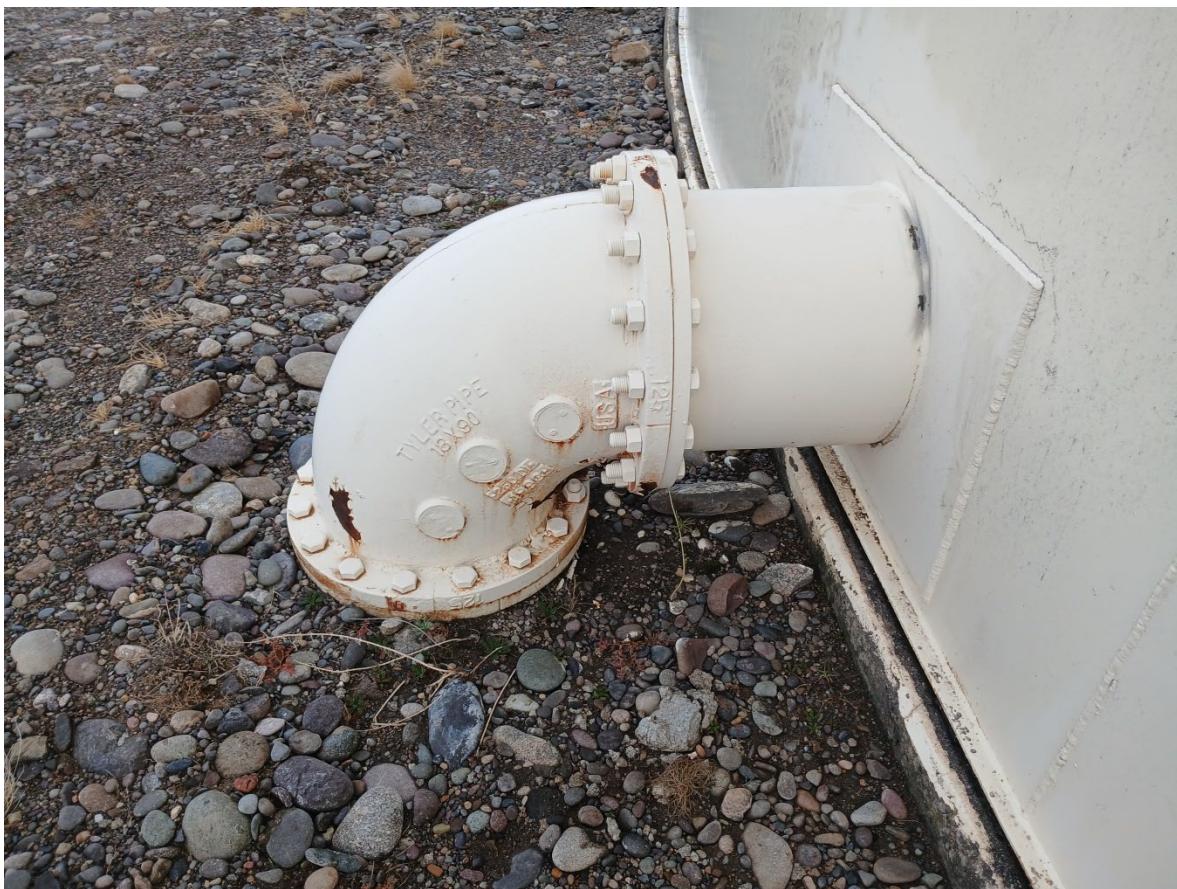
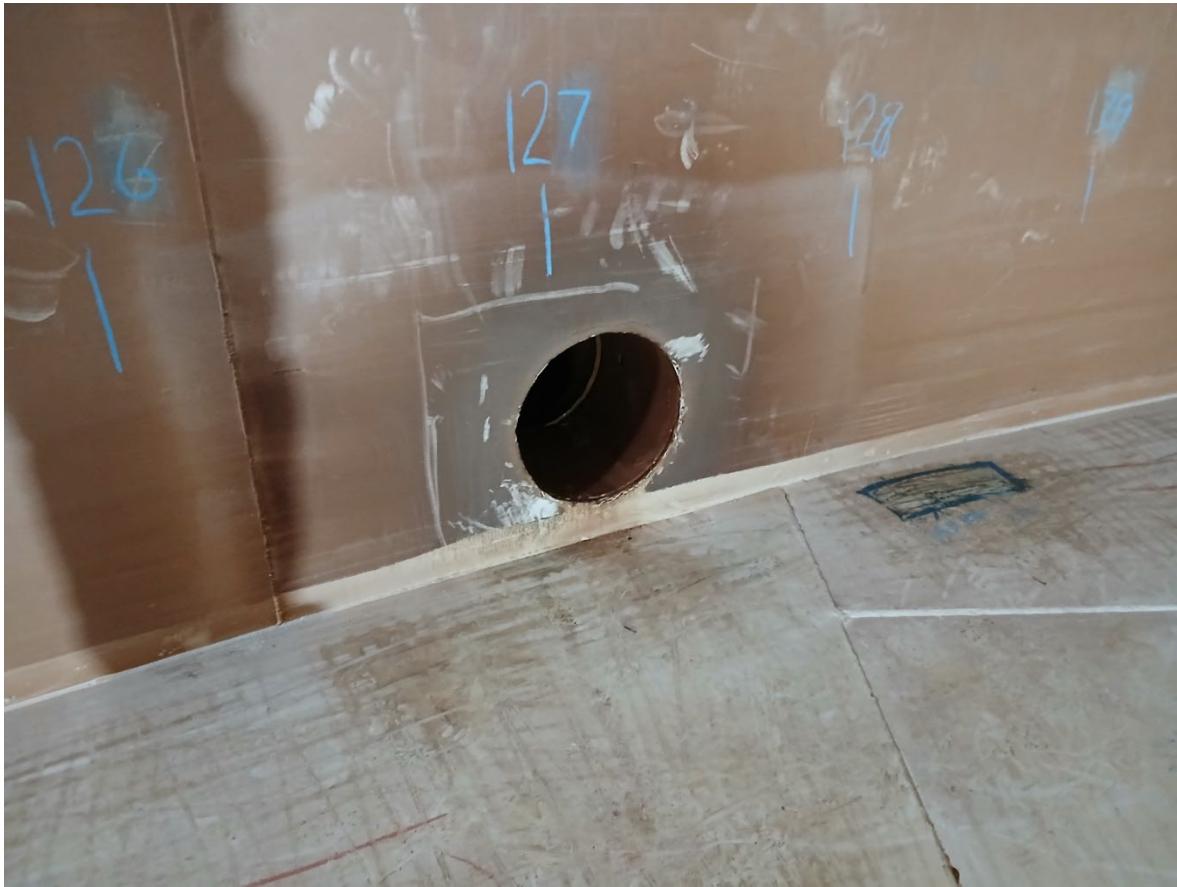
- There is an outlet nozzle at the Southwest side of the shell. The nozzle size is 19" as measured on the ID with an 18" elbow above grade on the exterior side of the tank. The nozzle is not original to the tank construction. The nozzle is not welded or sealed to the shell, which allows water between the exterior side of the shell and the repad. The nozzle appears to be welded to the square cornered reinforcement pad only with the reinforcement pad welded to the shell. There is internal corrosion / pitting at the bottom of the nozzle that has been coated to arrest further loss. Ultrasonic thickness readings indicate moderate wall loss from the suspected 0.250" nominal. A remaining wall thickness of 0.185" was found on the bottom. See photos 29 through 33. The current nozzle configuration is suspect.

Photo 29. Exterior view of shell outlet nozzle

Photo 30. Exterior view of shell outlet nozzle

Photo 31. Interior view of shell outlet nozzle

3. The shell outlet nozzle is recommended to be evaluated for suitability. The current configuration has several concerns.

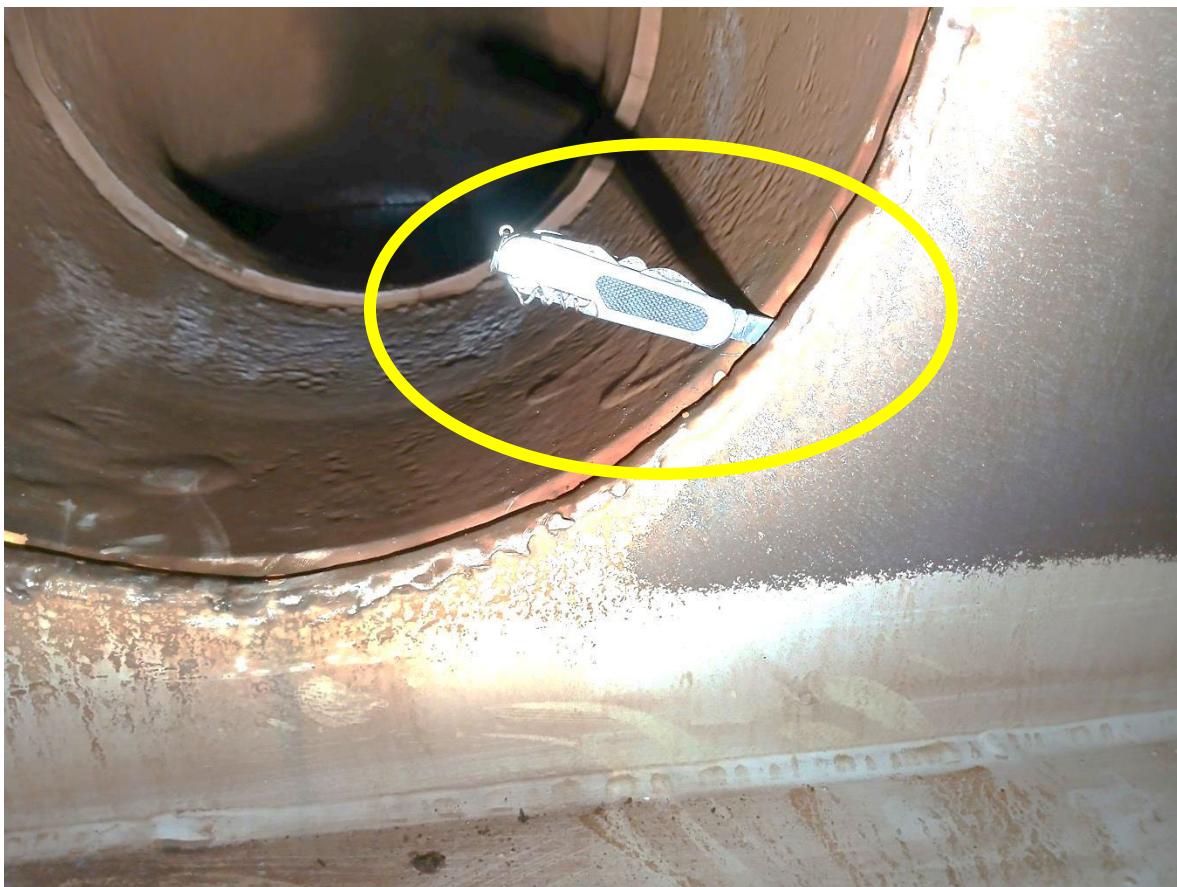
Photo 32. Air gap between shell outlet nozzle and shell, internal corrosion / pitting (coated)

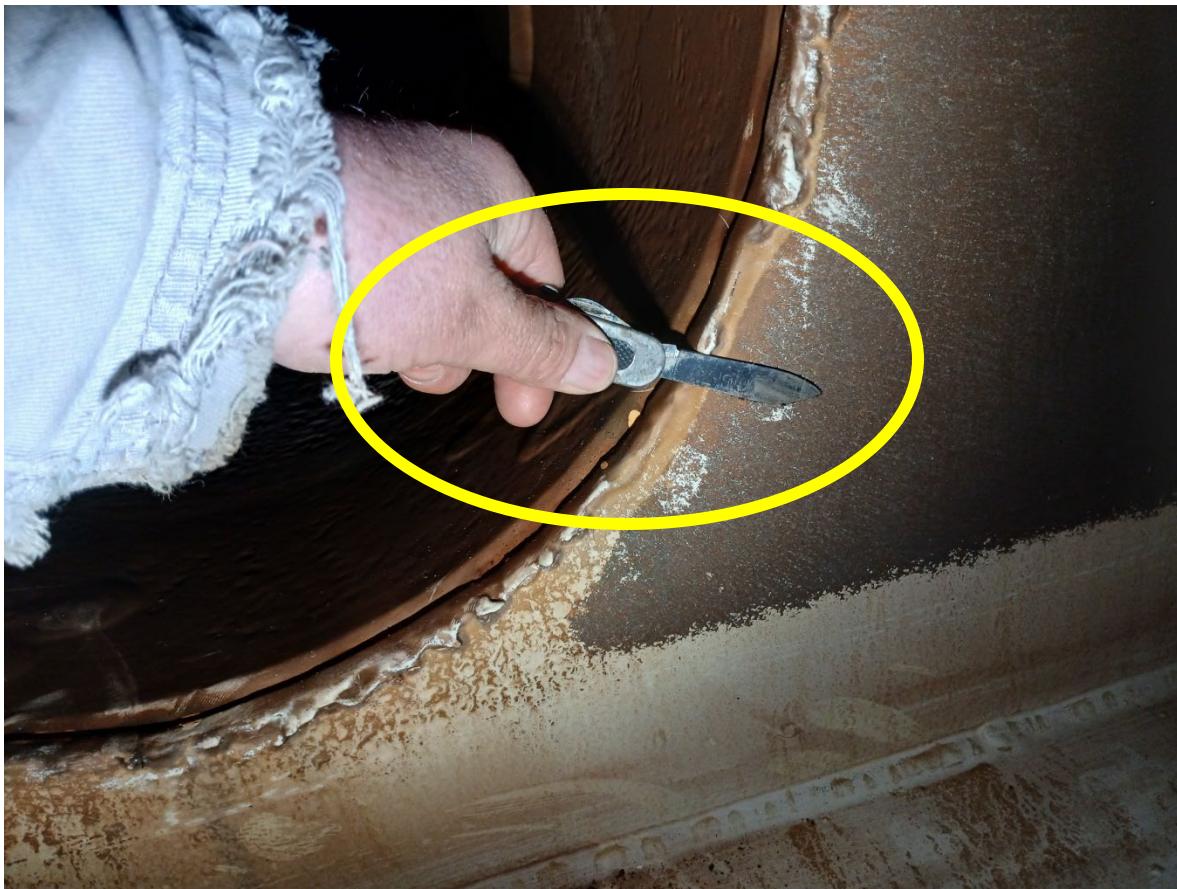
Photo 33. Air gap between shell outlet nozzle and shell

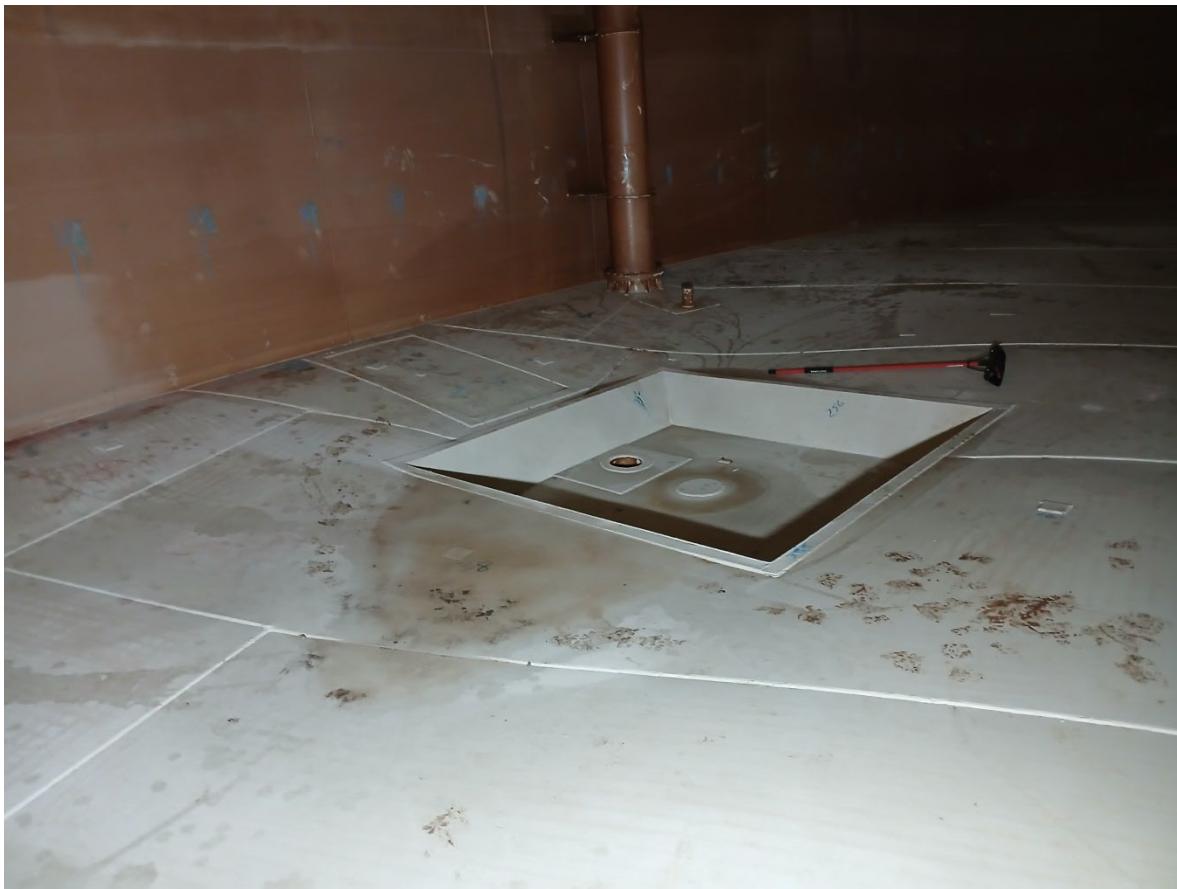
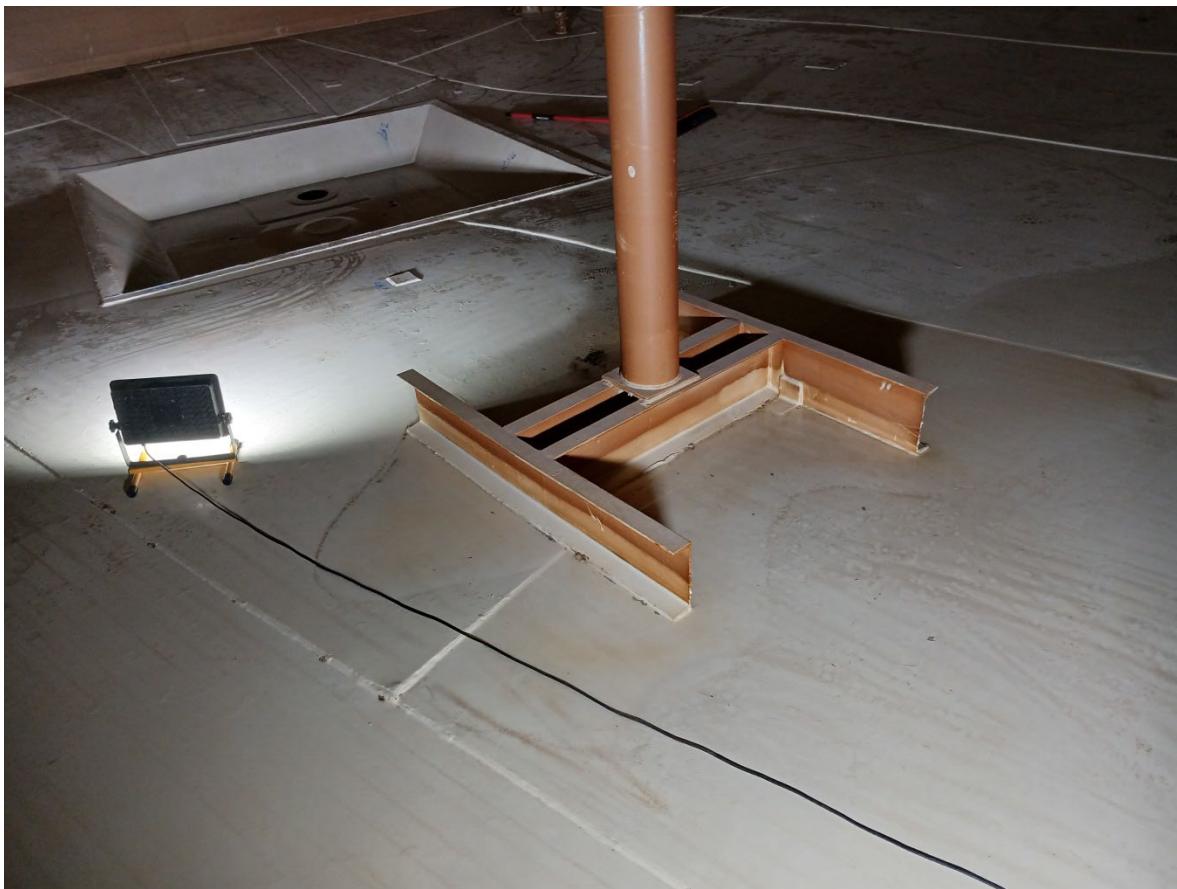
- The tank bottom is obviously sloped toward the sump. There have been previous modifications to the sump area along with mud jacking. Some of the fillet welded patch plates on the sump side of the tank are probably associated with the jacking. Some of the fillet-welded patches may be related to product or soil side corrosion issues. The patches range in size with square corners.

Photo 37. Sump and drain configuration, scattered small fillet welded patches on tank bottom

Photo 38. Sump and drain configuration, scattered small fillet welded patches on tank bottom

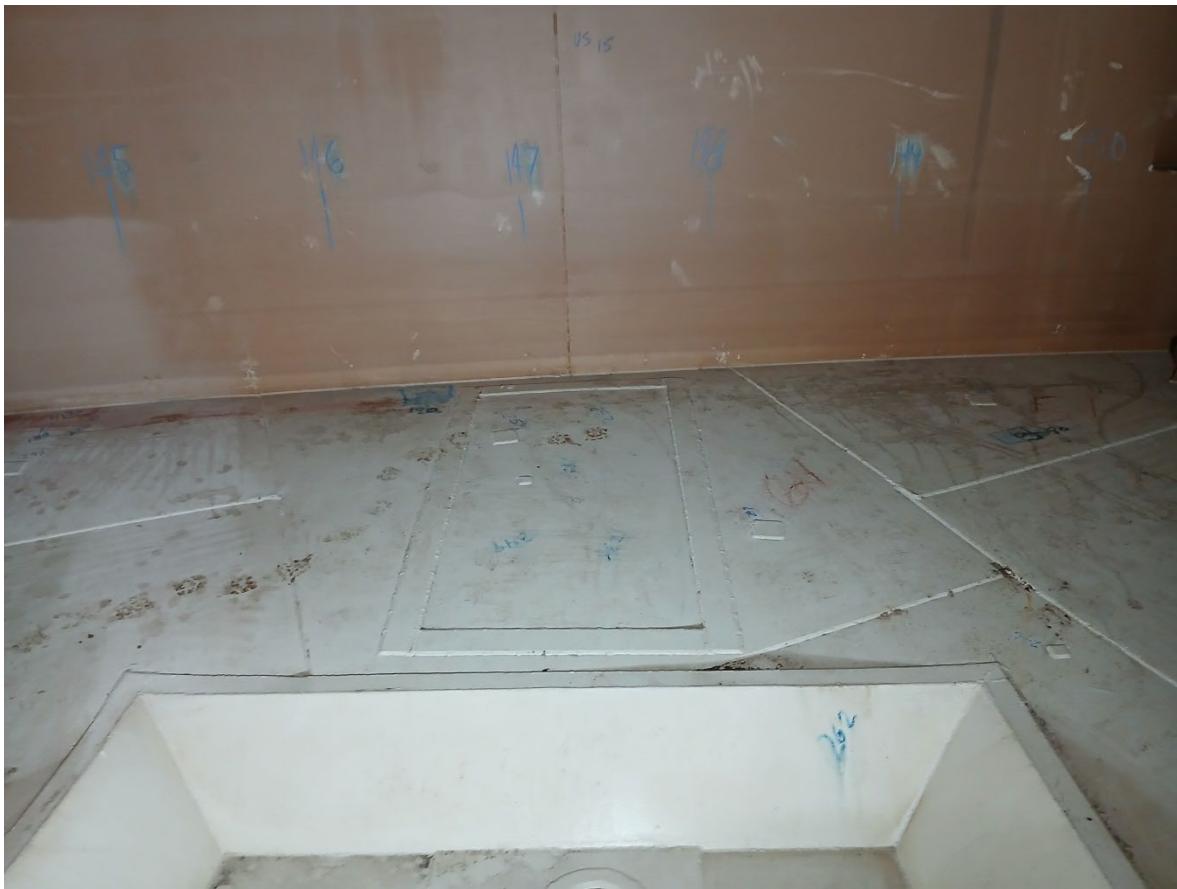
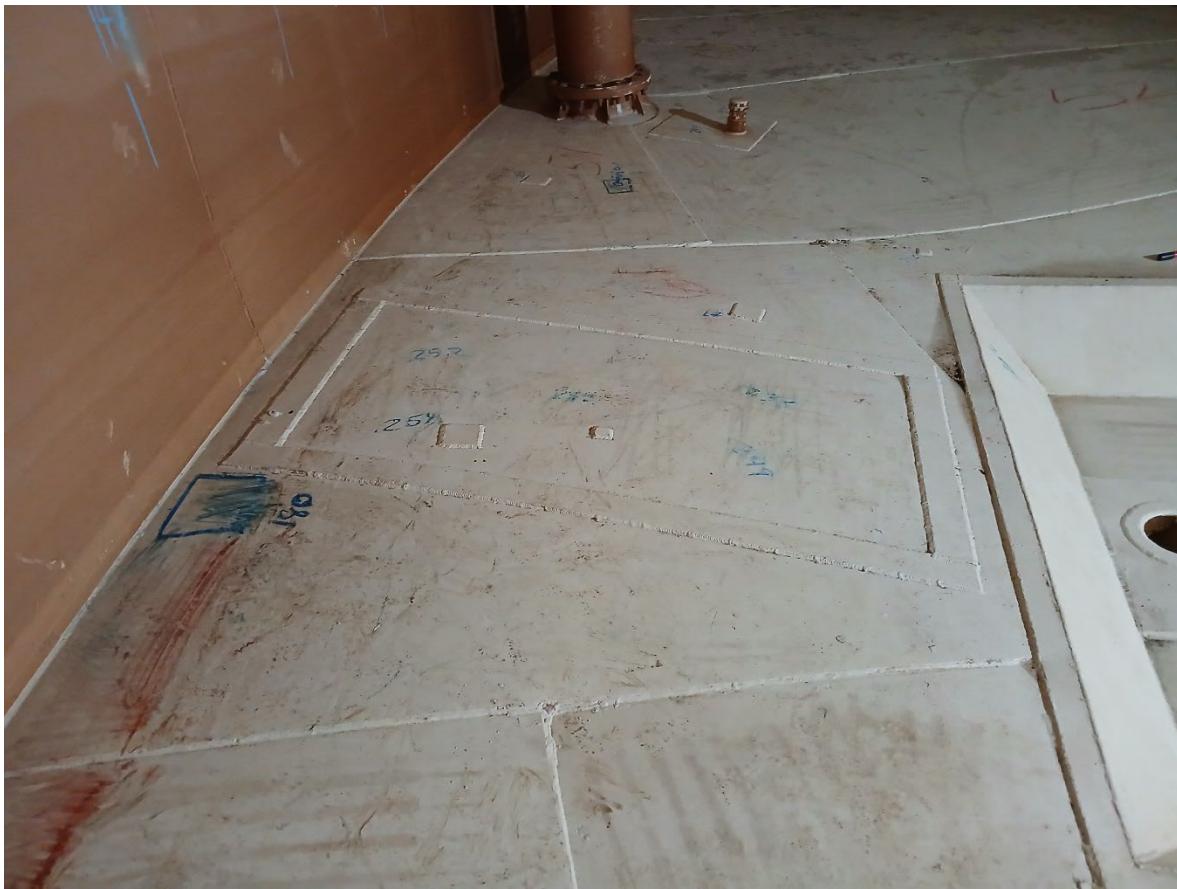
Photo 39. Patch plates around the sump

Photo 41. Patch plates around the sump
