TANK BOTTOM INSPECTION REPORT

**City of Grand Junction
South 4.0 MG Water Storage Tank
170' Diameter**

**Water Treatment Plant
Grand Junction, Colorado**

Inspection Completion Date: November 20, 2025

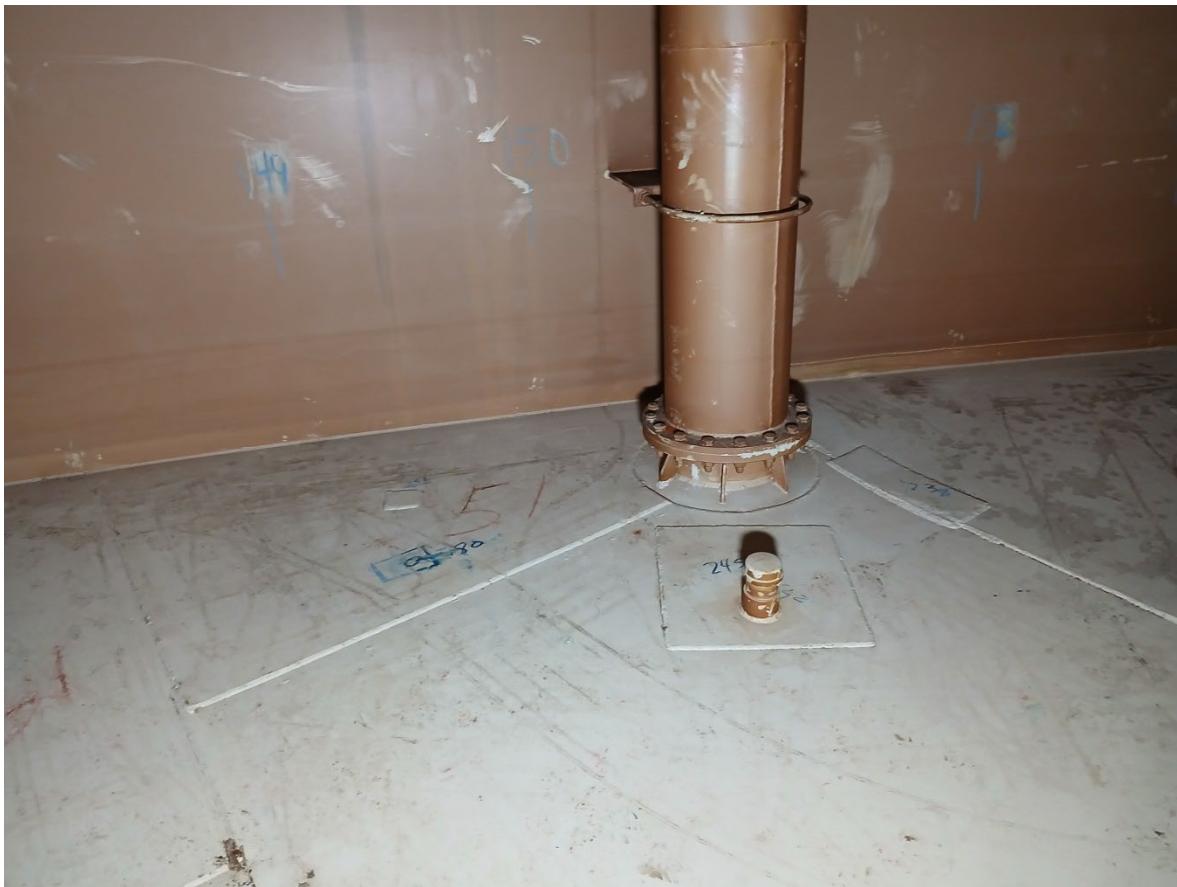
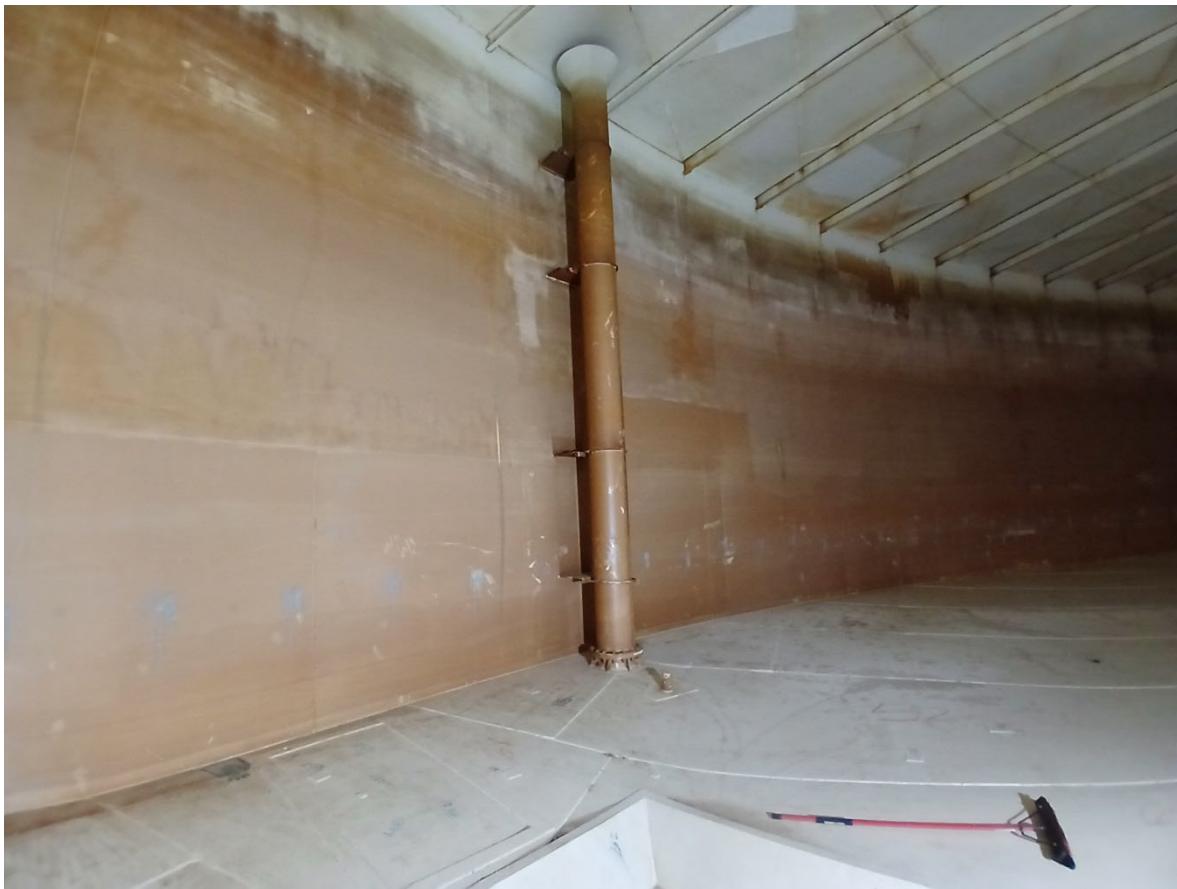
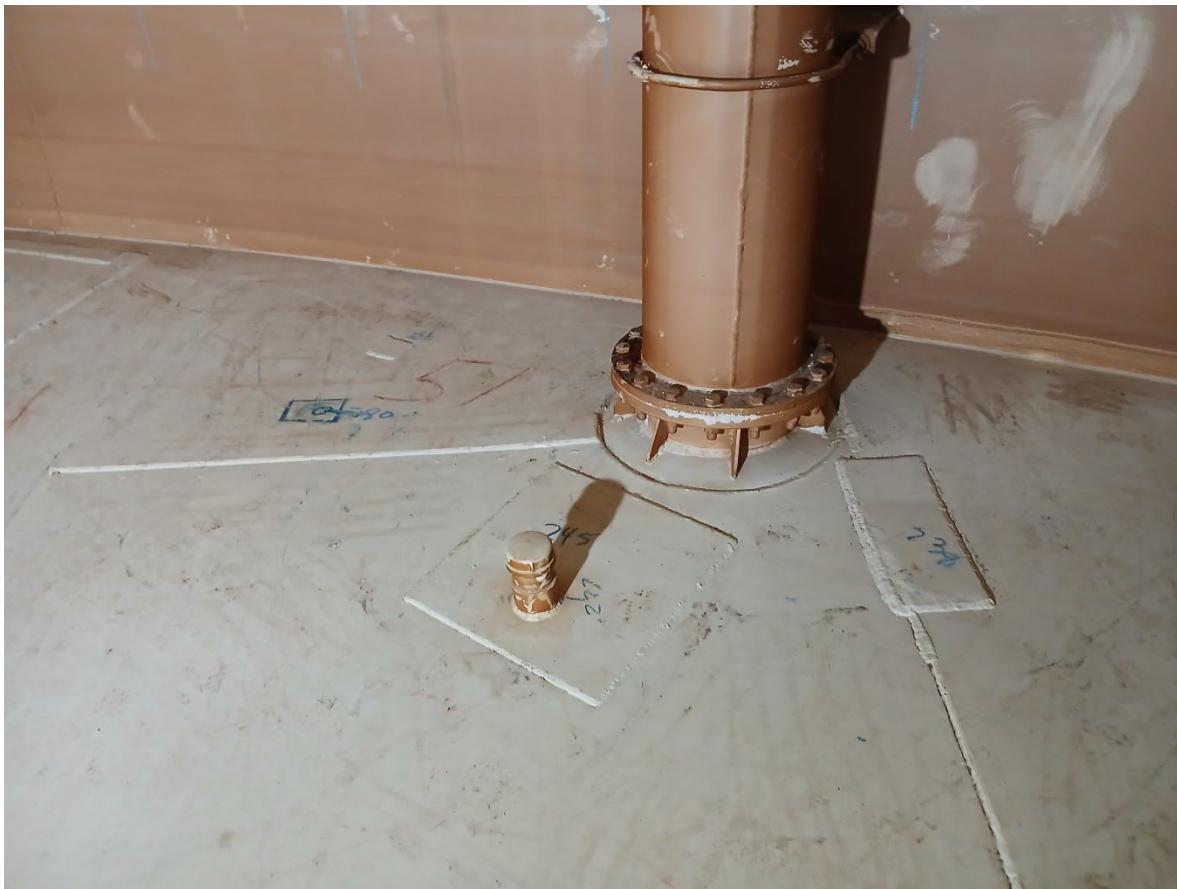
- There is a 16" flanged overflow pipe at bottom plate 51 with underside reinforcement. There are gussets at the flanged connection that may or may not be original to the tank construction. See photos 42 through 45. No obvious issue was observed with this overflow connection at this inspection.

Photo 42. Patch plates around the sump and 16" overflow

Photo 43. 16" overflow pipe

Photo 45. 16" overflow and patches on bottom

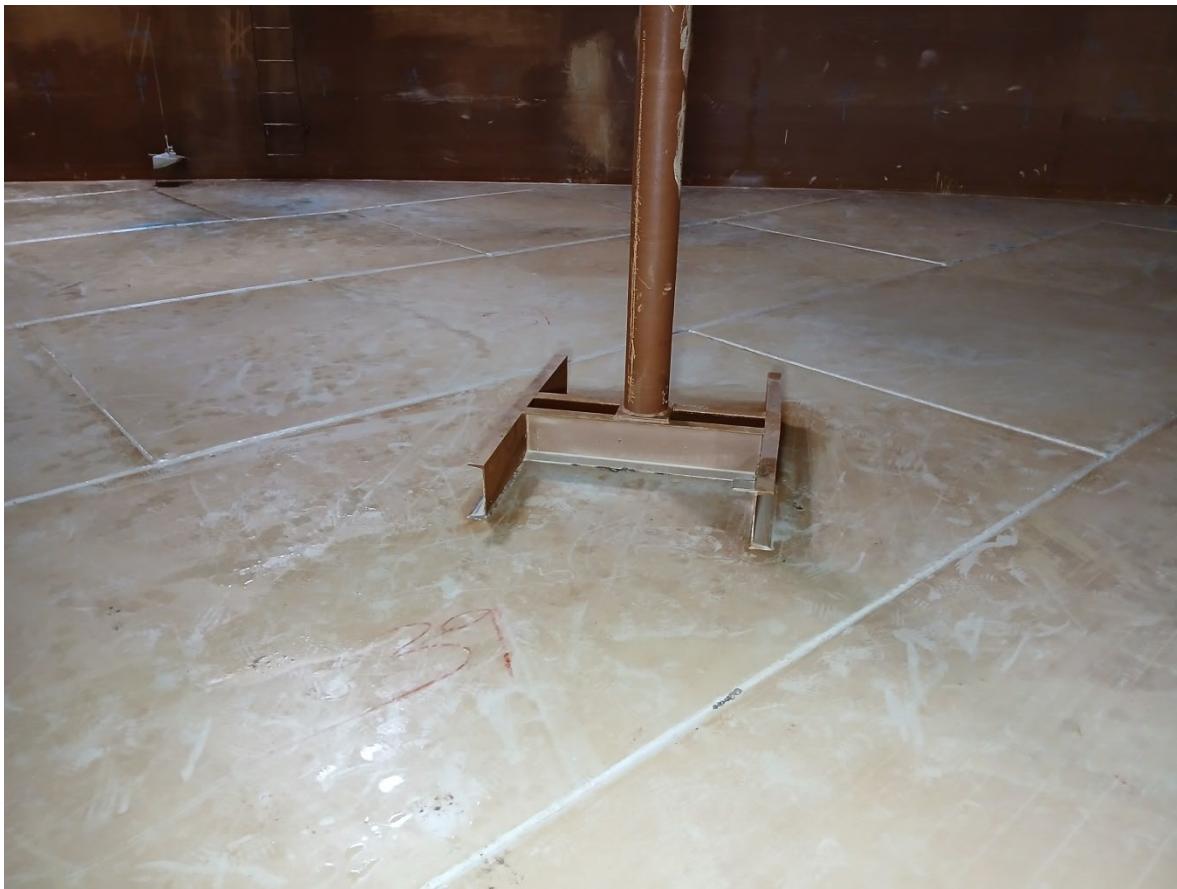
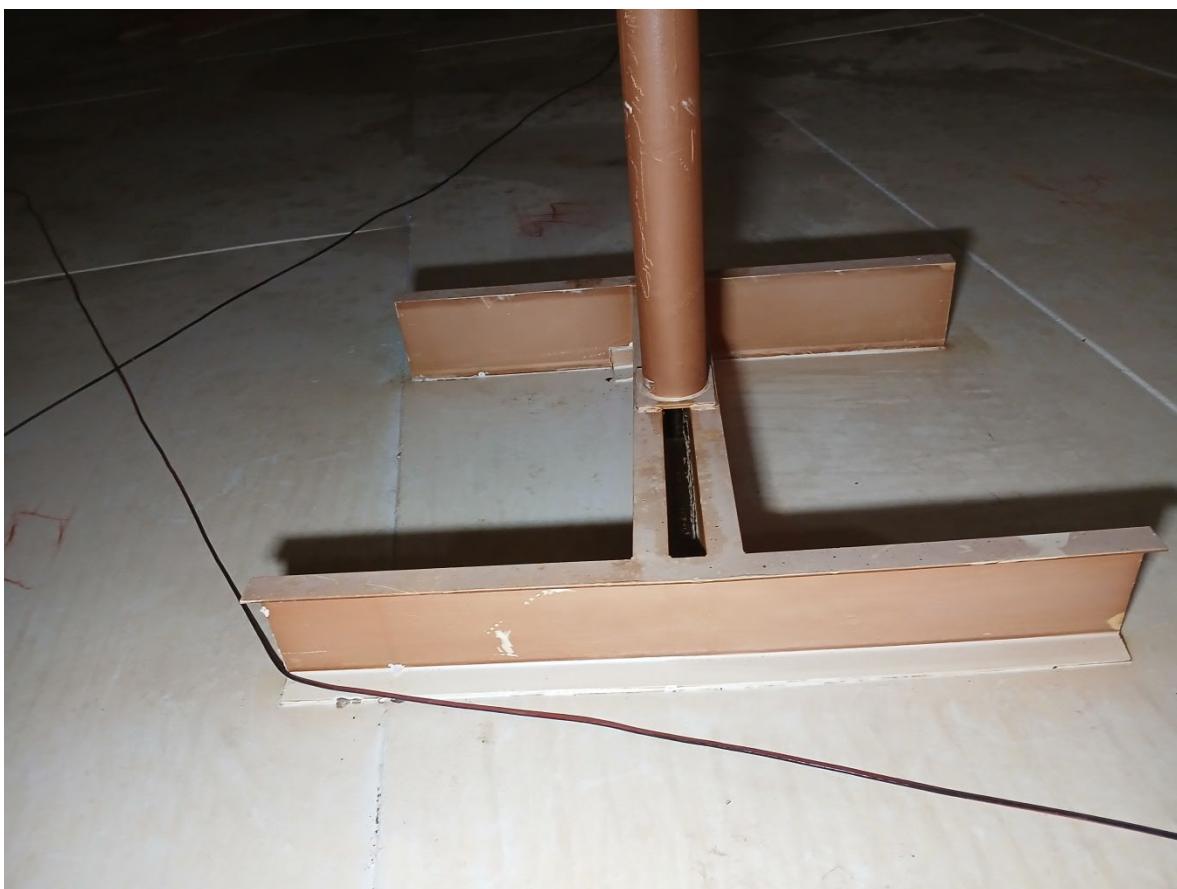
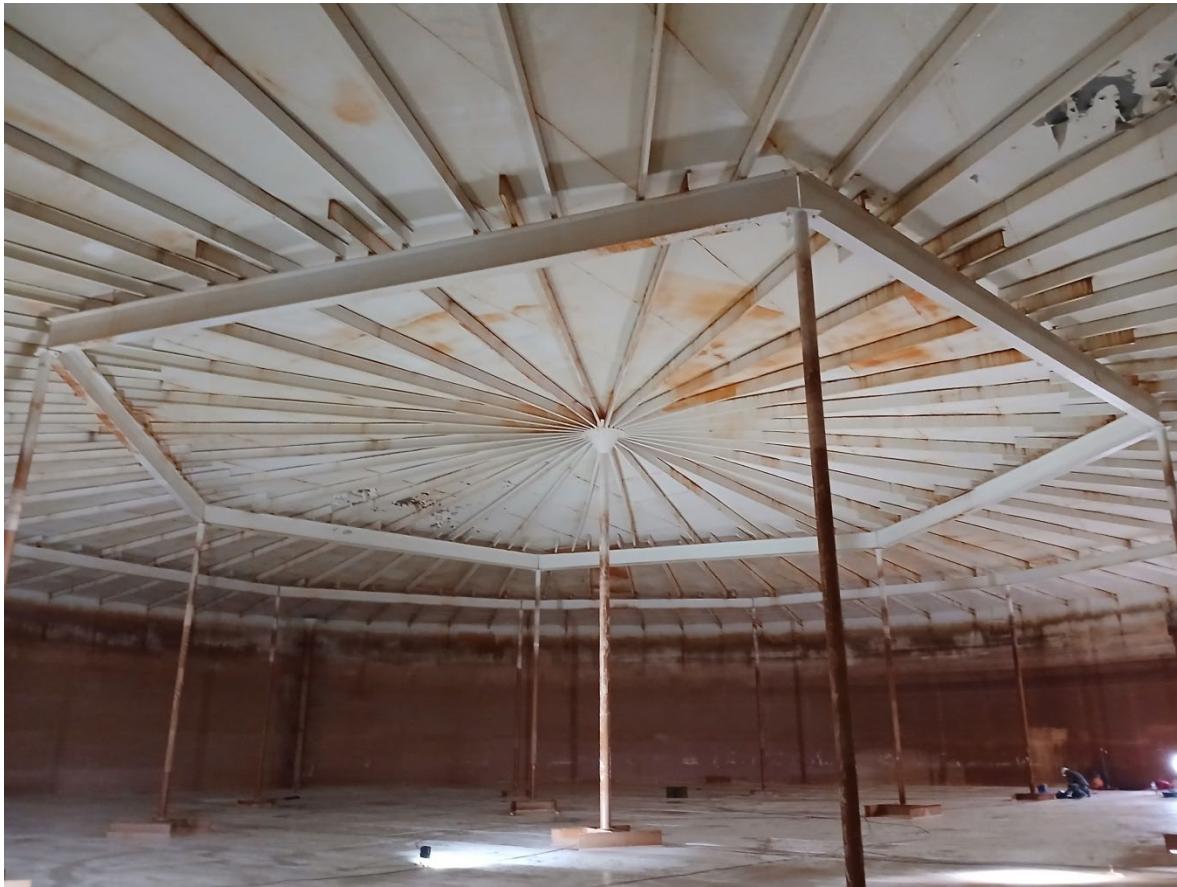
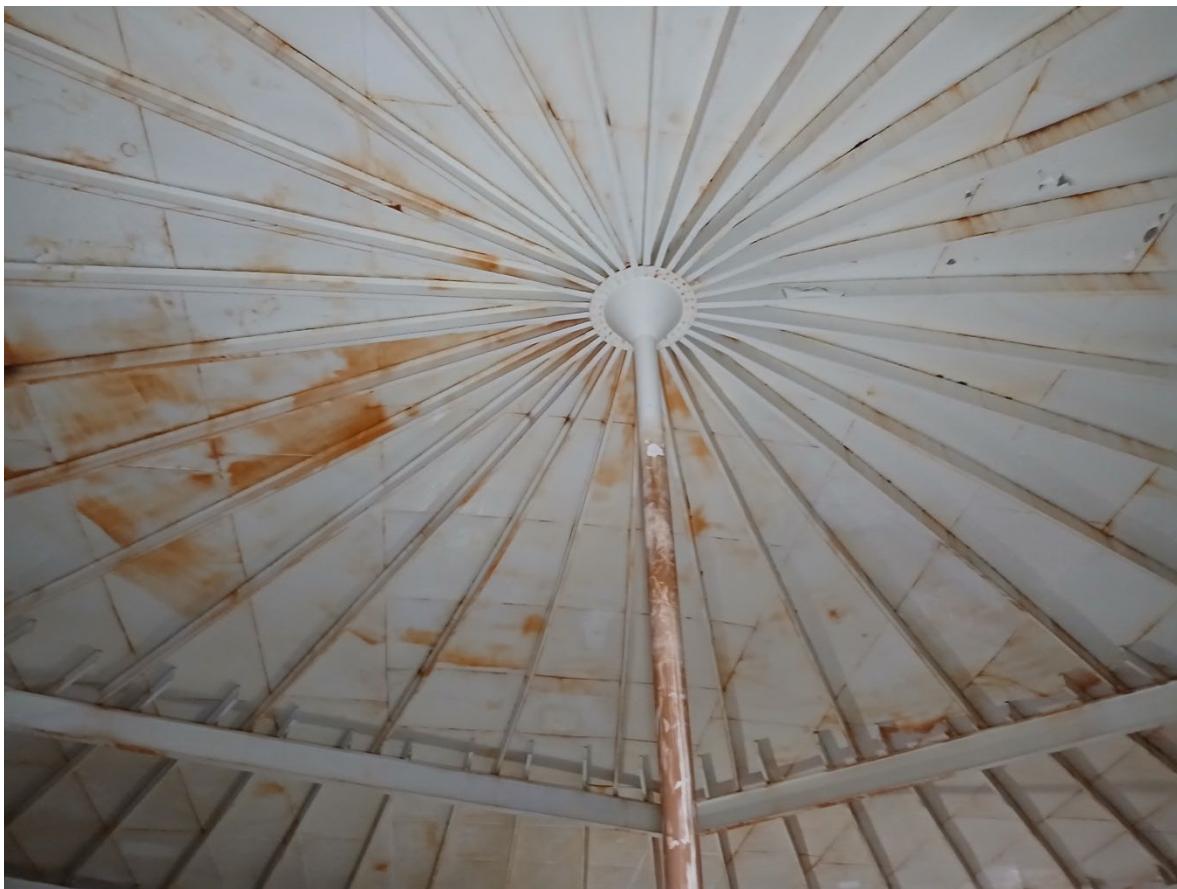
- There are twelve (12) outer roof support columns and six (6) associated with the inner ring. There is also a center column for a total of nineteen (19) roof supports. Spot ultrasonic thickness testing did not identify significant internal corrosion / pitting on the pipe columns. The support bases associated with all of the columns are channel iron(s) in direct contact with the bottom plates. There are restraining clips to limit lateral movement. There is caulking at these interfaces between the channel iron(s) with the bottom to prevent crevice corrosion, as coating the bottom plate under the support base is not possible. The concern is that crevice corrosion could be taking place. See photos 46 through 50.

Photo 47. Roof support column and base configuration

Photo 48. Roof support column and base configuration

Photo 49. Underside view of roof

Photo 50. Underside view of roof at center column

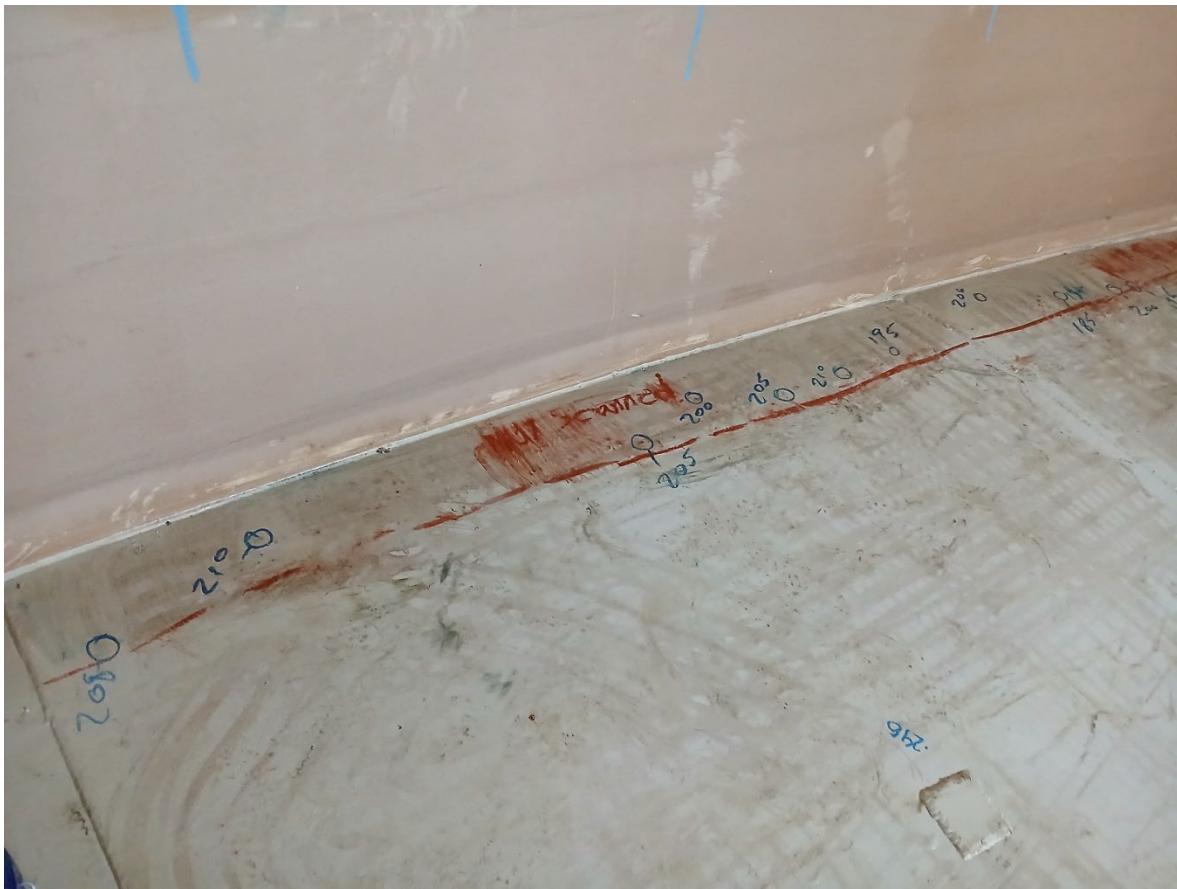
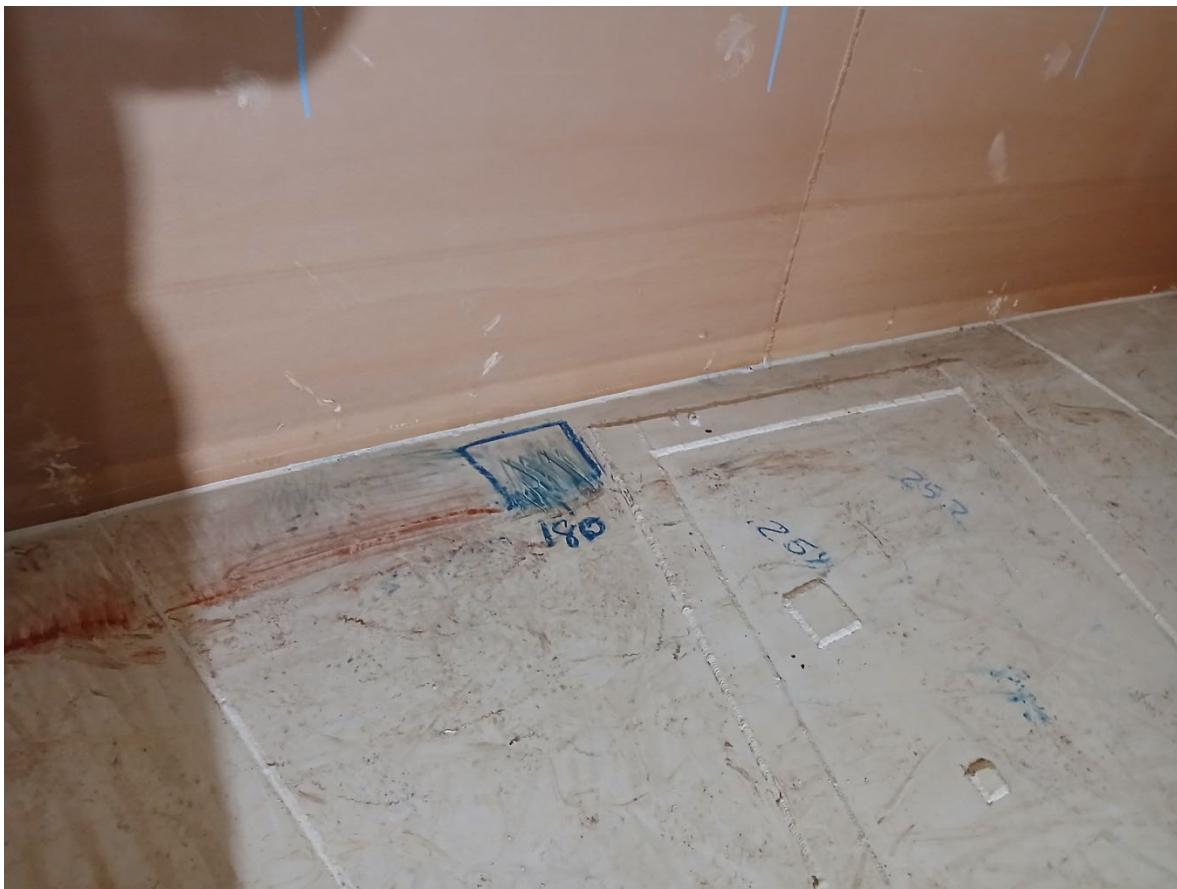
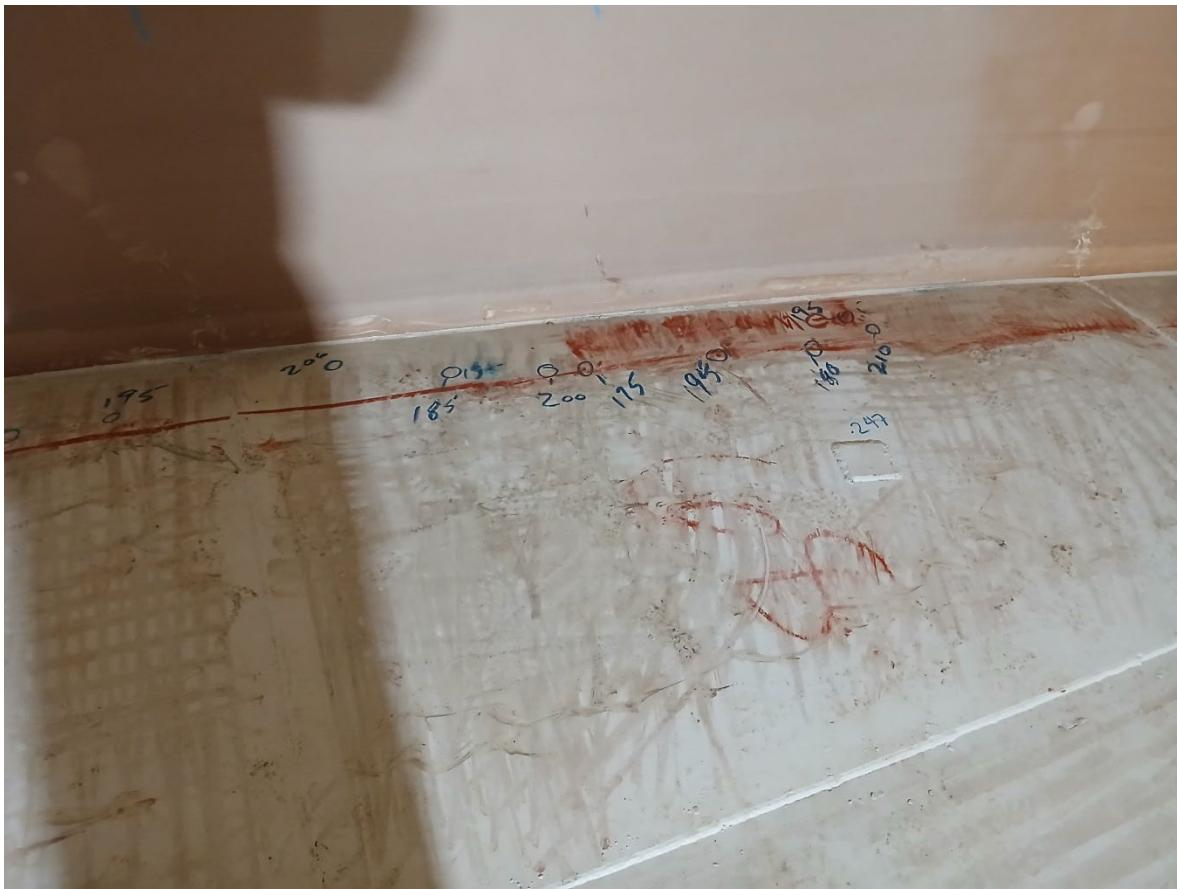
Photo 55. Example soil side corrosion / pitting at suspected edge of concrete ring wall

Photo 56. Example soil side corrosion / pitting at suspected edge of concrete ring wall

Photo 57. Example soil side corrosion / pitting at suspected edge of concrete ring wall

1. Per API 653, the tank bottom minimum thickness shall not be less than 0.100" at the end of the service period. This tank bottom has three (3) locations that are currently < 0.100". A minimum of two (2) $\frac{1}{4}$ " patch plates are recommended to cover these areas. Two (2) pass fillet welds are recommended with the plates air / vacuum box tested after completion. API 653 gives guidance for patch plate sizing and spacing requirements on lap-welded tank bottoms. After a 1-year run, it is assumed that the tank will be rehabilitated including a new internal coating. A more detailed MFL scan is recommended at the next out of service period to identify extent of repairs for a more lengthy service period after rehab. The use of a MFL edge scanner is also recommended. The scan is recommended to be completed after the epoxy coating is removed.

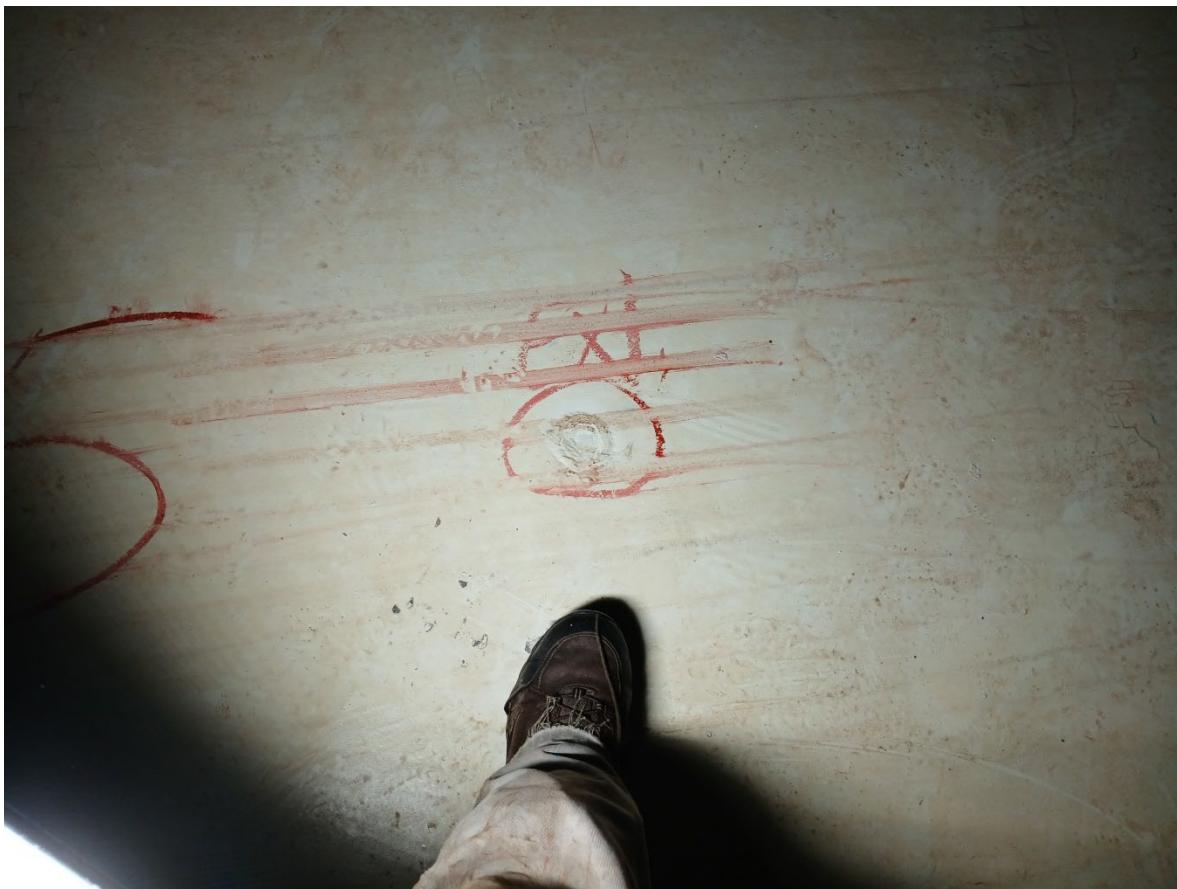
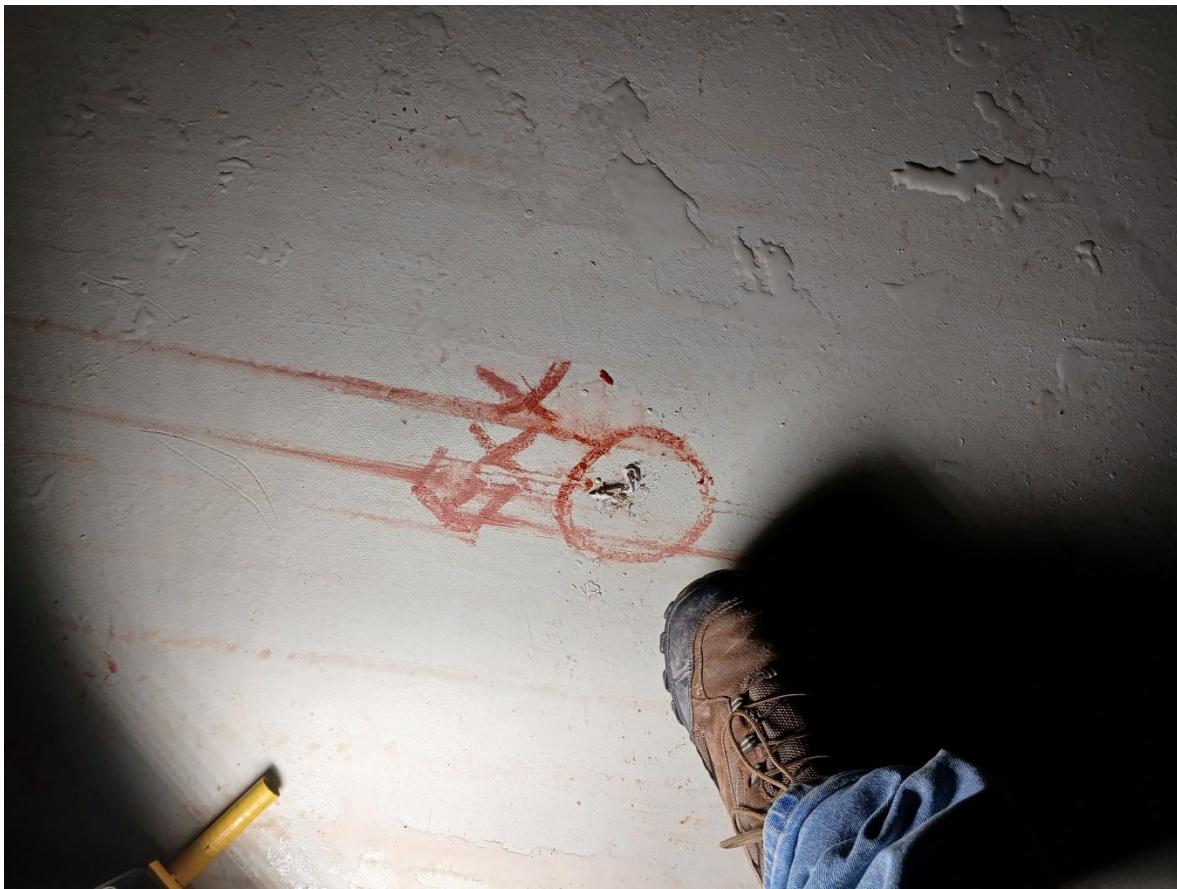
- There are several extraneous welds across the bottom. There are a few gouges and dents across the bottom. The locations are noted on drawings and a spreadsheet included with this report. See photos 58, 59 and 60.

Photo 58. Example of extraneous weld on tank bottom plate

Photo 59. Example of extraneous weld on tank bottom plate

2. Spot coating is recommended to arrest loss until the entire interior coating issues are addressed. The interior coating is recommended to be renewed in the near future based on the condition observed at this inspection. A better visual inspection could be completed on the tank bottom and welds after the coating is removed. Repairs and grinding smooth of extraneous welds, product side pits, etc. is recommended prior to re-coating.

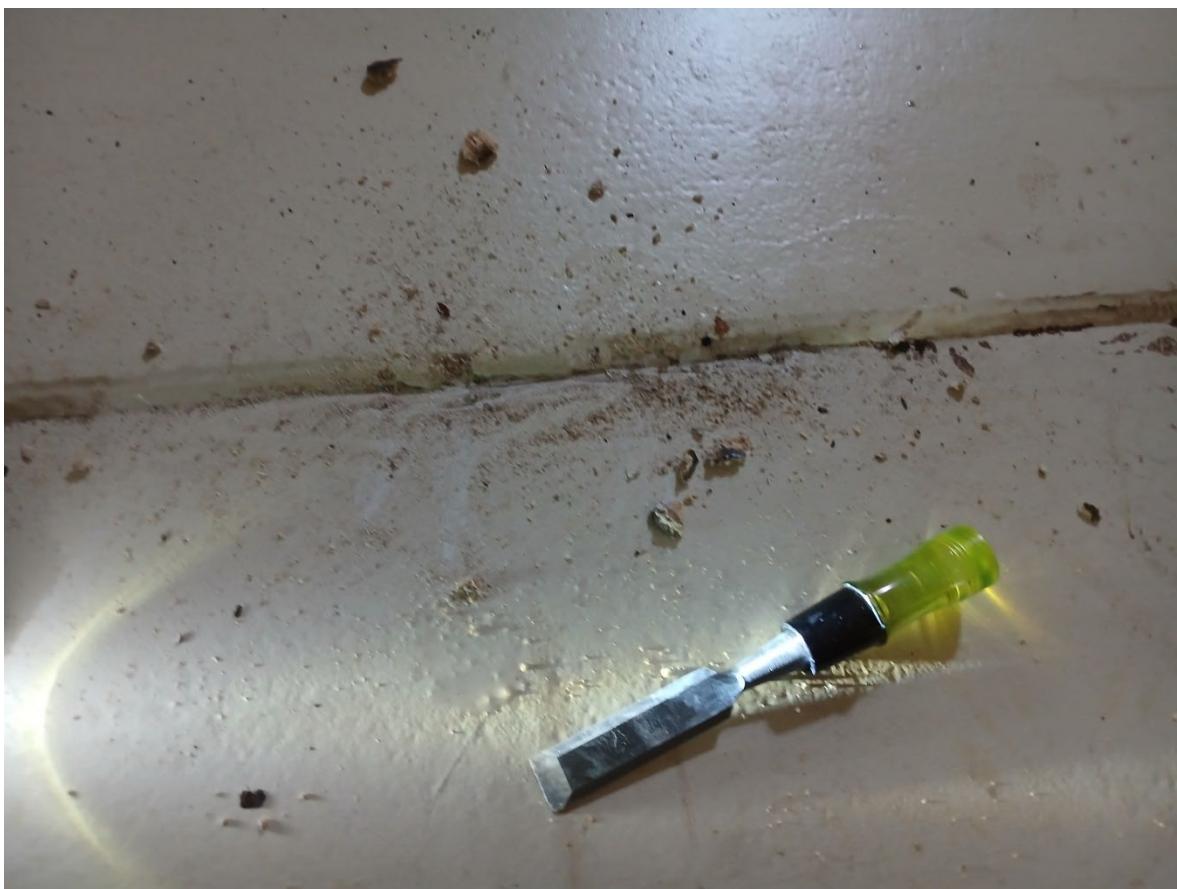
- The internal coating is not original to the tank construction. There appears to be a couple of layers with slightly different colors. There are calcium / mineral deposits at several of the lap welds with breaks in the coating visible when deposits are removed. See photos 61 and 62.

Photo 62. Areas of coating failure at removed calcium / mineral deposits
