TYPE OF RECORD:PERMANENTCATEGORY OF RECORD:UMTRA (REPORT)NAME OF CONTRACTOR:COLORADO DEPARTMENT OF HEALTHSUBJECT/PROJECT:RADIATION SURVEYSTREET ADDRESS/PARCEL/SUBDIVISION: 330 SOUTH 6TH STREET -MAIN FIRE STATION - LOCATION 00434PARCEL NO.:2945-143-31-944CITY DEPARTMENT:PUBLIC WORKSYEAR:1973EXPIRATION DATE:NONE

Re: Location #00434 Main Fire Station 330 South 6th St

OFFICIAL SURVEY REPORT

Property Address 330 S 6th Street Grand Junction, CO 81501
Property Owner City of G. J., Harvey Rose, City Manager
Stanley Anderson, Mayor Owner Address (if different than above) 5th & Rood, City Hall
Date of Report June 29, 1973

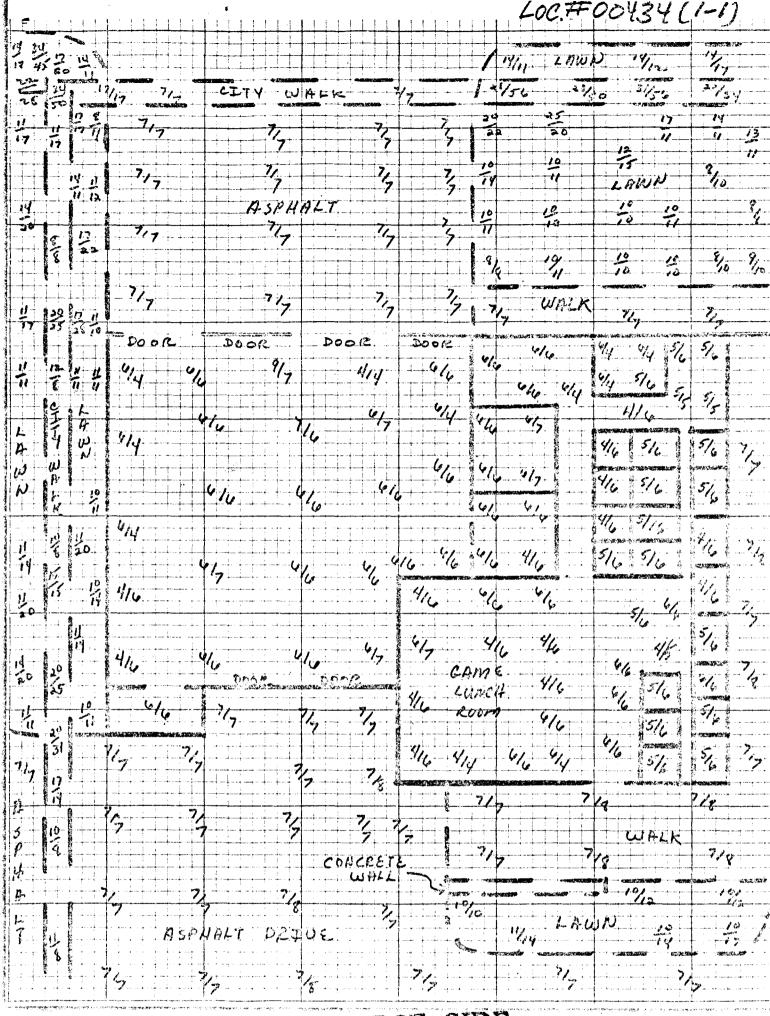
We must, however, inform you that tailings have been located on your property as indicated on the attached survey report. This location <u>does not</u> present any problem of radiation exposure to you at this time. If, at a later date, construction is considered over the indicated area, we recommend corrective action be considered.

I. No indication of uranium mill tailings has been found on this property. See Item III below.
Uranium Mill tailings are indicated to be on this property and are located:
in yard only walks and lawns
under or around garage or patio only
under or around the house
under or around the house and in yard
under or around the building (business, church, etc.)
II. RESULTS OF THE RADIATION SURVEY IN THE STRUCTURE INDICATE: essentially
Average gamma radiation exposure rate of <u>background</u> mR/hr. This compares with the Surgeon General's recommendation for
UNDETERMIN
Average radon daughter concentration ofWL. This compares with the Surgeon General's recommendation for corrective action at 0.010 WL.
The presence of uranium tailings under occupied areas necessitating corrective action.
III. RECOMMENDATION:
You are advised to remove tailings if feasible or take other means of corrective action to reduce the radiation exposure.

Location of identified tailings and radiation levels do not warrant immediate action. However, if use of the identified area is changed in the future, removal if feasible or other corrective action or control should be considered.
Recommendations will be provided to you when measurements of radon daughter concentration have been completed.
Other radiation sources (non-tailings) have been identified on your property, such as instrument dials, ore samples, etc. Removal is suggested, if practical.
