GRAND MESA NO. 6 RESERVOIR OUTLET WORKS REHABILITATION MESA COUNTY, W. DIV. 4, DAMID: 420121 MARCH 2012

City of Grand Junction, Colorado C-1180A Department of Public Works & Utilities Engineering Division

GRAND MESA RESERVOIR NO 6 MESA COUNTY, W. DIV. 4, DAMID: 420121 OUTLET WORKS REHAB PHOTOS

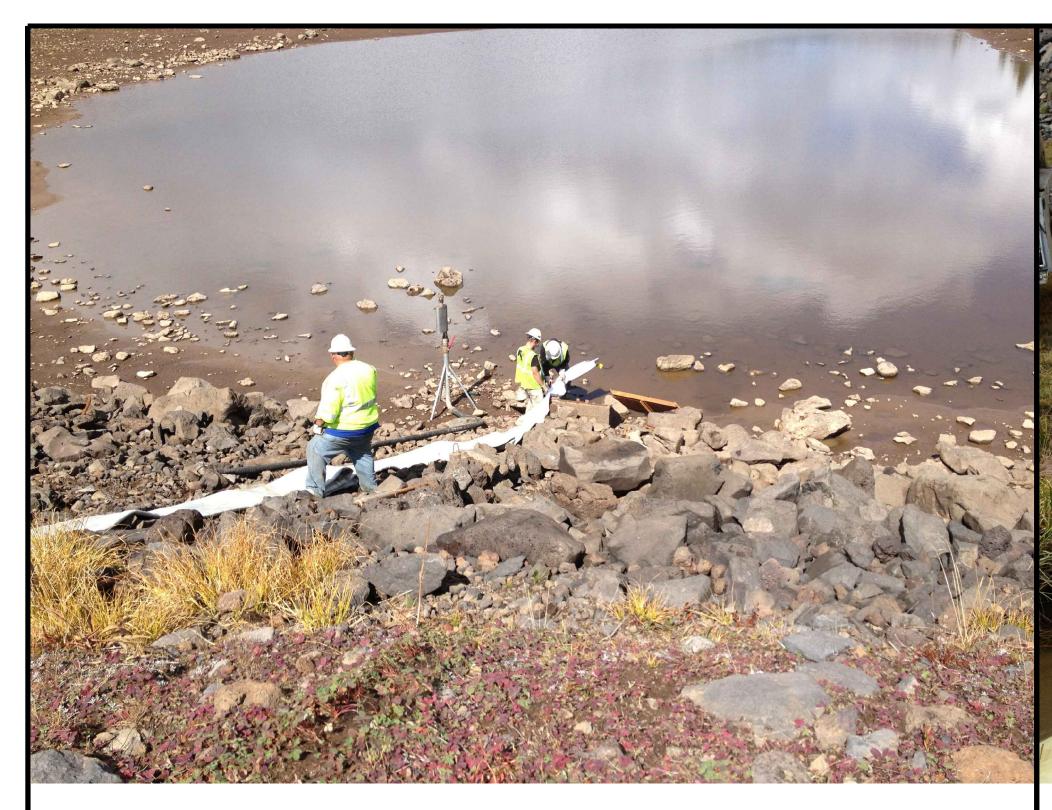
PHOTO 1:
WORKERS PREPPING OUTER PORTION OF 2 PART LINER TO PULL
THROUGH HOST PIPE FROM THE RESERVOIR OR INLET STRUCTURE END
OF THE HOST PIPE.

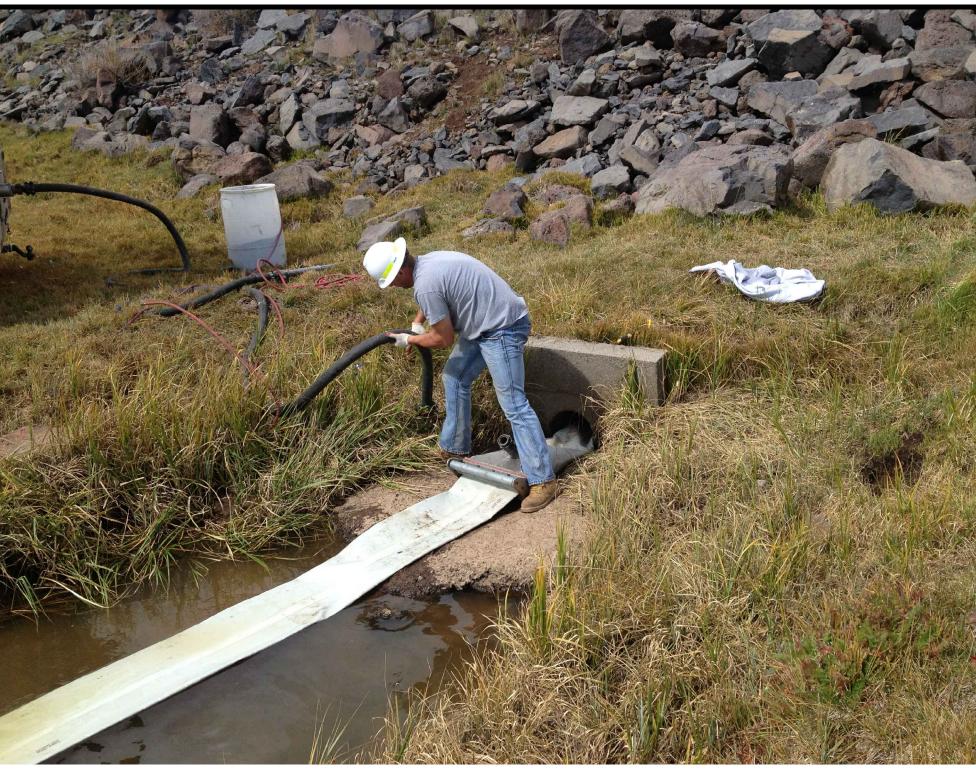
PHOTO 3:
WORKER PREPPING INNER PORTION OF 2 PART LINER FROM OUTLET SIDE
OF DAM TO BE PUSHED AND INVERTED BACK THROUGH THE OUTER
PORTION PREVIOUSLY PULLED THROUGH THE HOST PIPE FROM THIS SIDE

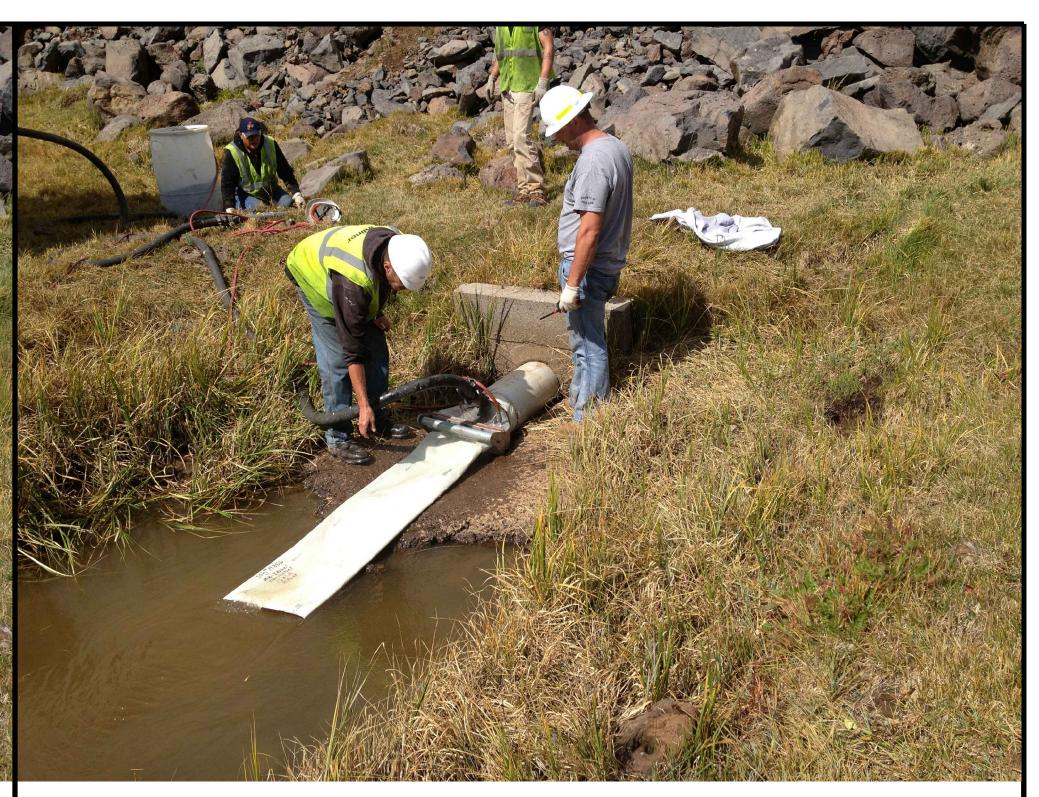
PHOTO 5:
END OF INNER PORTION OF 2 PART LINER APPROACHING PIPE LINER AIR
INVERSION TOOL AND PUSHED NEARLY ALL THE WAY BACK THROUGH THE
OUTER LINER AND HOST PIPE TOWARD THE RESERVOIR SIDE. PHOTO AT
THE OUTLET SIDE.

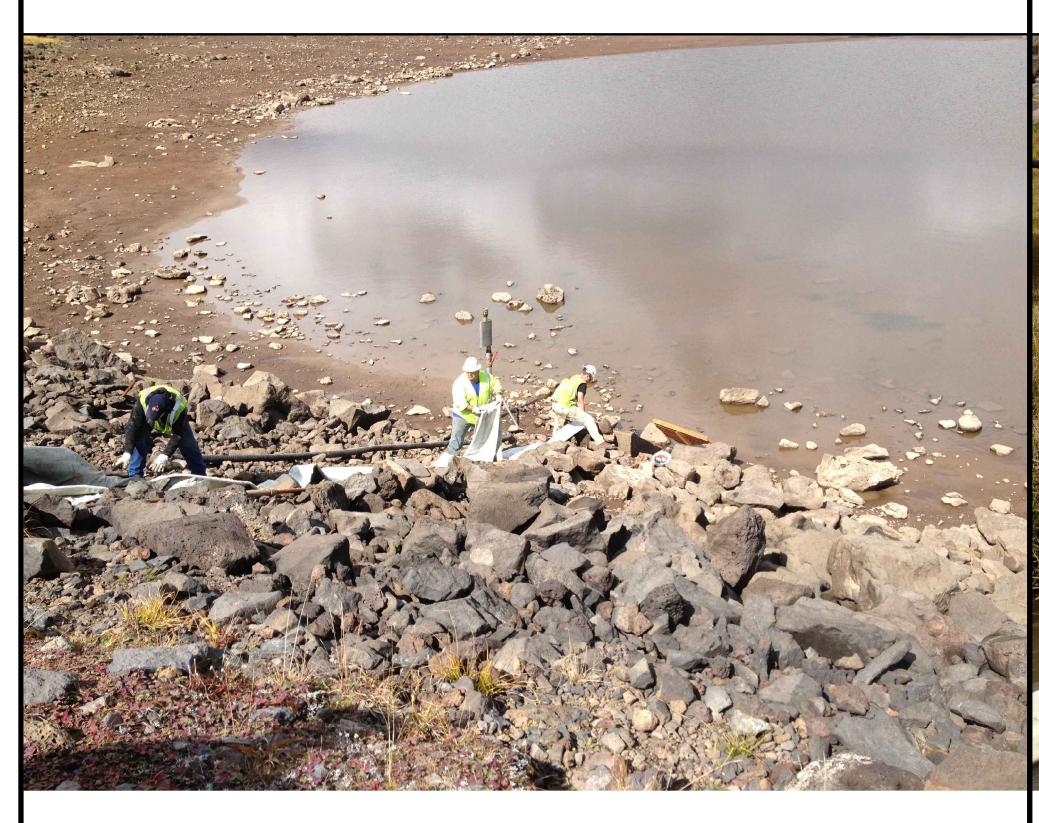
PHOTO 2:
OUTER PORTION OF 2 PART LINER BEING FED THROUGH HOST PIPE
FROM THE RESERVOIR OR INLET STRUCTURE END OF THE HOST PIPE
AND PULLED FROM THE OUTLET END OF THE PIPE (NOT SHOWN).

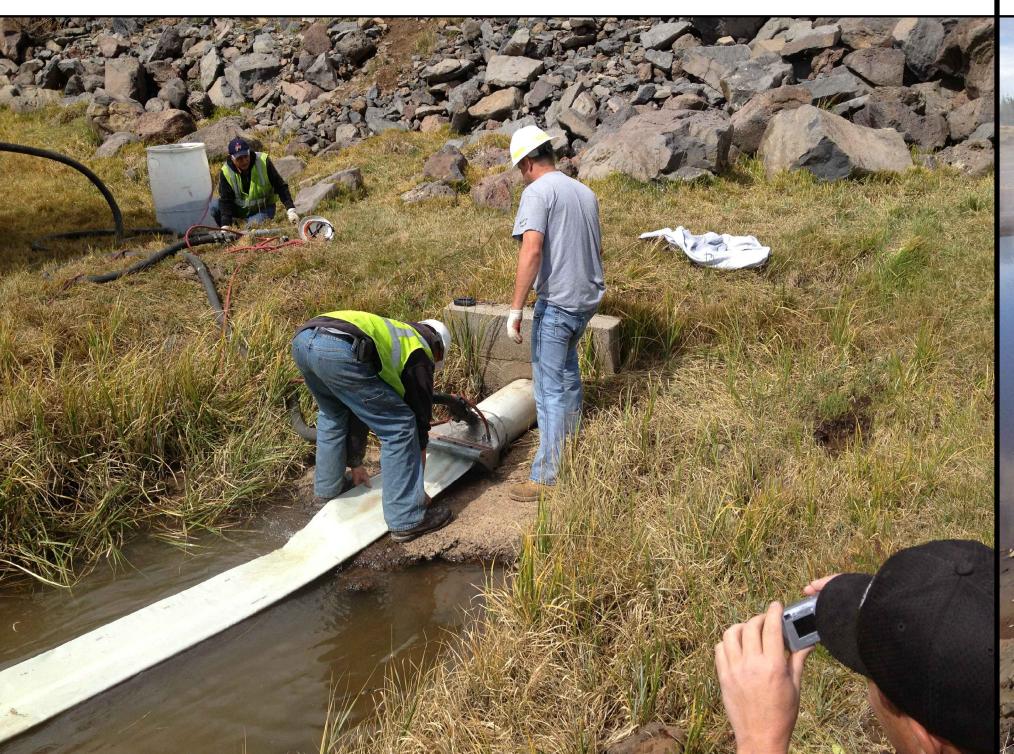
PHOTO 4:
INNER PORTION OF 2 PART LINER FROM OUTLET SIDE OF DAM PUSHED
AND INVERTED BACK THROUGH THE OUTER PORTION OF LINER WITH
COMPRESSED AIR VIA A PIPE LINER AIR INVERSION TOOL

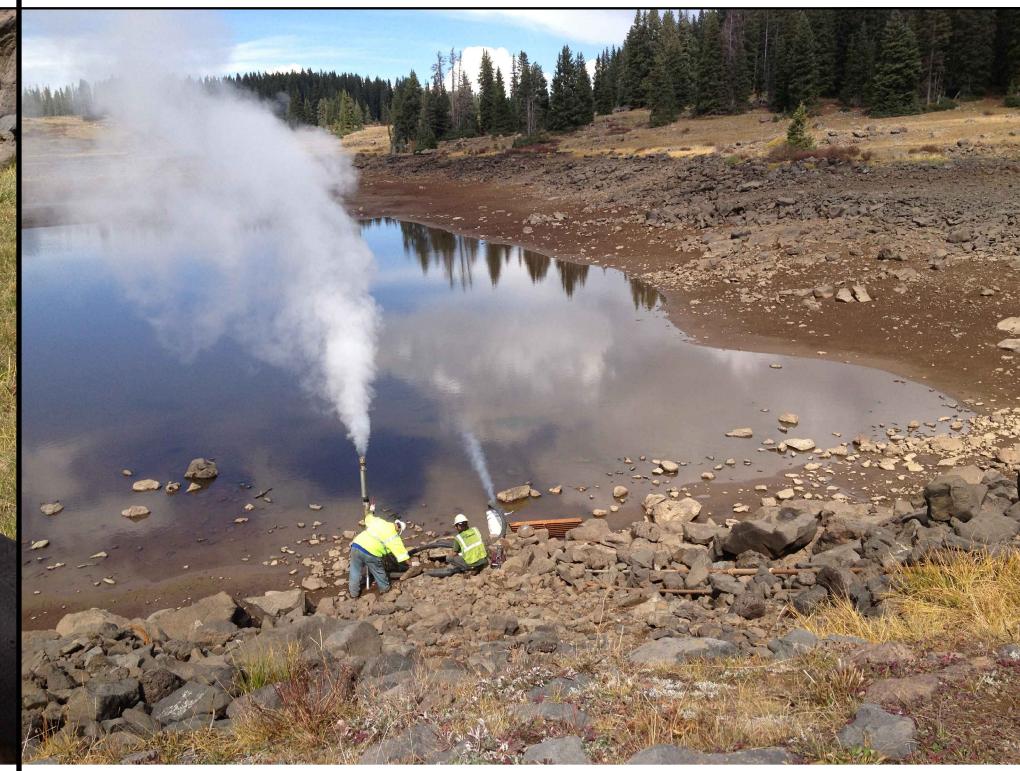
PHOTO 6:
STEAM IS ADDED TO COMPRESSED AIR FROM A CONNECTION ON THE
PIPE LINER AIR INVERSION TOOL (NOT SHOWN, BUT SHOWN IN PHOTO 5) TO
ACTIVATE THE CATALYST CURING THE RESIN THEREBY COMPLETING THE
CURED IN PIPE PROCESS FOR THE PROJECT
