## GRAND MESA NO. 6 RESERVOIR OUTLET WORKS REHABILITATION MESA COUNTY, W. DIV. 4, DAMID: 420121 MARCH 2012

City of Grand Junction, Colorado C-1180A Department of Public Works & Utilities Engineering Division

GRAND MESA RESERVOIR NO 6
MESA COUNTY, W. DIV. 4, DAMID: 420121
OUTLET WORKS REHAB PHOTOS

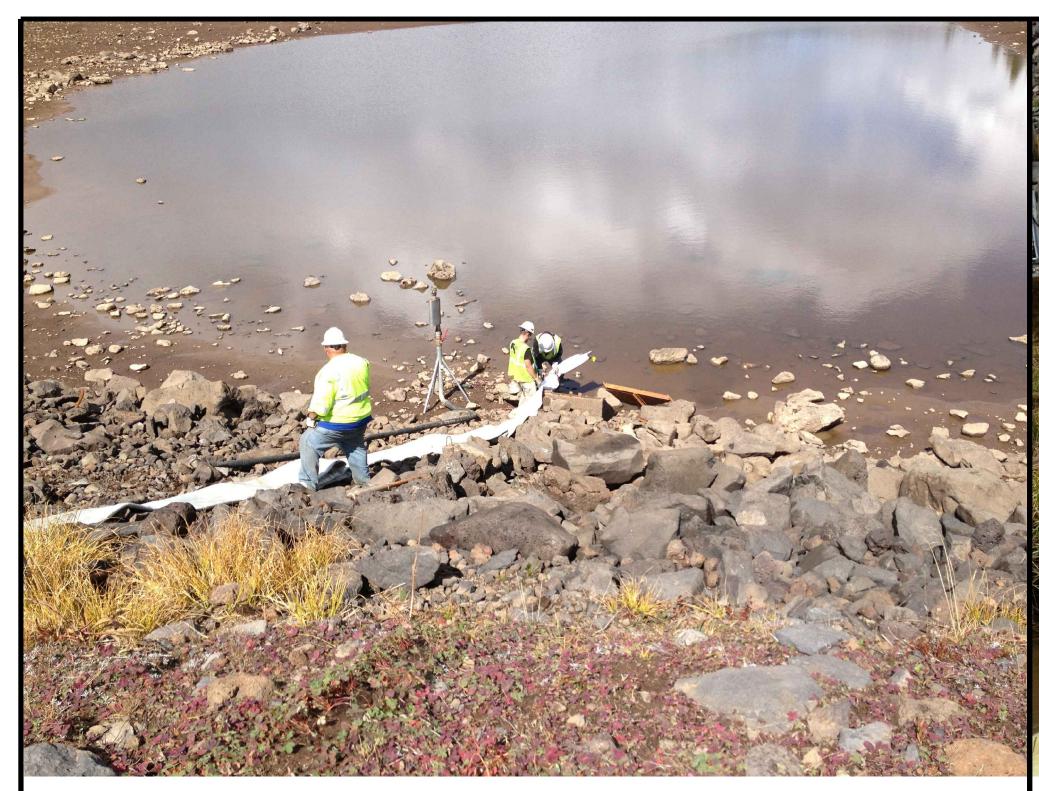
PHOTO 1:
WORKERS PREPPING OUTER PORTION OF 2 PART LINER TO PULL
THROUGH HOST PIPE FROM THE RESERVOIR OR INLET STRUCTURE END
OF THE HOST PIPE.

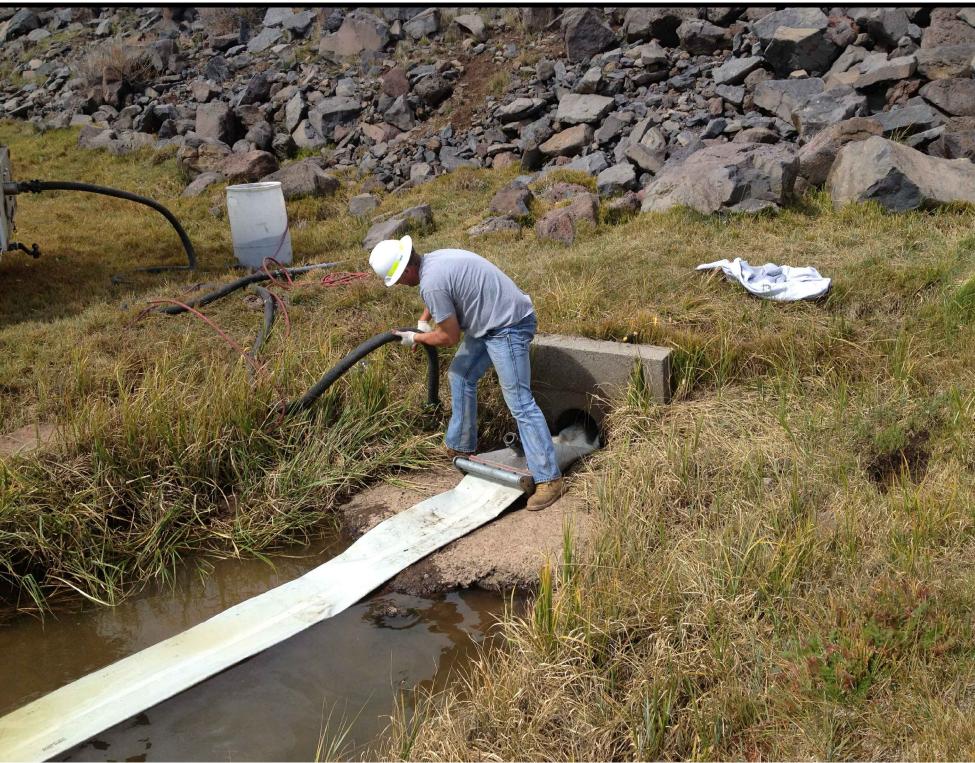
PHOTO 3:
WORKER PREPPING INNER PORTION OF 2 PART LINER FROM OUTLET SIDE OF DAM TO BE PUSHED AND INVERTED BACK THROUGH THE OUTER PORTION WITH COMPRESSED AIR VIA A PIPE LINER AIR INVERSION TOOL. OUTER LINER PREVIOUSLY PULLED THROUGH THE HOST PIPE FROM THIS SIDE.

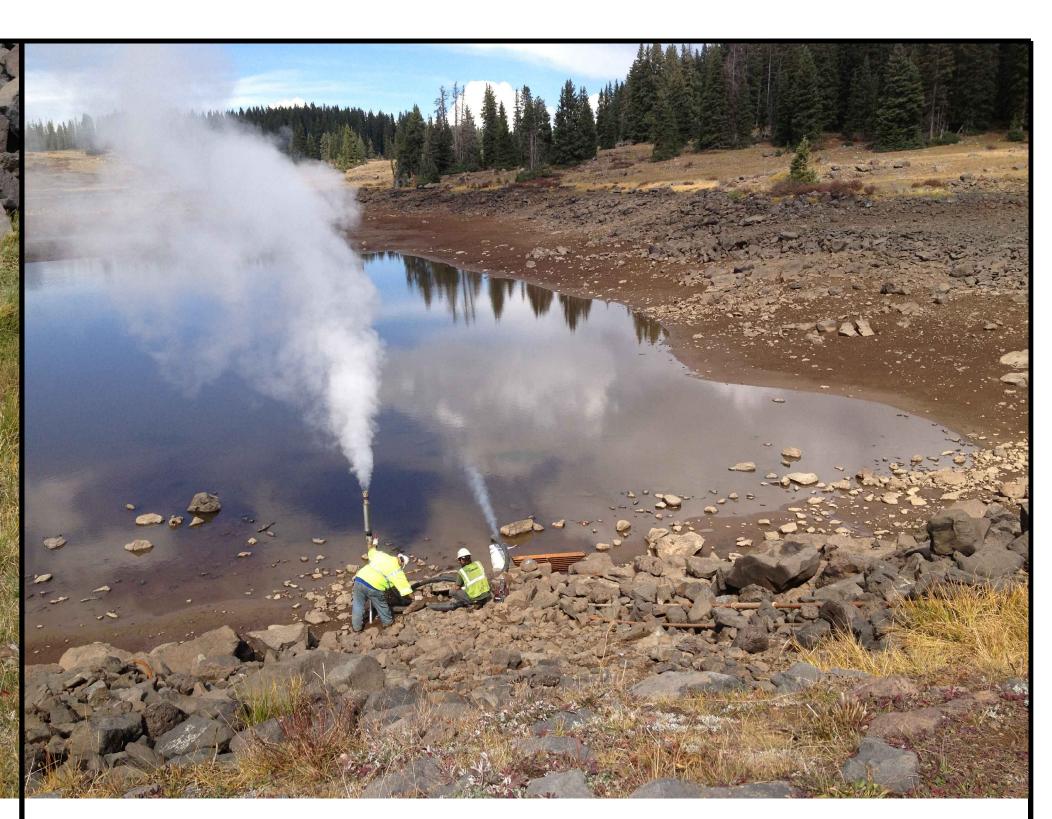
PHOTO 6:
STEAM IS ADDED TO COMPRESSED AIR FROM A CONNECTION ON THE
PIPE LINER AIR INVERSION TOOL (NOT SHOWN, BUT SHOWN IN PHOTO 5) TO
ACTIVATE THE CATALYST CURING THE RESIN THEREBY COMPLETING THE
CURED IN PIPE PROCESS FOR THE PROJECT

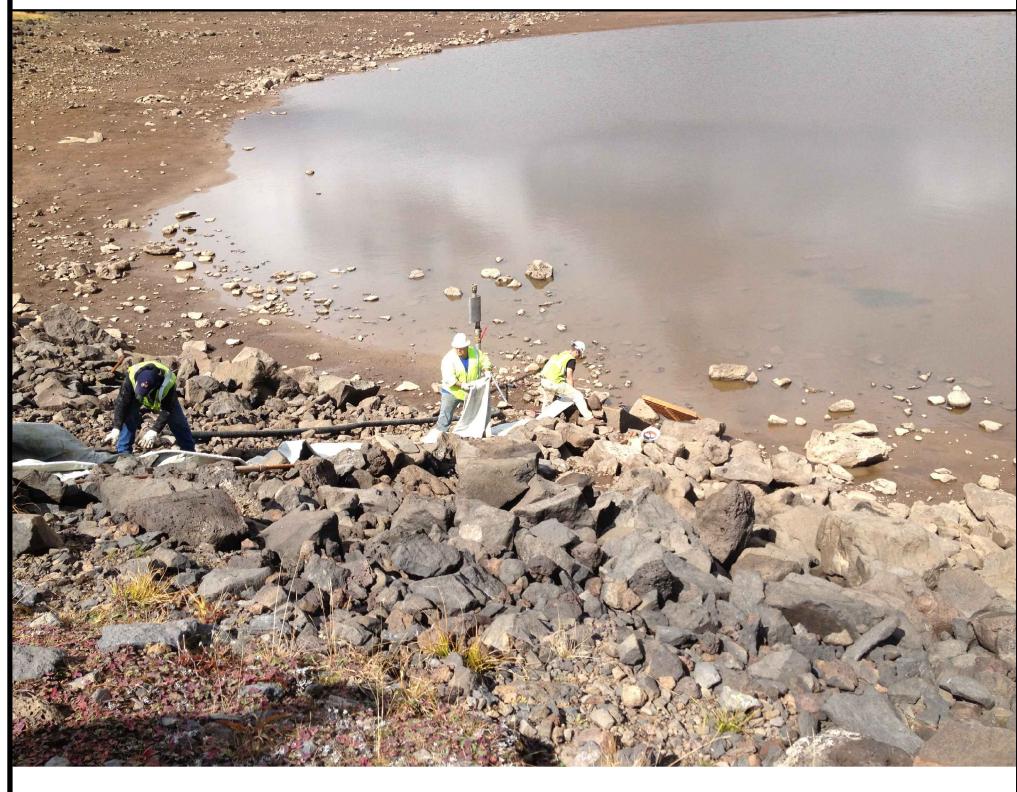
PHOTO 2:
OUTER PORTION OF 2 PART LINER BEING FED THROUGH HOST PIPE
FROM THE RESERVOIR OR INLET STRUCTURE END OF THE HOST PIPE
AND PULLED FROM THE OUTLET END OF THE PIPE (NOT SHOWN).

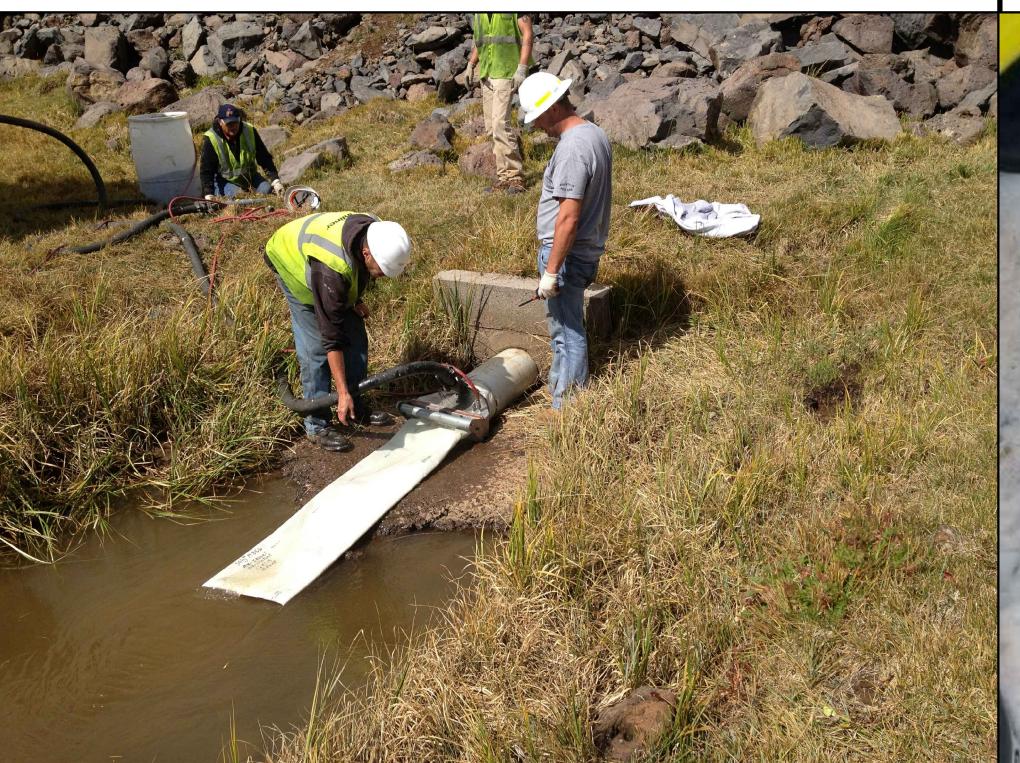
PHOTO 5:
END OF INNER PORTION OF 2 PART LINER APPROACHING PIPE LINER AIR
INVERSION TOOL AND PUSHED NEARLY ALL THE WAY BACK THROUGH THE
OUTER LINER AND HOST PIPE TOWARD THE RESERVOIR SIDE. PHOTO AT
THE OUTLET SIDE.

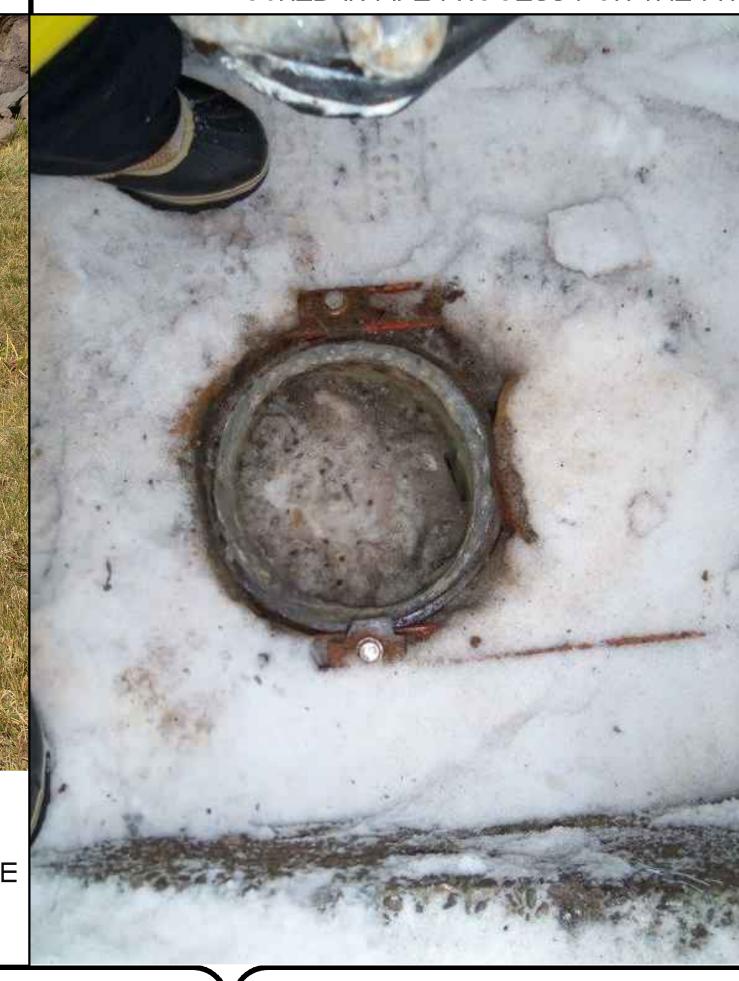
PHOTO 7:
FEBRUARY 16,
2013 - 2 PART
CALKING
BETWEEN THE
HOST PIPE AND
THE CURED IN
PLACE PIPE
REPLACED AT
THE THE
RESERVOIR OR
INLET
STRUCTURE END
OF THE HOST
PIPE.
