**APPENDIX A. GEOTECHNICAL INVESTIGATION**

## PERSIGO WASTEWATER TREATMENT PLANT Geotechnical Investigation

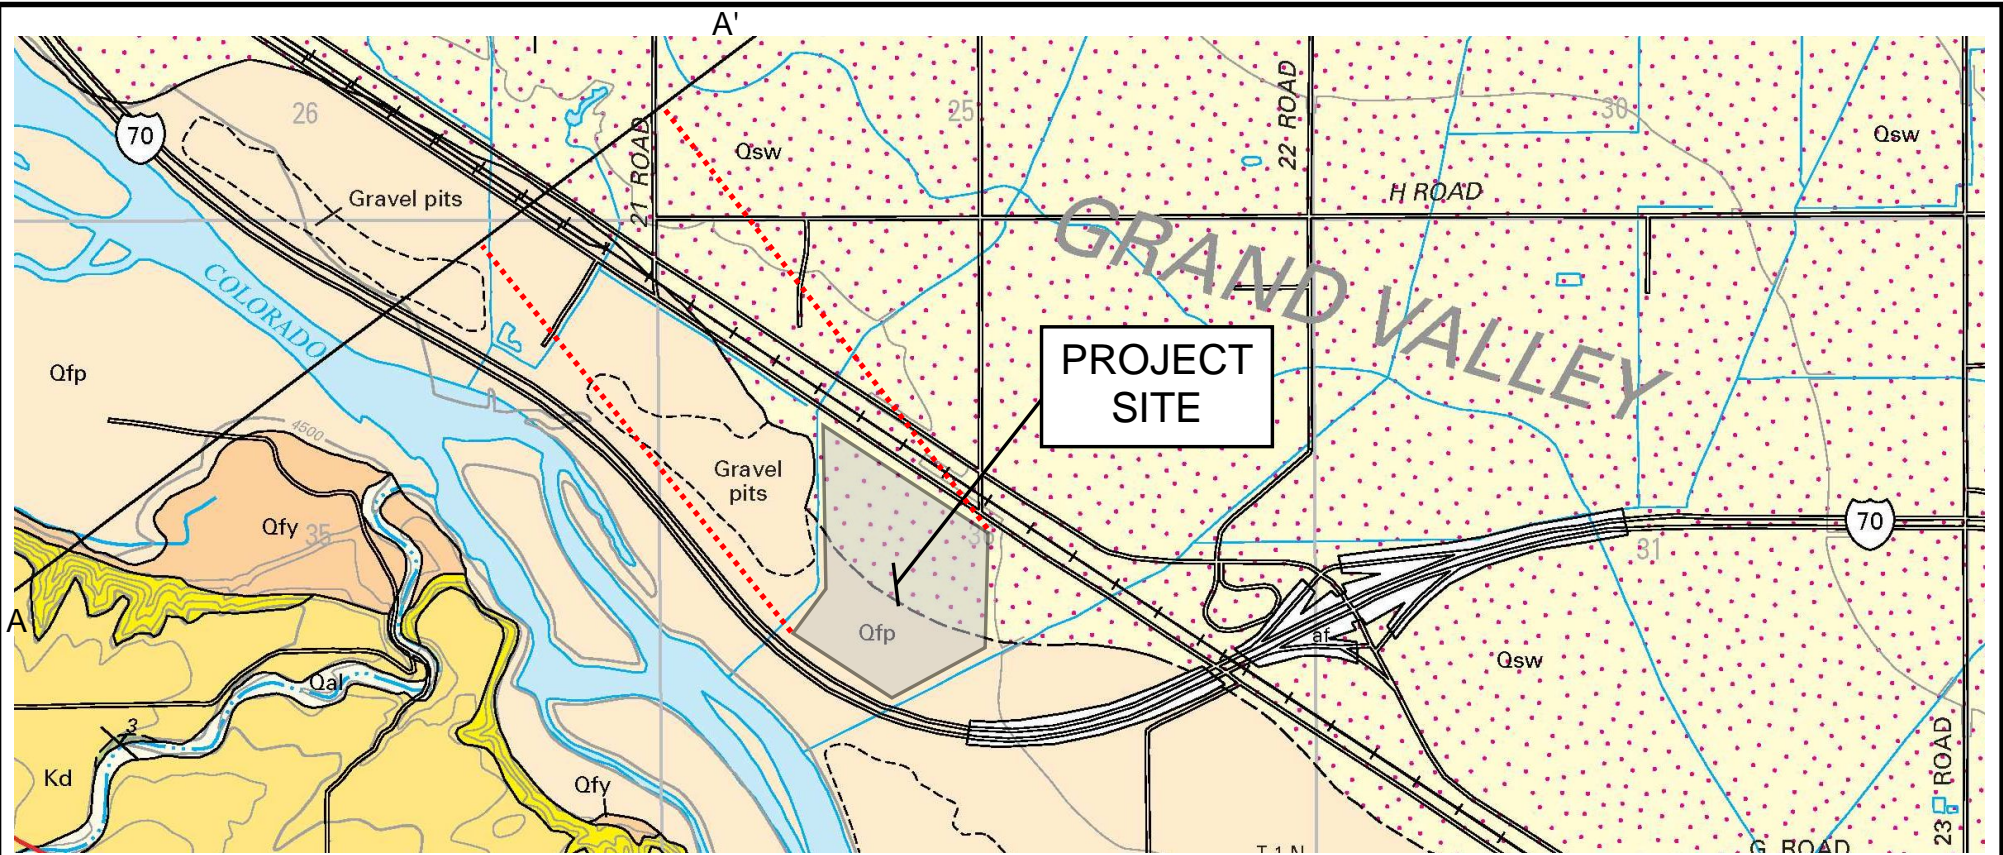
### DESCRIPTION OF MAP UNITS

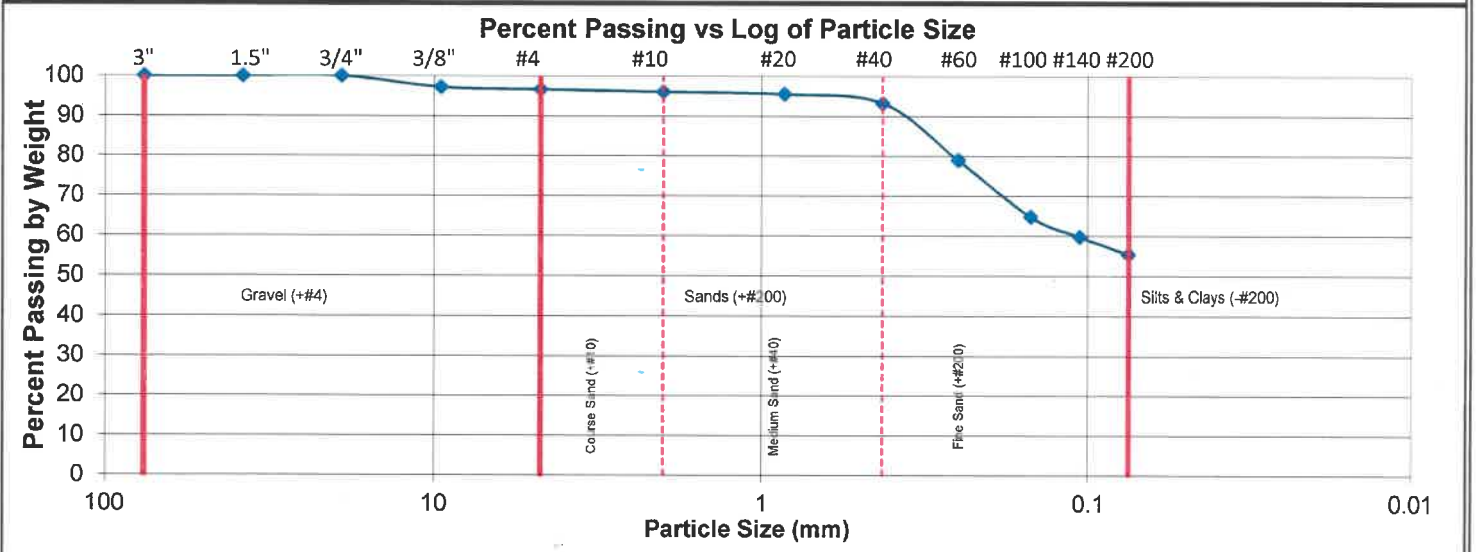
**USCS Classification ASTM D 2487**

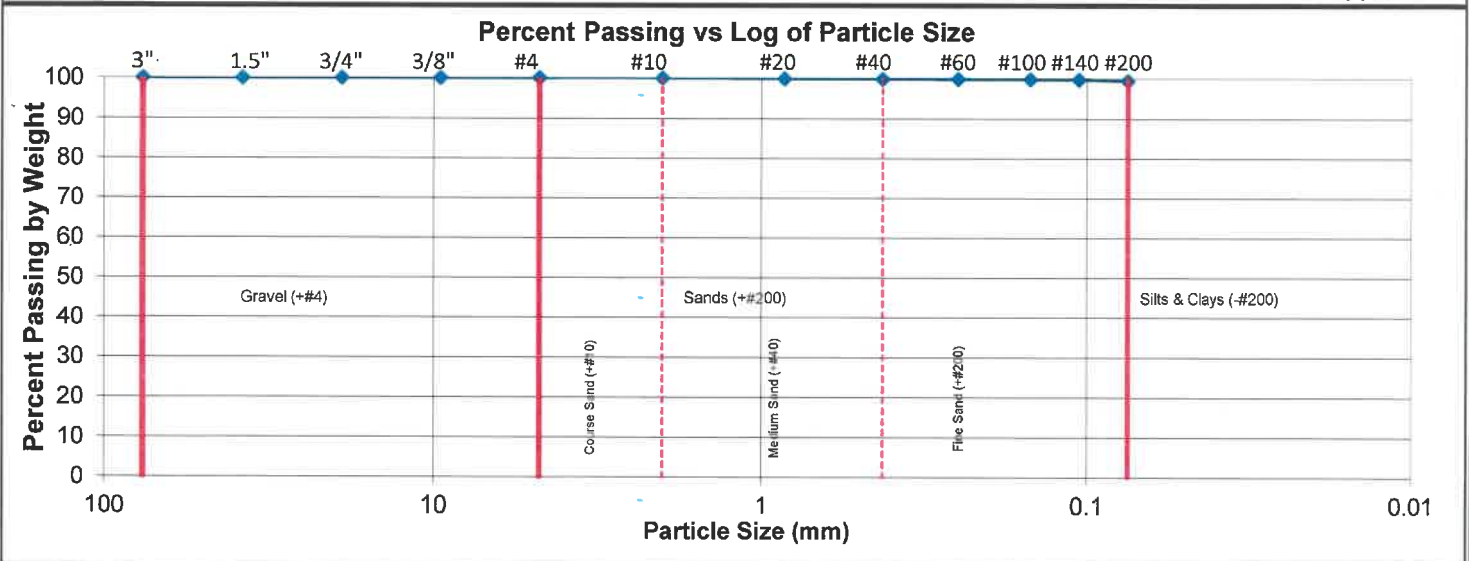
USCS Classification ASTM D 2487	
Atterberg Classification: CL	Coefficient of Curvature - C <sub>c</sub> : --
Group Symbol: CL	Coefficient of Uniformity - C <sub>u</sub> : --
USCS Classification: Lean Clay

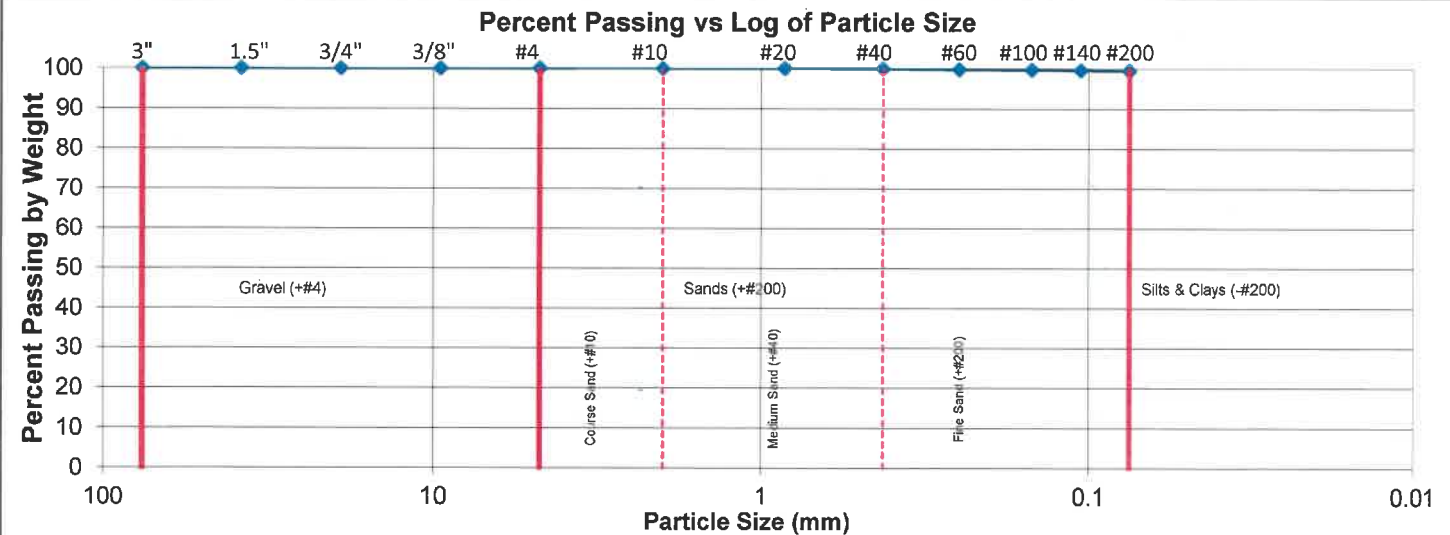
**USCS Classification ASTM D 2487**

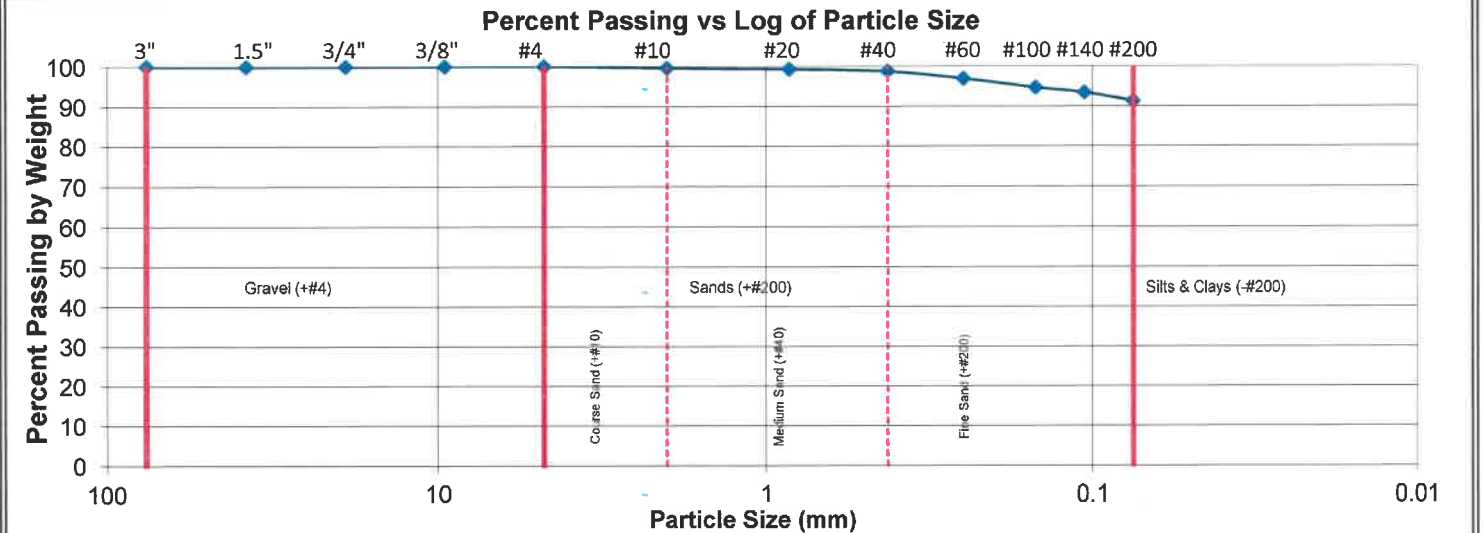
**USCS Classification ASTM D 2487**

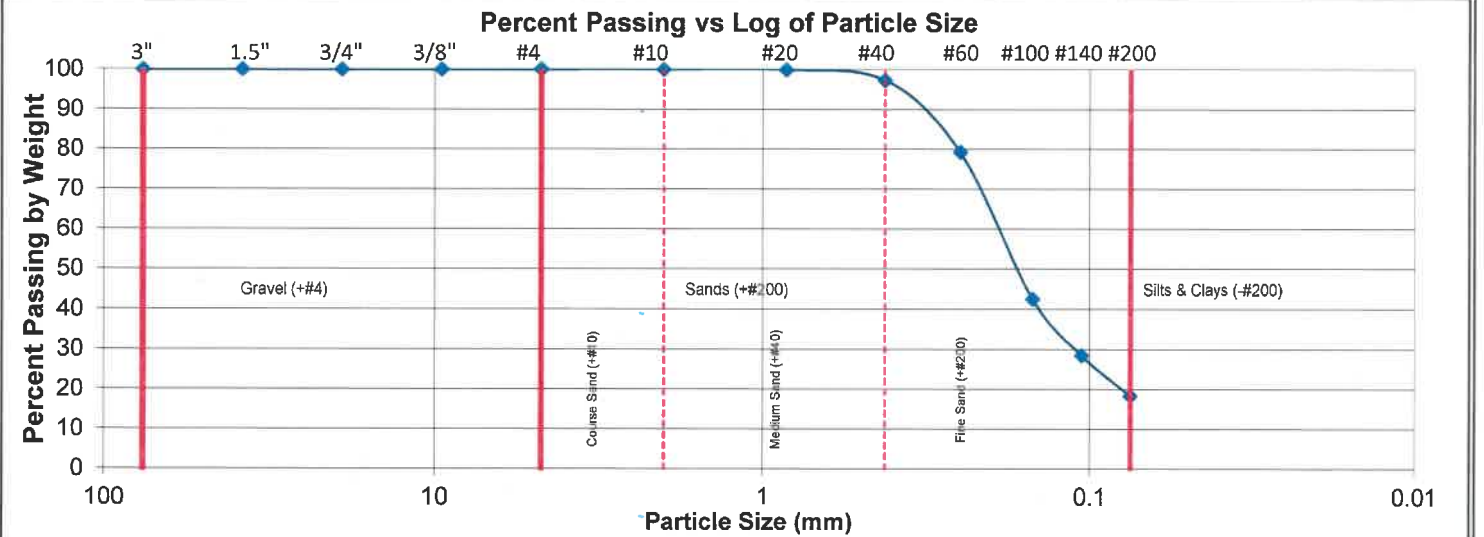
**USCS Classification ASTM D 2487**

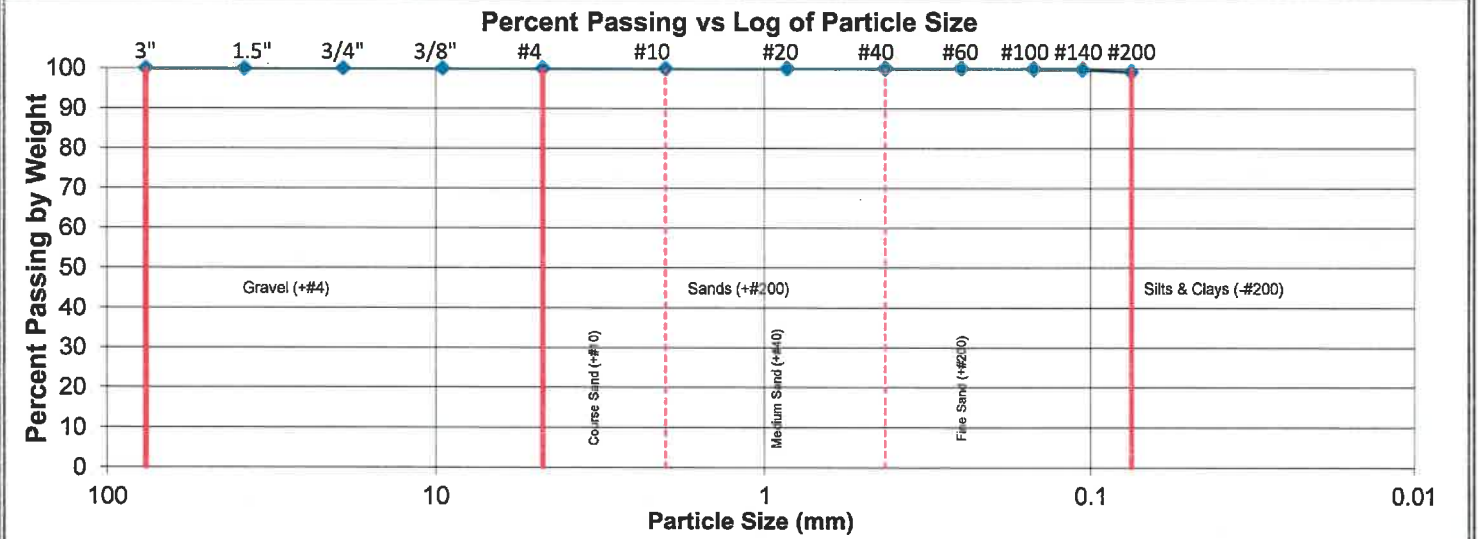
**USCS Classification ASTM D 2487**

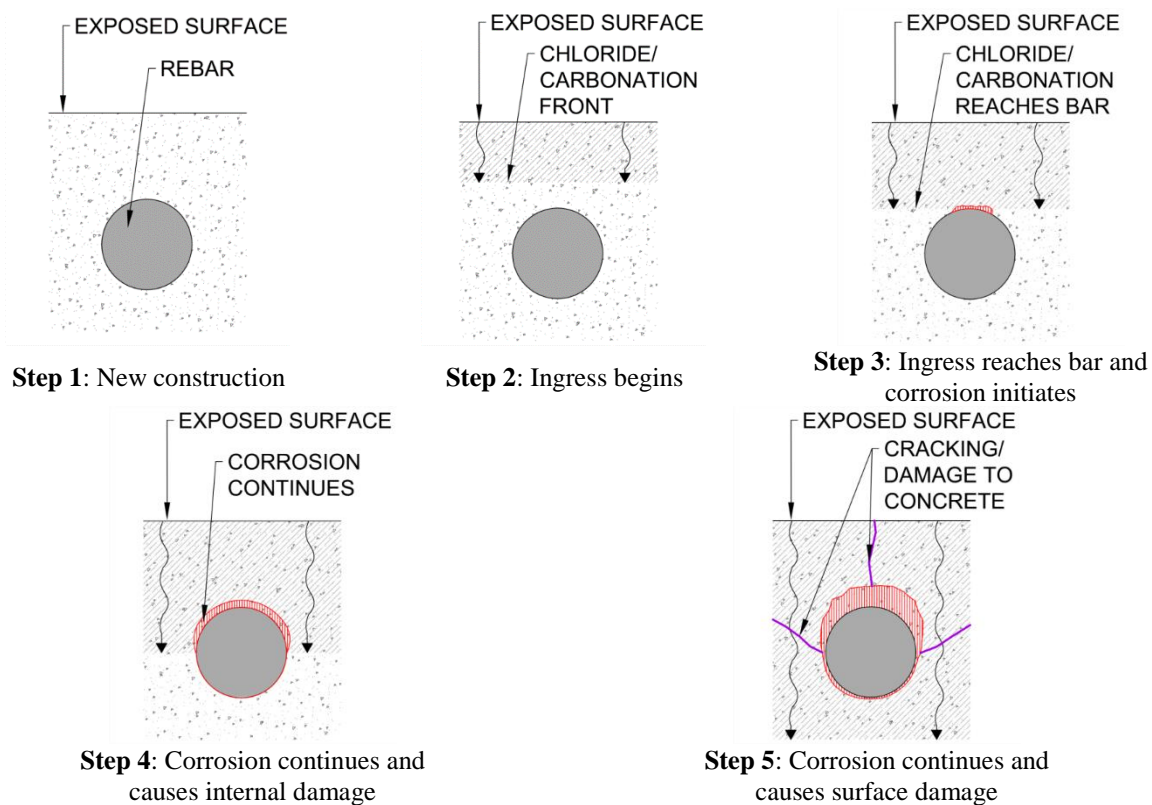
*Illustration of corrosion sequence.*

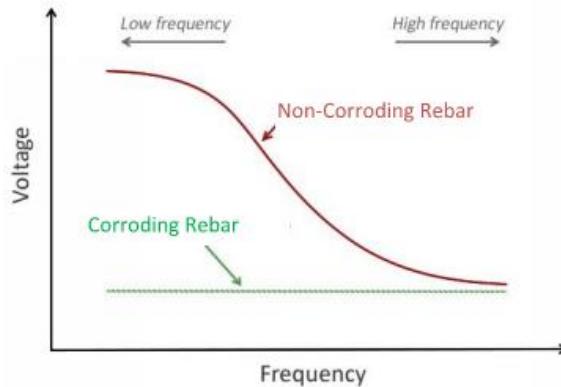
Figure 2. Schematic illustration of the voltage-frequency response of a corroding and non-corroding rebar (figure from iCOR manual).

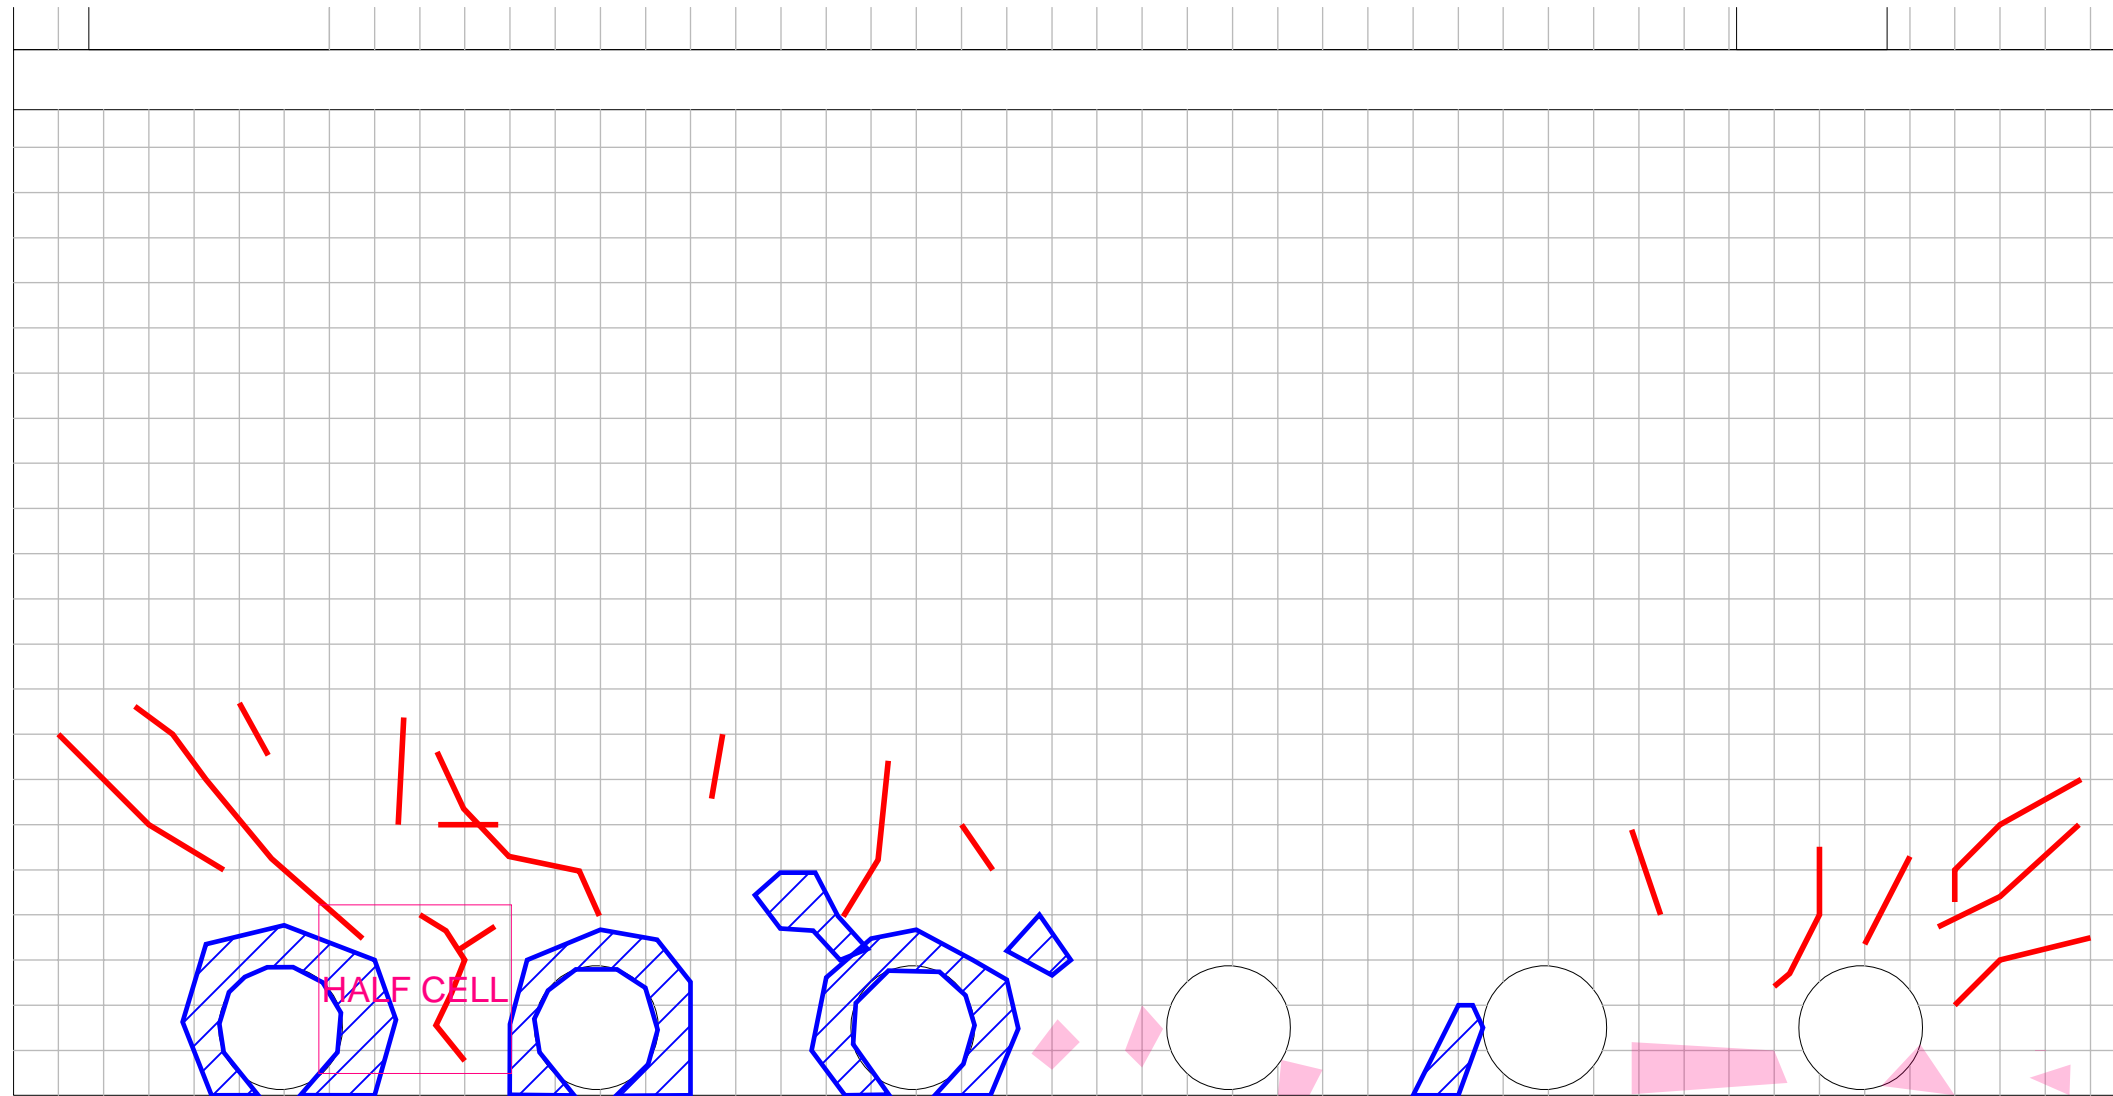
1 NORTH WALL INTERIOR ELEVATION  
Scale: 1 box - 1'-0"

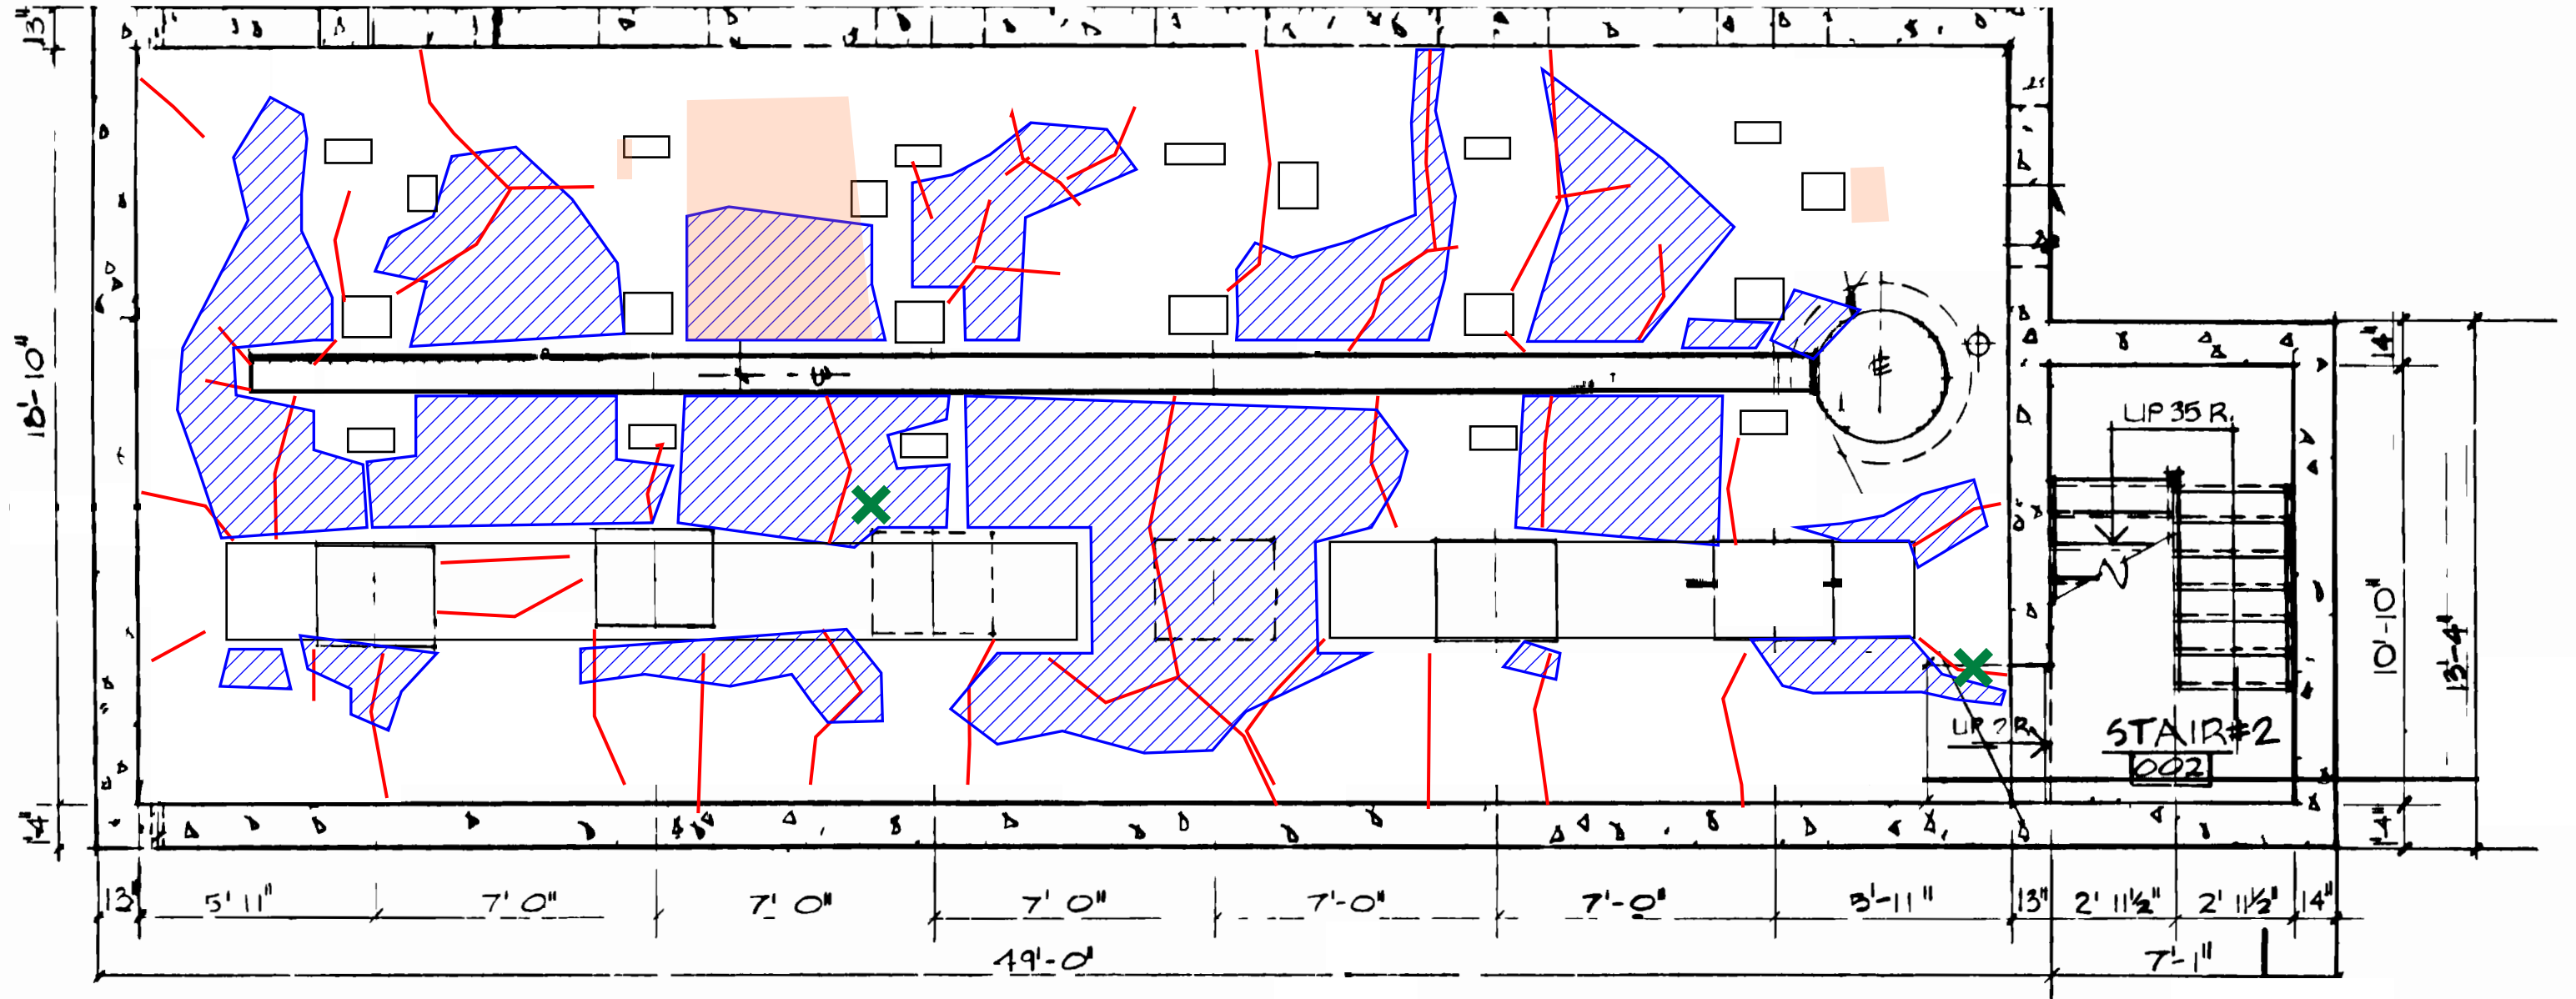
1 Pit Floor Plan  
Scale: Dimensioned as Indicated on Drawing

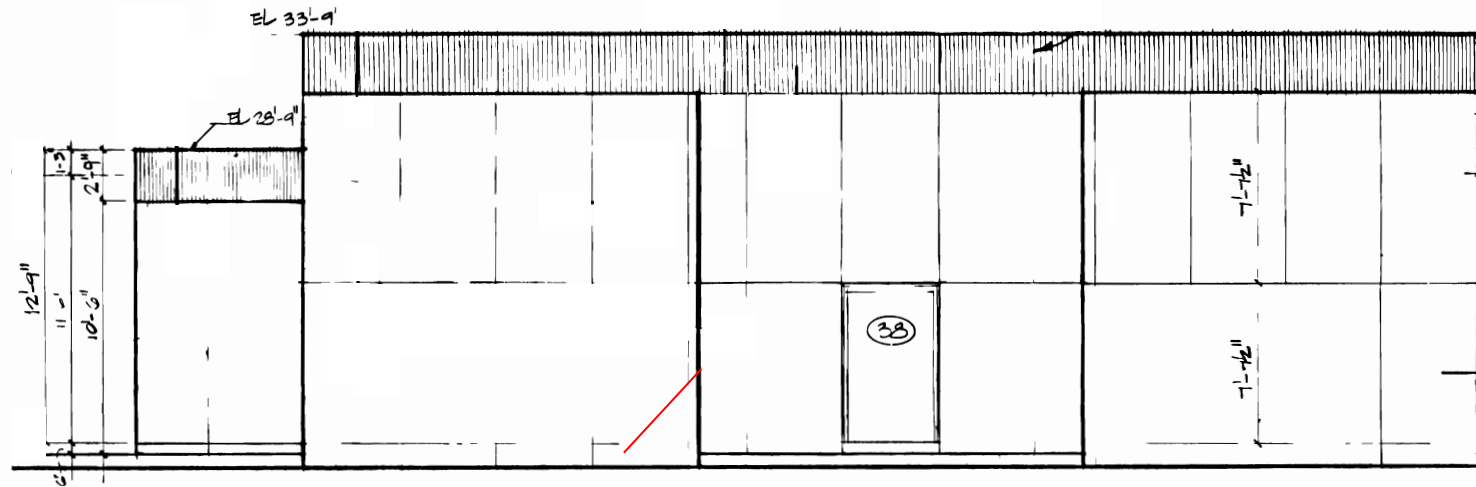
1 North Elevation  
Scale: Dimensioned as Indicated on Drawing

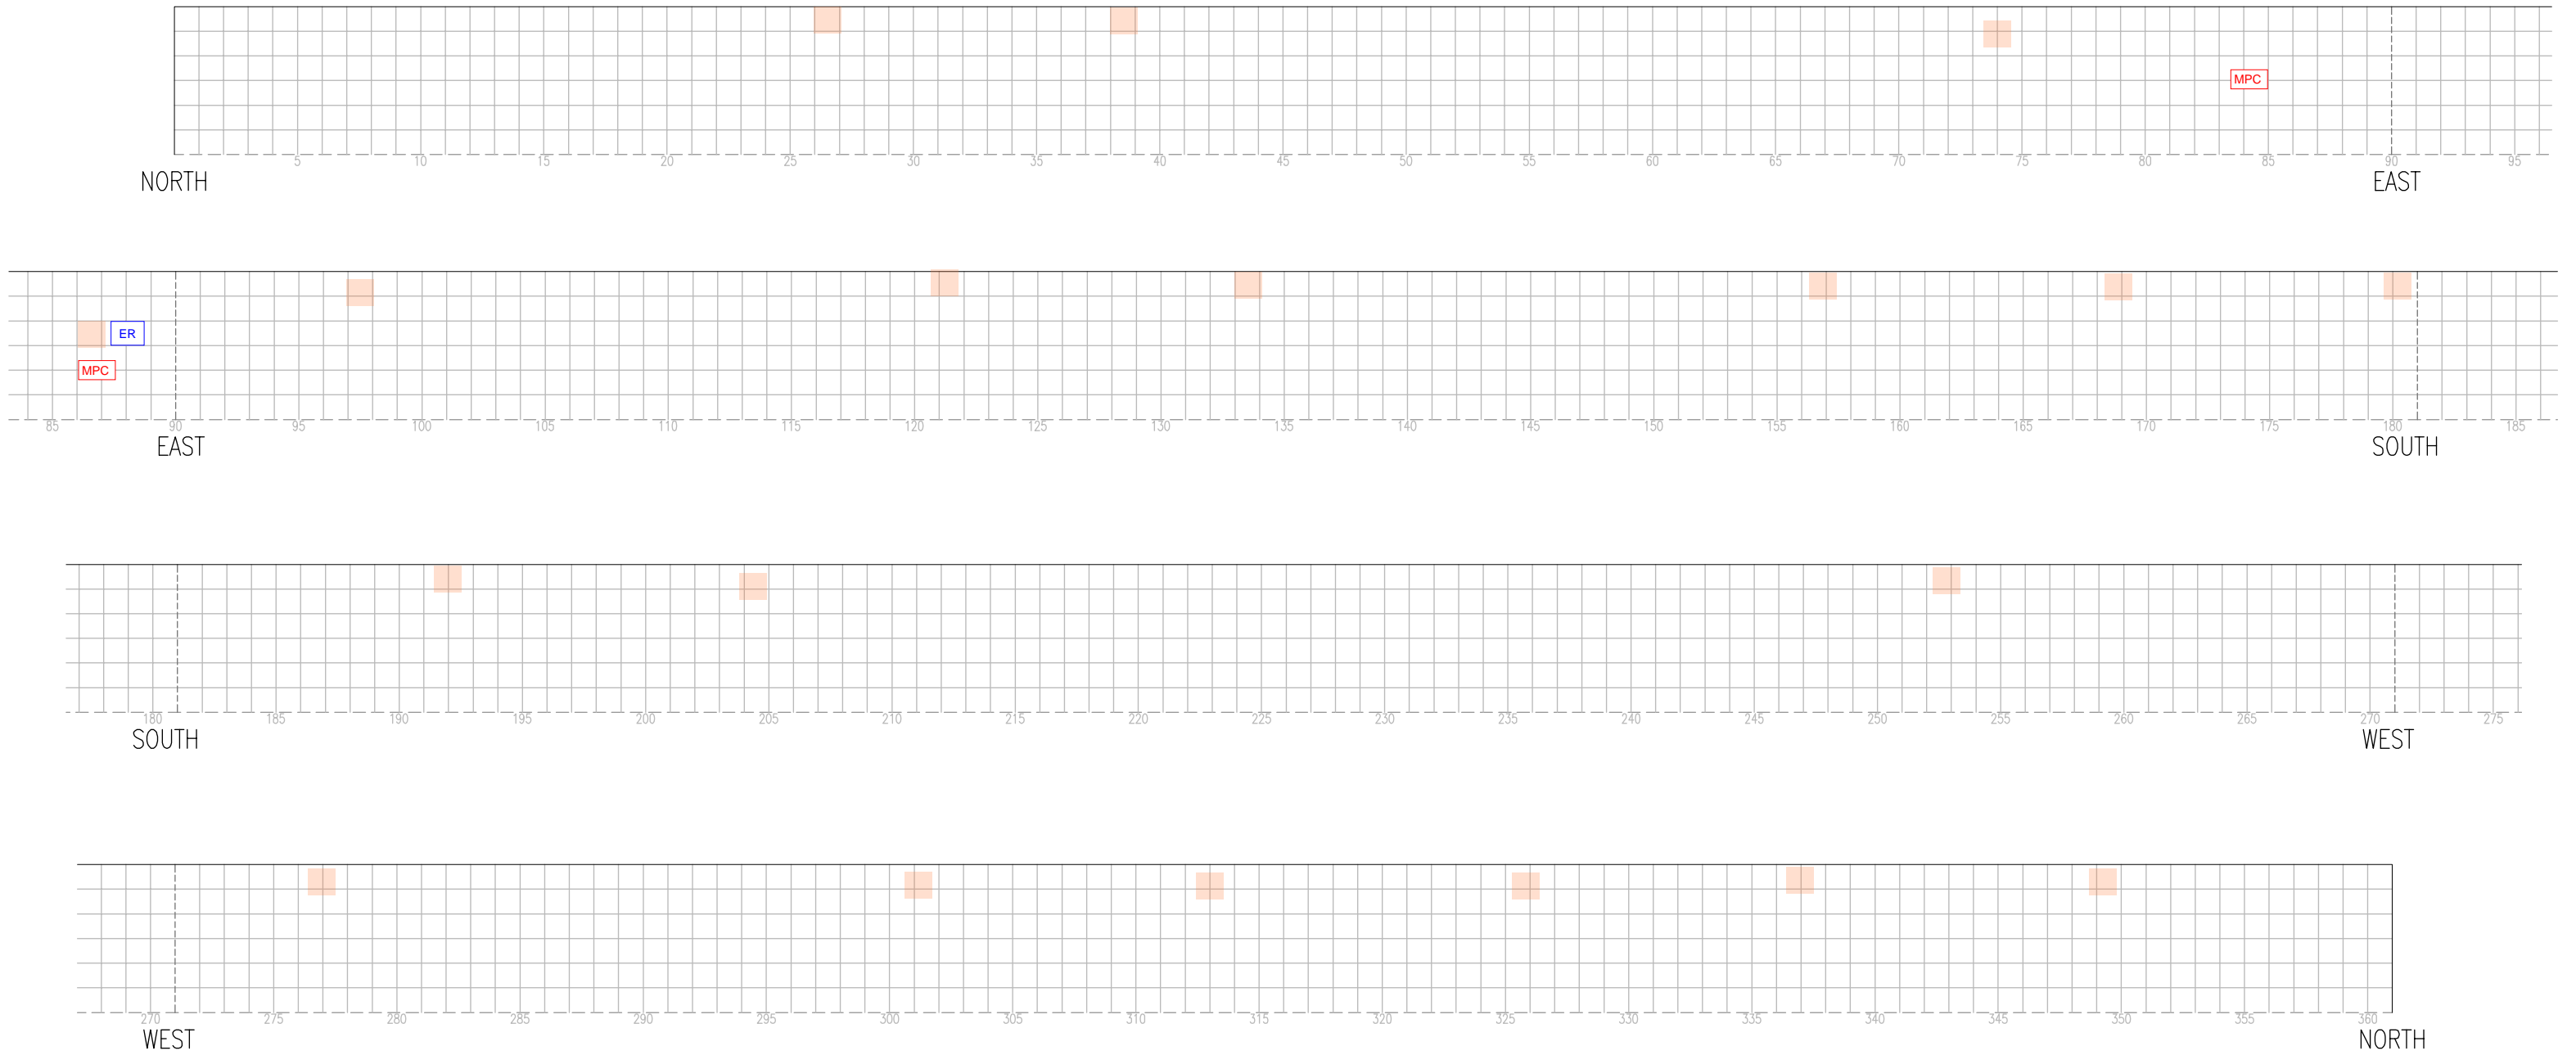
1 Clarifier #1 - Unwrapped Exterior  
Scale: Dimensioned as Indicated on Drawing

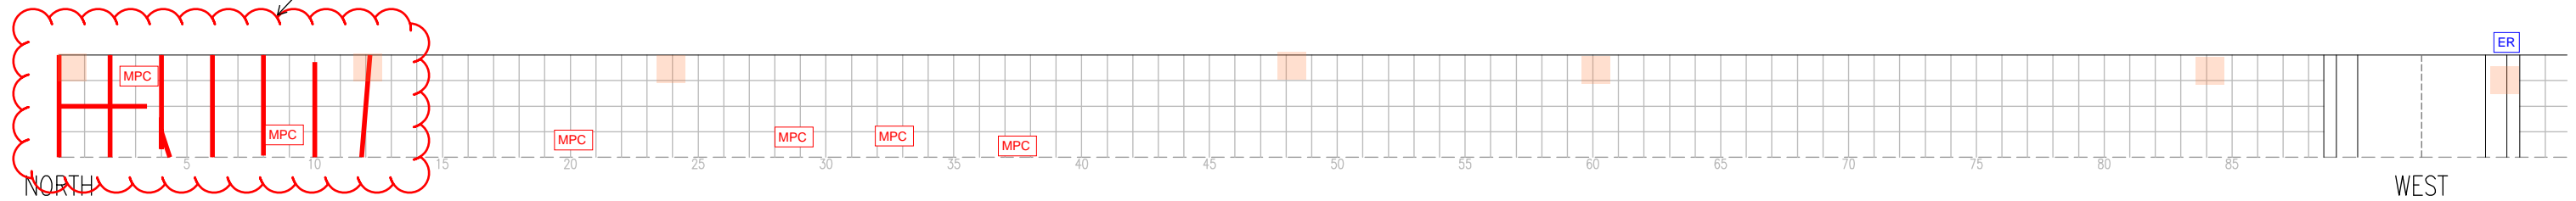
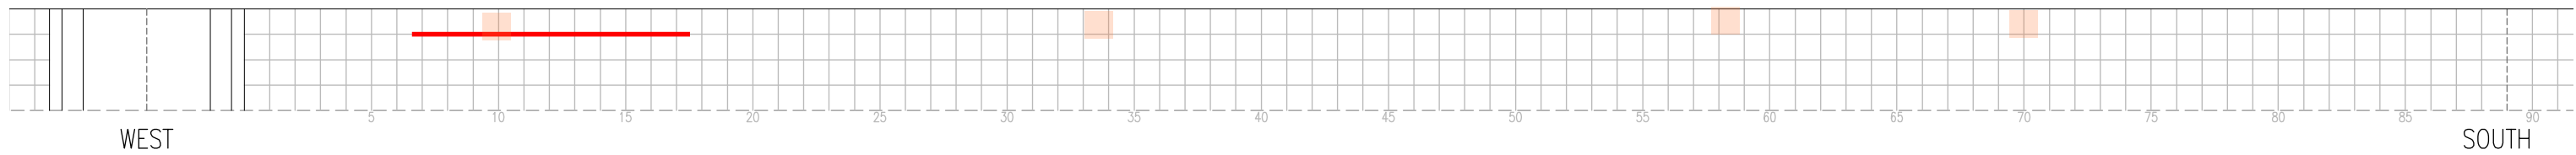
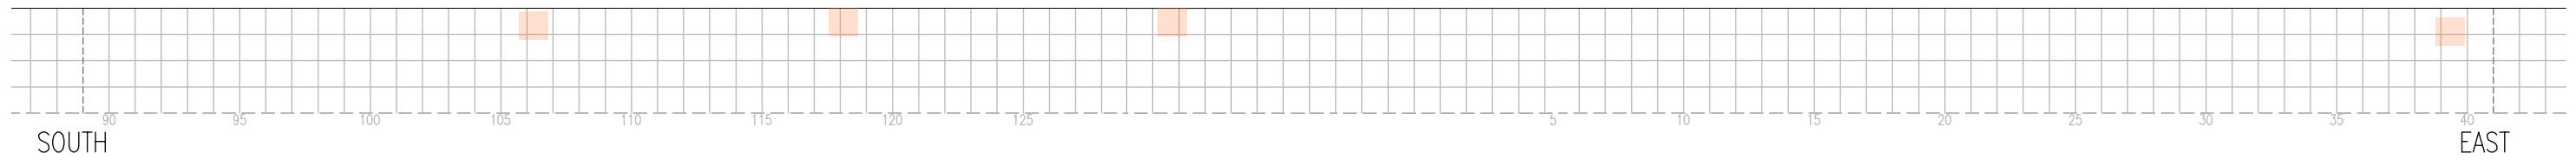
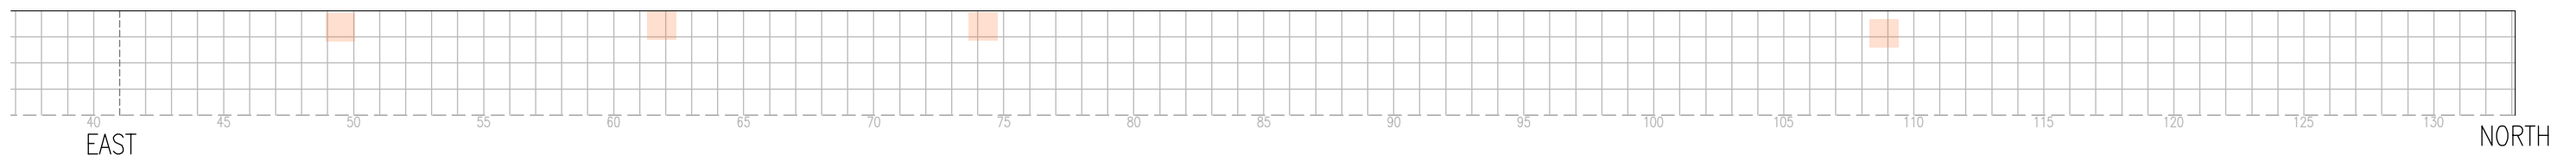
1 Clarifier #2 - Unwrapped Exterior  
Scale: Dimensioned as Indicated on Drawing

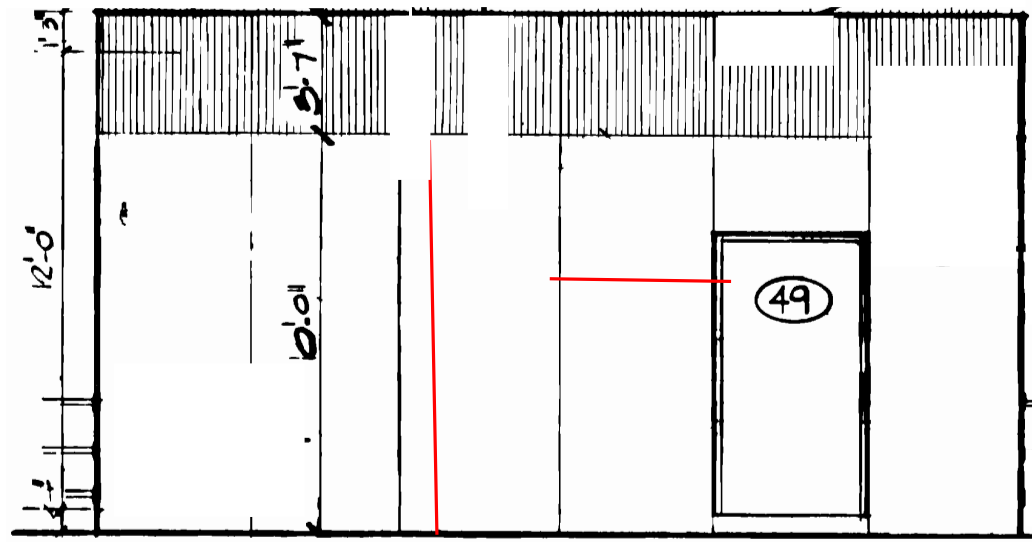
- BOWED PANEL		- JOINT LEAK		- SEALANT JOINT DISTRESS
	- EFFLORESCENCE		- MAP PATTERN CRACKING		
	- EXPOSED REINFORCING		- PIPE STAINING

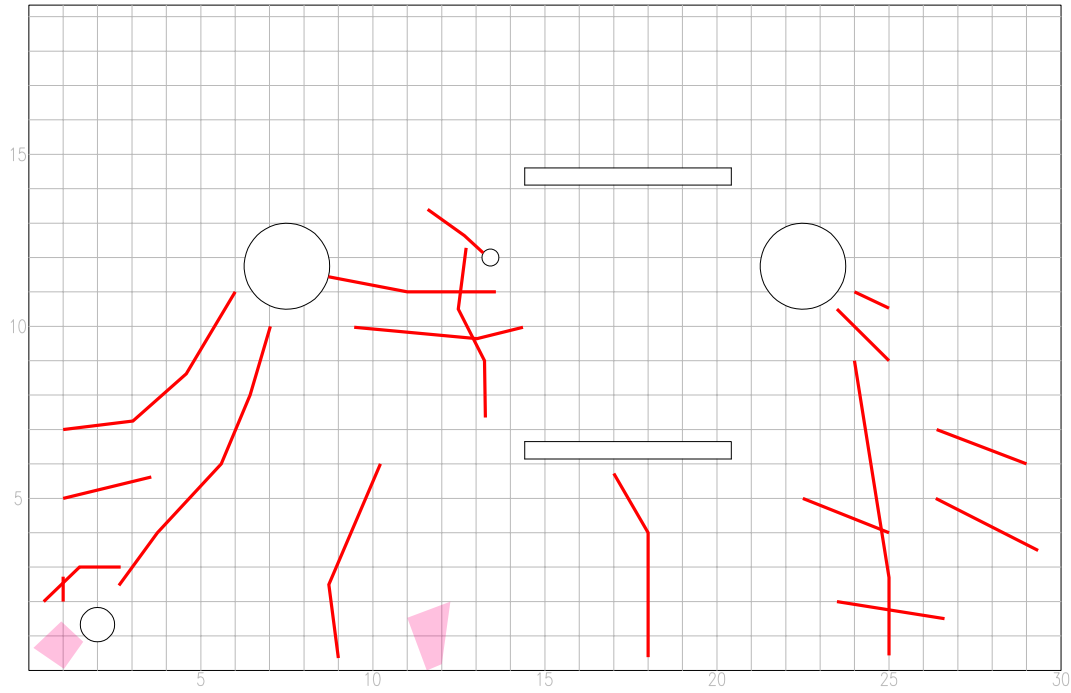
1 NORTH WALL  
Scale: 1 box - 1'-0"

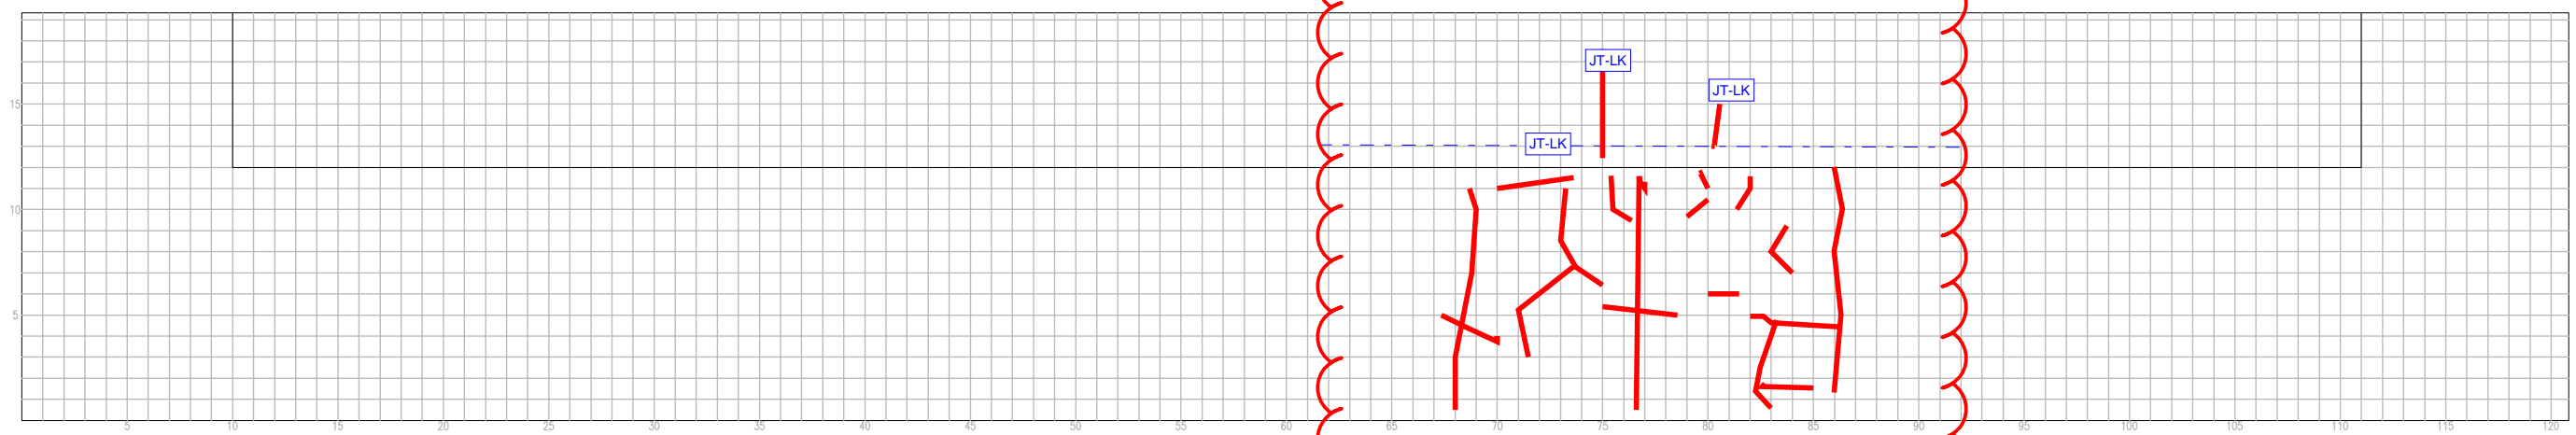
2 EAST WALL  
Scale: 1 box - 1'-0"

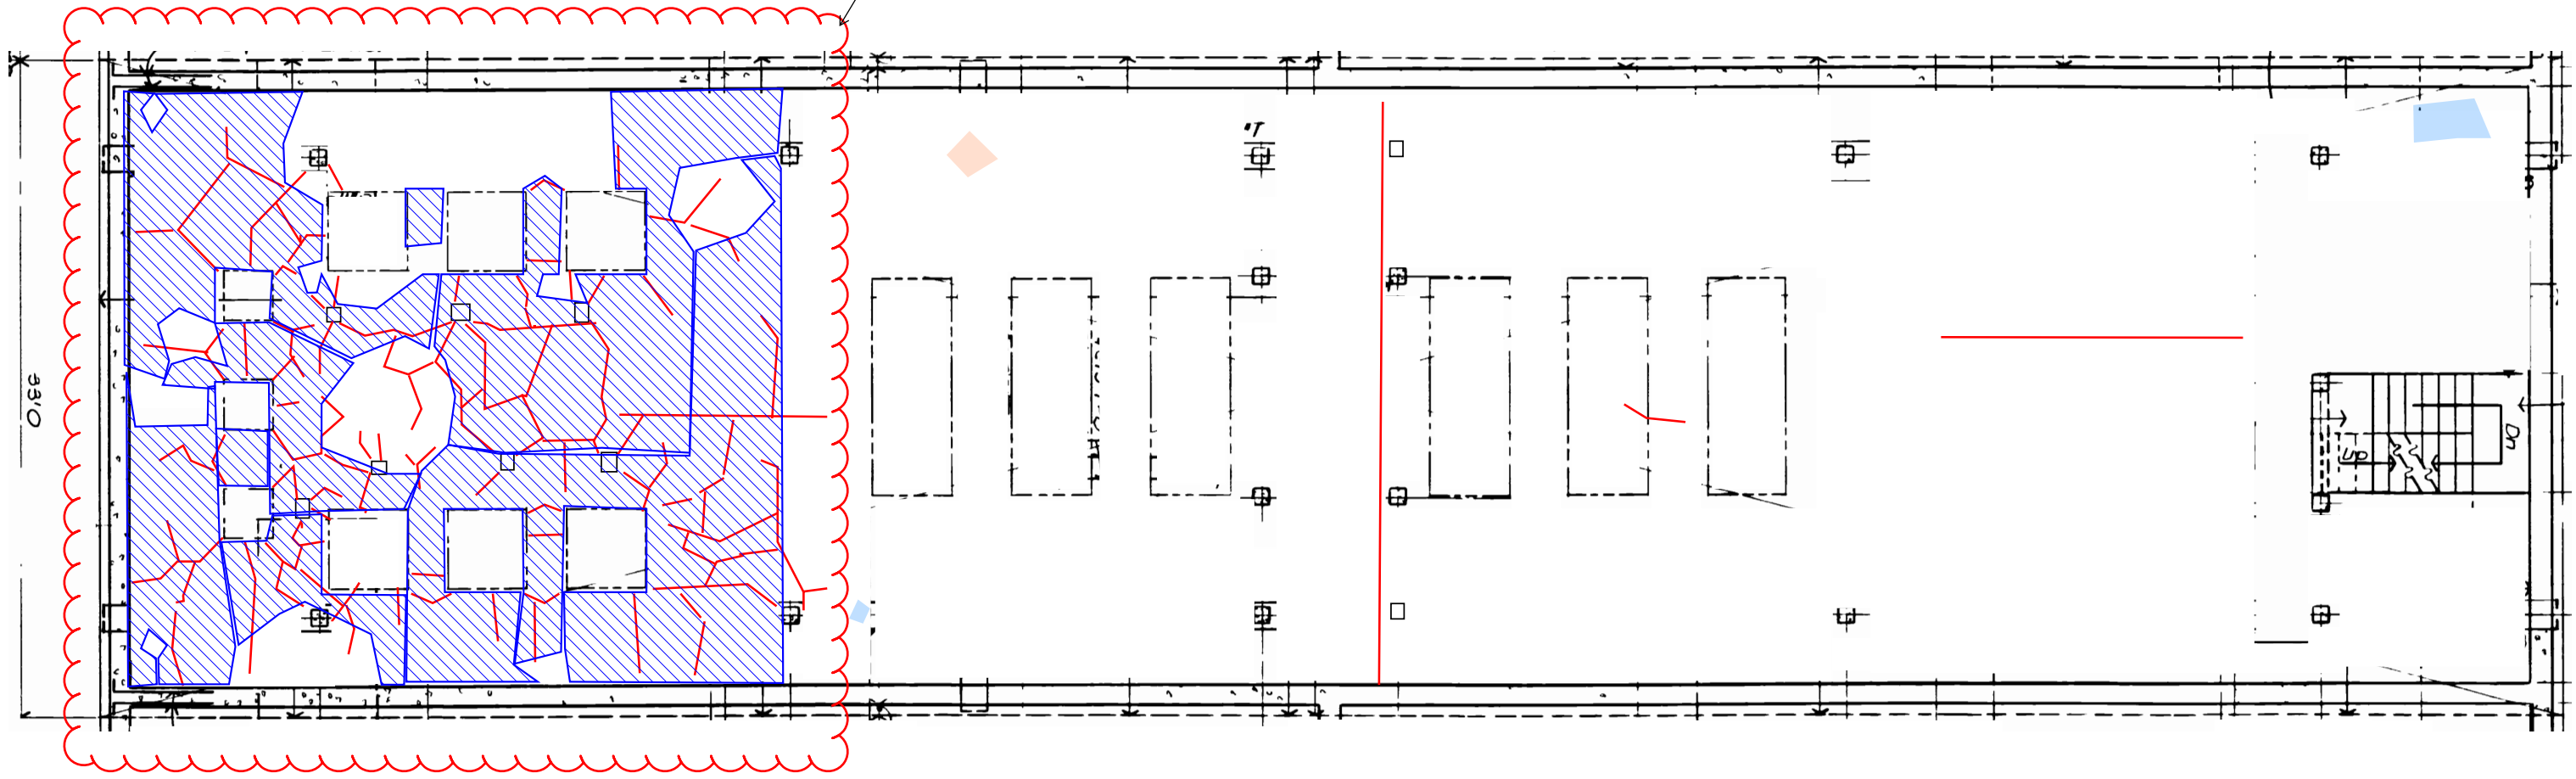
1 Blower Room Slab Plan  
Scale: Dimensioned as Indicated on Drawing
