**APPENDIX A. GEOTECHNICAL INVESTIGATION**

## PERSIGO WASTEWATER TREATMENT PLANT Geotechnical Investigation

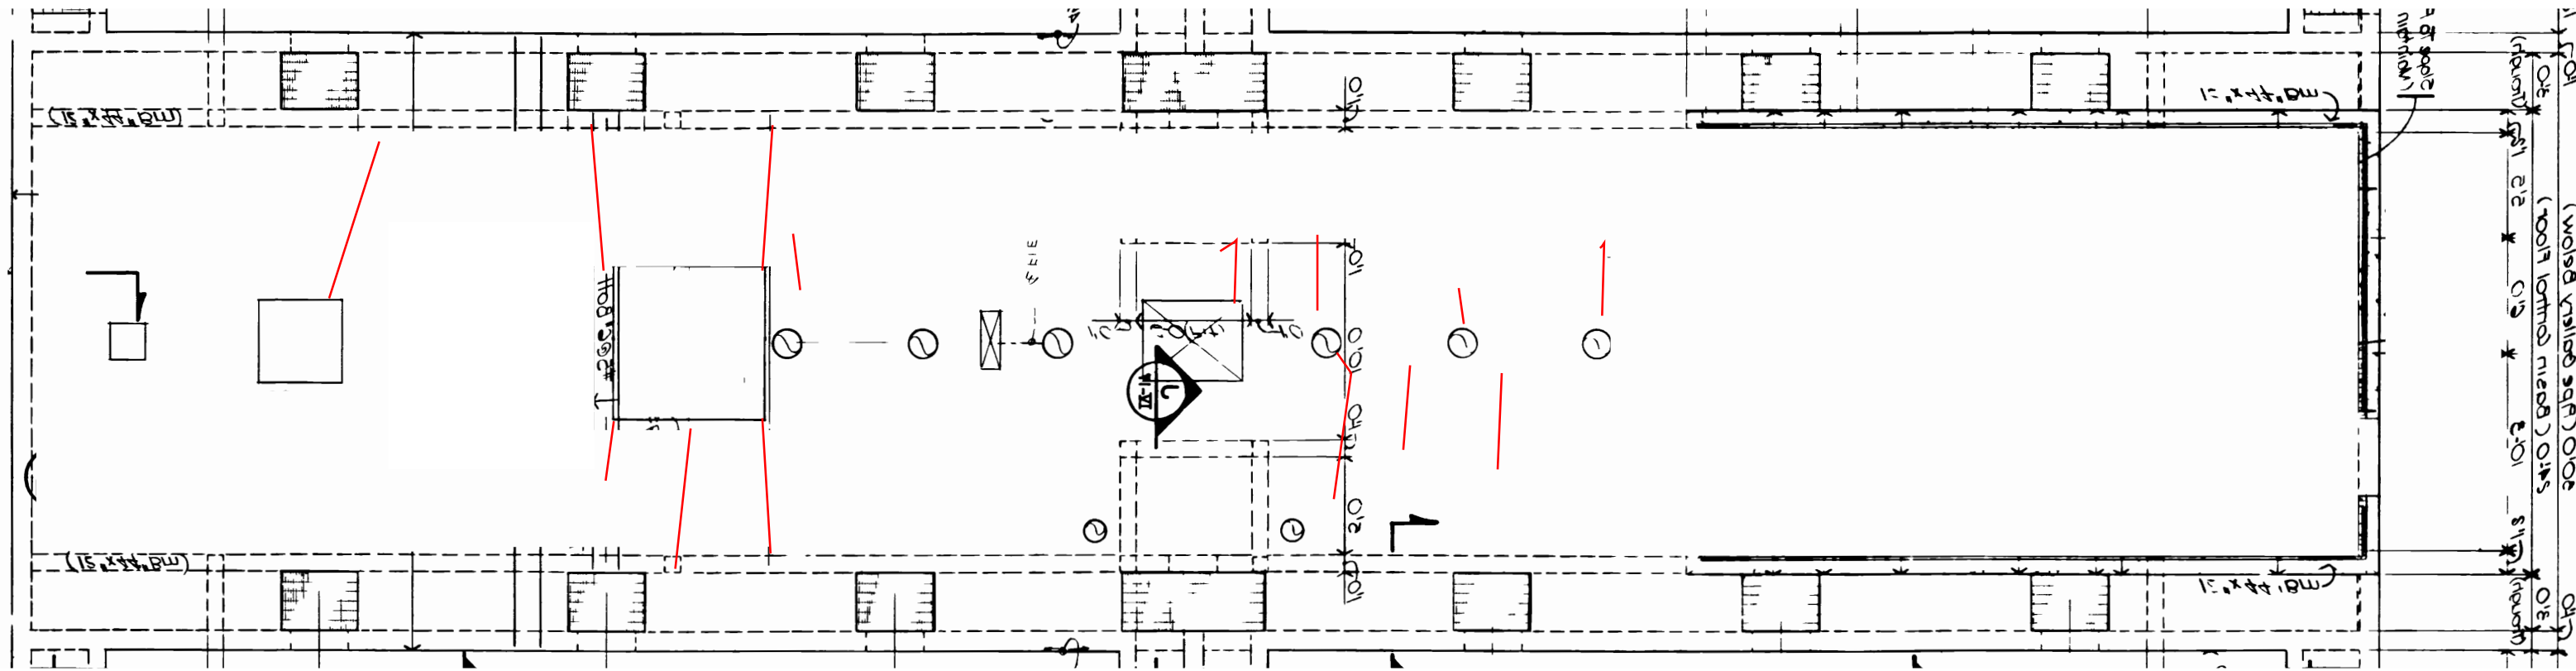
1 Catwalk Soffit Plan  
Scale: Dimensioned as Indicated on Drawing

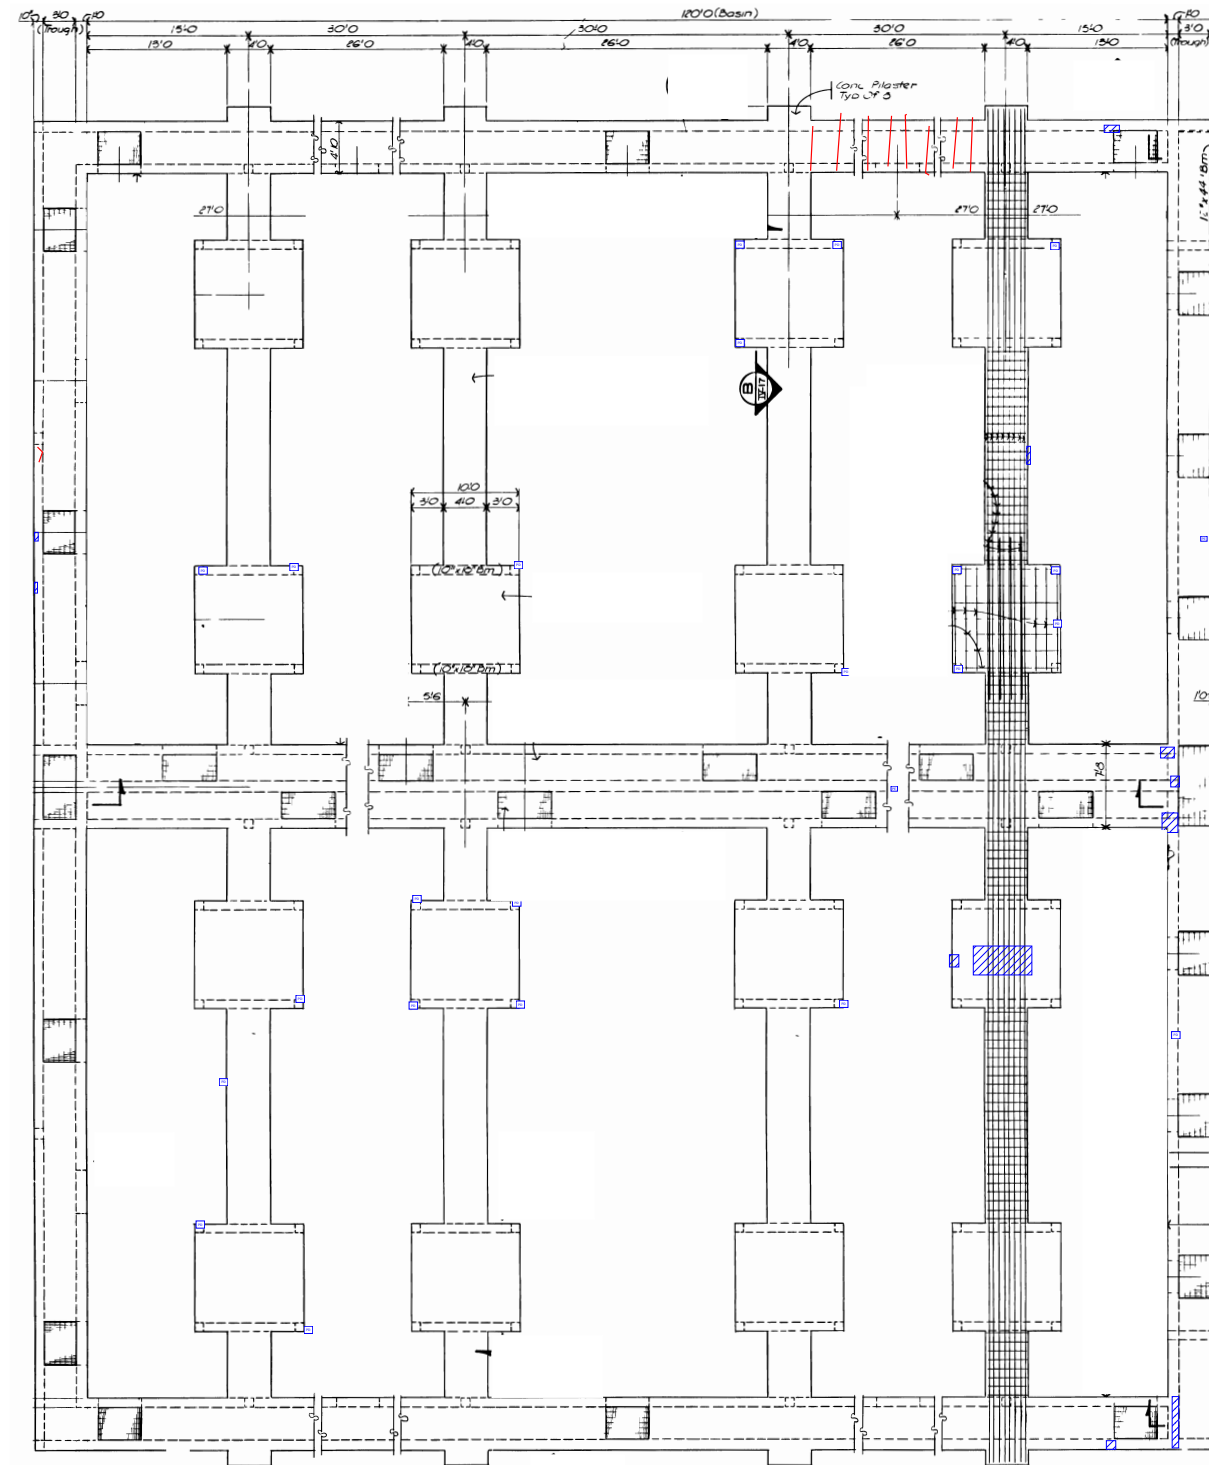
1 West End Catwalks  
Scale: Dimensioned as Indicated on Drawing

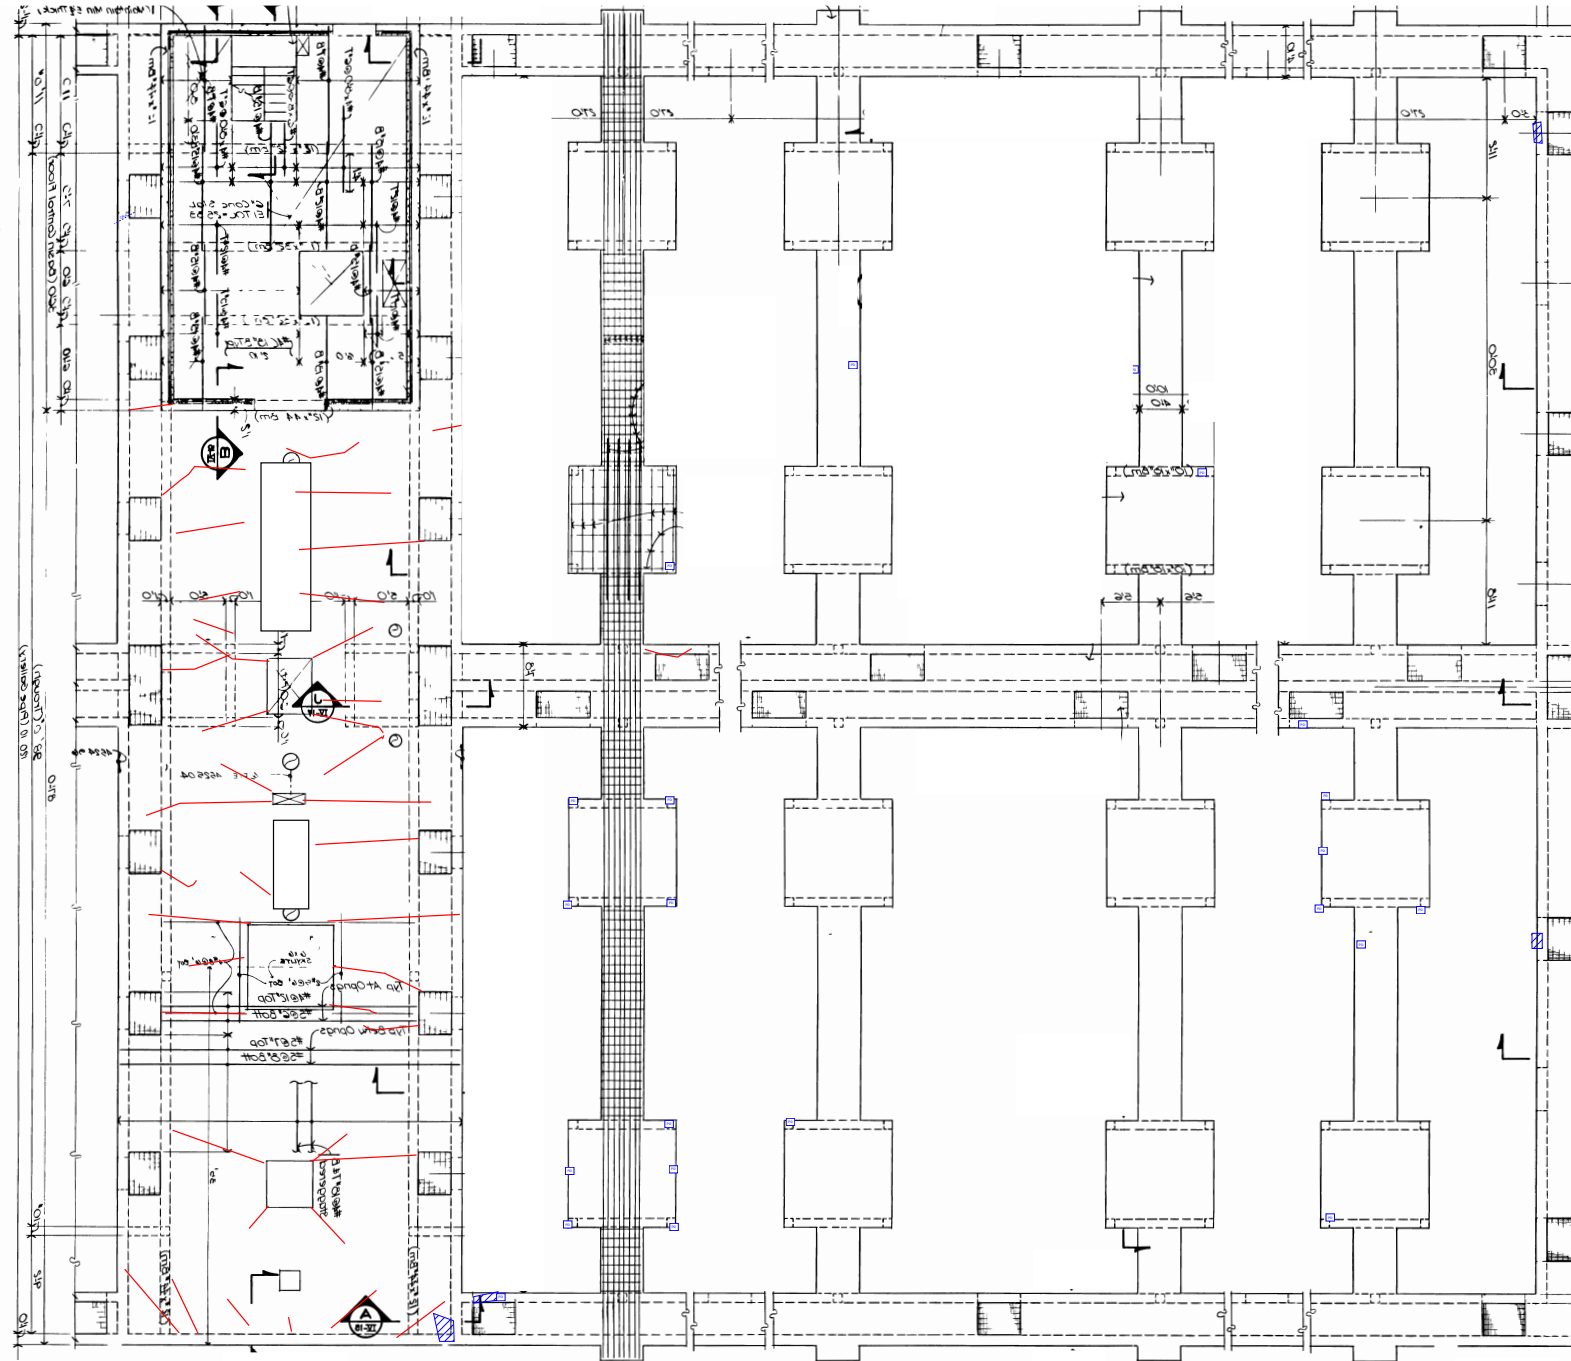
1 East End Catwalks  
Scale: Dimensioned as Indicated on Drawing

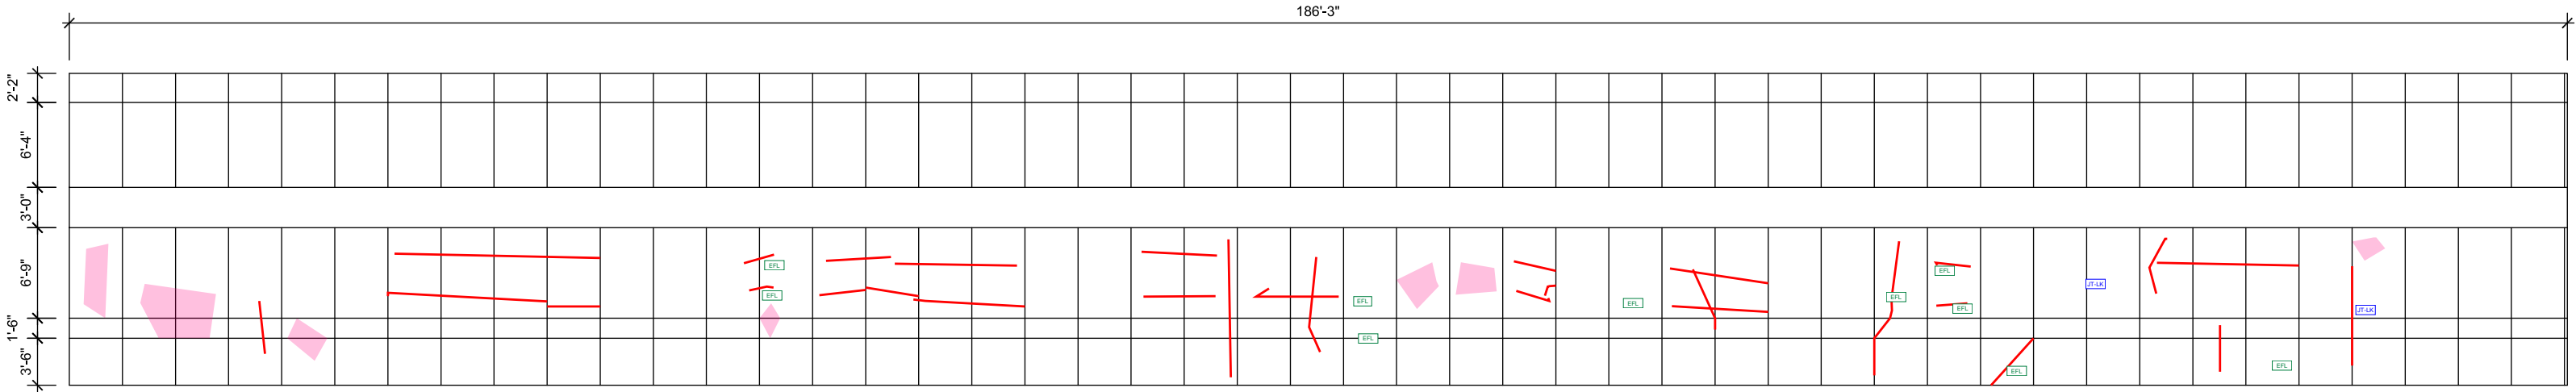
**1 South Elevation**  
Scale: Dimensioned as Indicated on Drawing

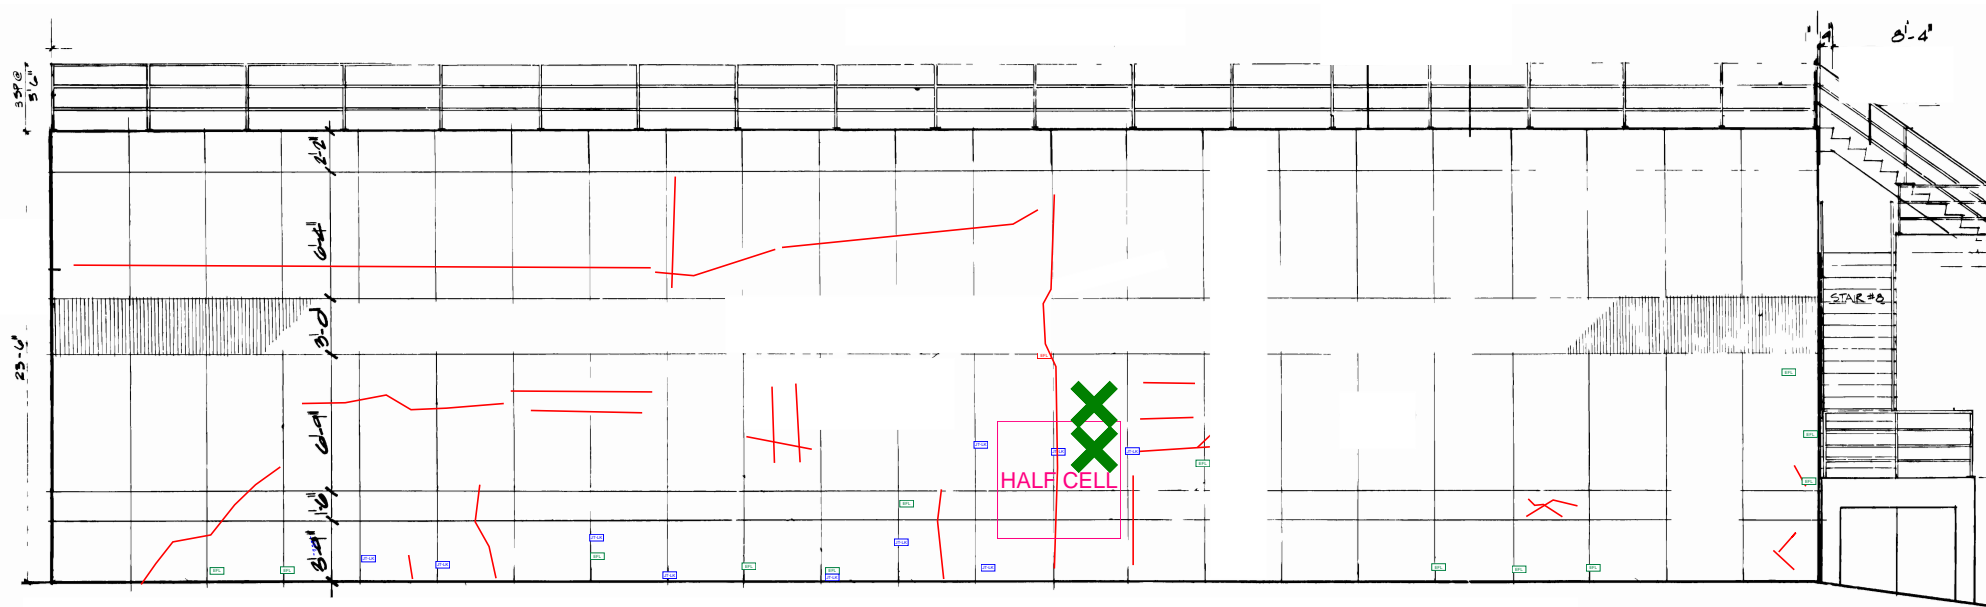
1 East Elevation  
Scale: Dimensioned as Indicated on Drawing

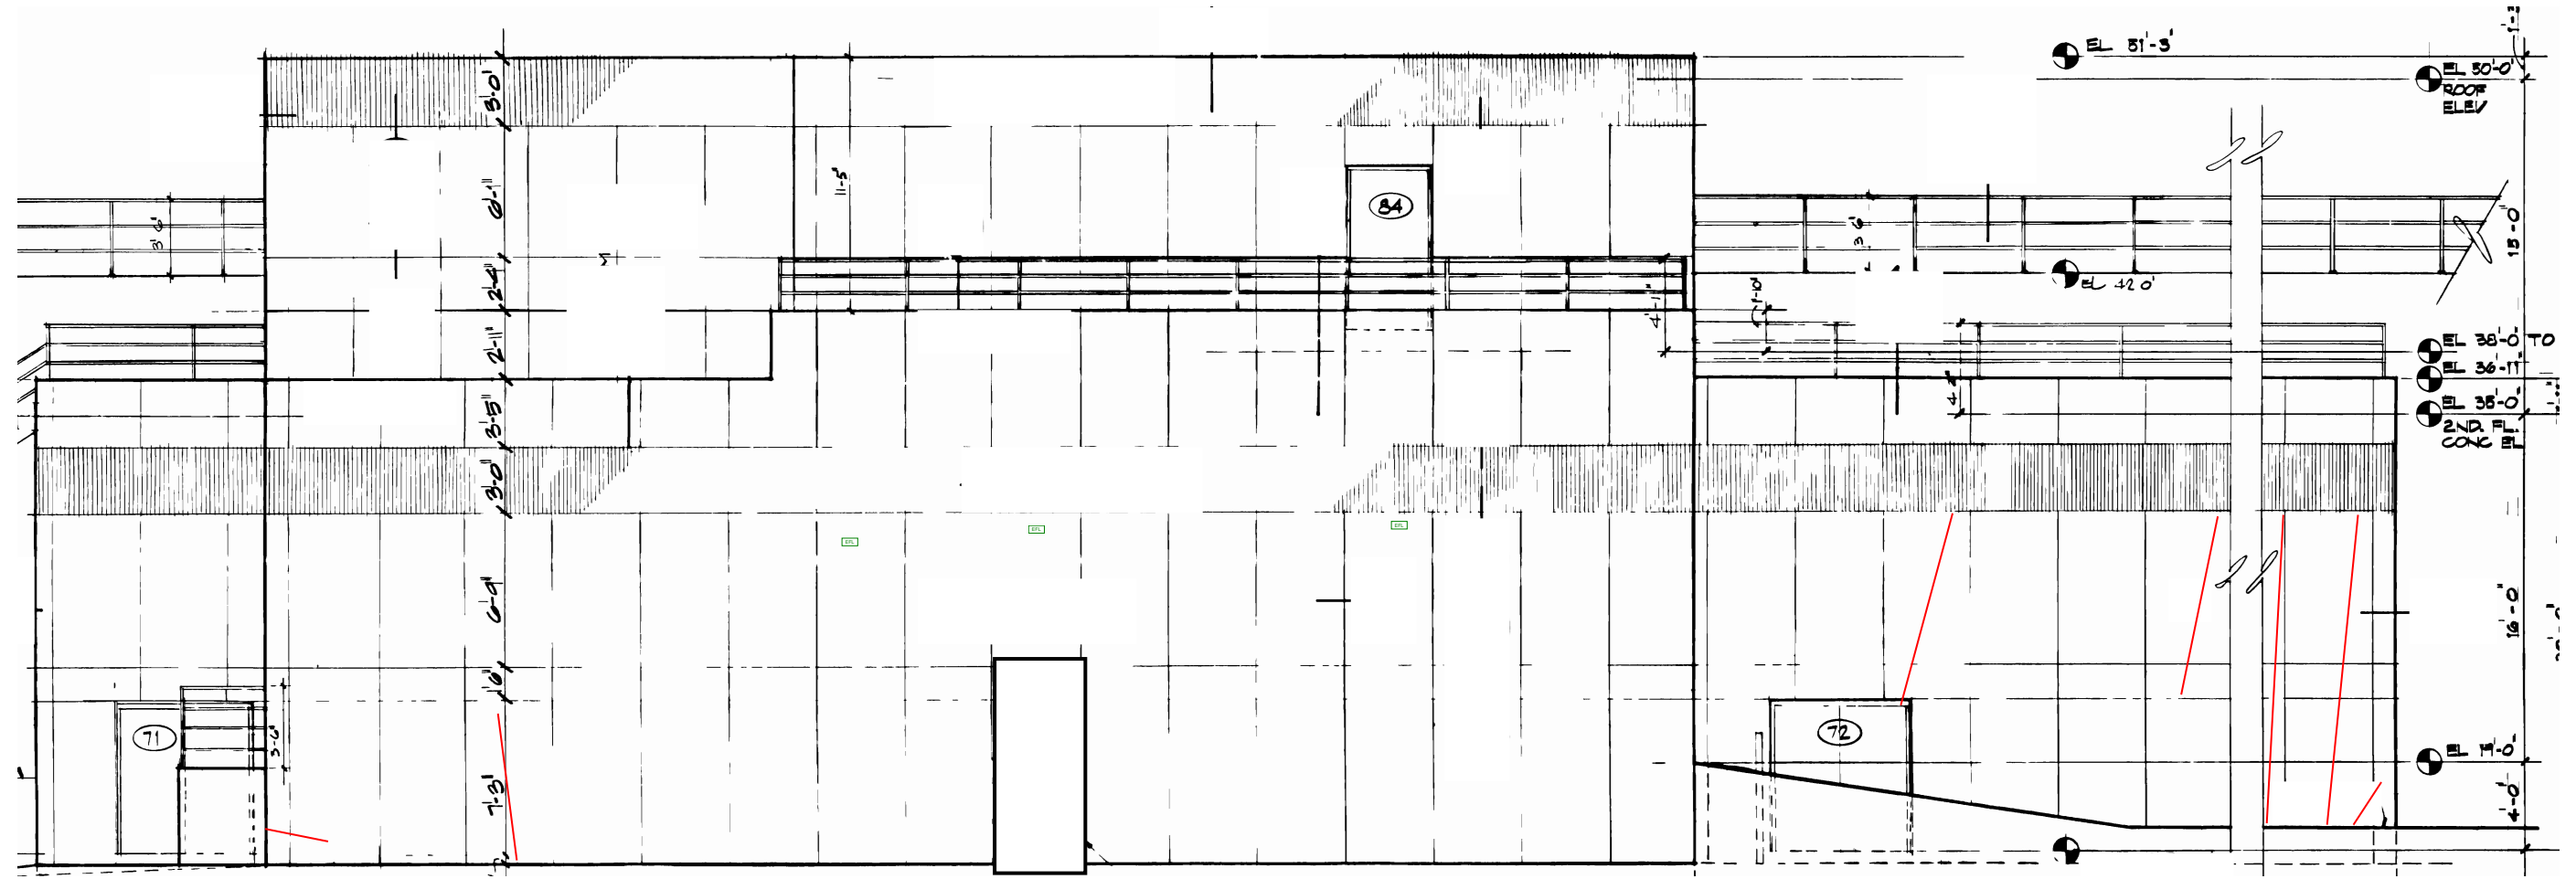
1 North Elevation  
Scale: Dimensioned as Indicated on Drawing

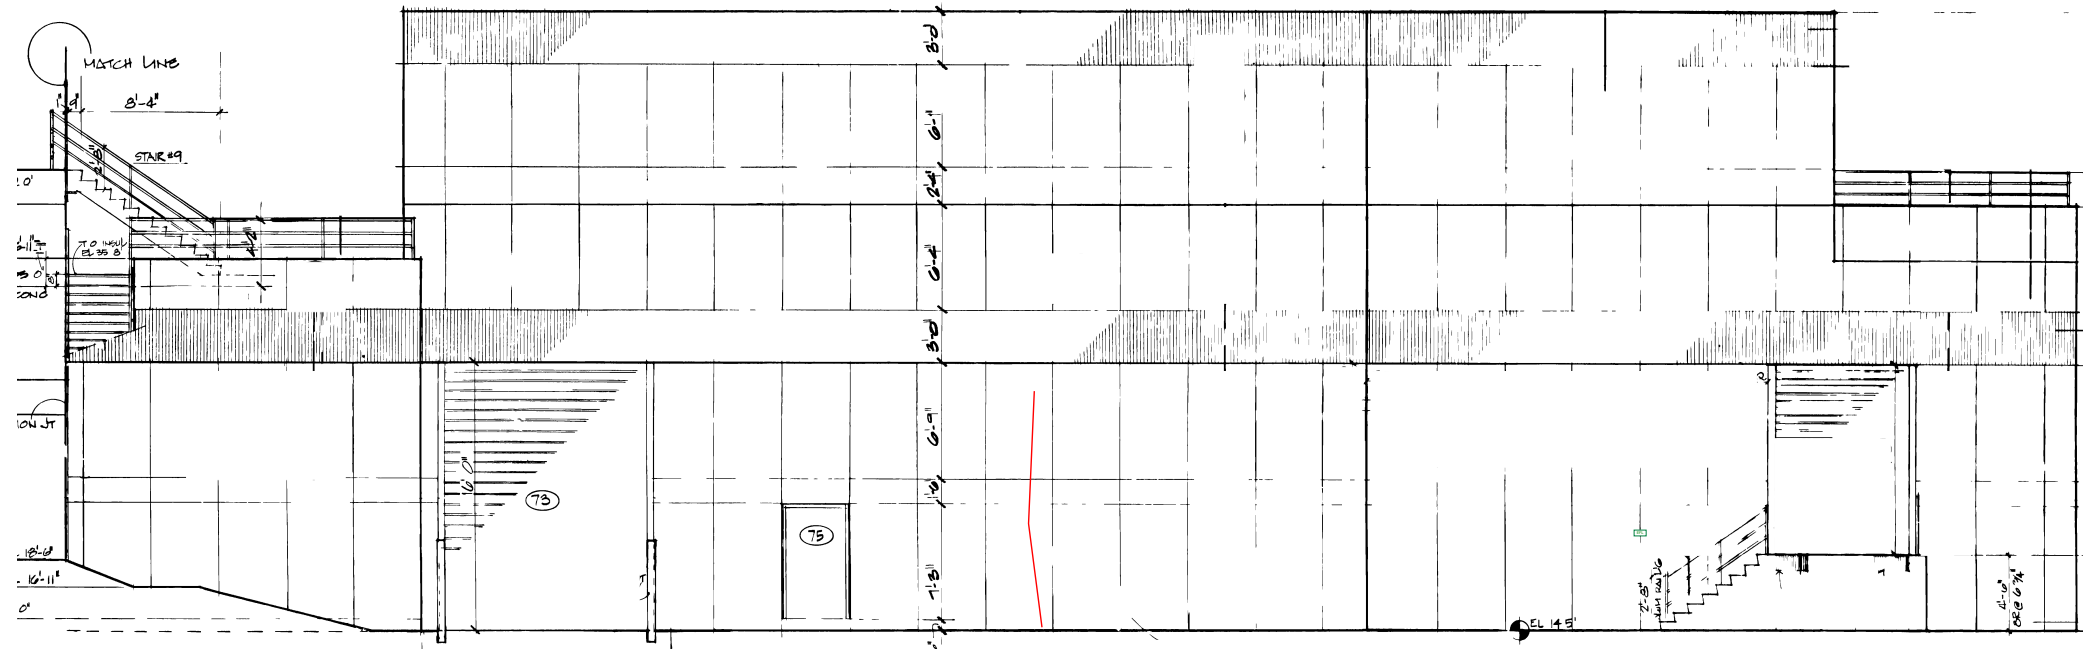
1 East Elevation  
Scale: Dimensioned as Indicated on Drawing

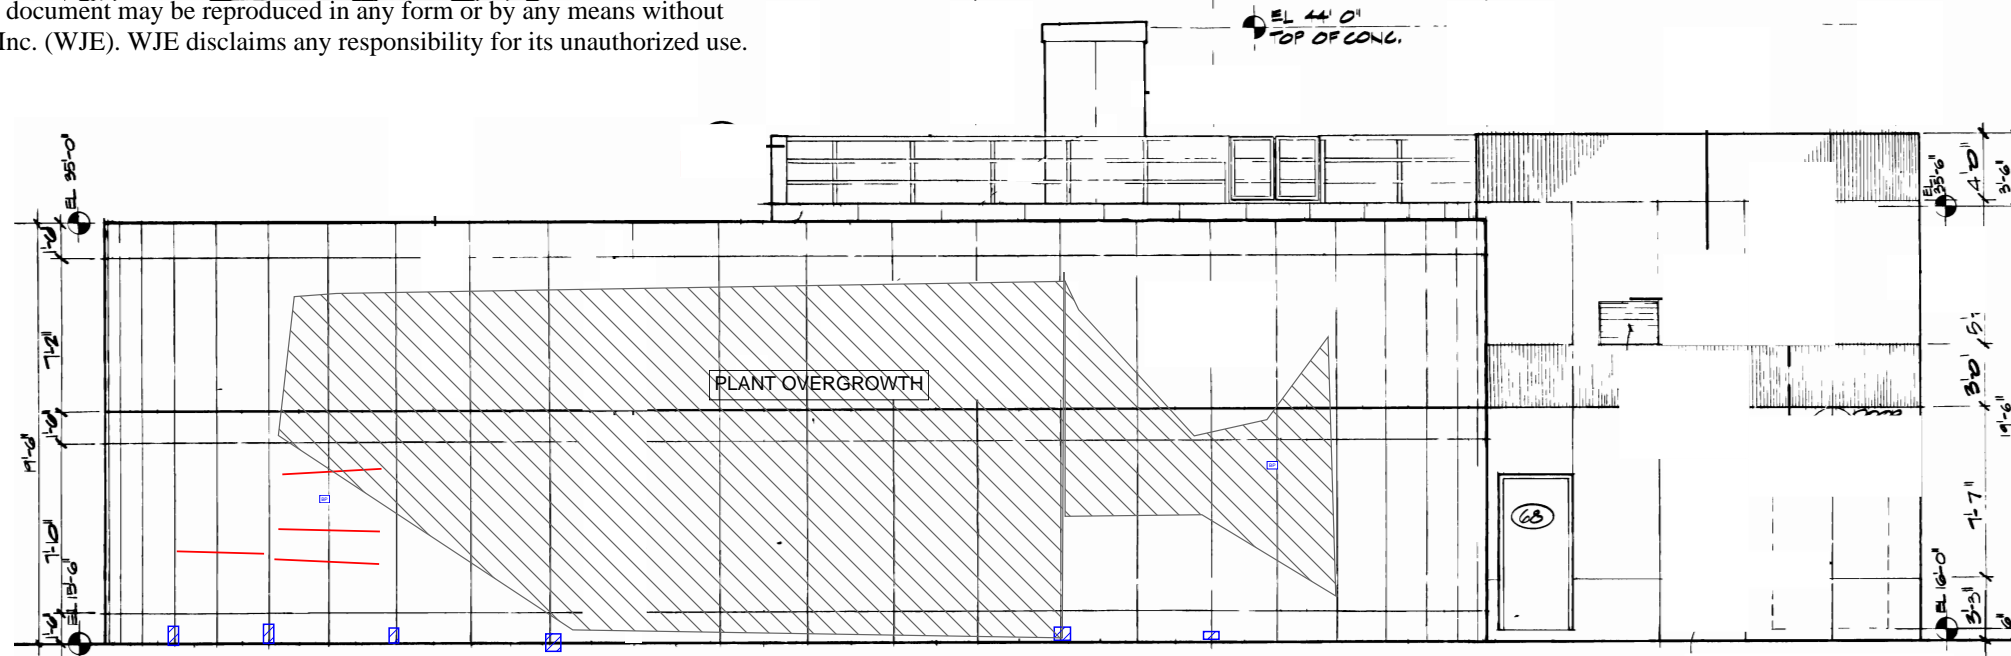
1 North Elevation  
Scale: Dimensioned as Indicated on Drawing

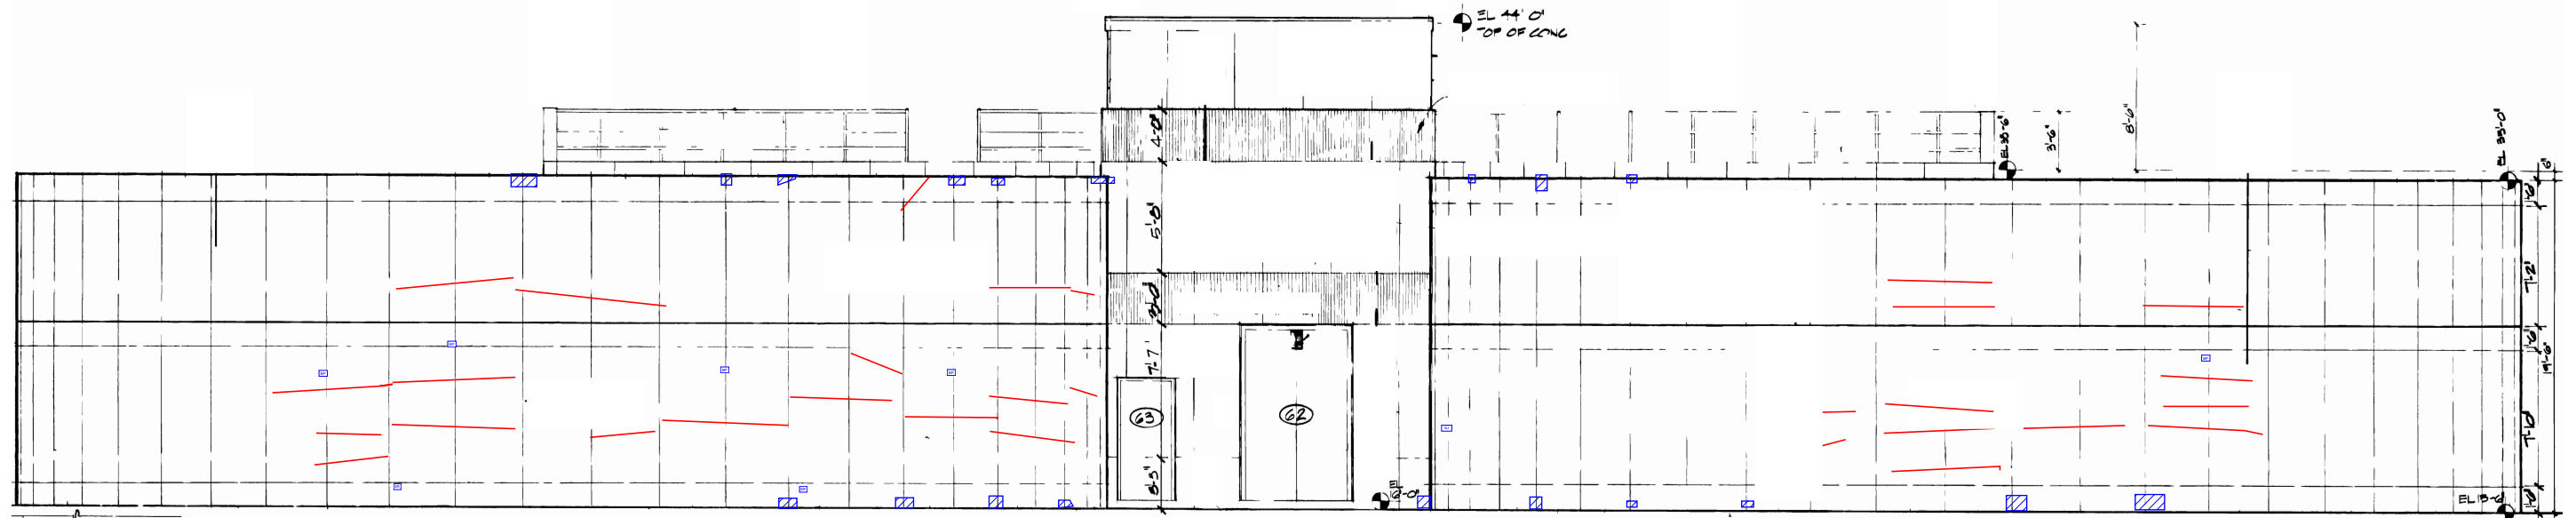
1 East Elevation  
Scale: Dimensioned as Indicated on Drawing

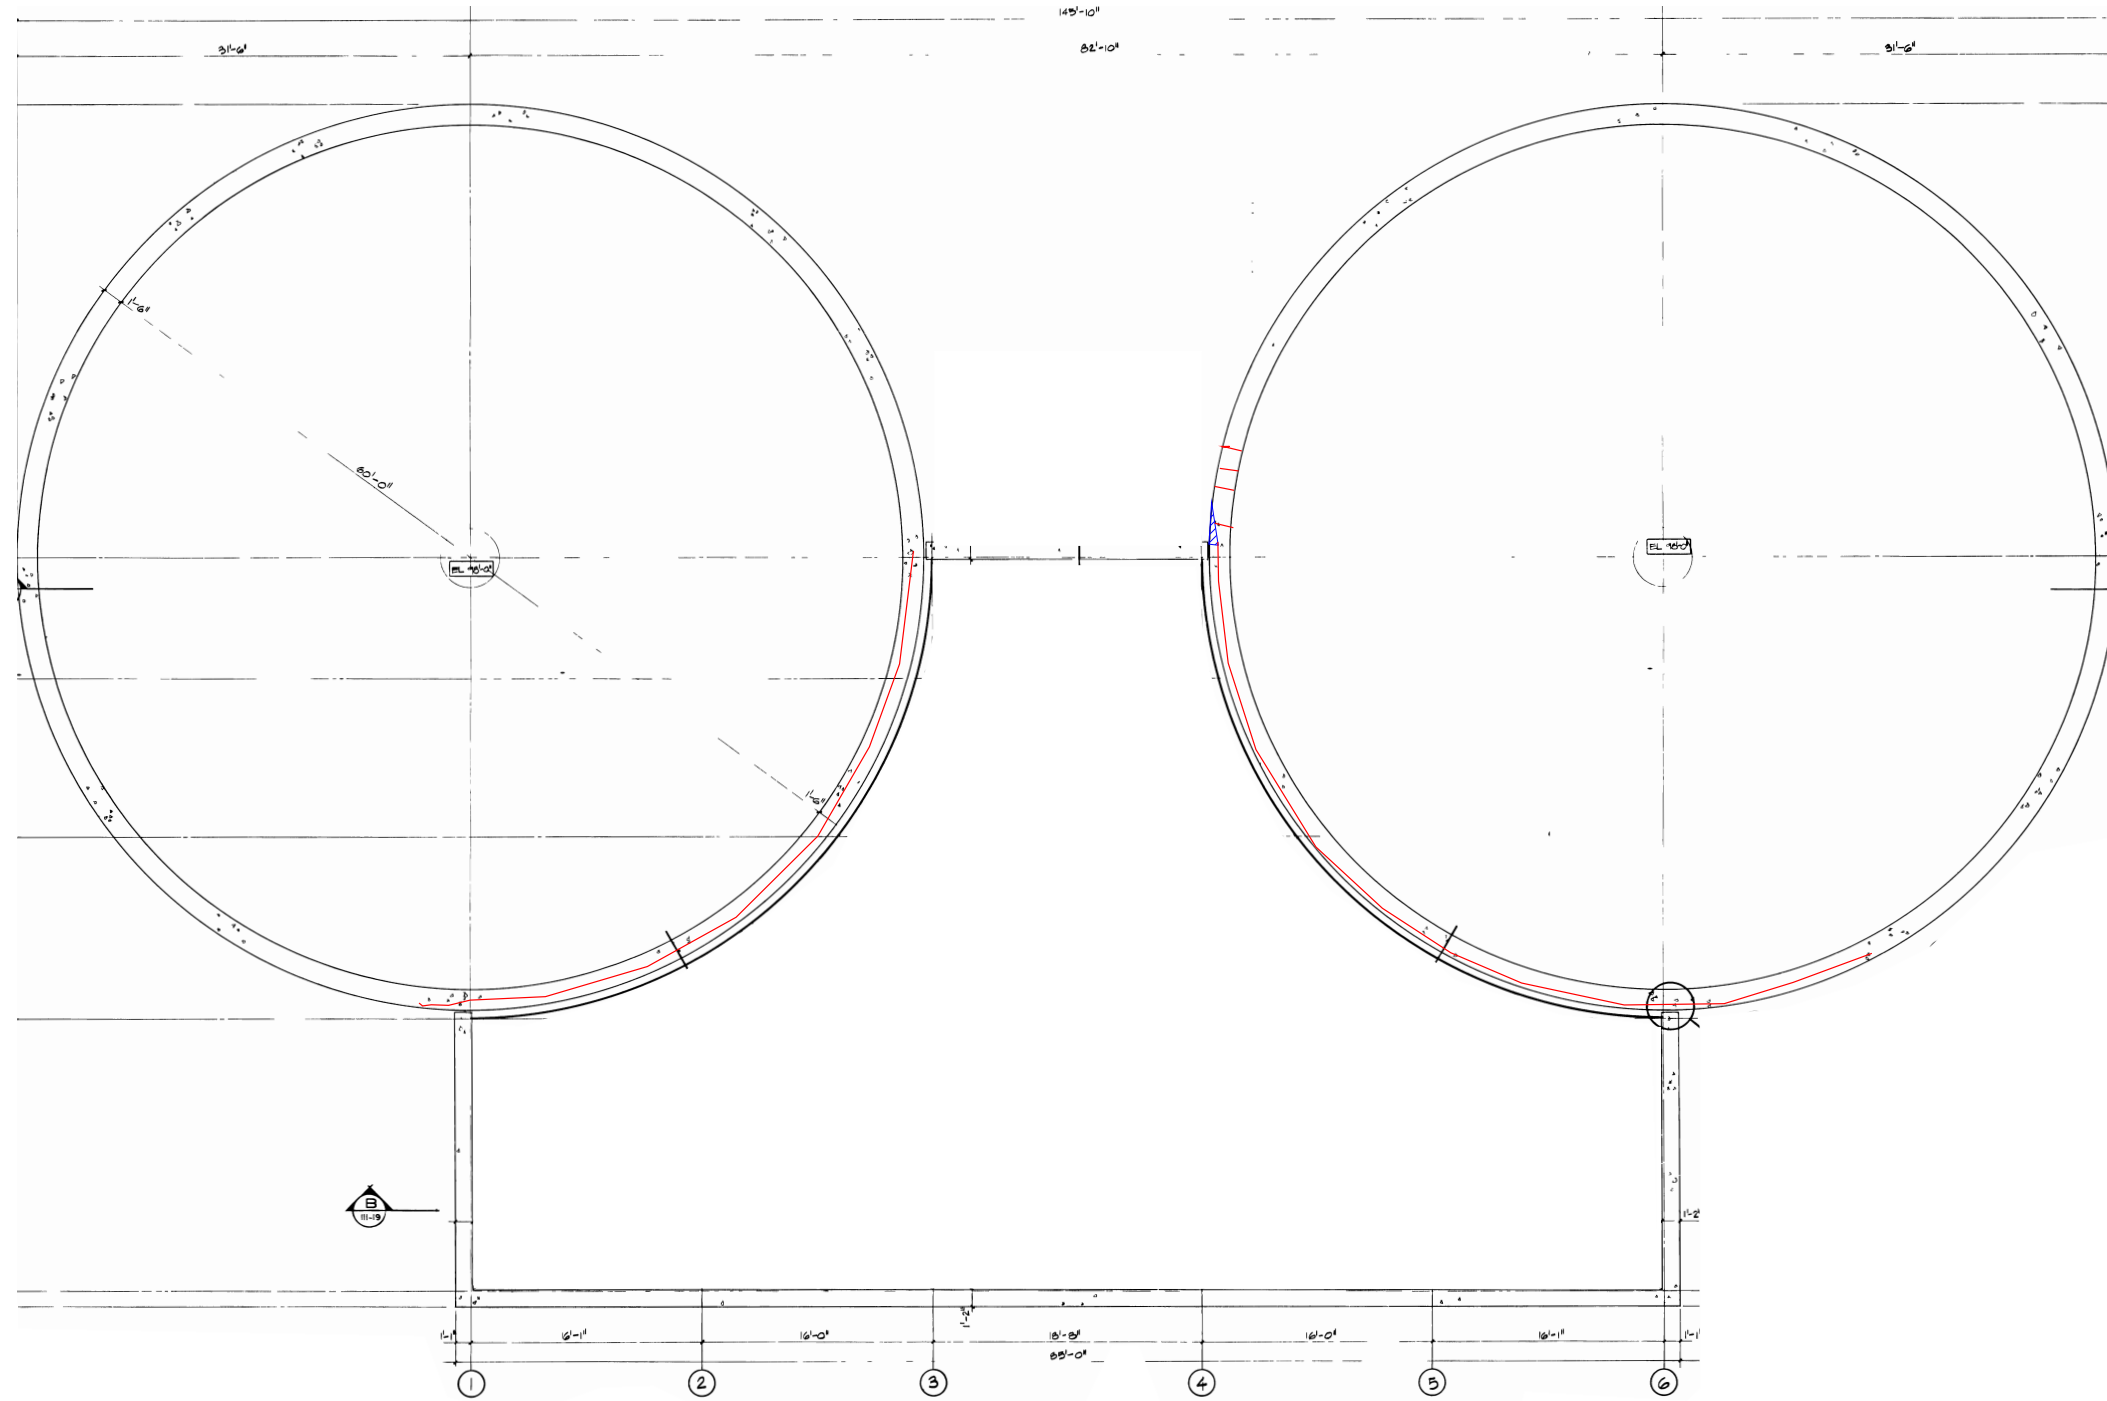
1 Digester Lids  
Scale: Dimensioned as Indicated on Drawing

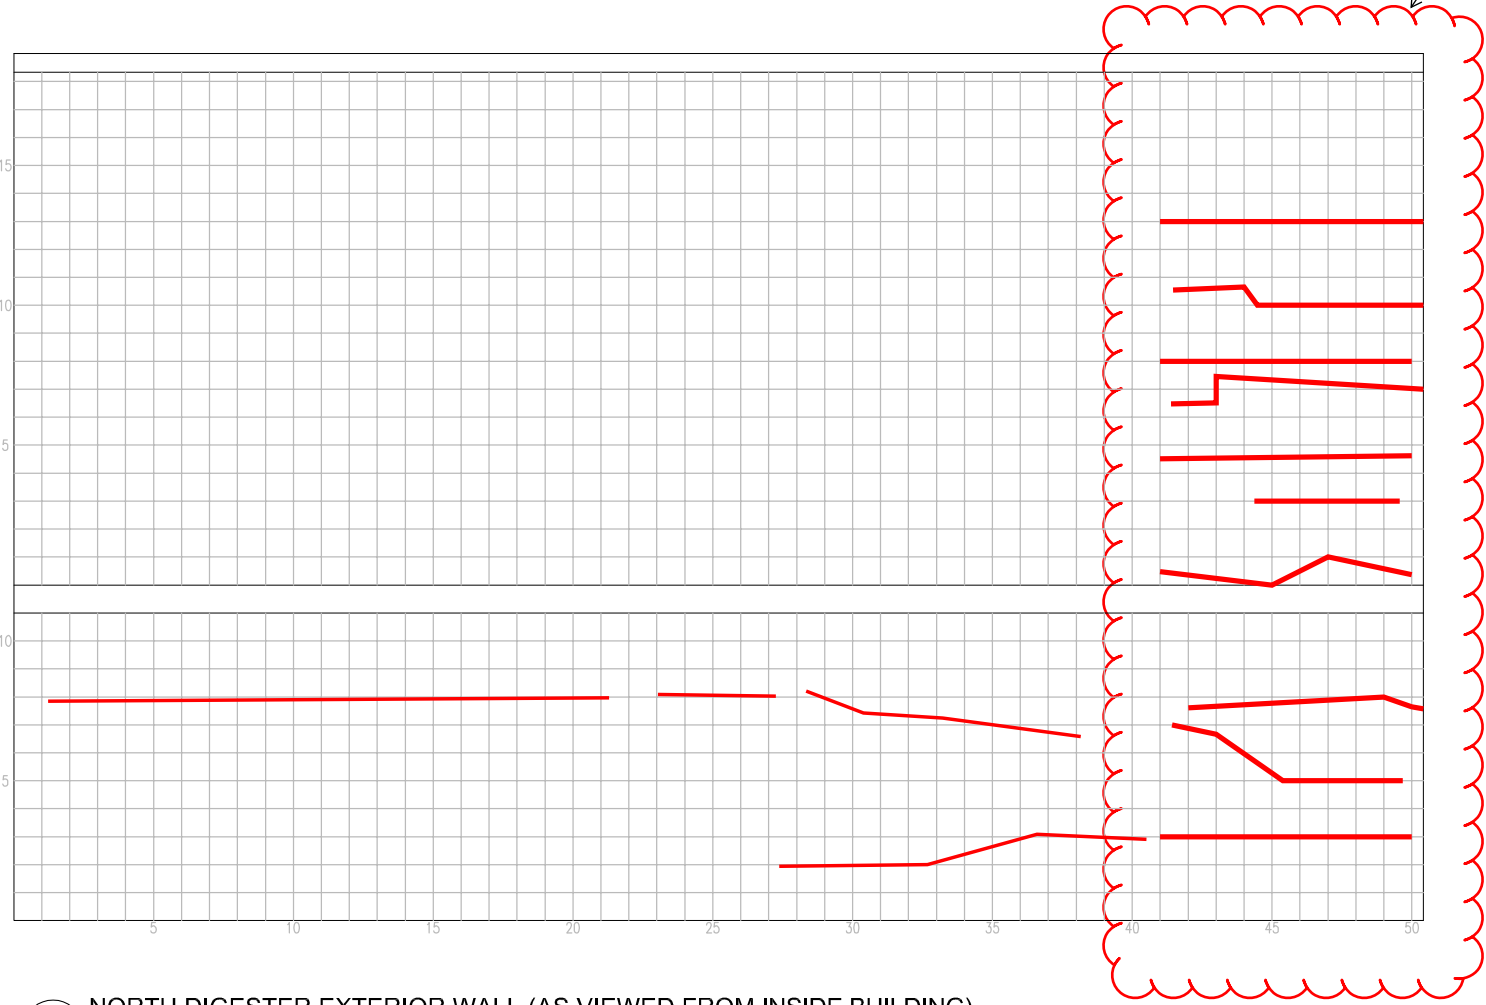
1 NORTH DIGESTER EXTERIOR WALL (AS VIEWED FROM INSIDE BUILDING)  
Scale: 1/4" = 1' Dimensioned as Indicated on Drawing

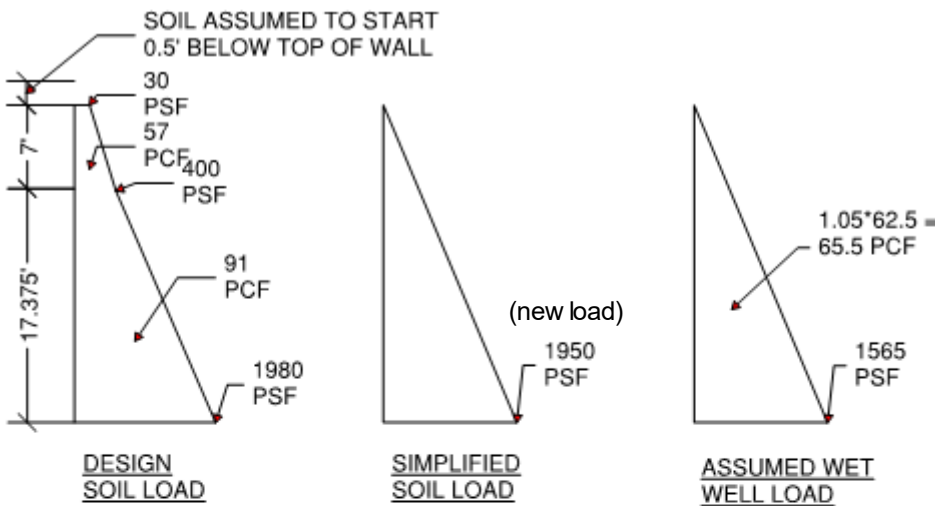
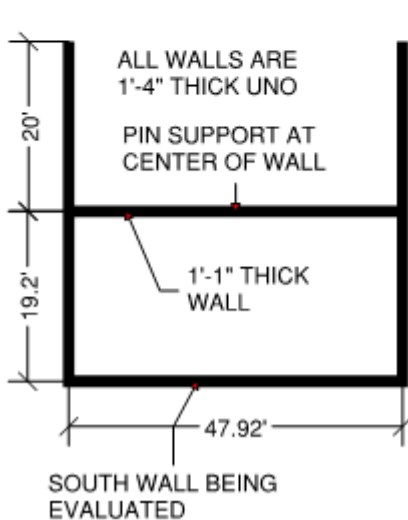
(original loading approximately 0.77 times new)

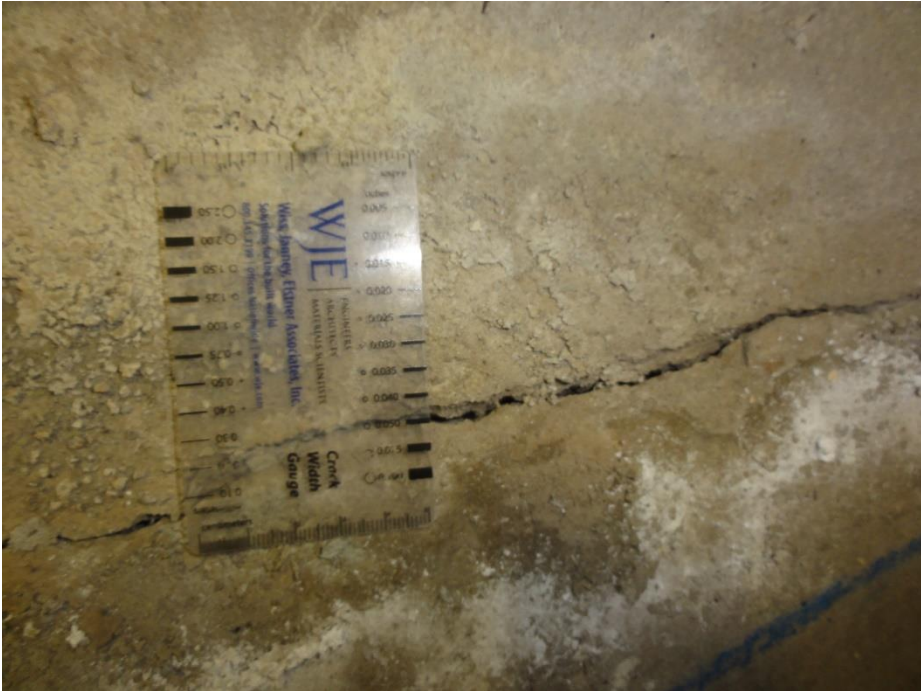
*Figure 2. Measurement of a crack at the topping slab.*

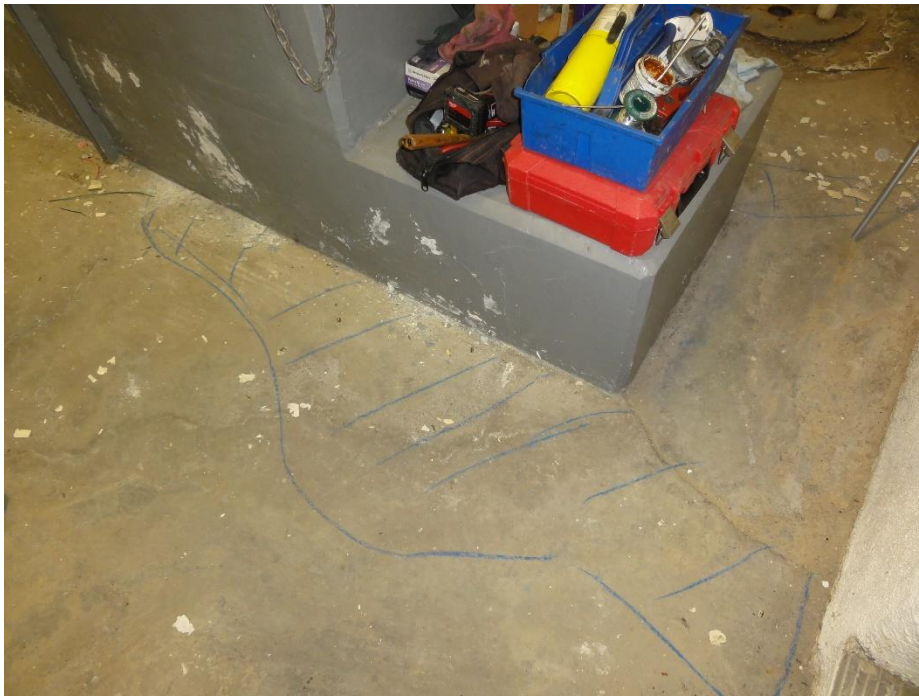
*Figure 3. Noted delamination, adjacent to a pipe support pedestal, highlighted in blue*

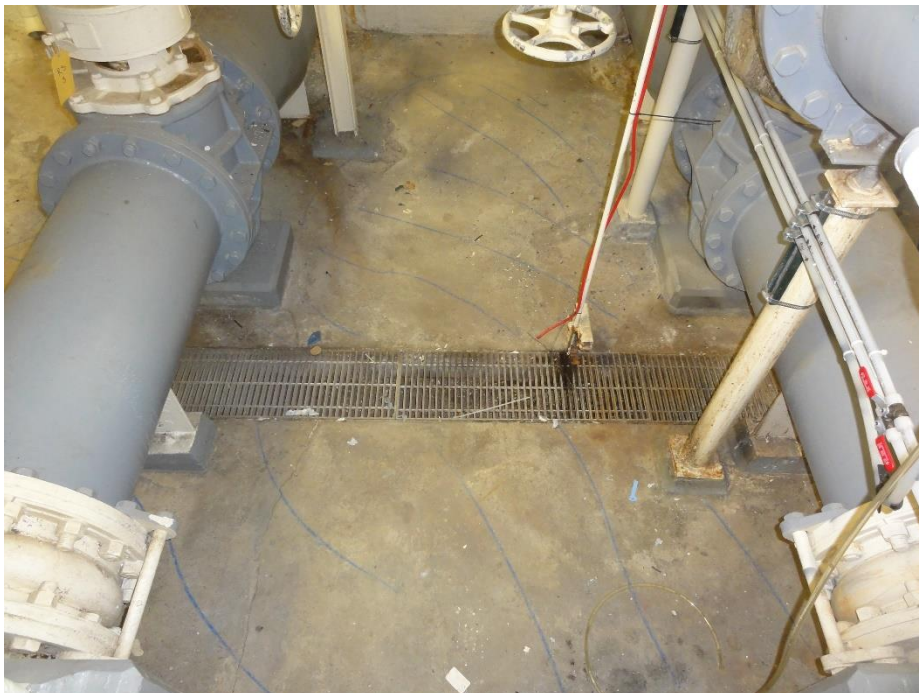
*Figure 4. Noted delamination, adjacent to the central trench drain, highlighted in blue*

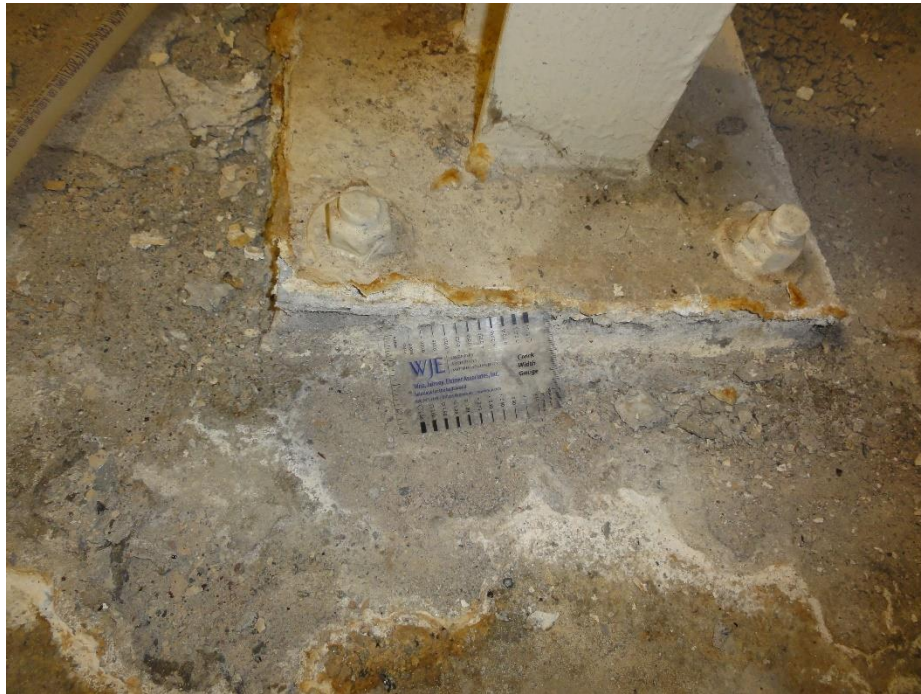
*Figure 5. Observed paste erosion at piping element support*

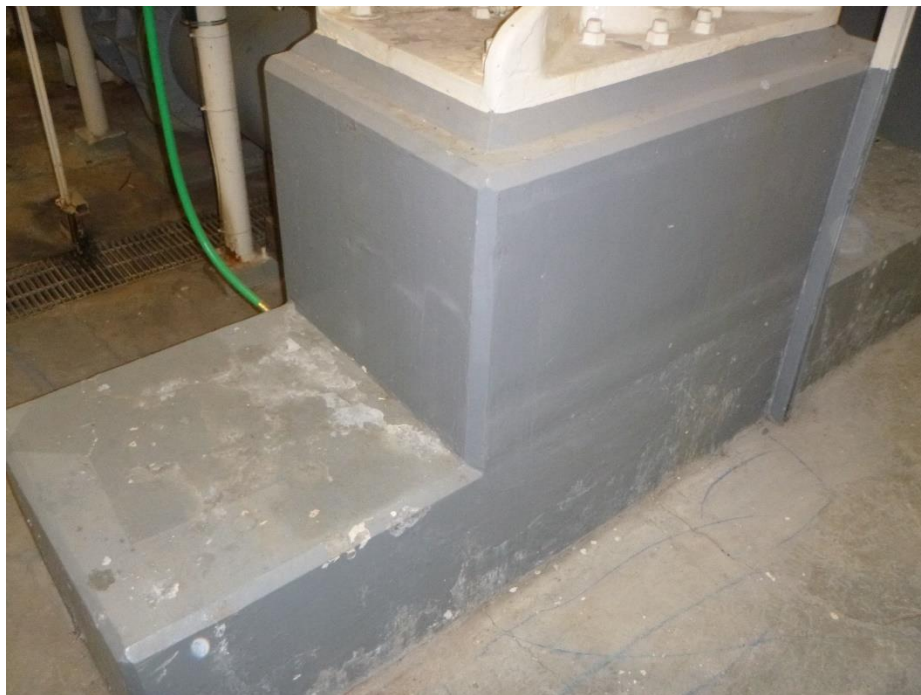
*Figure 6. Typical concrete support pedestal*

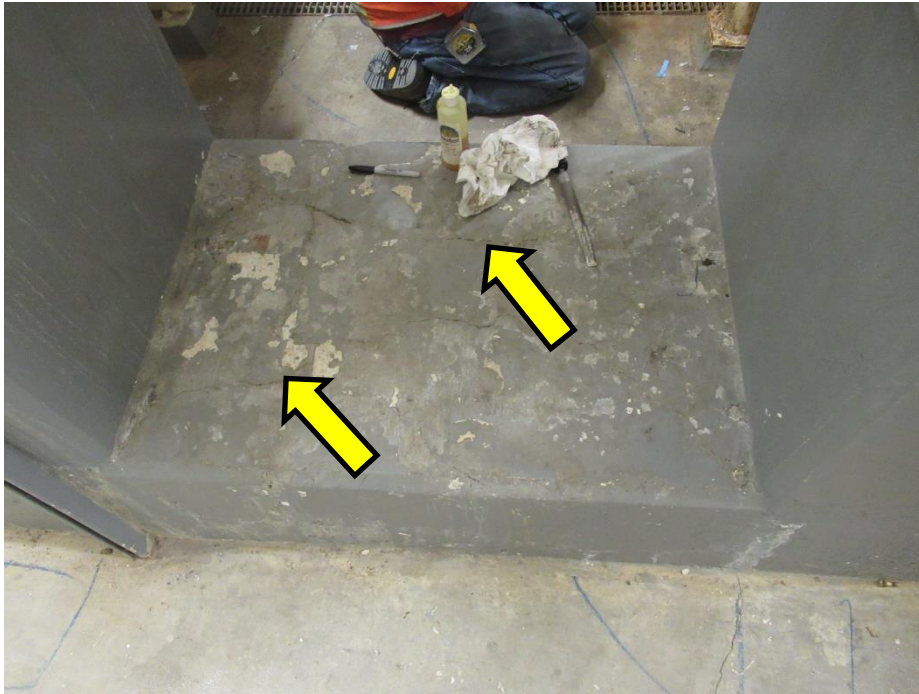
*Figure 7. Noted cracking on topside of support pedestal*
