**APPENDIX A. GEOTECHNICAL INVESTIGATION**

## PERSIGO WASTEWATER TREATMENT PLANT Geotechnical Investigation

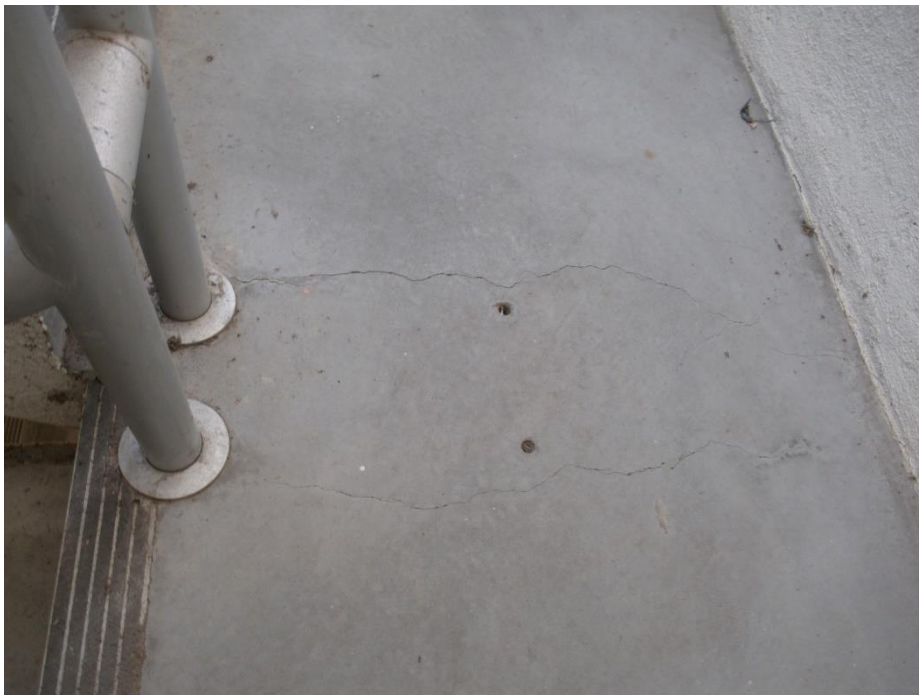
*Figure 8. Isolated stair landing cracks*

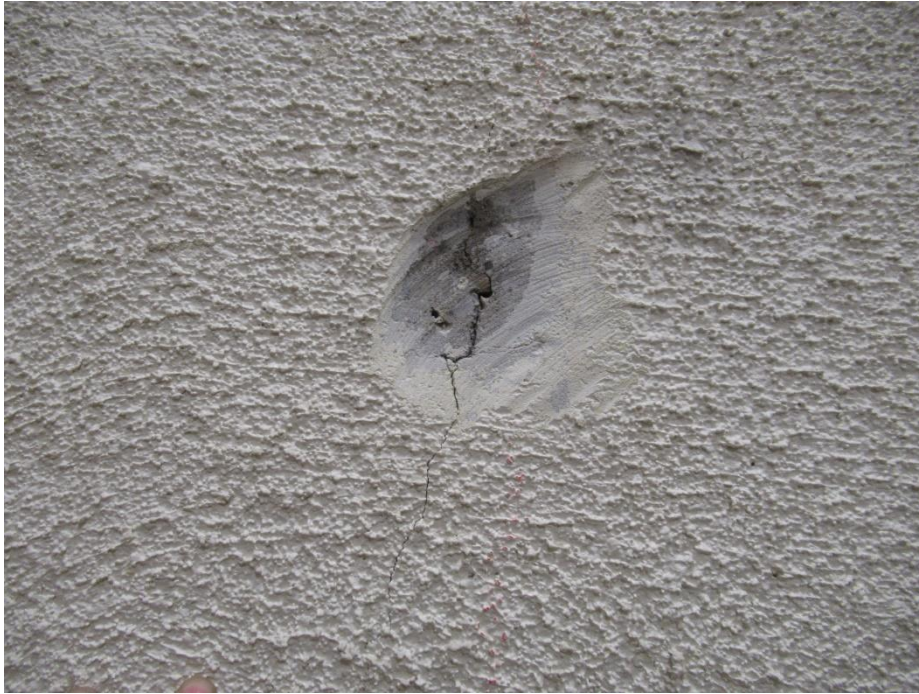
*Figure 9. Typical coating installation at interior wall surfaces, with crack highlighted where coating was removed.*

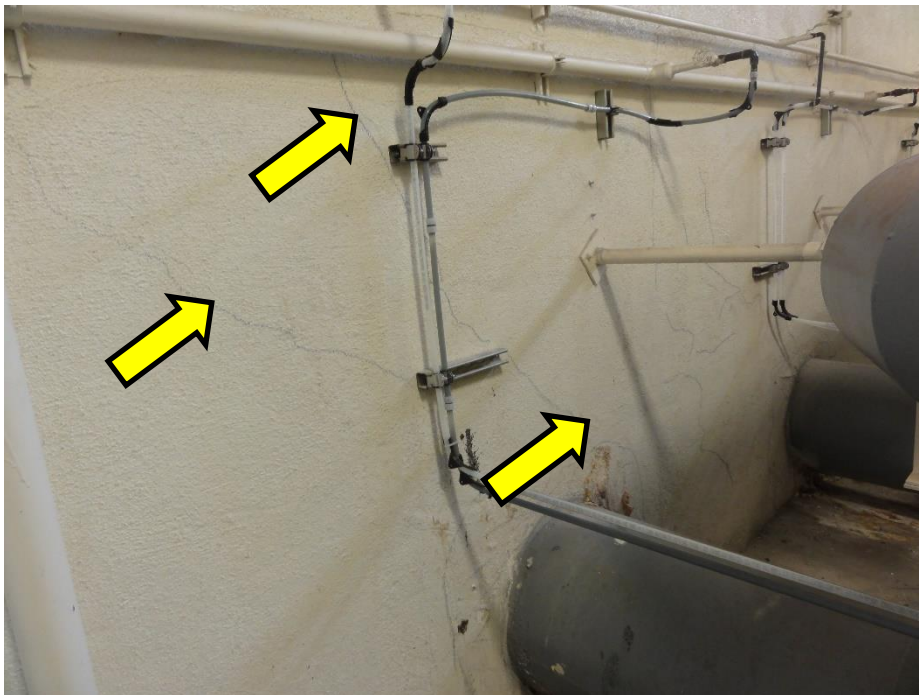
*Figure 10. Noted cracks at the pump room perimeter wall (demising wall between the pump room and the wet well), traced in blue*

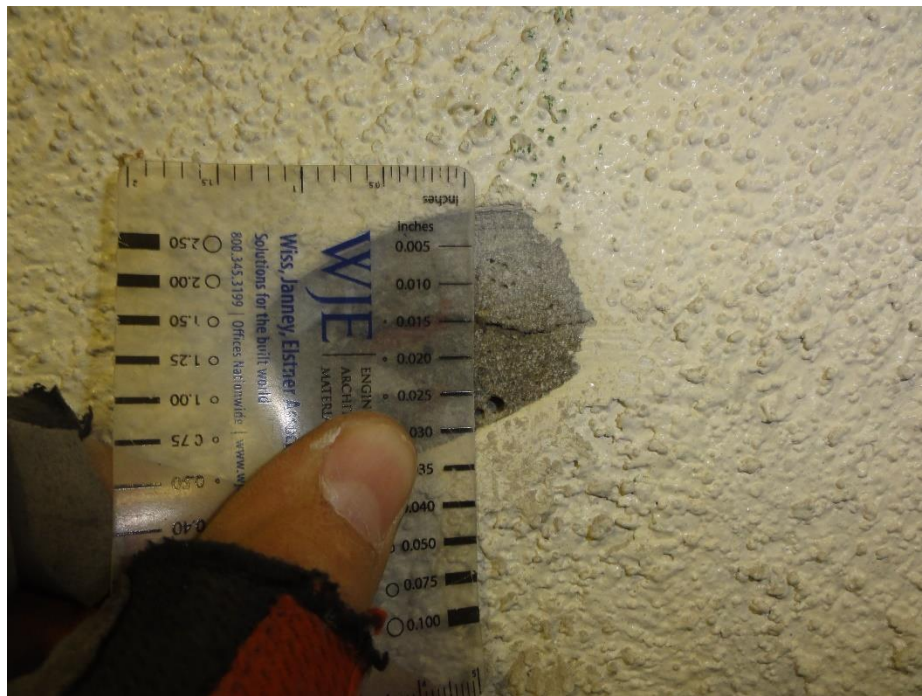
*Figure 11. 15 mil crack observed in concrete substrate, that had not yet propagated through the wall coating*

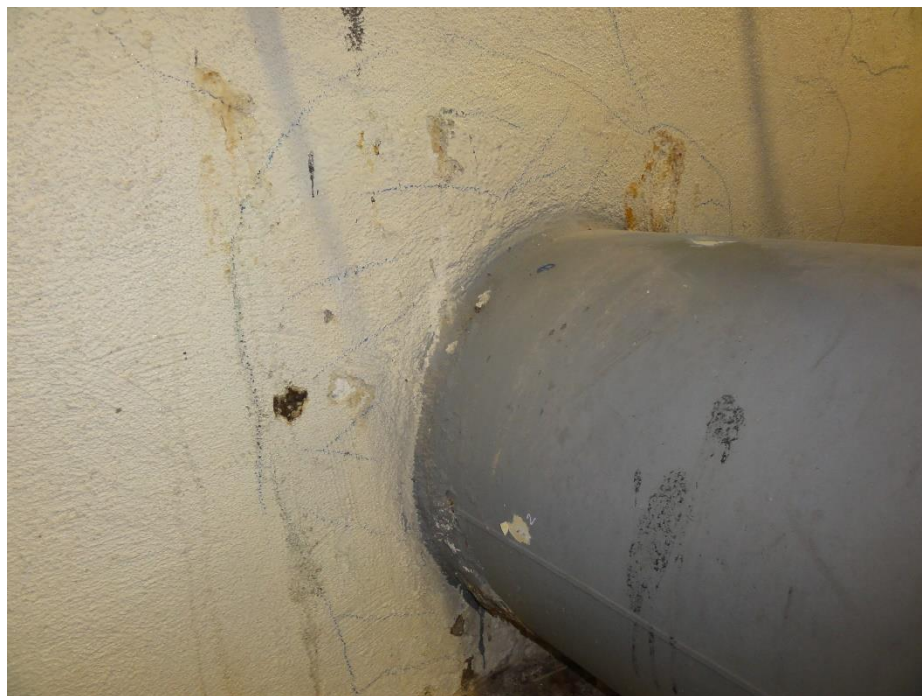
*Figure 12. Sounded coating delamination adjacent to inlet pipe, noted in blue*

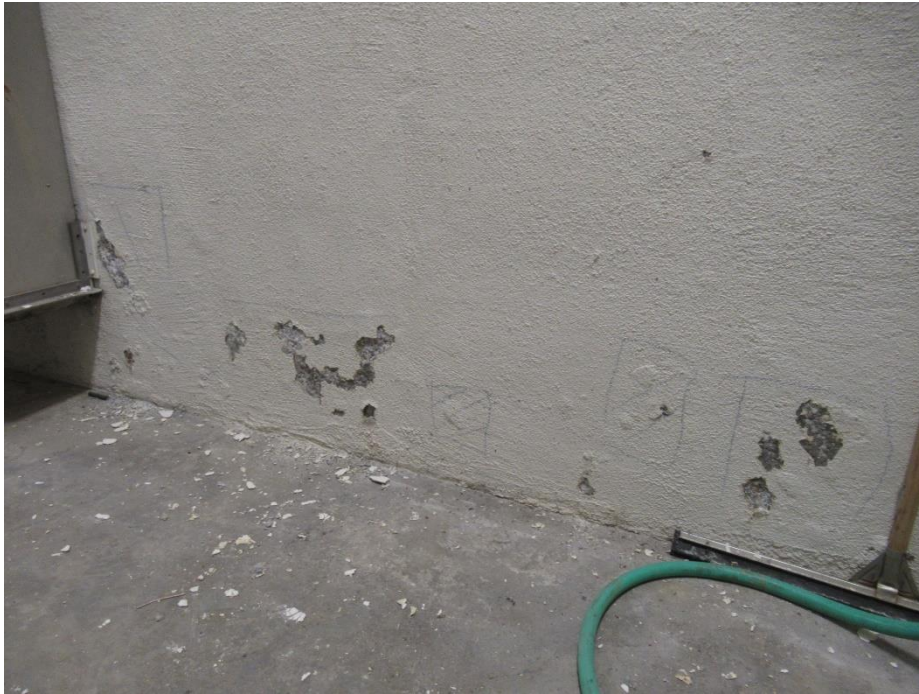
*Figure 13. Coating delaminations at the base of the interior walls, note also concrete surface distress where coating was removed*

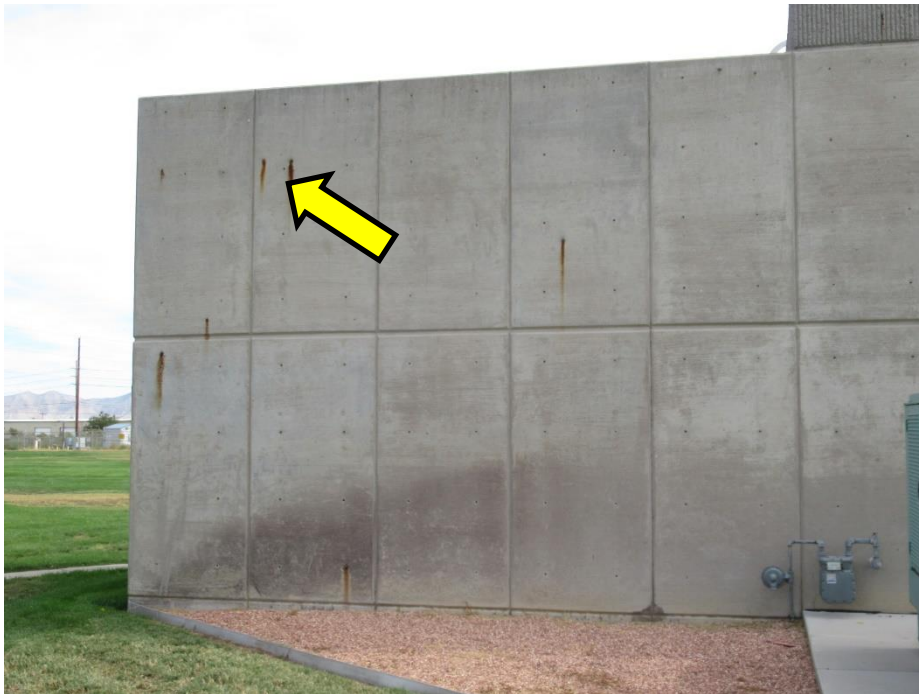
*Figure 15. Typical and isolated corrosion staining at aggregate particles*

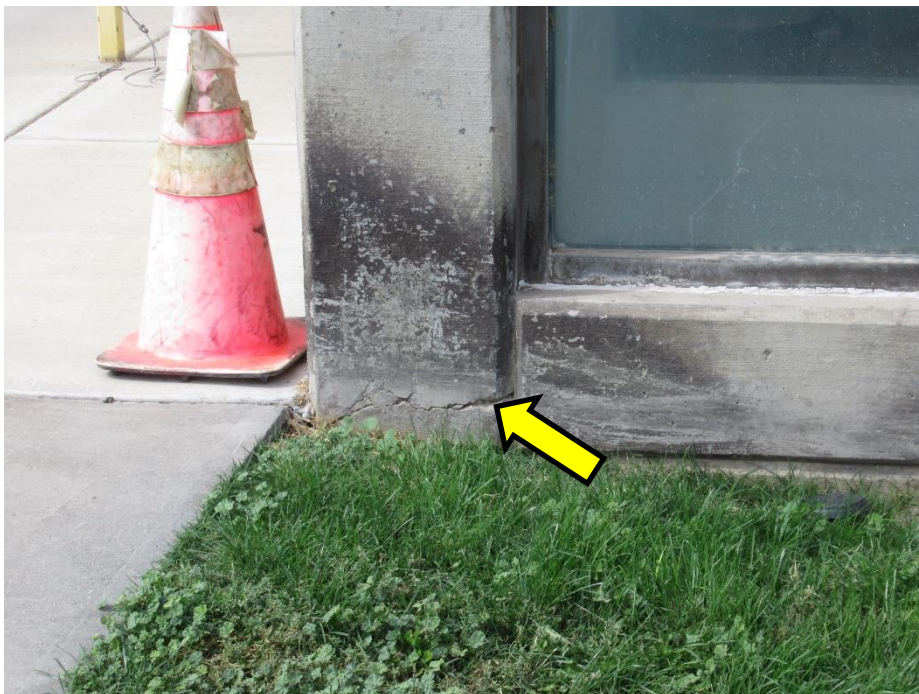
*Figure 16. Isolated cracking at base of wall location*

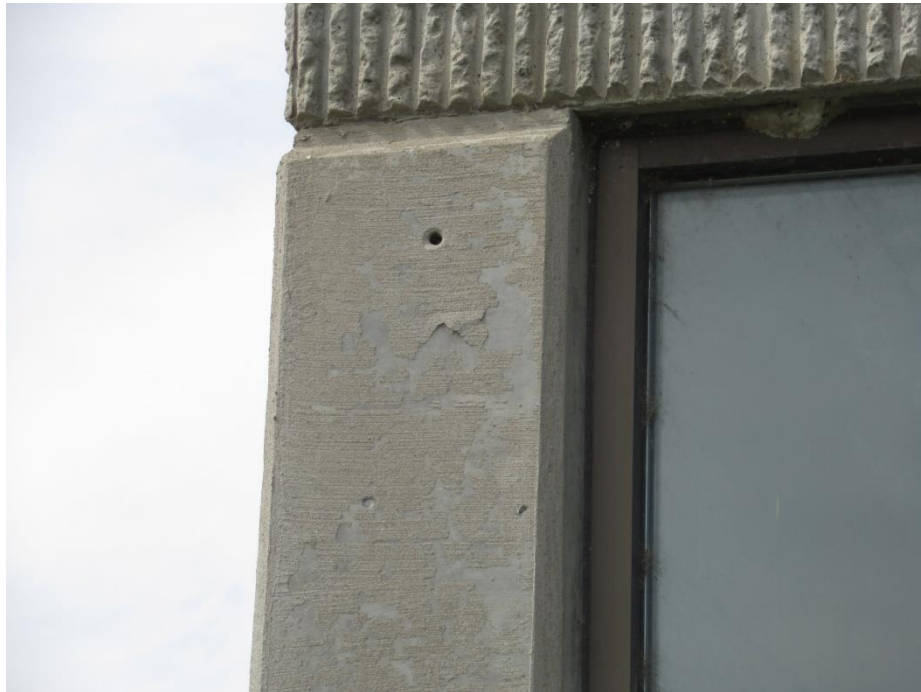
*Figure 17. Isolated flaking of surface applied skim coat*

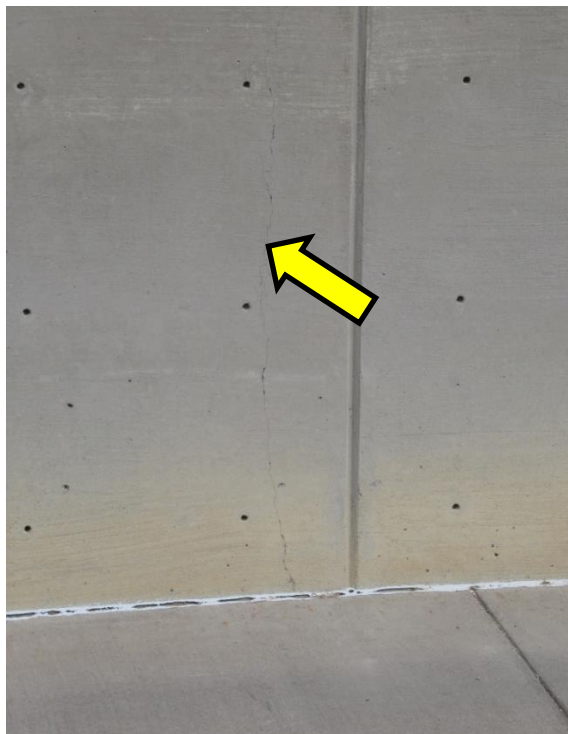
*Figure 18. Typical vertical cracking within field of the exterior wall*

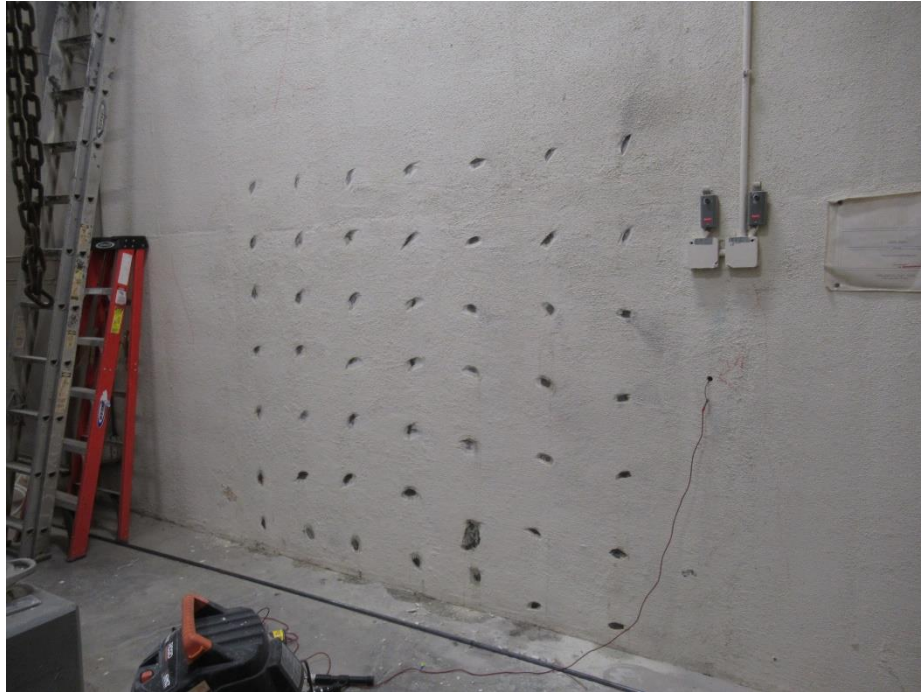
*Figure 19. Overall view of HCP testing at south elevation wall*

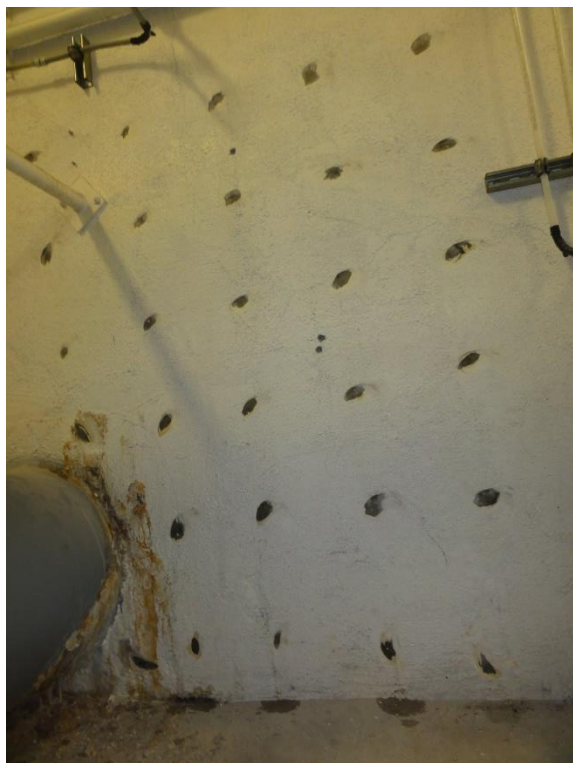
*Figure 20. Corrosion Potential measurements on south wall of raw sewage pump station*

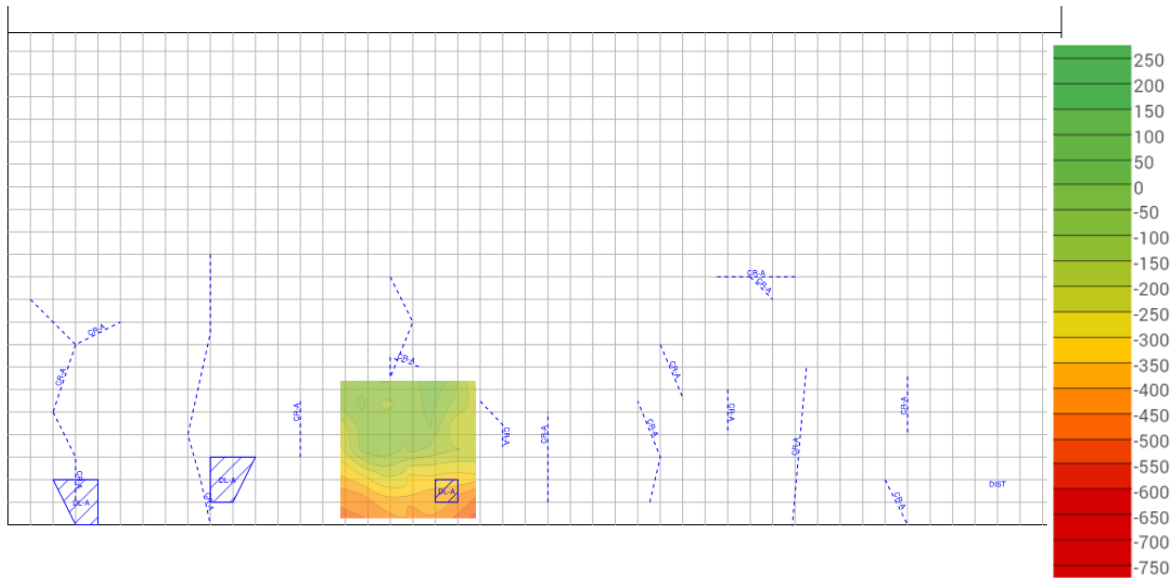
1 SOUTH WALL INTERIOR ELEVATION  
Scale: 3/8" = 1'-0"

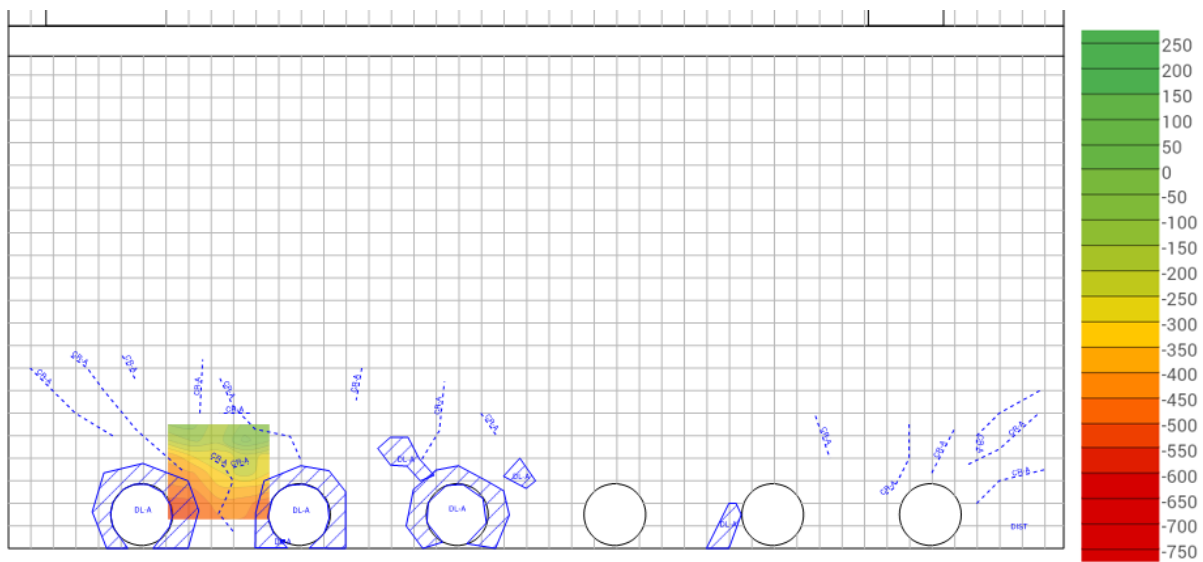
1 NORTH WALL INTERIOR ELEVATION  
Scale: 3/8" = 1'-0"

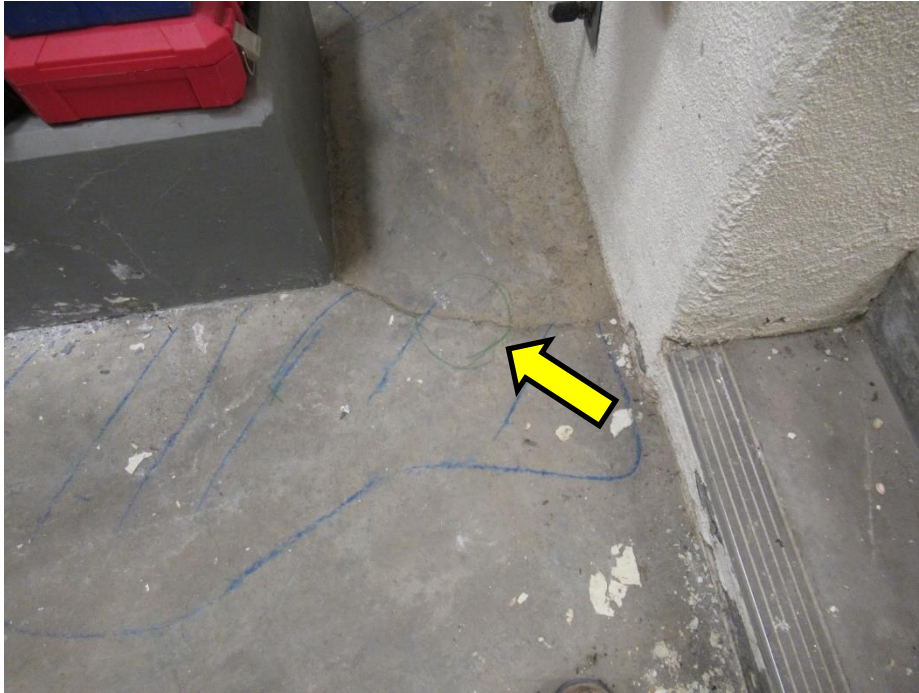
*Figure 23. Core location through topping slab crack*

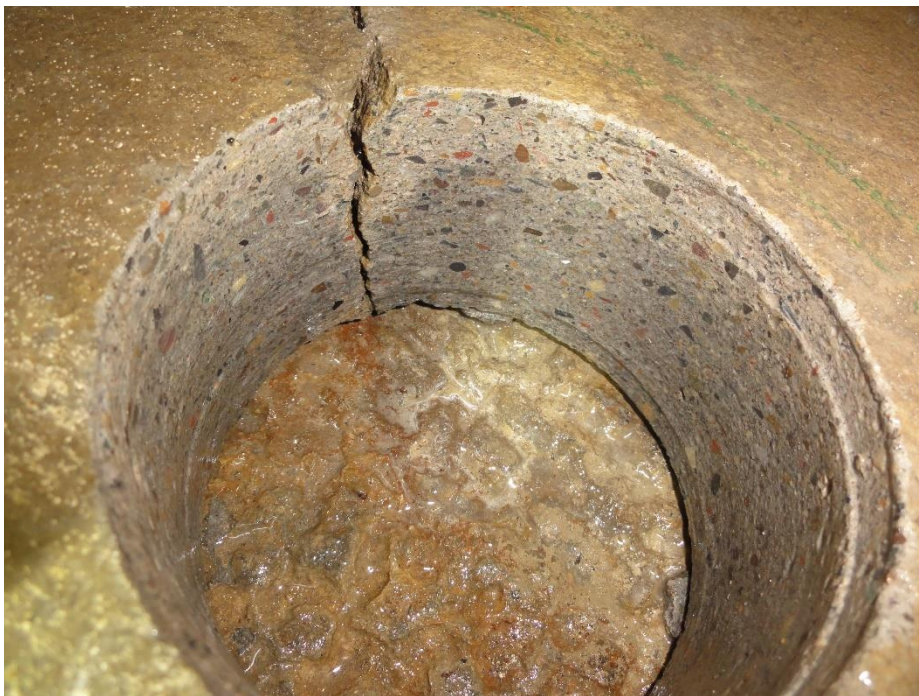
*Figure 24. Topside of structural slab present after removal of topping slab. Note that the topping slab crack does not continue into the structural slab below.*

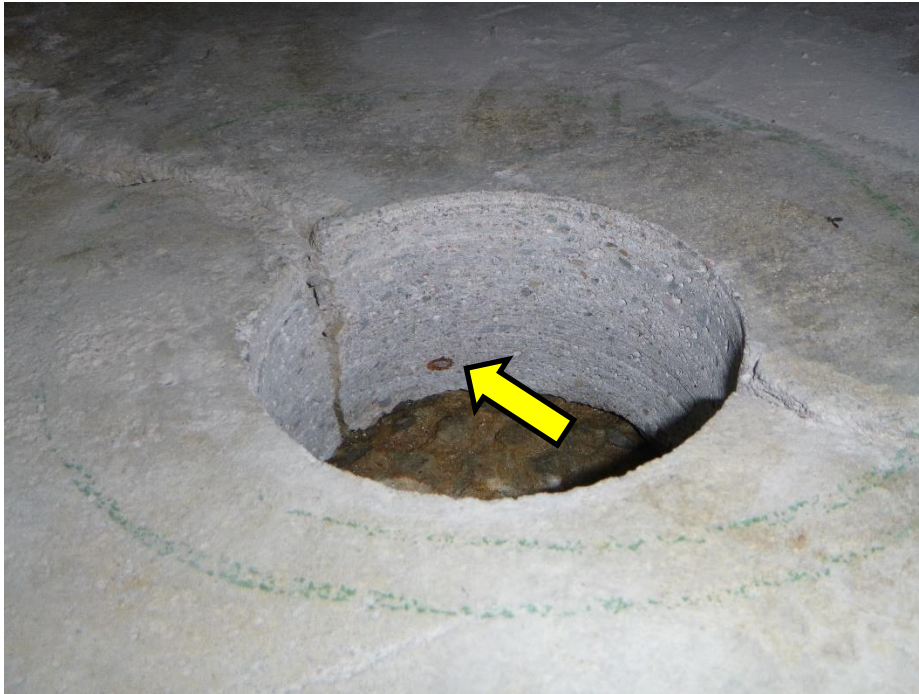
*Figure 25. WWR observed near the bottom surface of the extracted core*

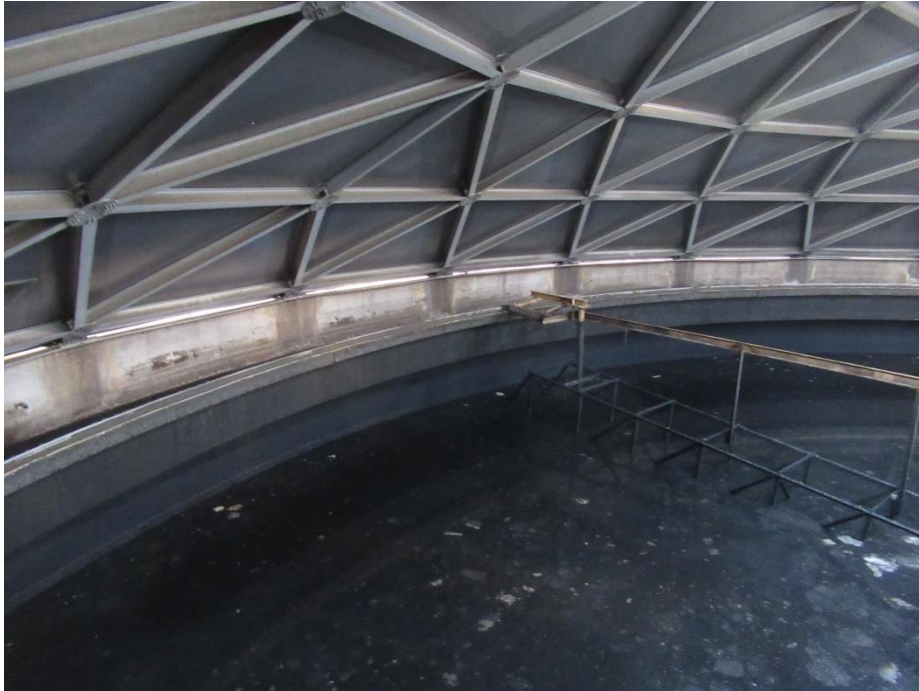
*Figure 26. Overall view of the interior of the primary clarifier*

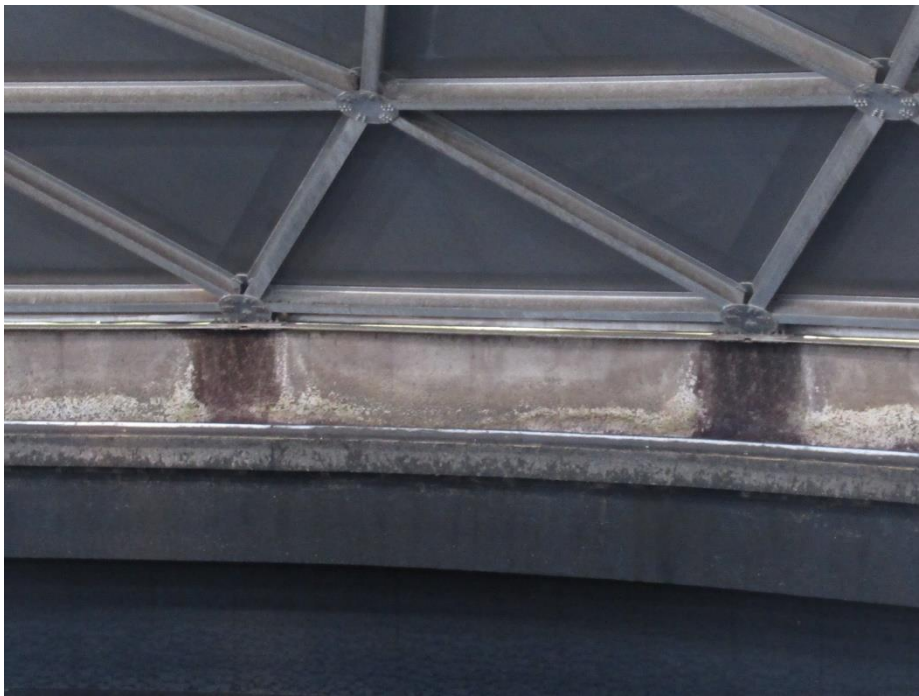
*Figure 27. Moisture staining present beneath roof attachment locations*

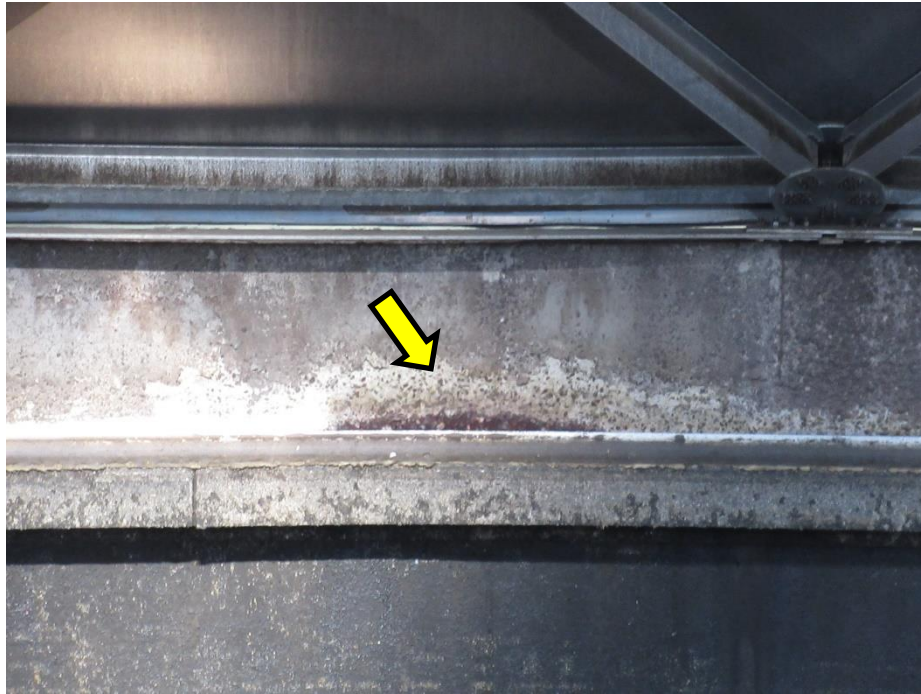
*Figure 28. Paste erosion within the effluent trough*

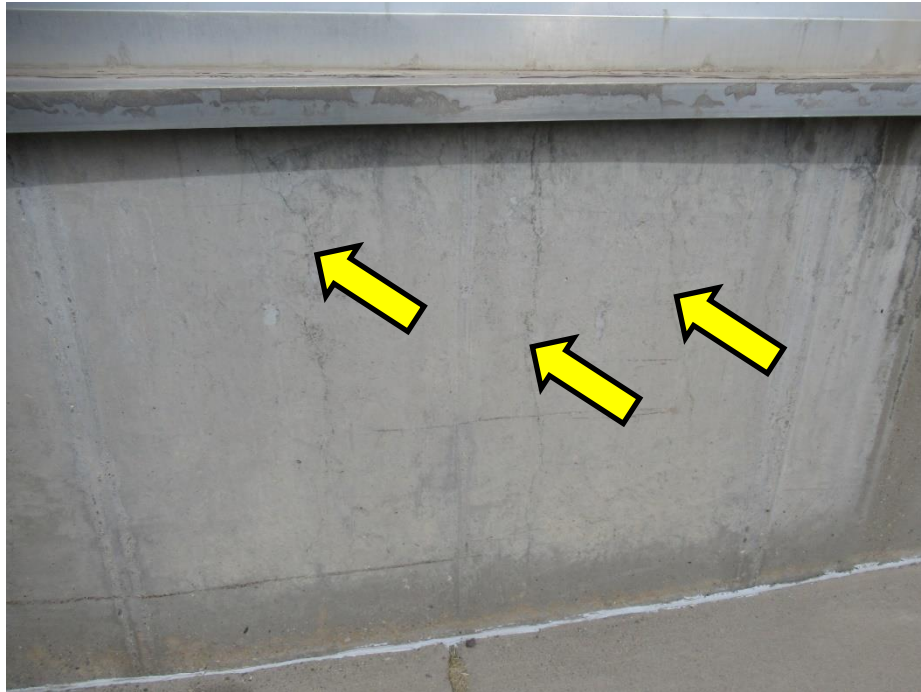
*Figure 30. Transverse cracking at exterior of clarifier walls*

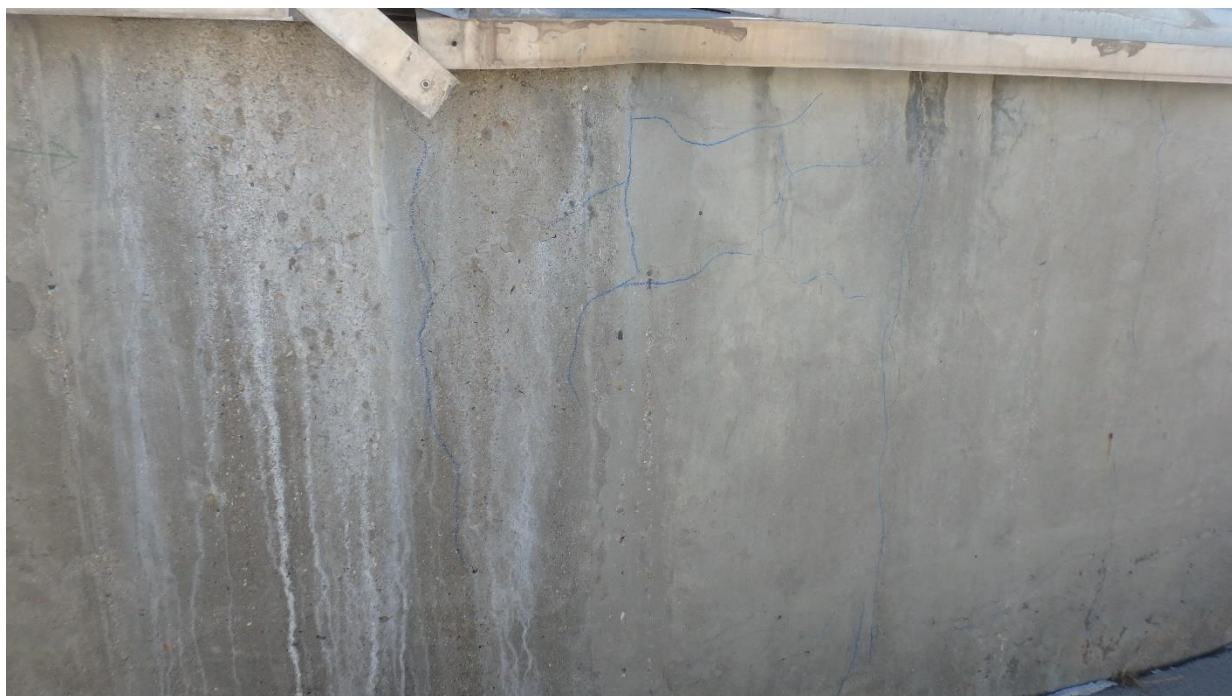
*Figure 31. Map patterned cracking at exterior of clarifier walls*

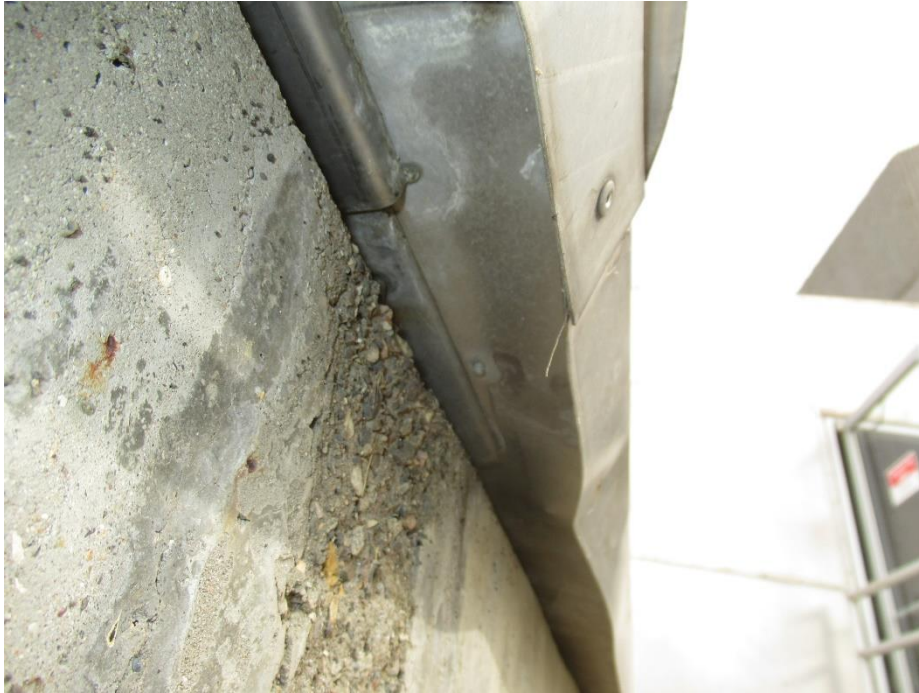
*Figure 32. Underside of roof attachment, with a 1-inch wide gap between the roof framing and the top surface of the clarifier walls*

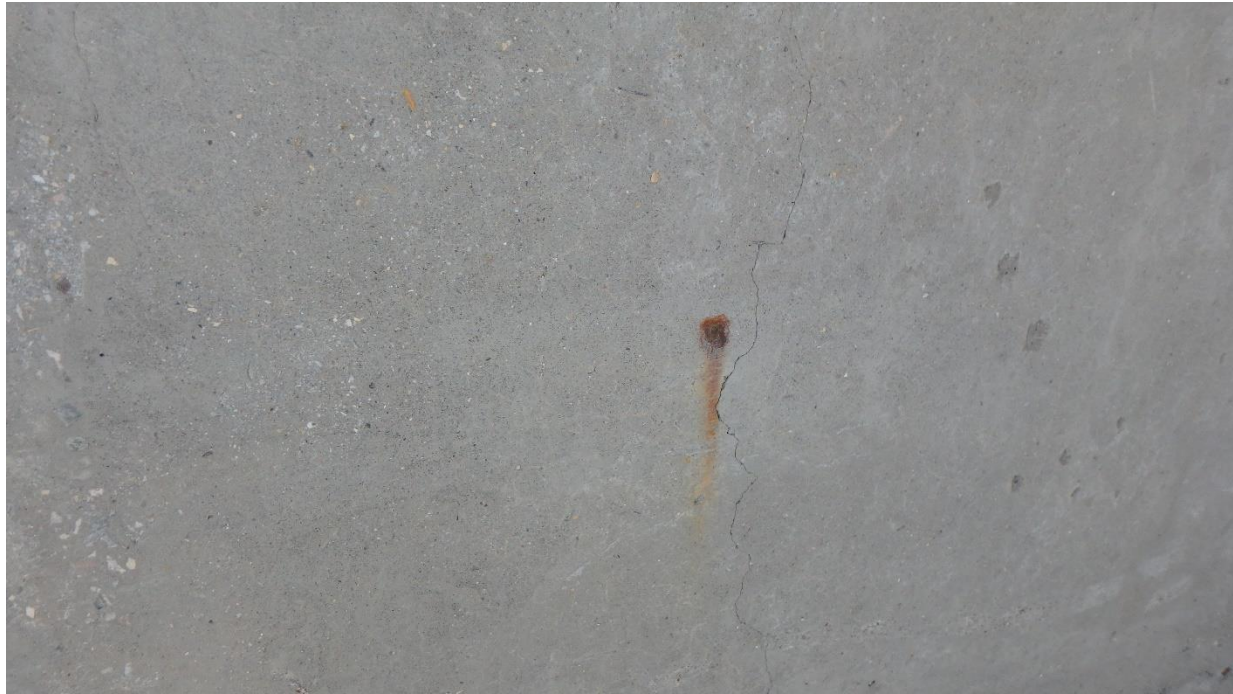
*Figure 34. Typical and isolated corrosion staining at aggregate particles*

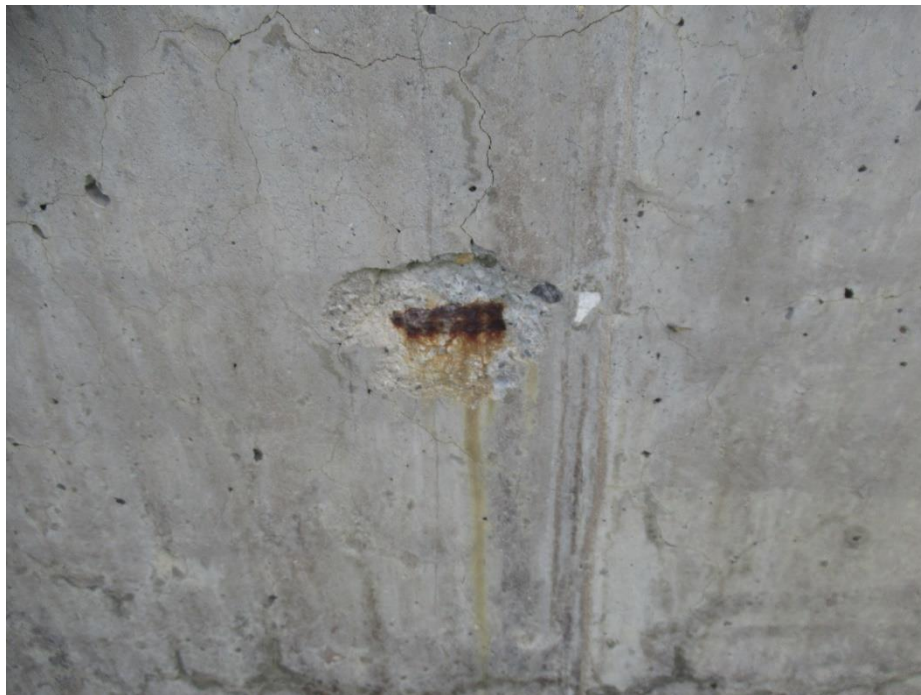
*Figure 35. Isolated exposed and corroded reinforcing bar*

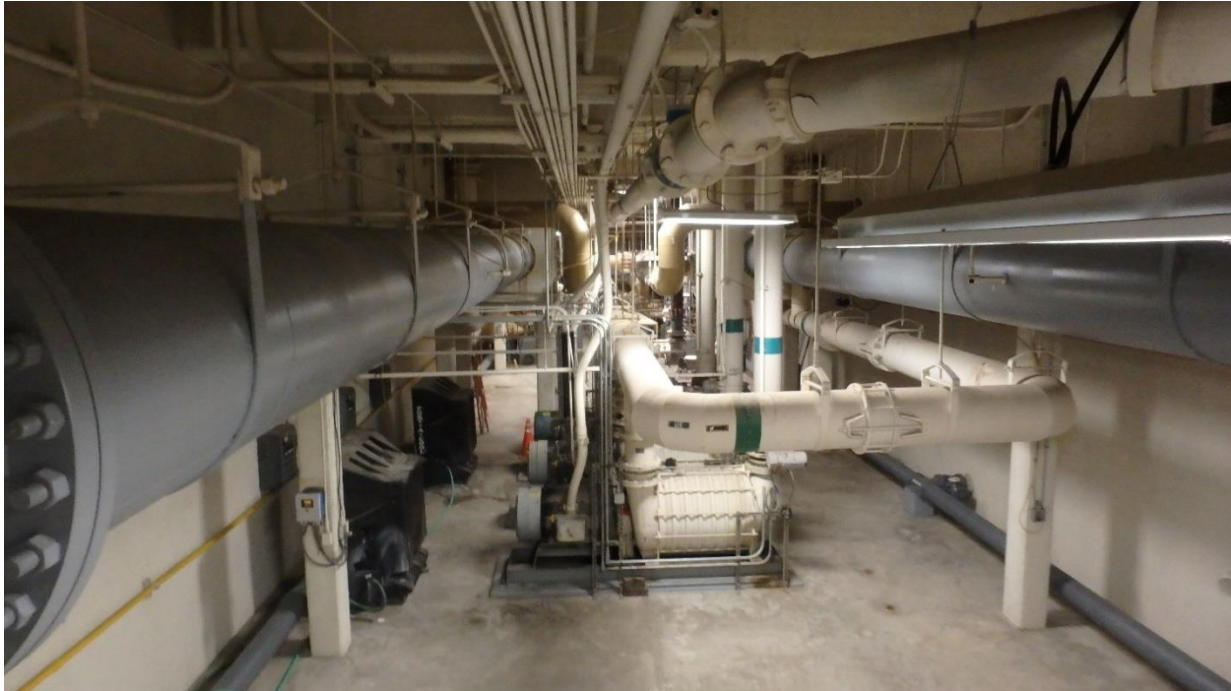
*Figure 36. Overall view of the blower room, looking south*

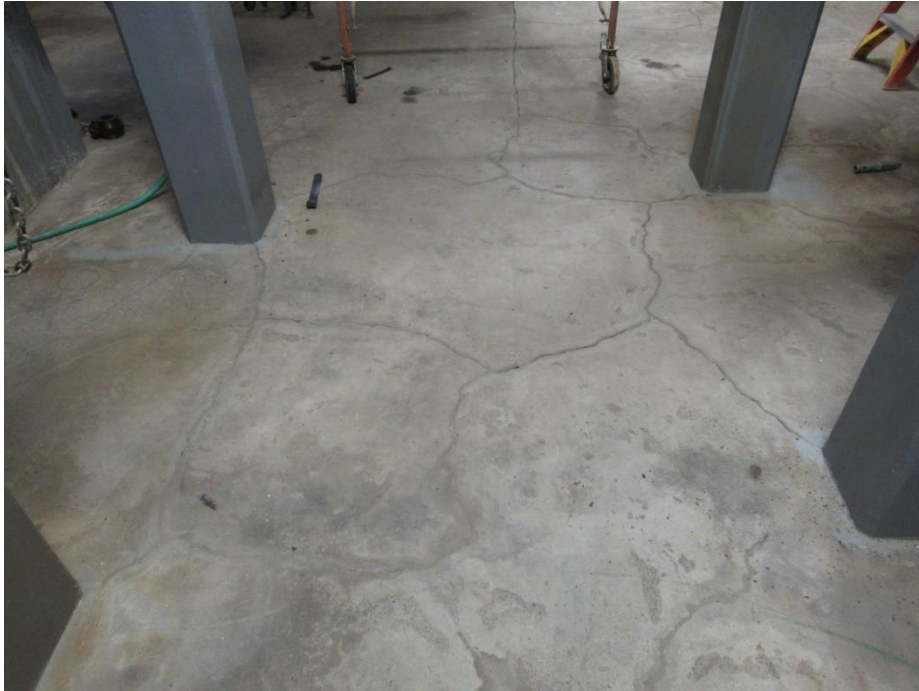
*Figure 38. Typical topping slab cracking*

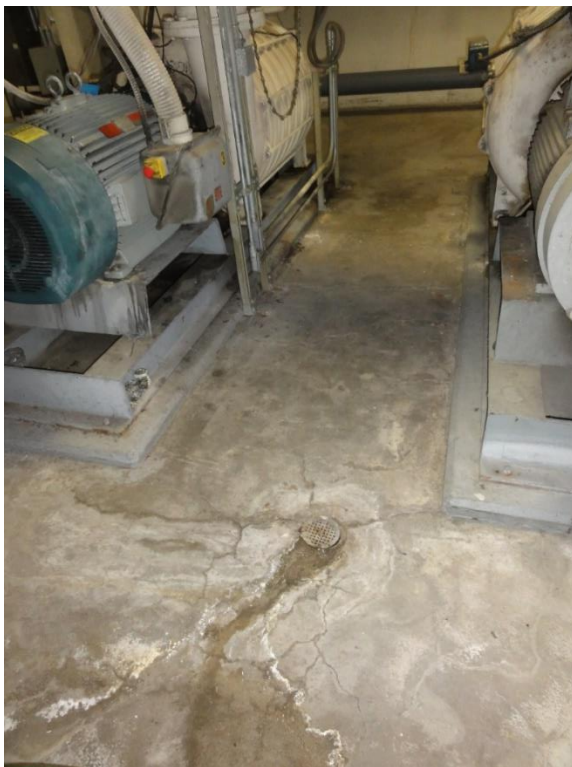
*Figure 39. Evidence of ponding water at existing floor drain*

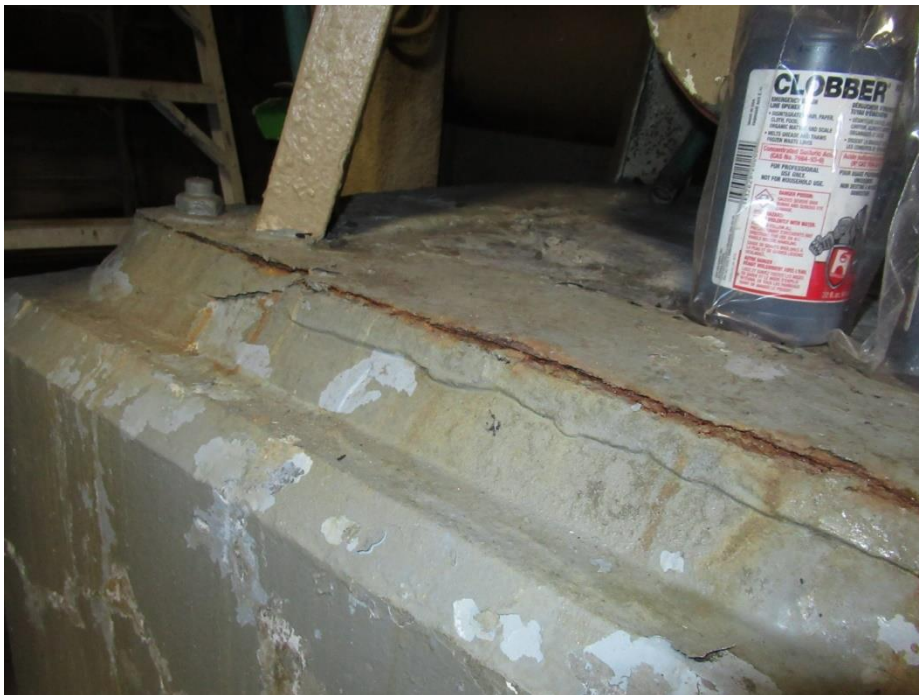
*Figure 41. Isolated corrosion on pipe support pedestal framing plate*

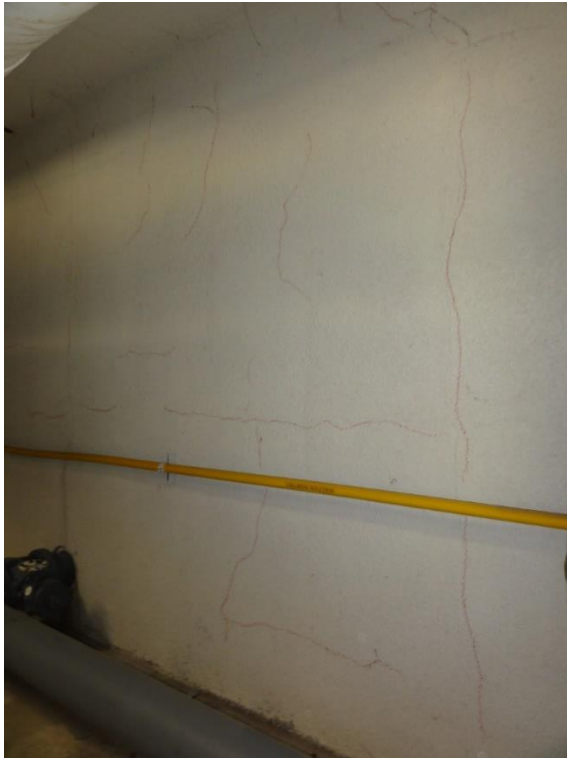
*Figure 42. Interior cracking, observed on the north elevation foundation wall (traced in red)*

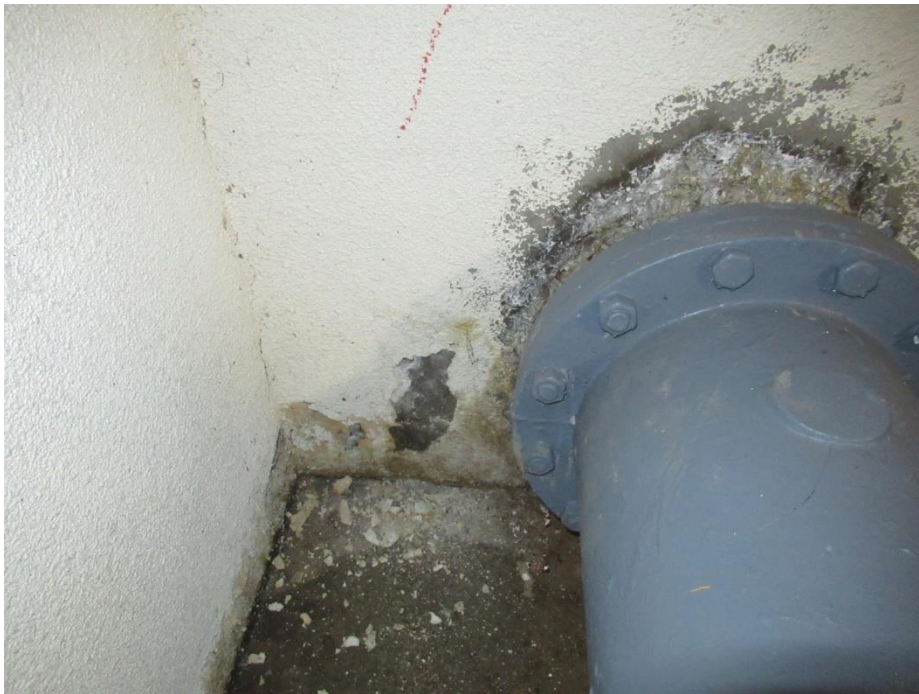
*Figure 43. Sounded delaminated coating adjacent to piping element at the north elevation wall*

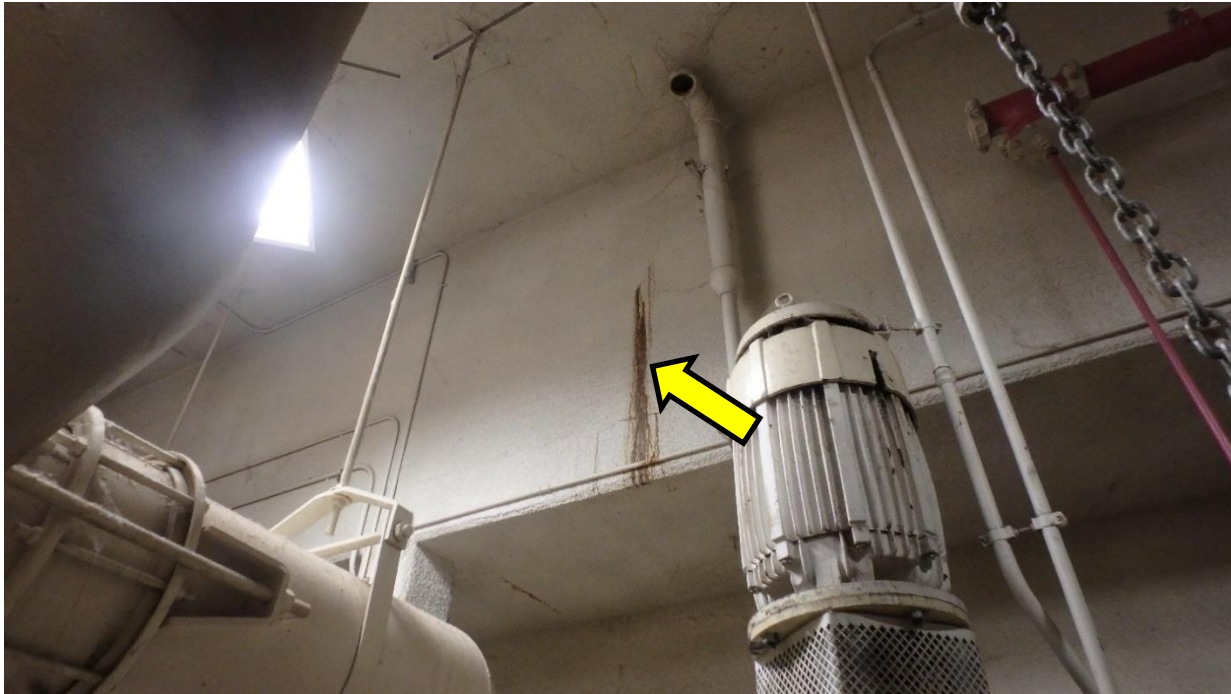
*Figure 44. Staining at elevated trough*

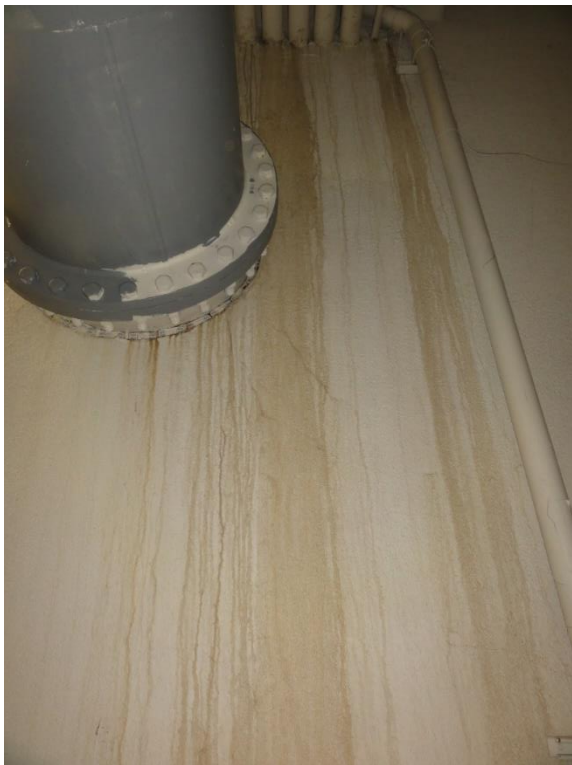
*Figure 45. Staining below through-wall penetrations at the north elevation foundation wall*

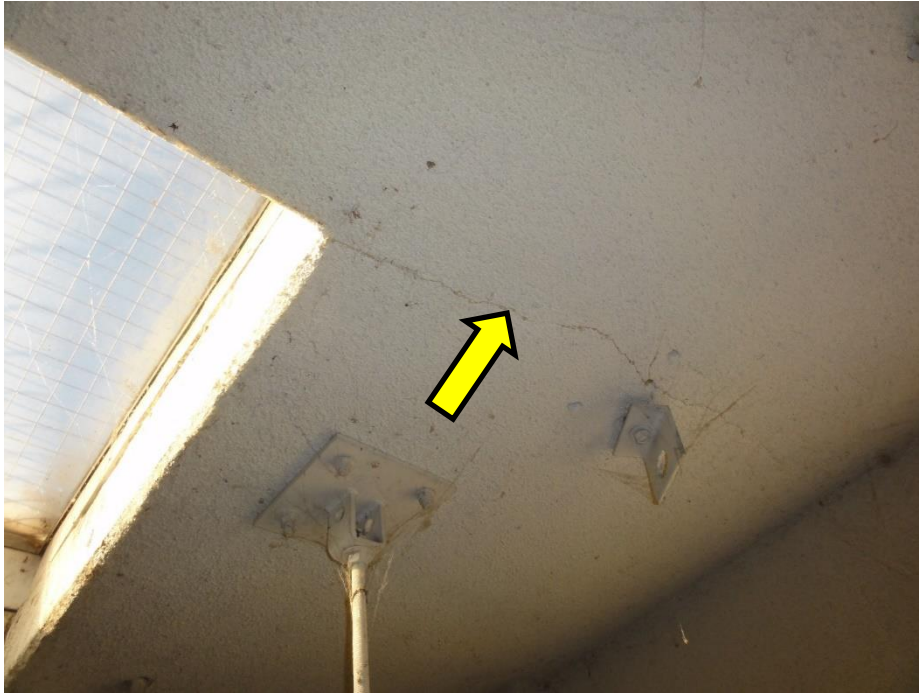
*Figure 46. Re-entrant corner cracking at blower room skylight, as observed on the soffit of the ground floor slab*

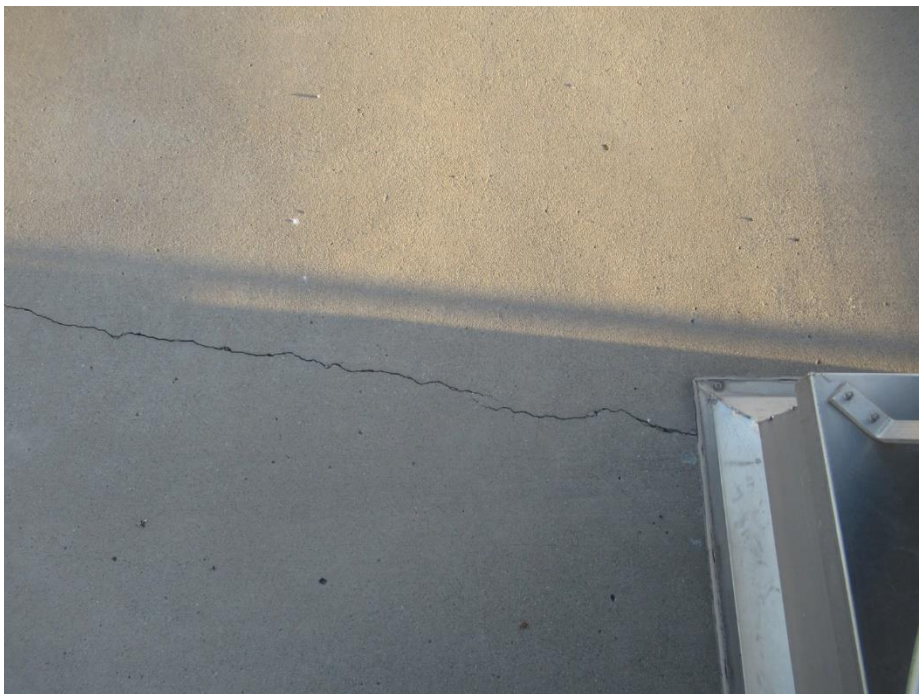
*Figure 47. Re-entrant corner cracking at blower room skylight, as observed on the top surface of the ground floor slab*
