**APPENDIX A. GEOTECHNICAL INVESTIGATION**

## PERSIGO WASTEWATER TREATMENT PLANT Geotechnical Investigation

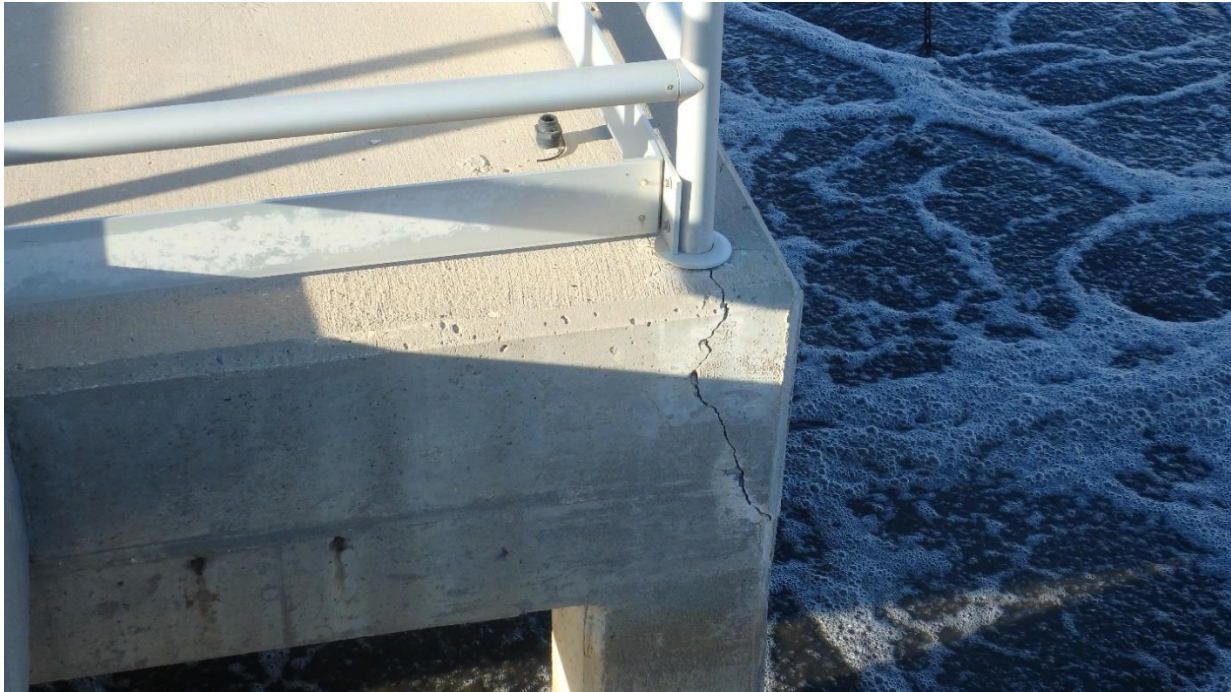
*Figure 48. Incipient spall at guardrail post embed*

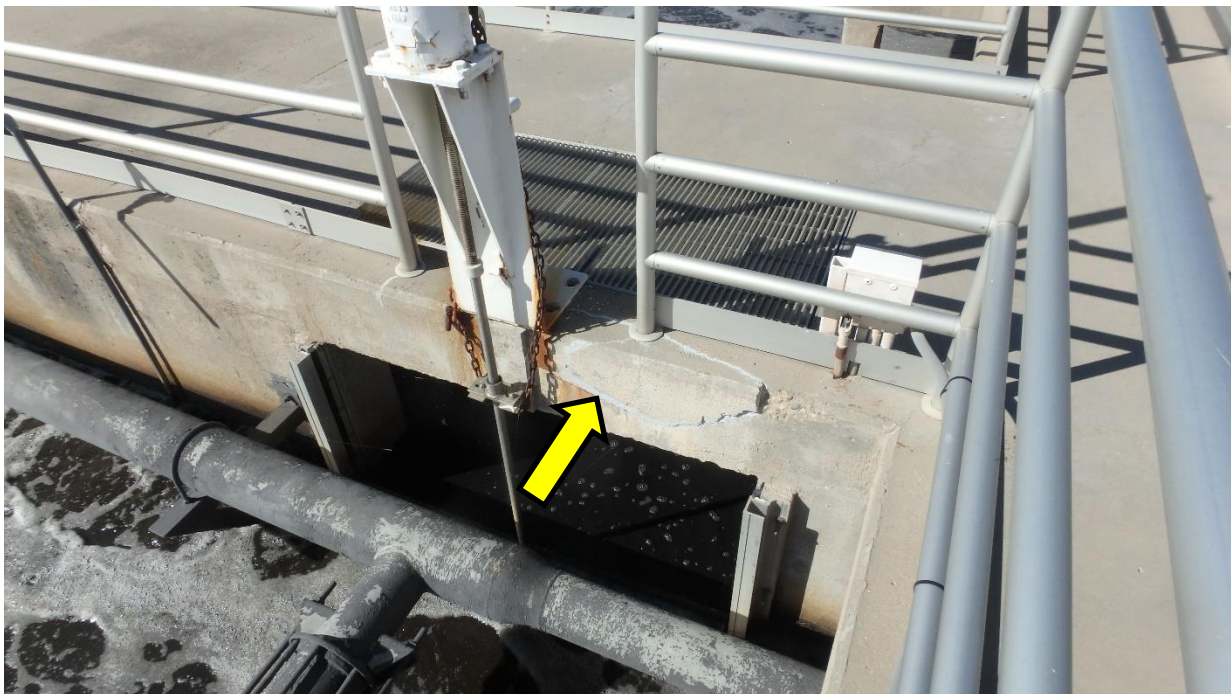
*Figure 49. Previously installed sealant at incipient spall location*

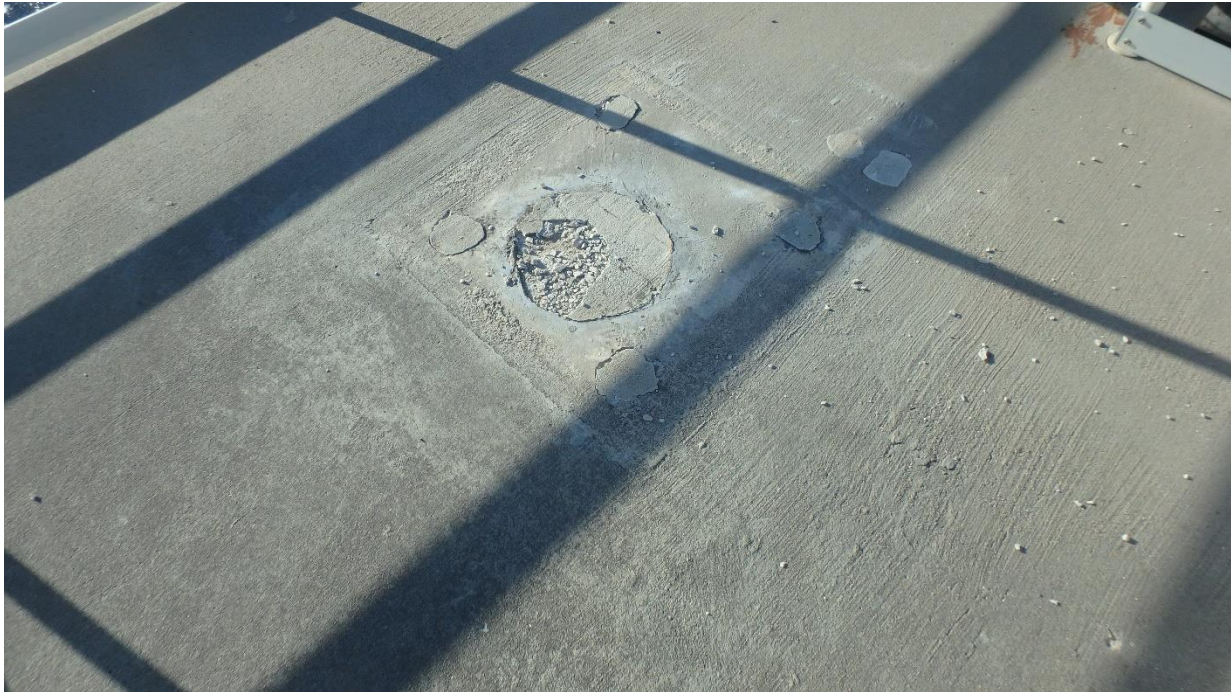
*Figure 50. Distressed concrete surface at location of previously removed equipment attachment*

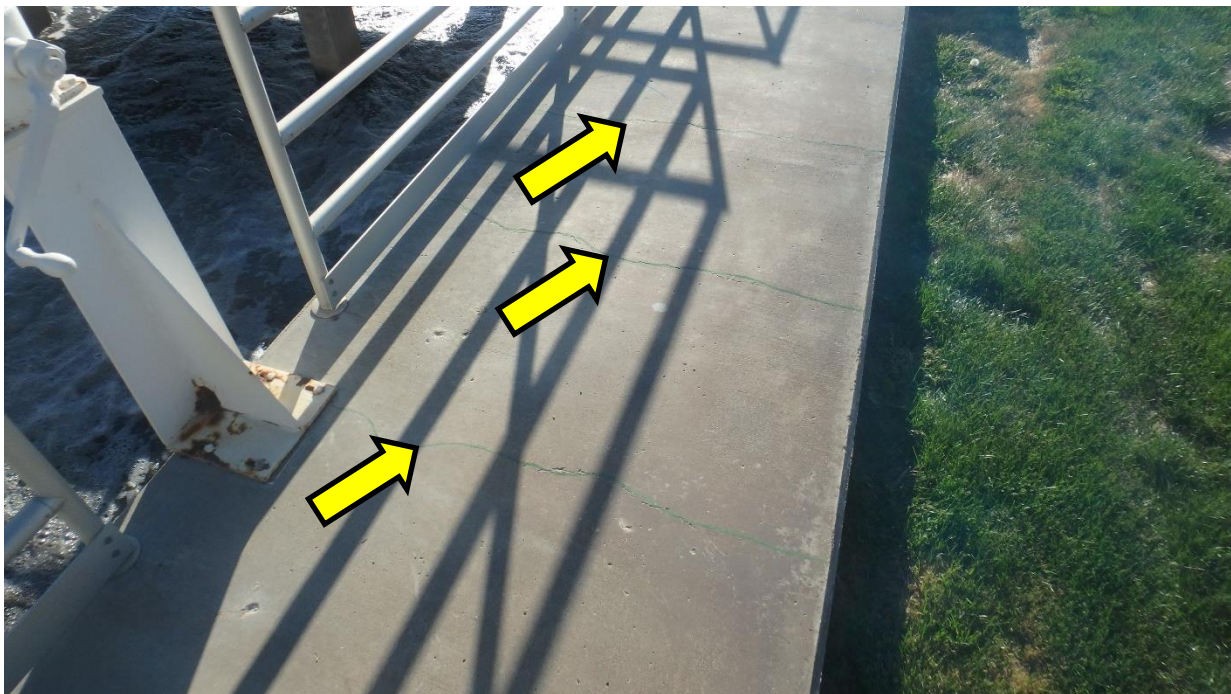
*Figure 51. Regularly spaced transverse cracking at catwalk topside*

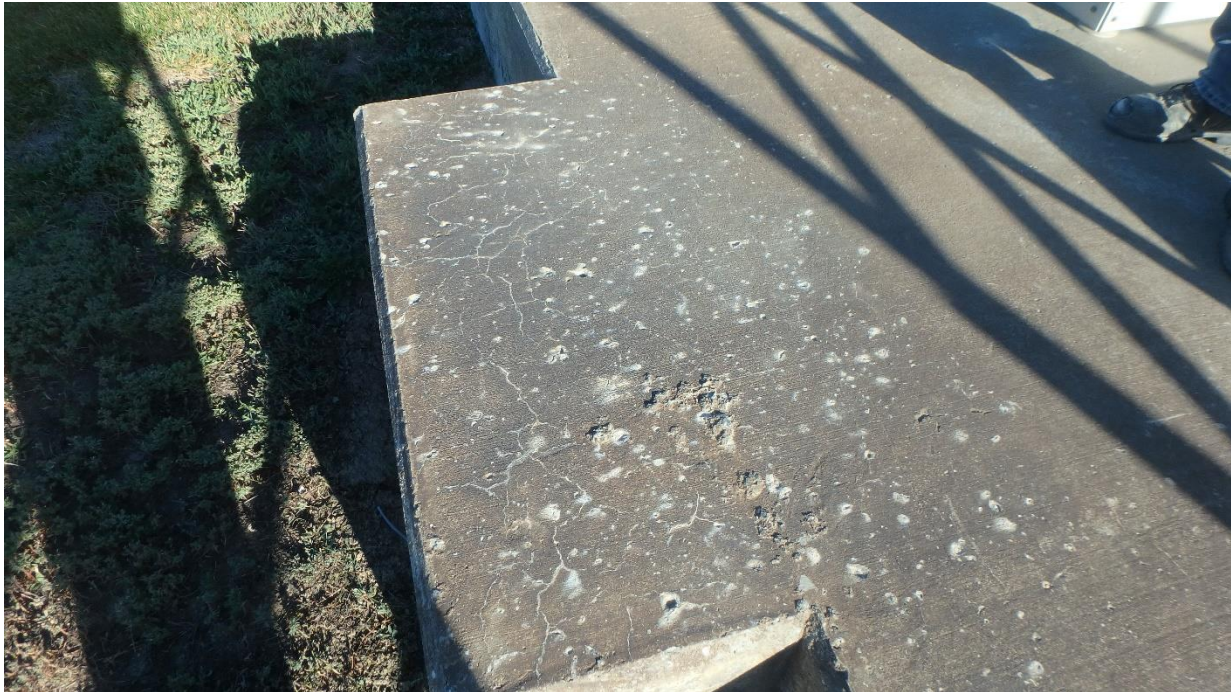
*Figure 52. Map pattern cracking and scaling at catwalk topside*

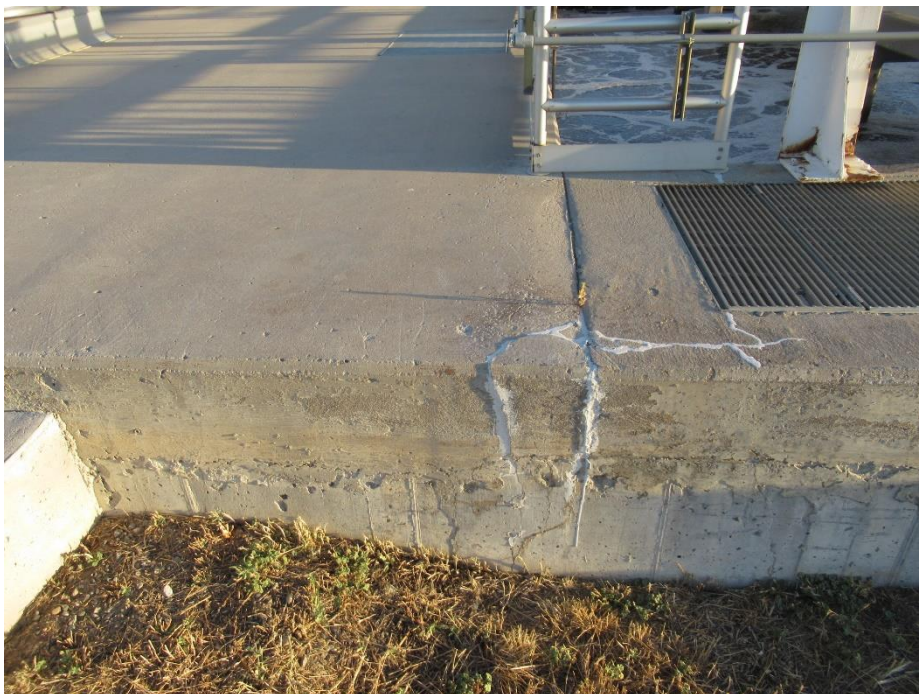
*Figure 53. Previously installed sealant at incipient spall location*

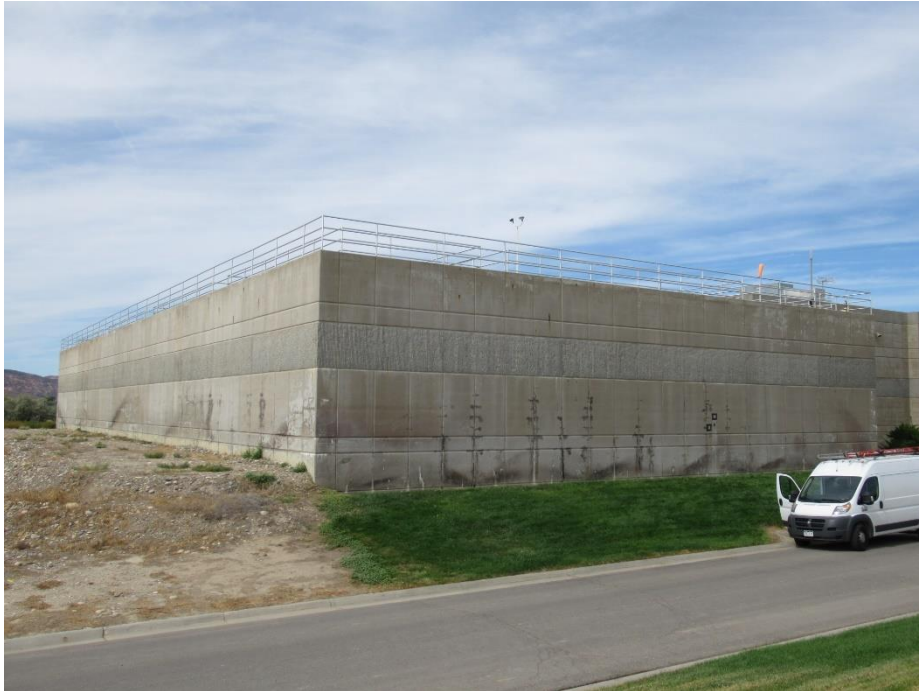
*Figure 54. Overall view of the east elevation of the Aerobic Digester*

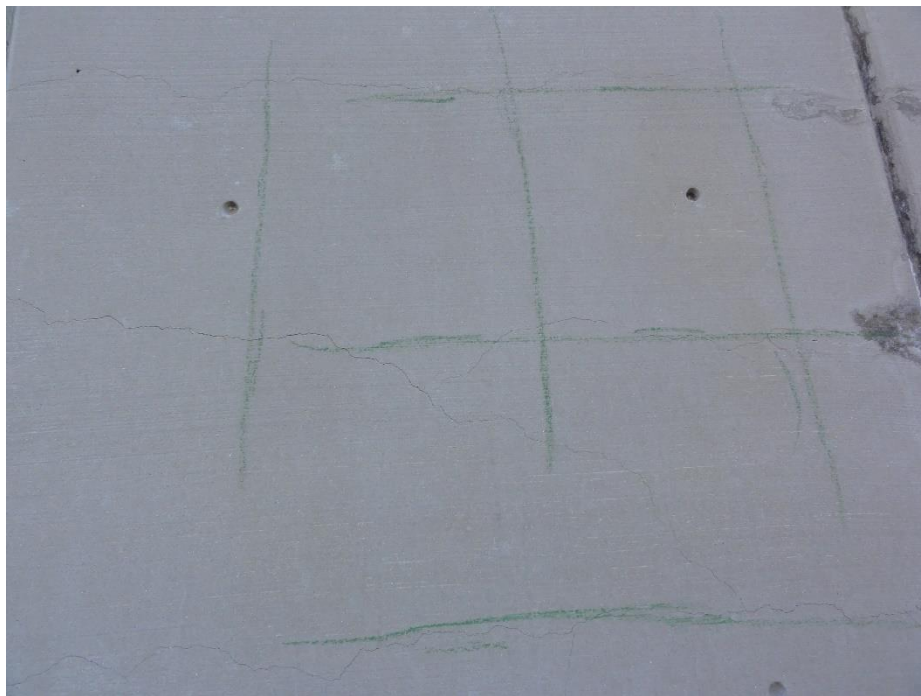
*Figure 57. Typical longitudinal and transverse cracking, aligning with locations of embedded reinforcing (reinforcing traced in green)*

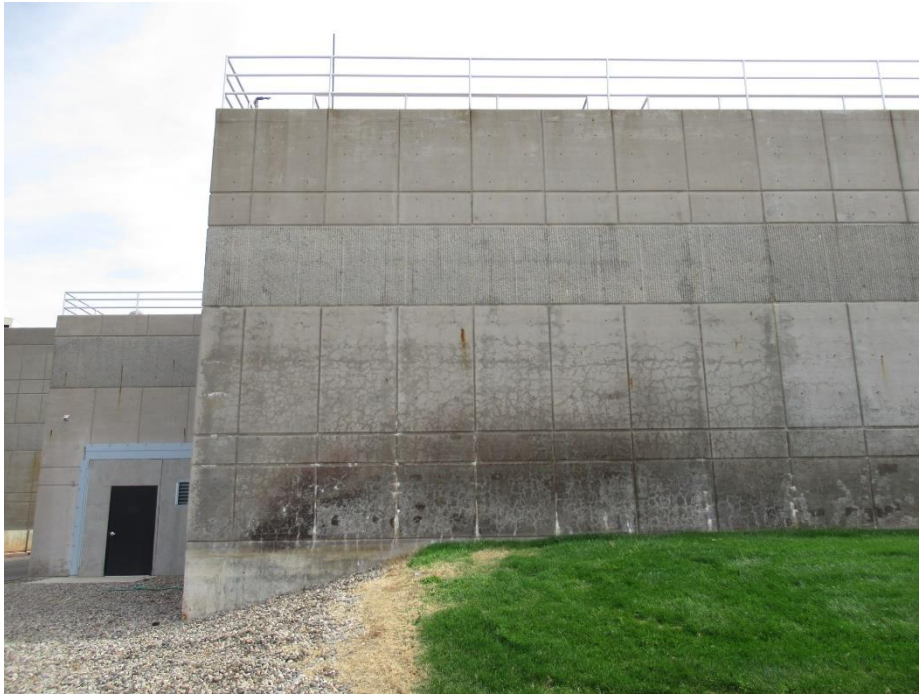
*Figure 58. Map patterned cracking at lower half of perimeter walls*

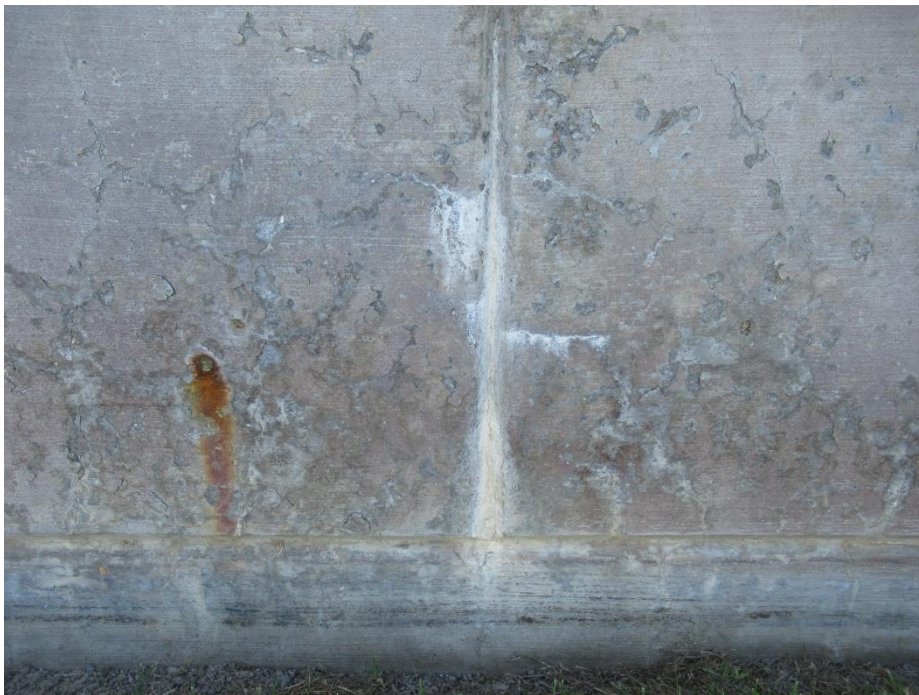
*Figure 59. Evidence of moisture intrusion and efflorescence staining at reveal joint*

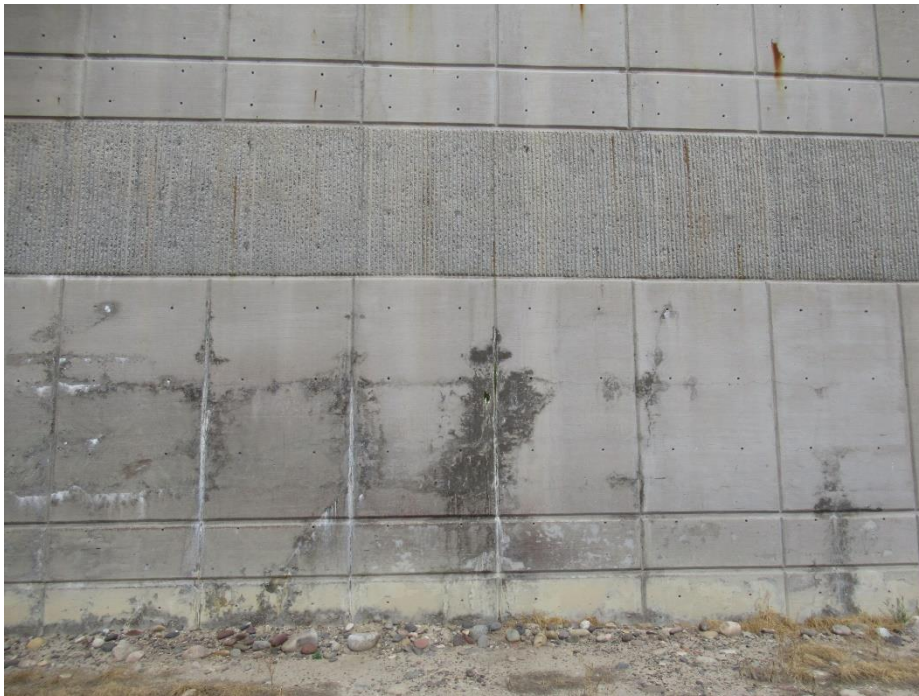
*Figure 60. Evidence of moisture intrusion and efflorescence staining at reveal joints*

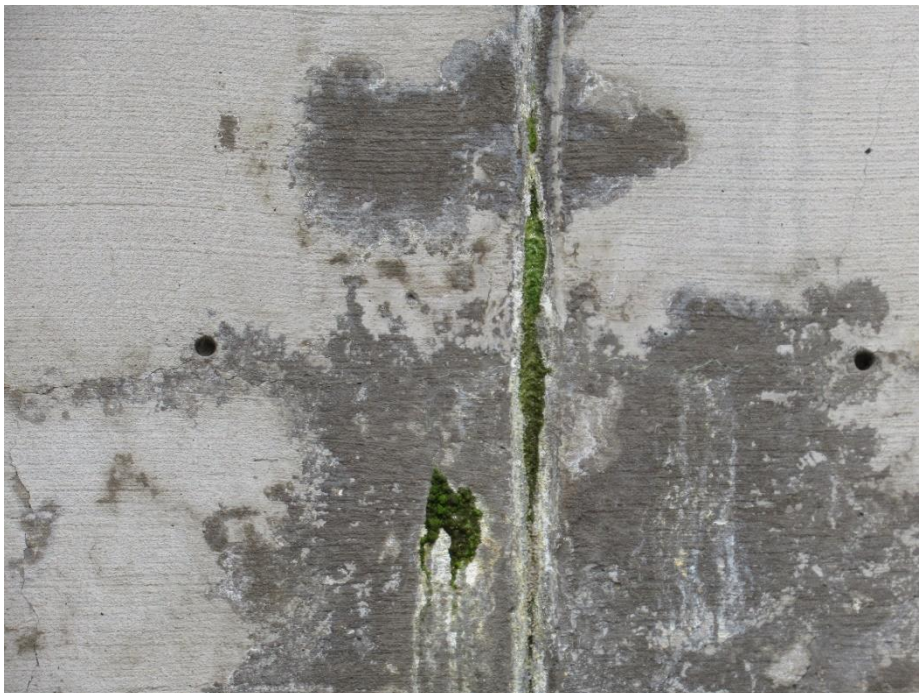
*Figure 61. Evidence of moisture intrusion and potential organic growth staining at reveal joint*

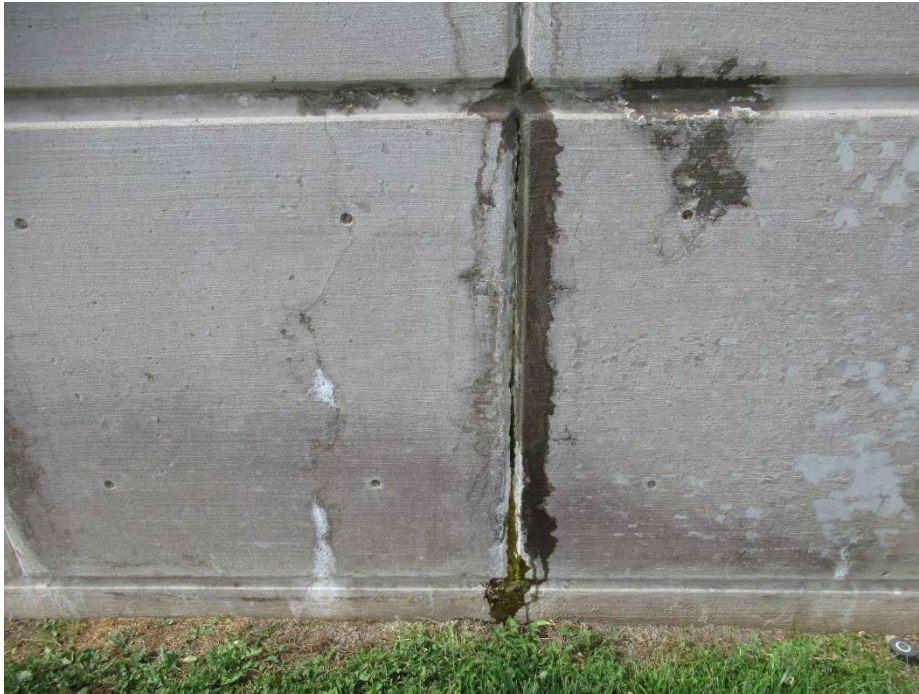
*Figure 62. Actively leaking crack within reveal joint*

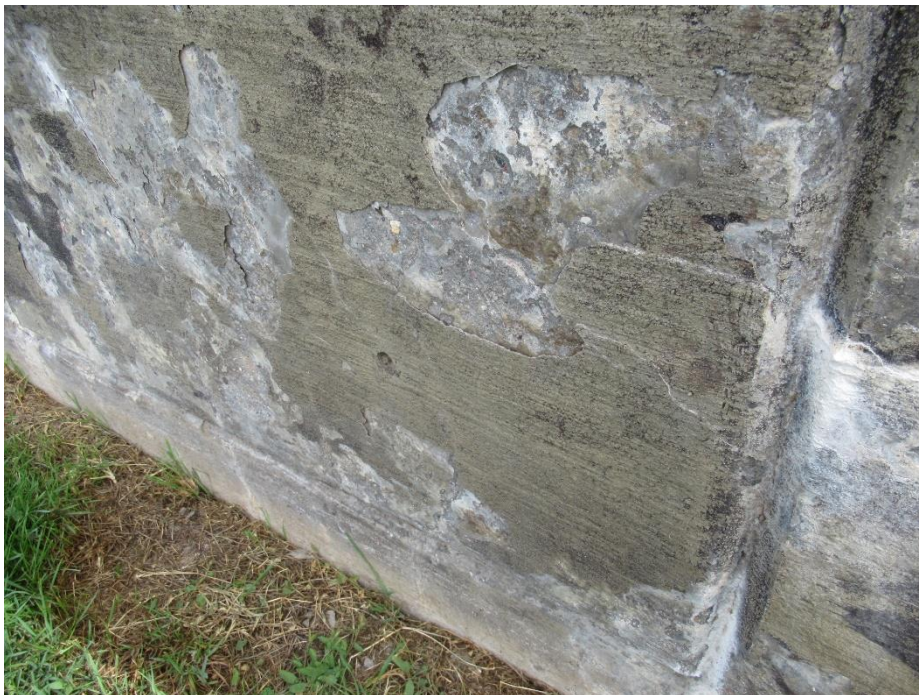
*Figure 63. Flaking of surface applied skim coat*

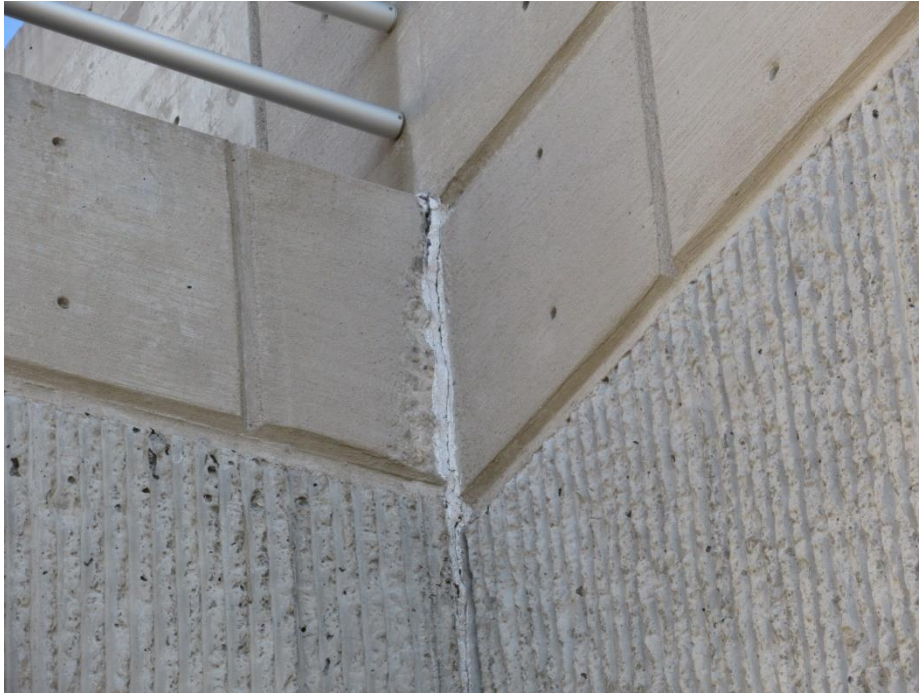
*Figure 64. Failed sealant joint between Aerobic Digester and Sludge Processing Unit*

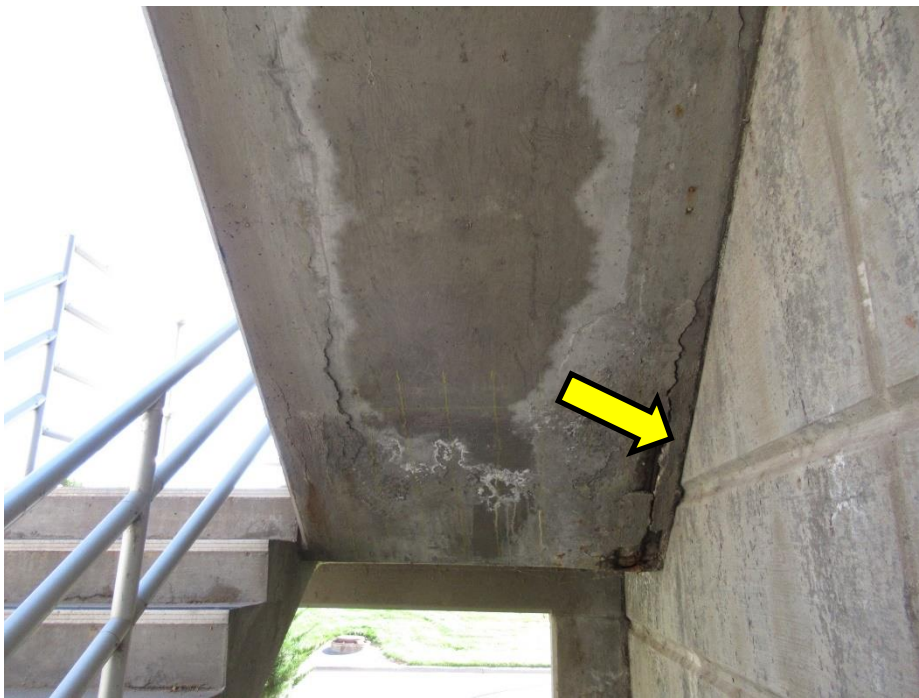
*Figure 65. Overall view of the soffit of the ground level stairwell, with noted cracking, spalls, and exposed corroded reinforcing*

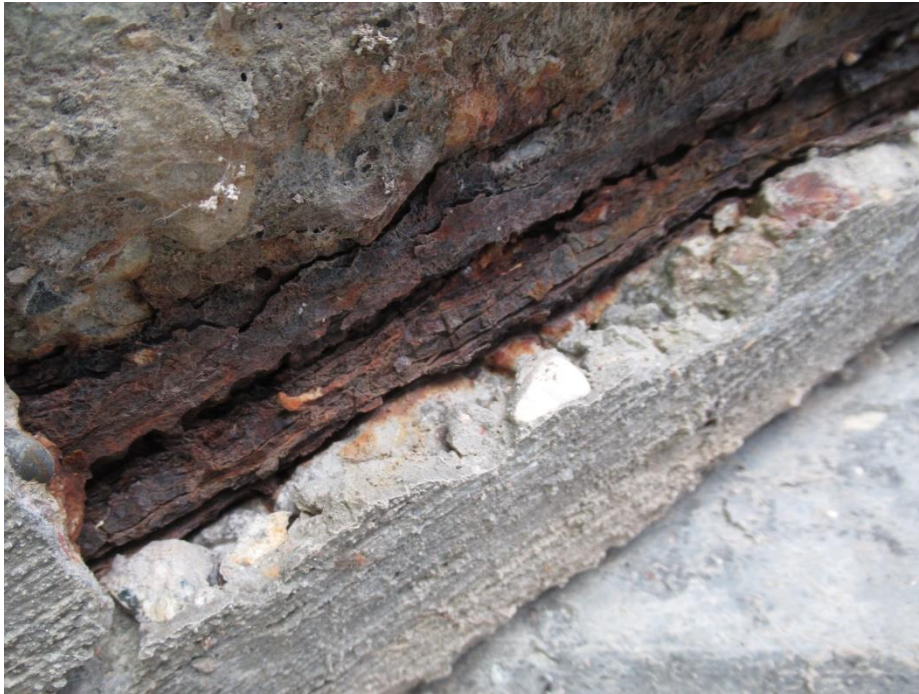
*Figure 66. Up-close view of exposed corroded reinforcing at the soffit of the ground level stairs*

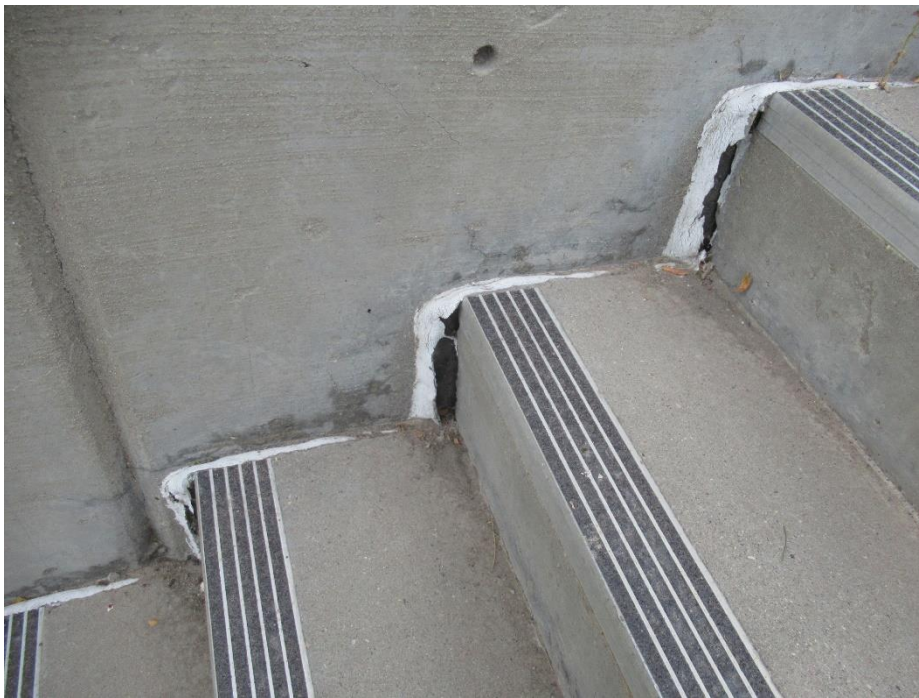
*Figure 67. Sealant joint between the ground level stairs and the adjacent building face that had failed and was no longer in contact with both substrate surfaces*

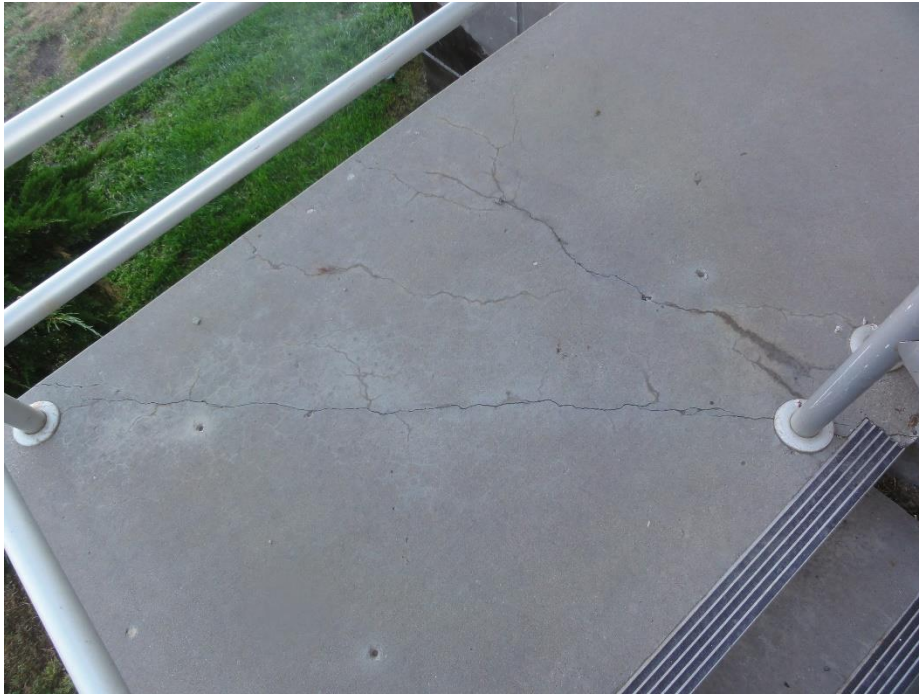
*Figure 68. Cracking at ground level stair intermediate landing*

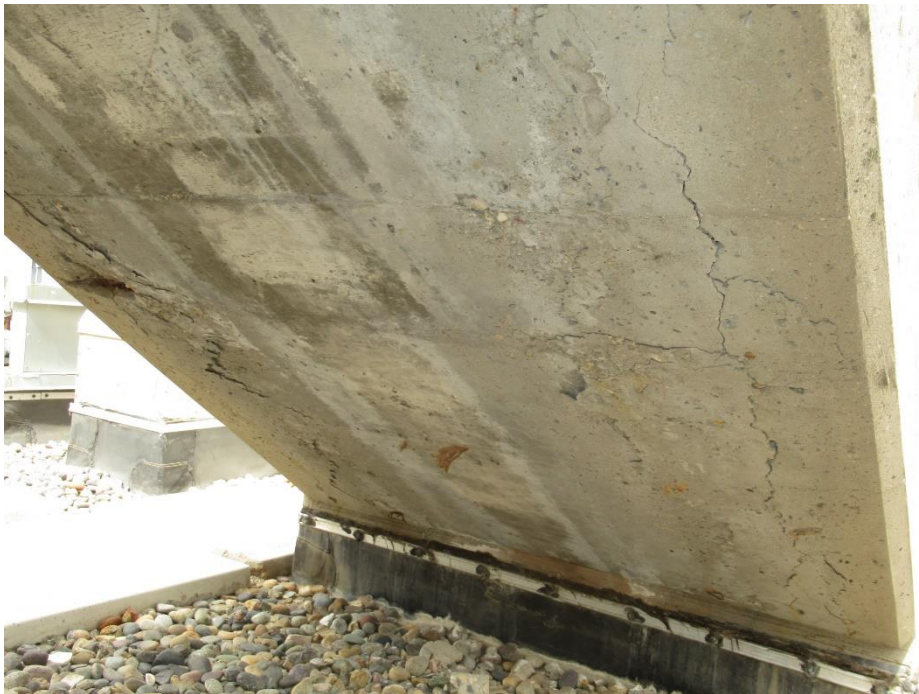
*Figure 69. Overall view of the soffit of the roof level stairwell, with noted cracking and spalls*

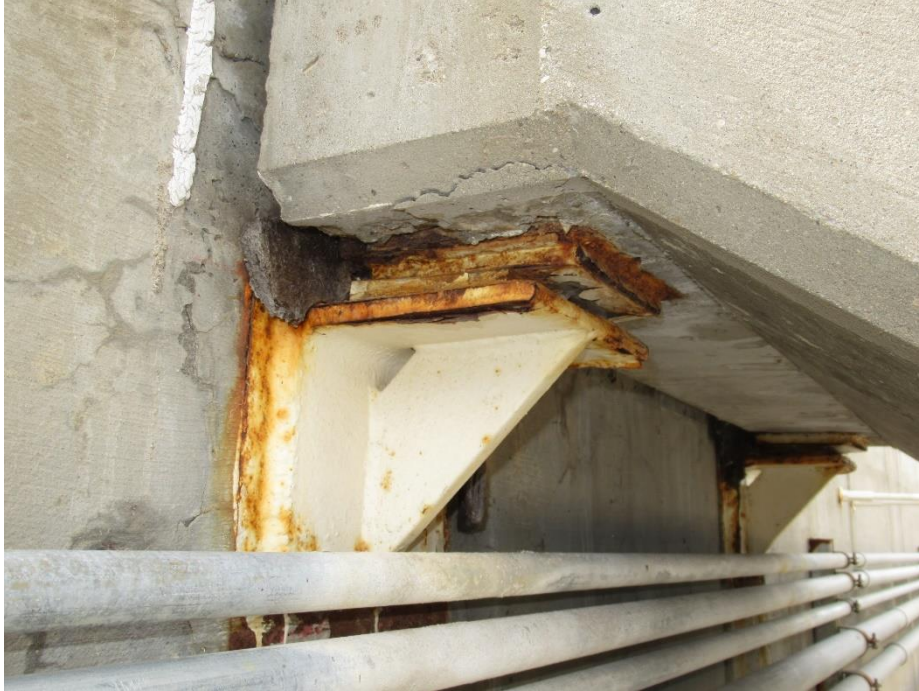
*Figure 70. Surface corrosion on the upper support bearing angles and plates for the roof level stairwell*

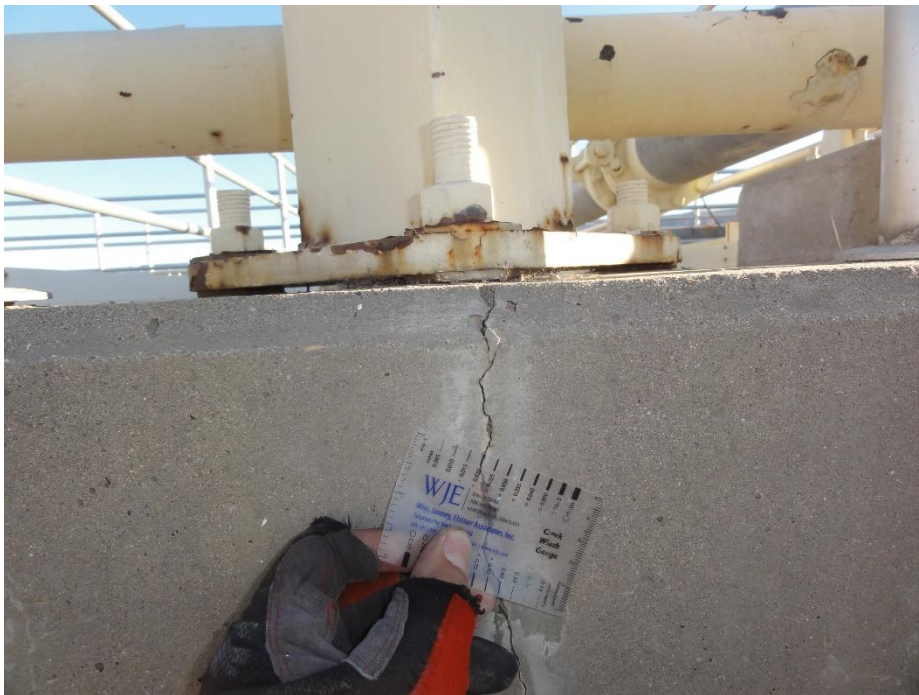
*Figure 71. Isolated transverse cracking aligning with guardrail post embeds for the catwalks above*

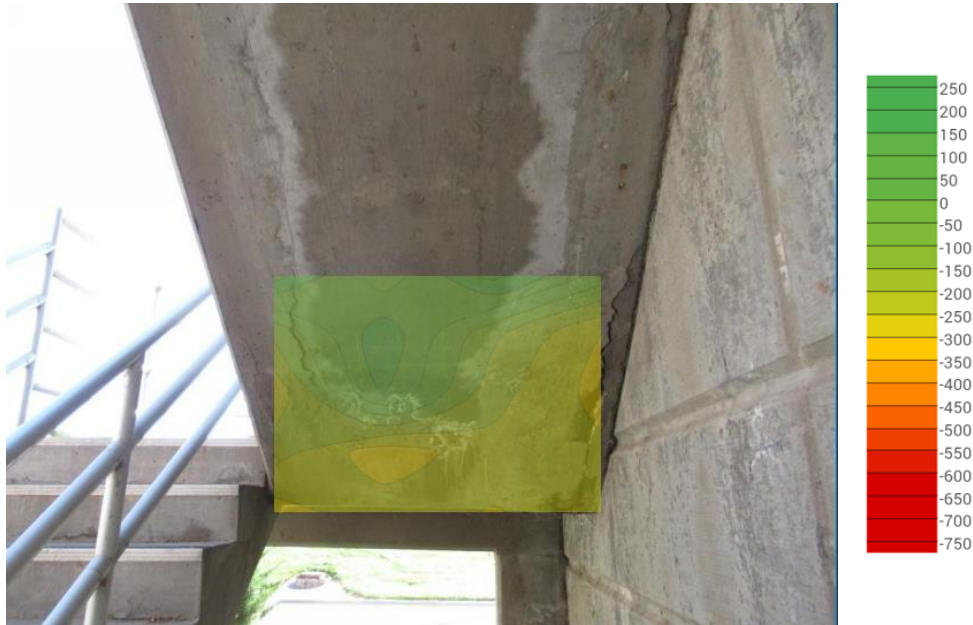
Figure 72. Half-cell potential data overlaid on top of photo documenting spalling and staining at underside of ground level staircase. The color scale is in mV and the reference electrode is a CSE

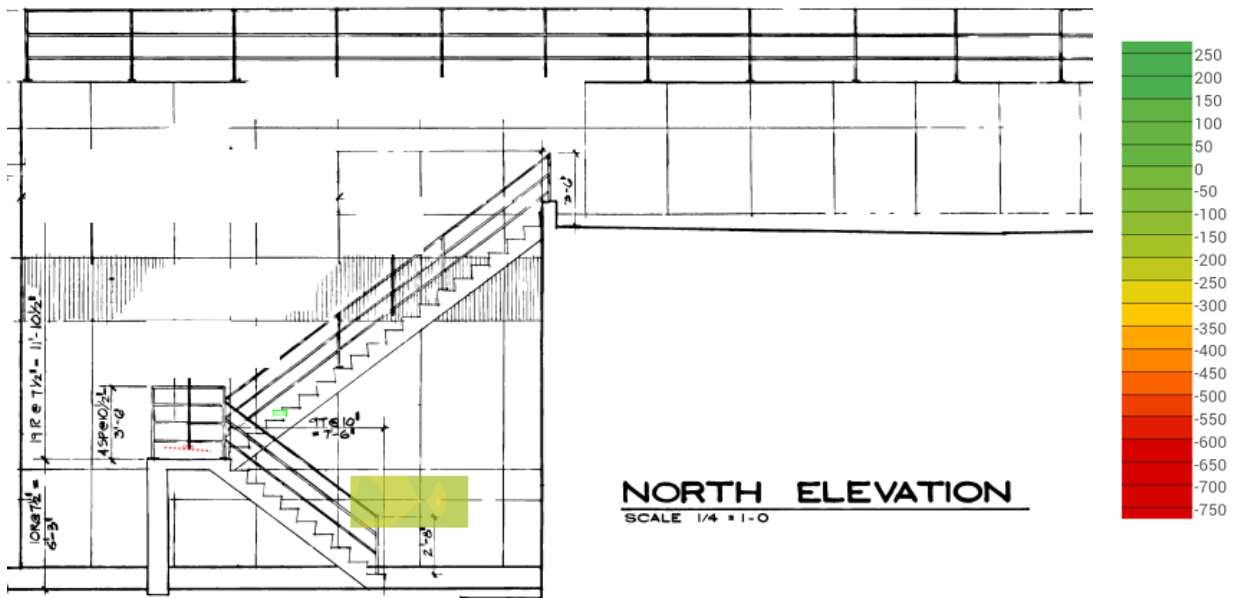
Figure 73. Half-cell potential data overlaid on top of field notes from delamination and crack survey, at the north elevation exterior wall. The color scale is in mV and the reference electrode is a CSE

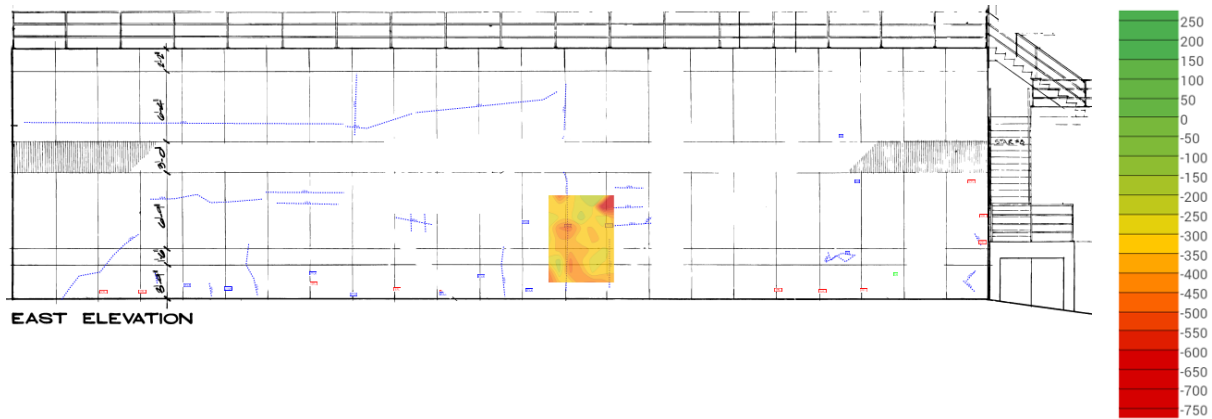
Figure 74. Half-cell potential data overlaid on top of field notes from delamination and crack survey, at the east elevation exterior wall. The color scale is in mV and the reference electrode is a CSE

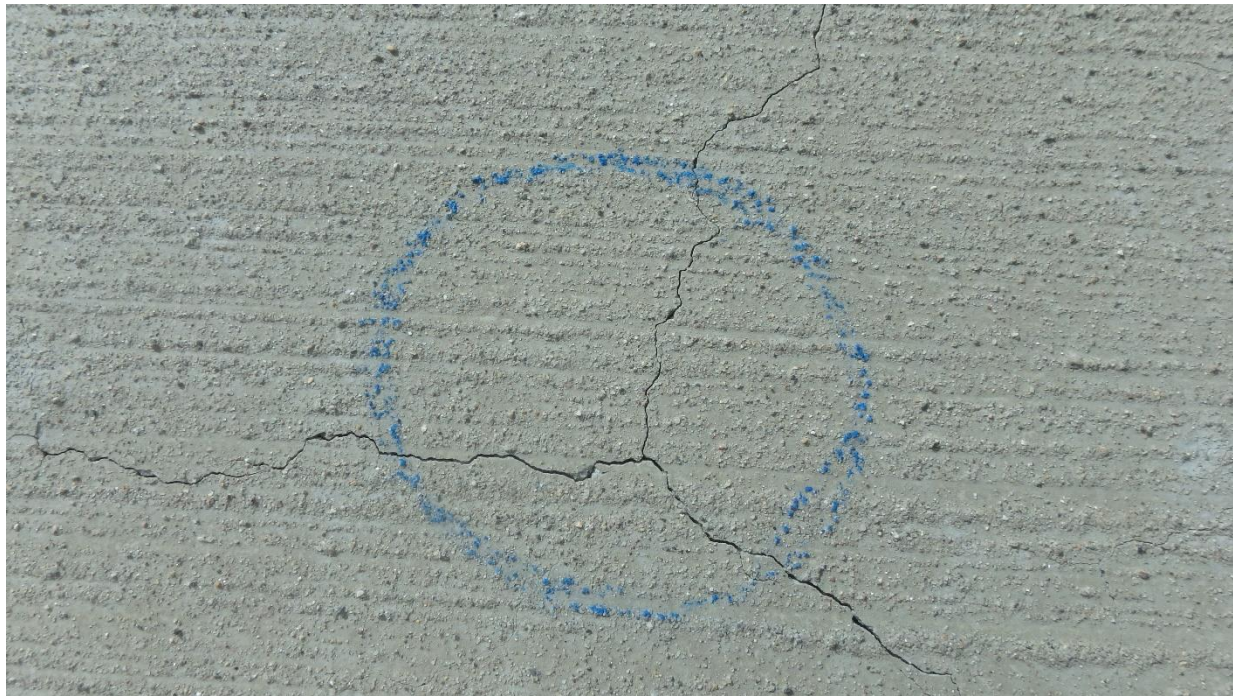
Figure 75. Core sample location at east elevation wall, intersecting multiple surface cracks

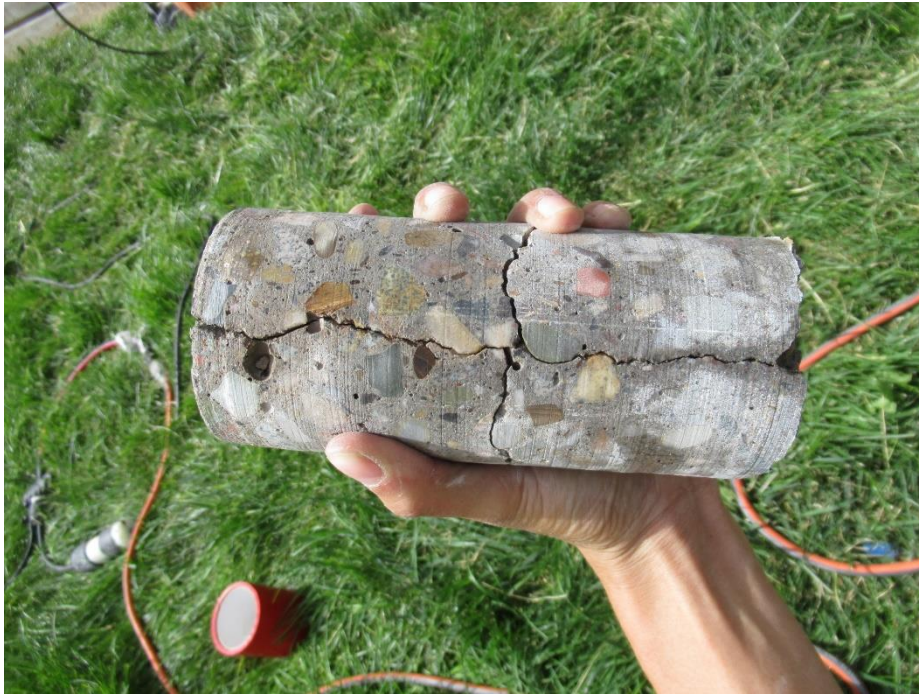
*Figure 76. Partial depth core sample obtained from area documented in Figure 75*

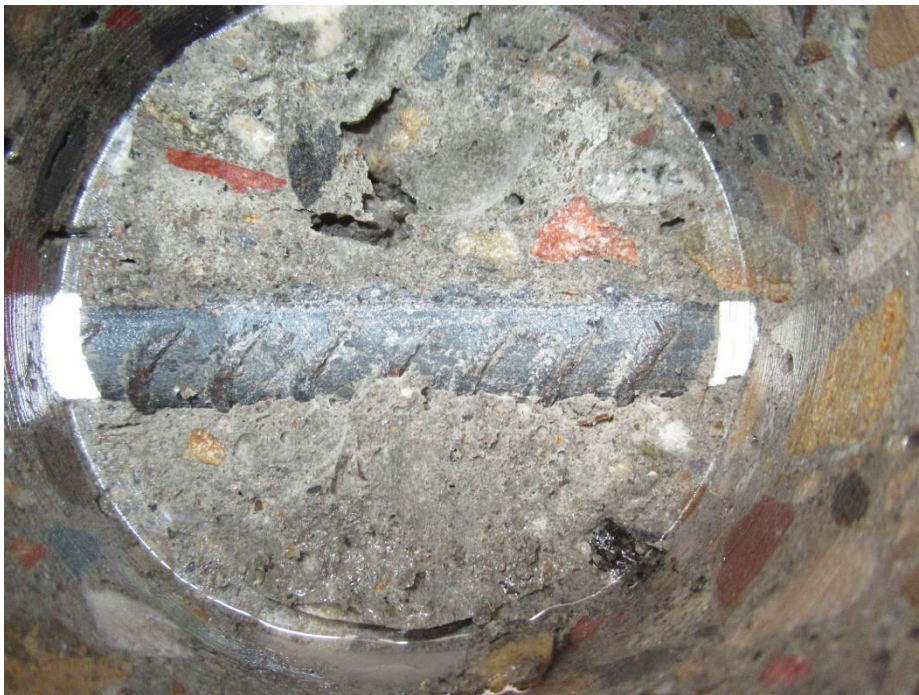
*Figure 77. Exposed embedded reinforcing bar, with little to no surface corrosion present*

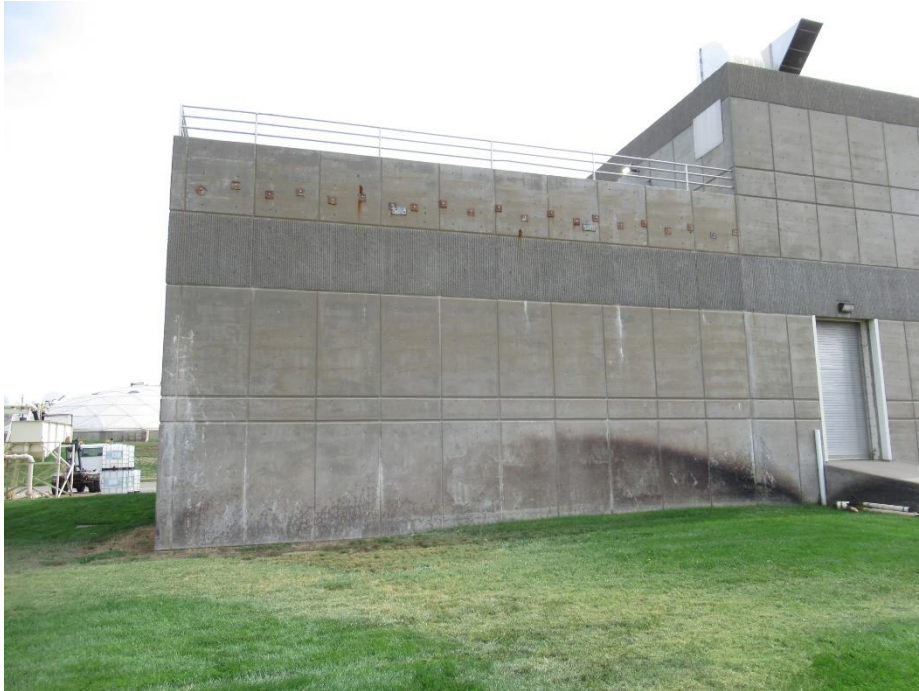
Figure 78. Overall view of the northwest corner of the Sludge Processing Unit

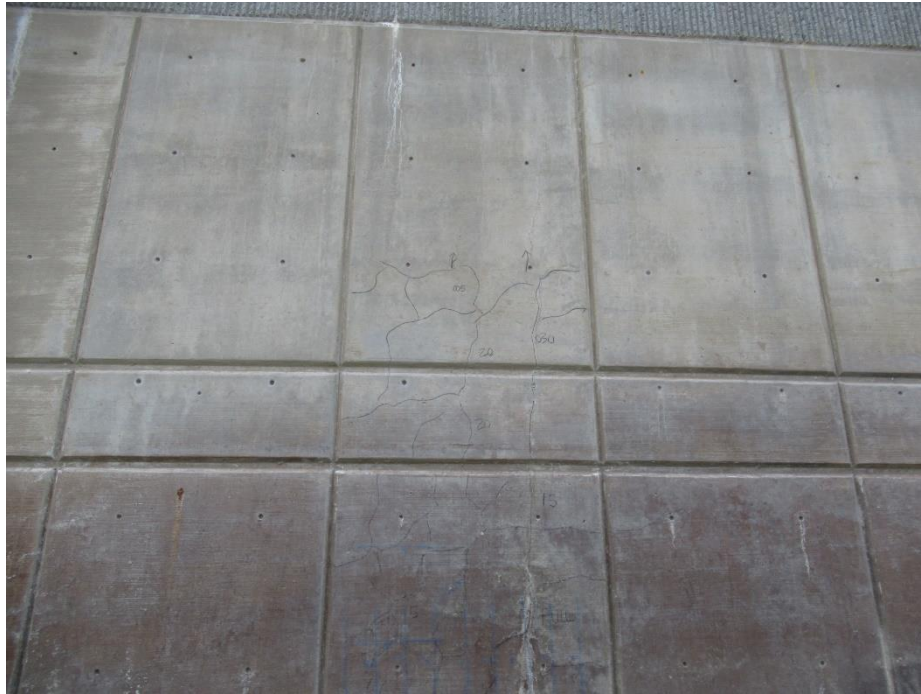
*Figure 80. Map patterned cracking at lower portion of exterior walls*

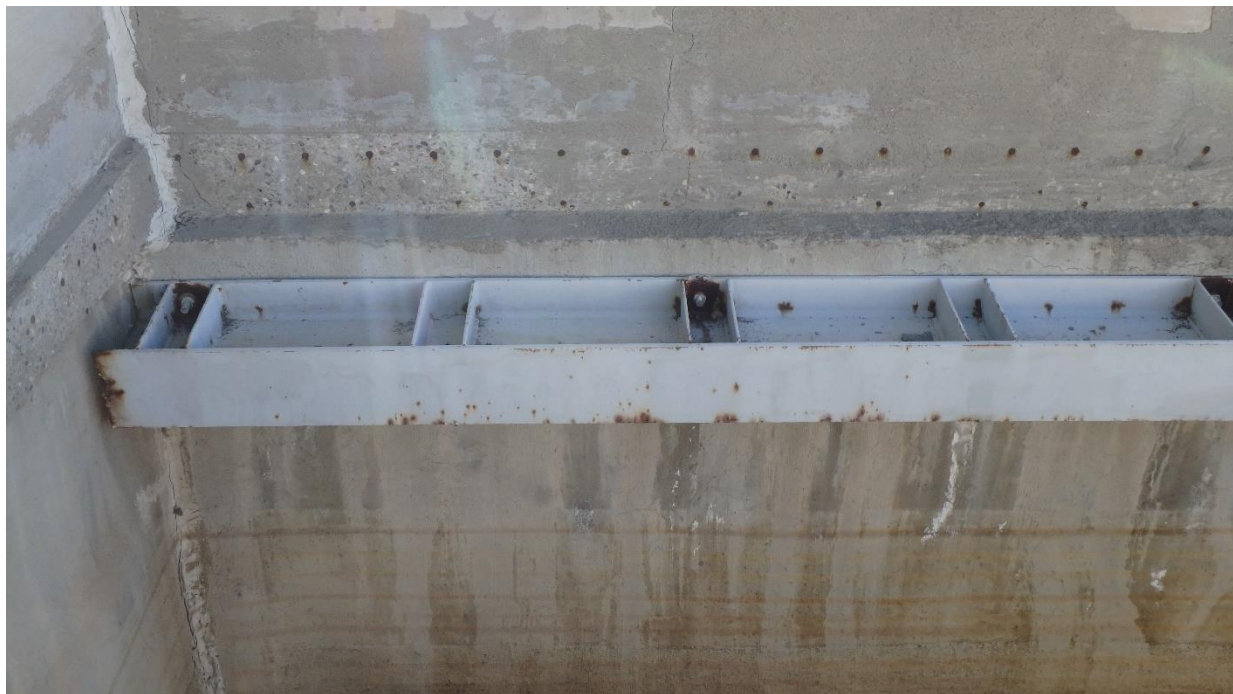
*Figure 81. Typical steel framing and attachment at north and west walls of blending tank*

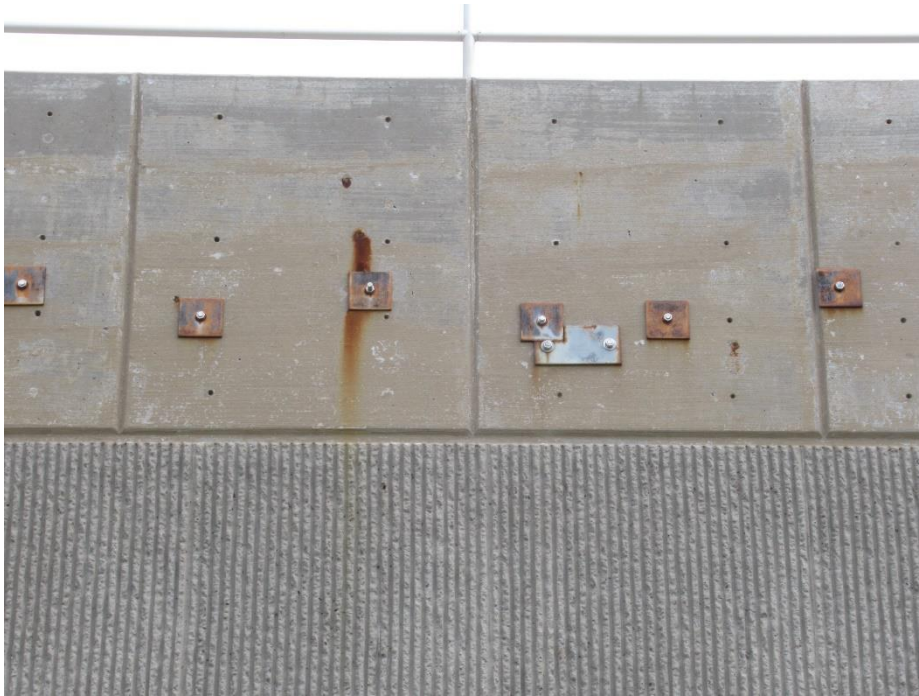
*Figure 82. Corrosion of plate washers, as viewed from the exterior of the blending tank walls*
