**APPENDIX A. GEOTECHNICAL INVESTIGATION**

## PERSIGO WASTEWATER TREATMENT PLANT Geotechnical Investigation

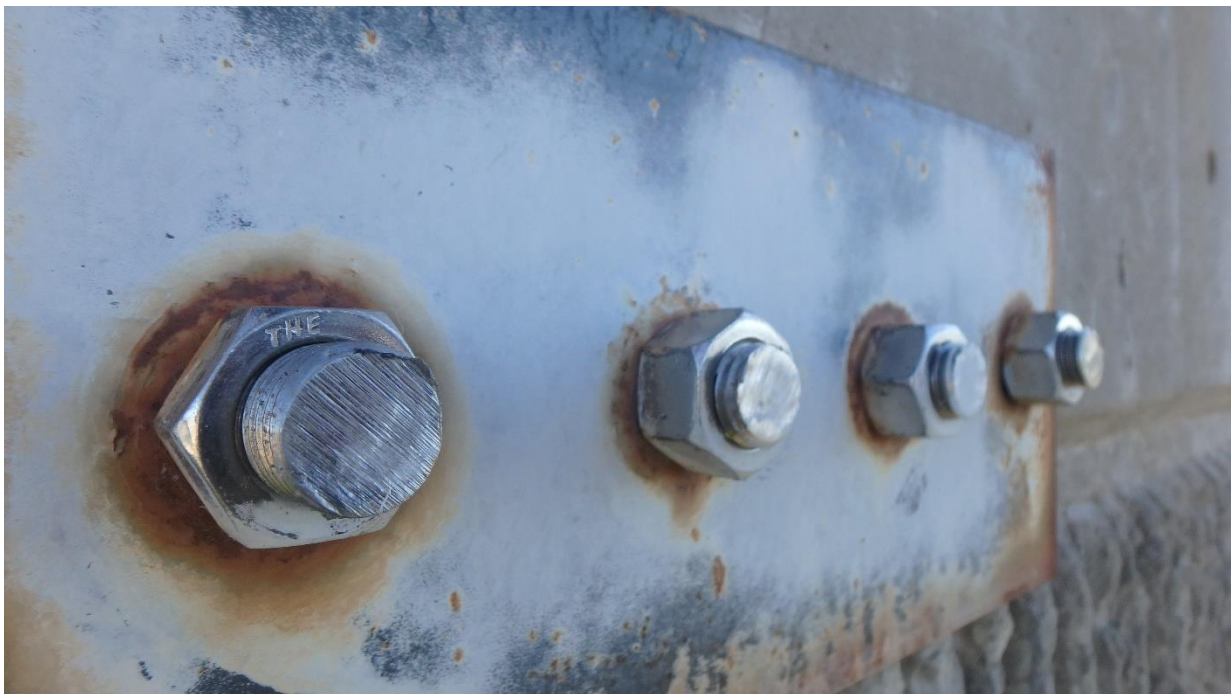
*Figure 83. Corrosion of plate washers adjacent to bolt attachments, as viewed from the exterior of the blending tank walls*

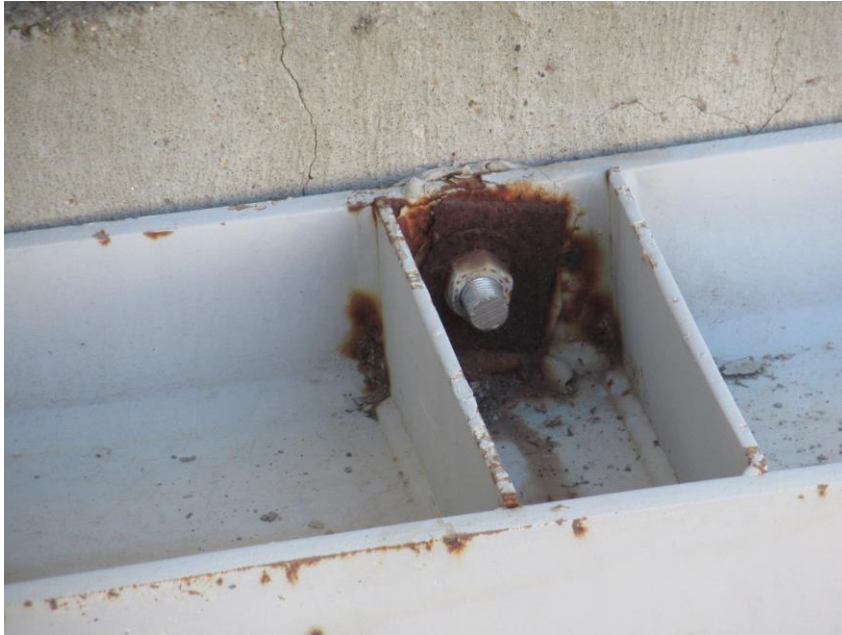
*Figure 84. Corrosion of plate washers adjacent to bolt attachments, as viewed from the interior of the blending tank walls*

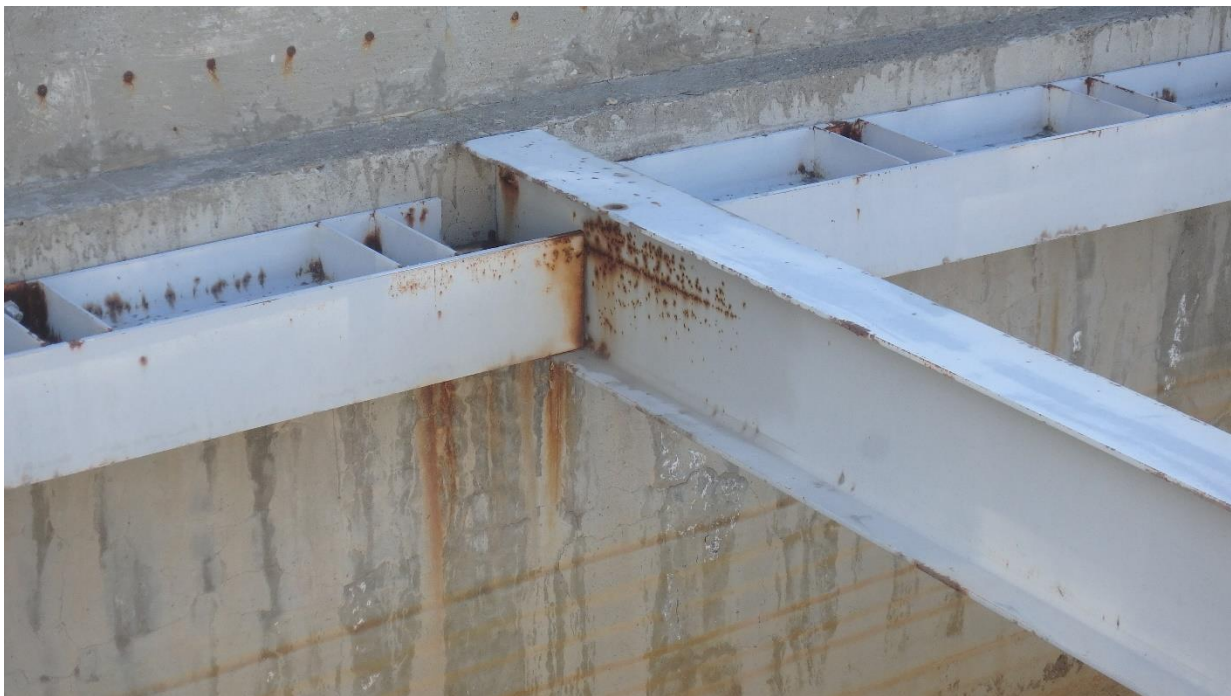
*Figure 85. Surface corrosion on coated framing members*

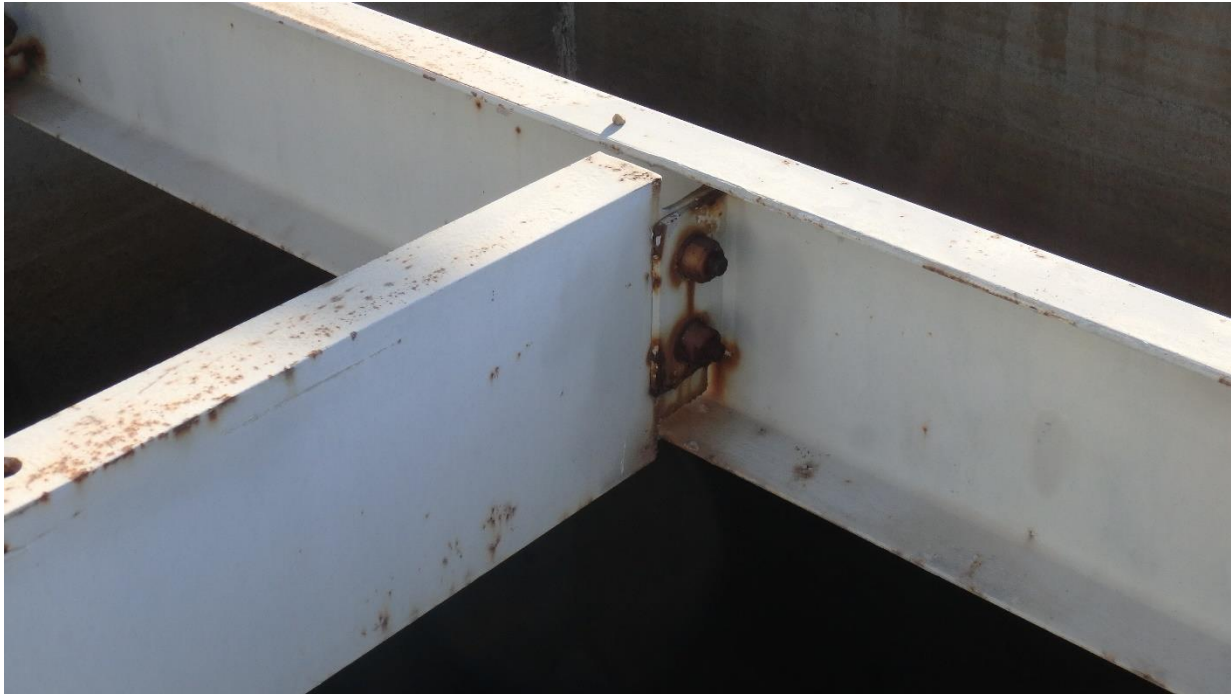
*Figure 86. Corrosion on bolted connection for the interior framing support*

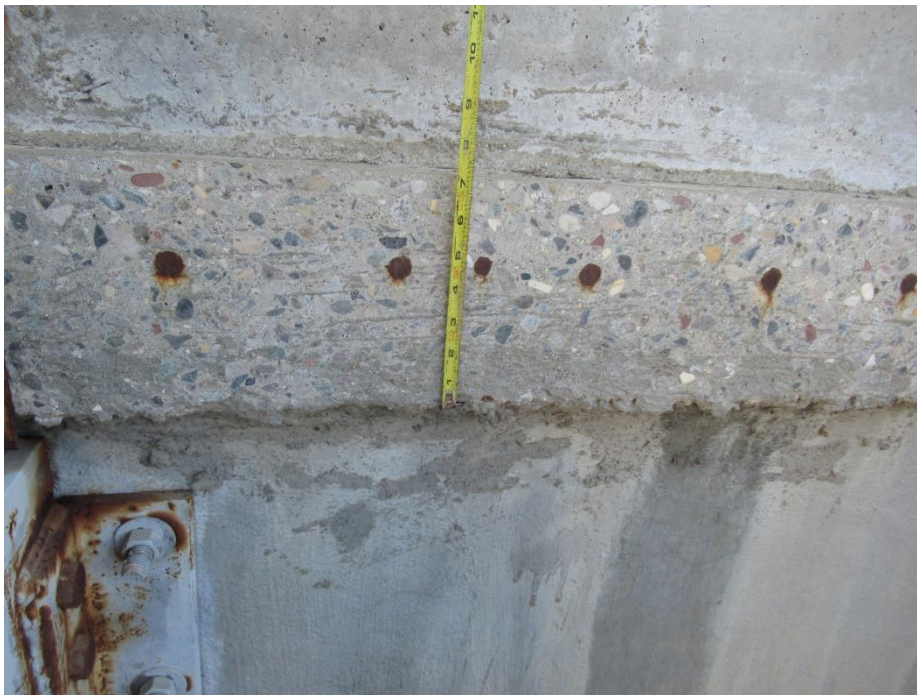
*Figure 87. Surface corrosion on previously sawcut reinforcing, which was abandoned when concrete lid/roof was removed*

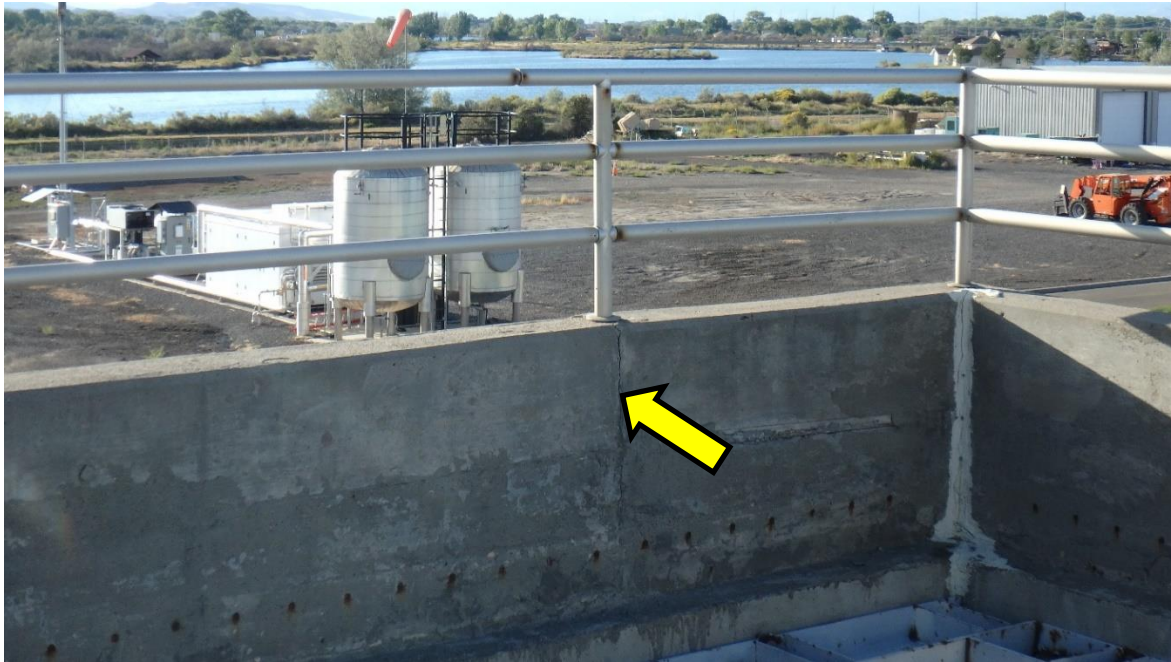
Figure 88. Vertical cracking on interior face of exterior wall, aligning with the guardrail post above

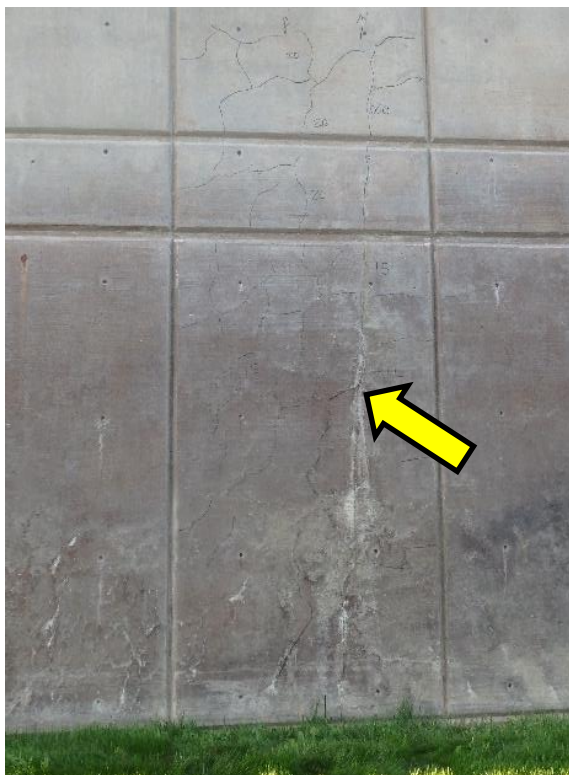
Figure 89. Vertical cracking at exterior of blending tank

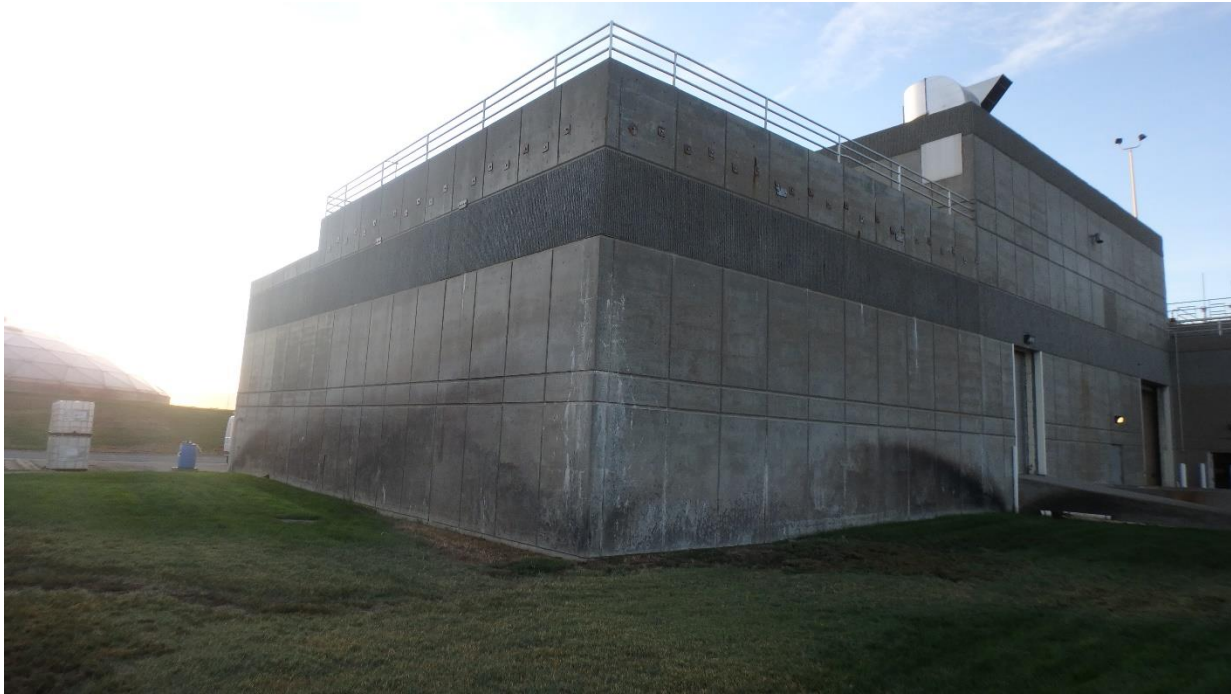
*Figure 90. Noted efflorescence and staining at northwest corner of blending tank*

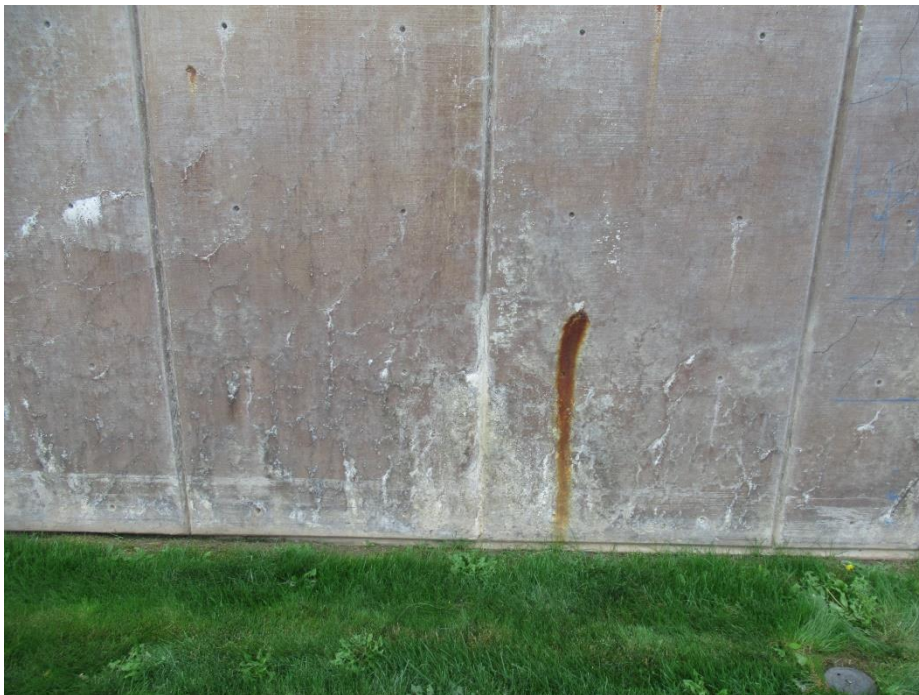
*Figure 91. Noted efflorescence at panel reveal joint*

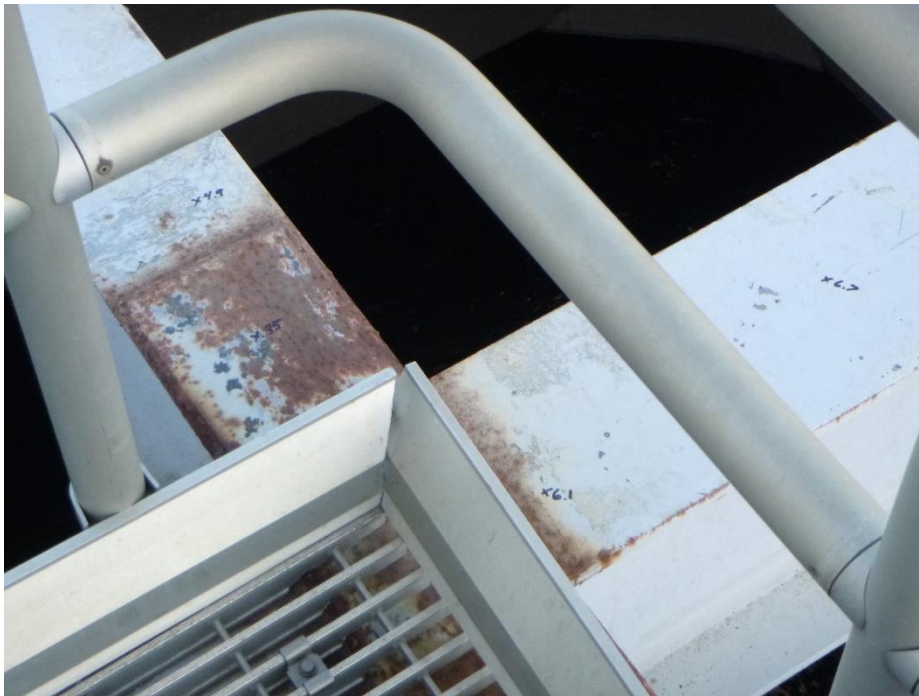
*Figure 92. Coating thickness correlated to corrosion distress, note black coating thickness measurements in mils*

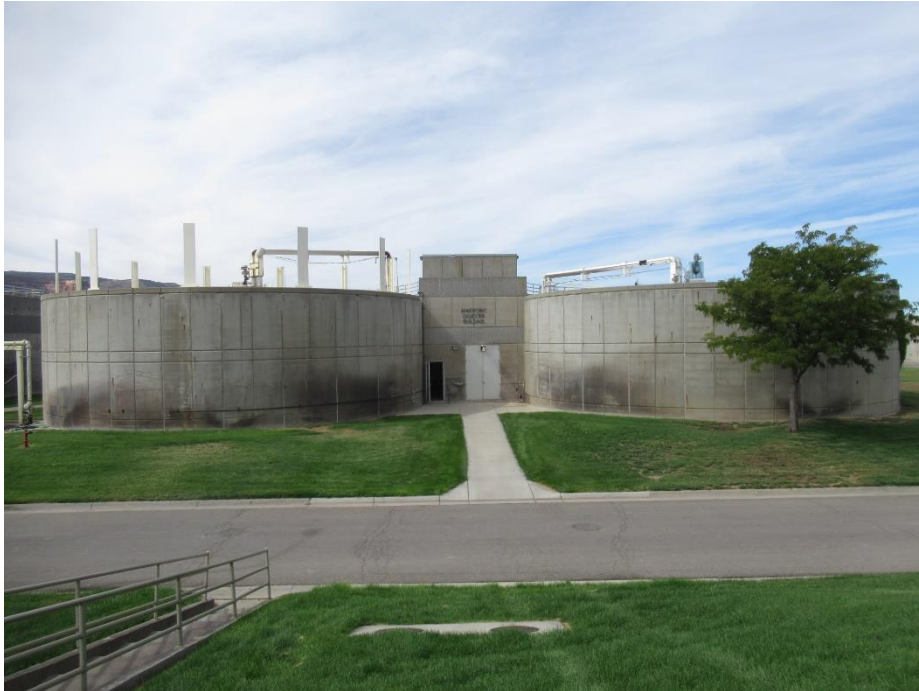
*Figure 93. Overall view of the east elevation of the Anaerobic Digesters, with the Anaerobic Digester Building situated in the center*

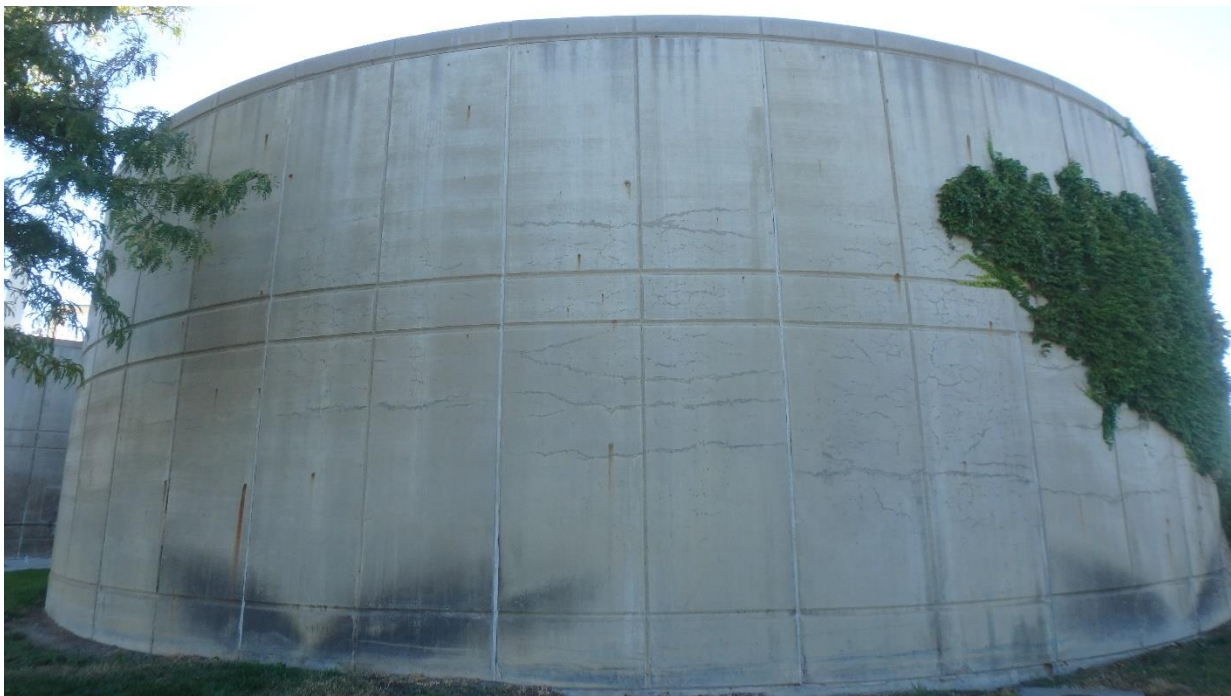
*Figure 96. Transverse cracking observed on multiple panels*

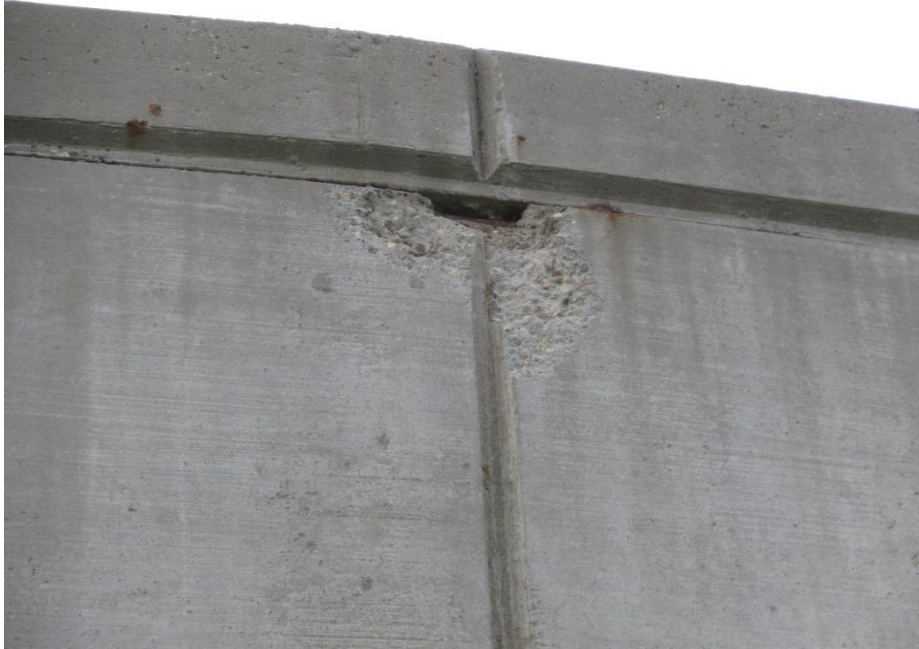
*Figure 97. Spalled concrete at upper corner of exterior panel*

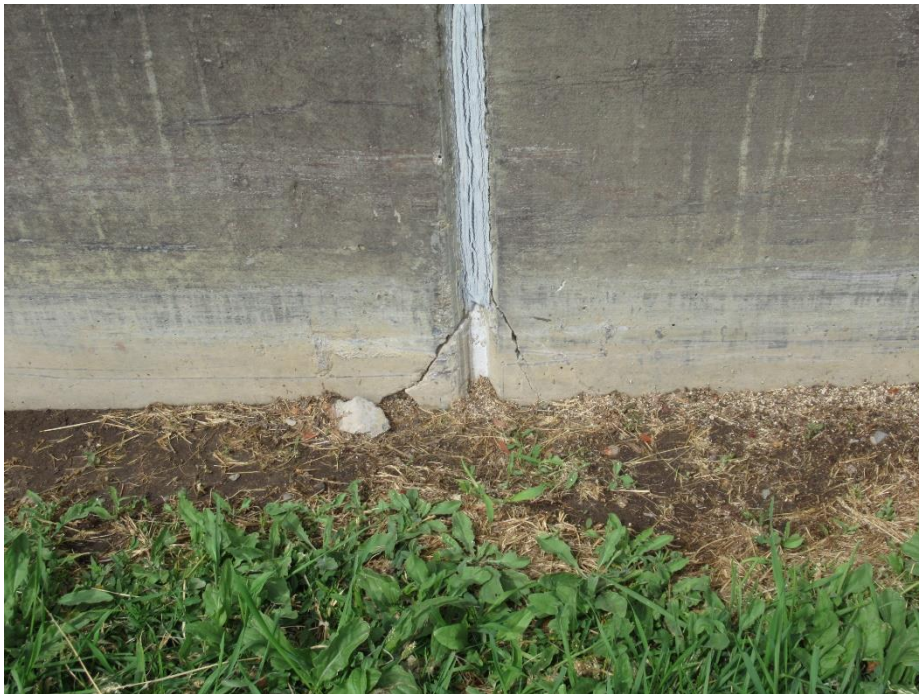
*Figure 98. Spalled concrete at lower corner of exterior panel*

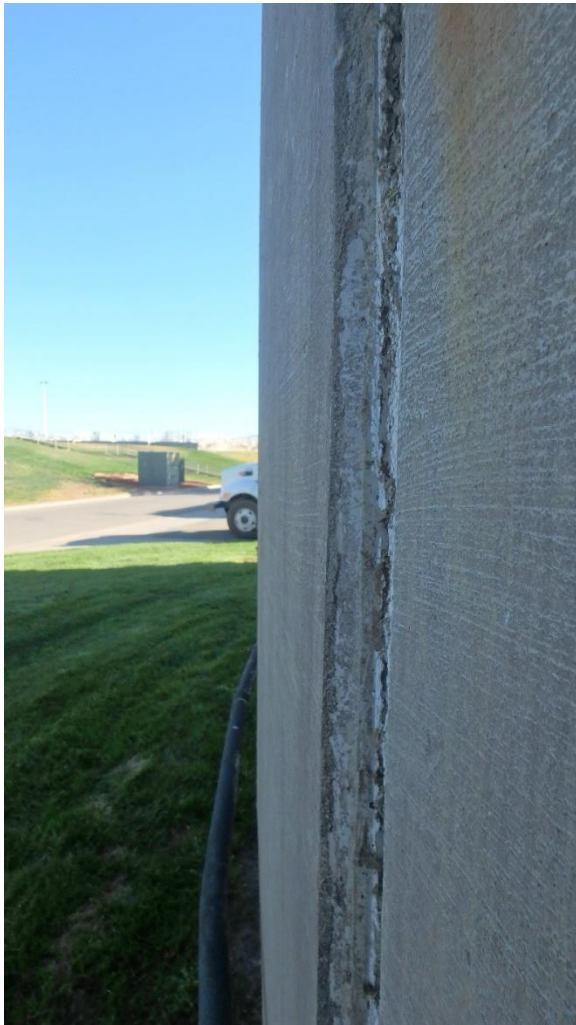
*Figure 99. Outward bowing of panel in the background at a vertical sealant joint, with respect to the panel in the foreground*

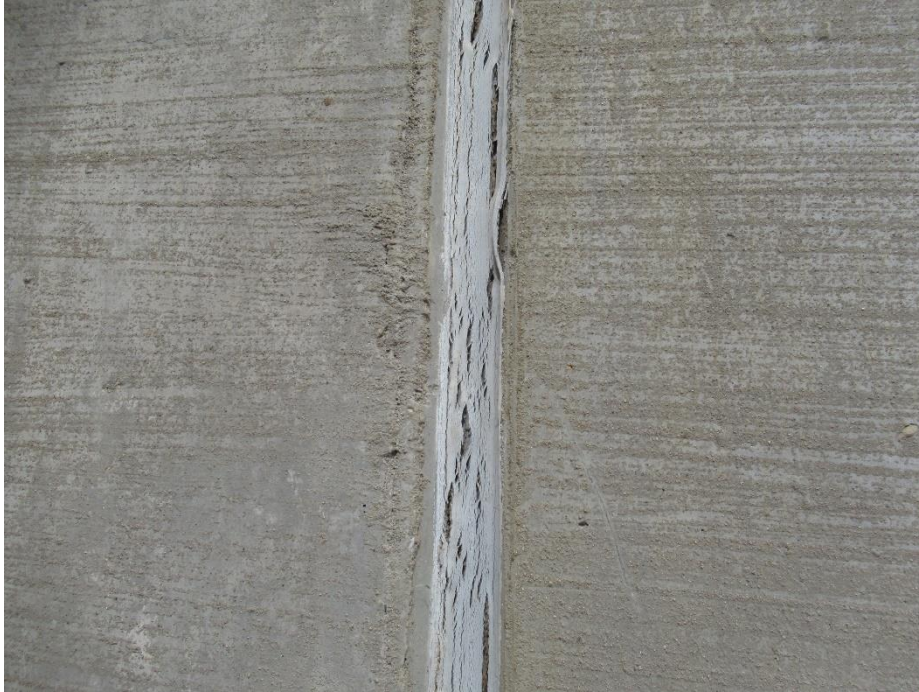
*Figure 102. Sealant joint that had failed in both adhesion and cohesion*

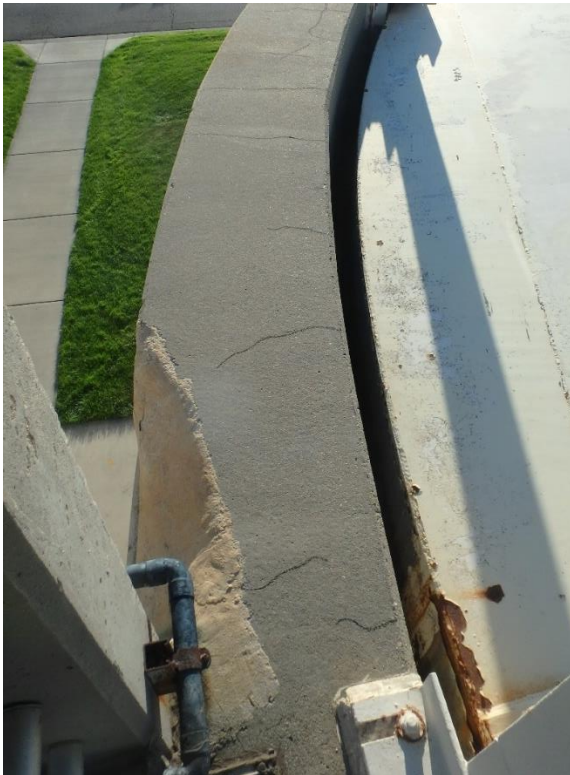
*Figure 104. Transverse cracking at the concrete coping cap*

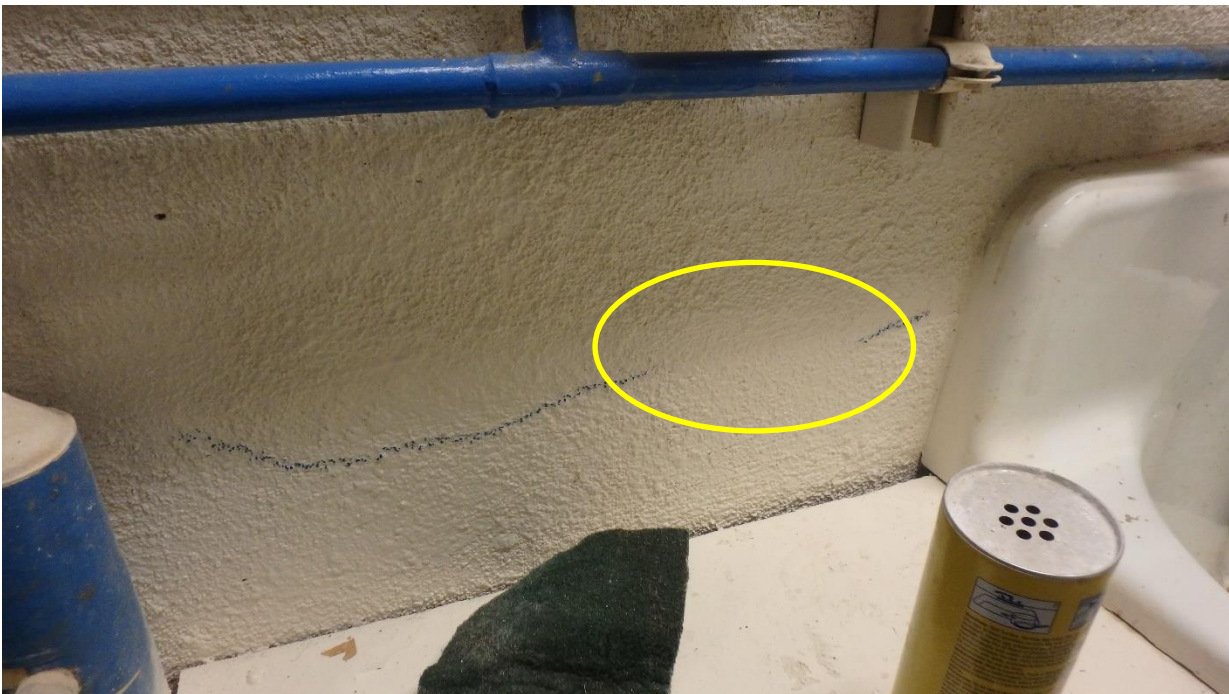
*Figure 105. Previous coating repair location at the south digester interior wall*

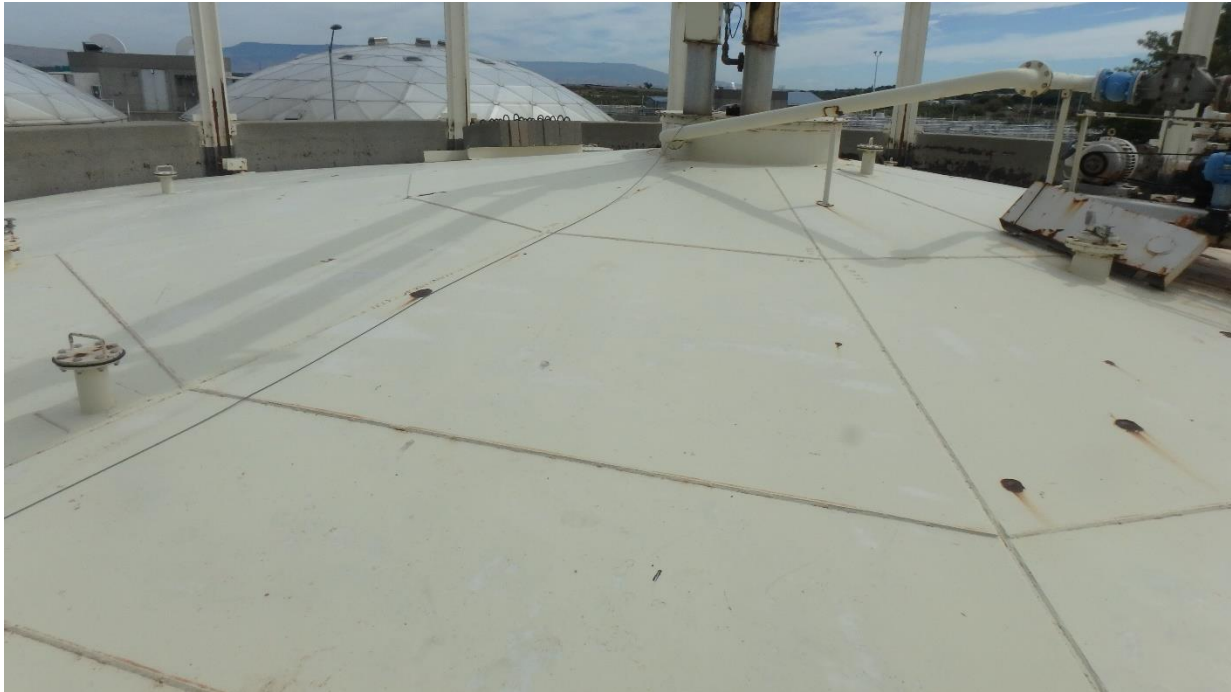
*Figure 106. Overall view of the coating on the top surface of the south digester lid*

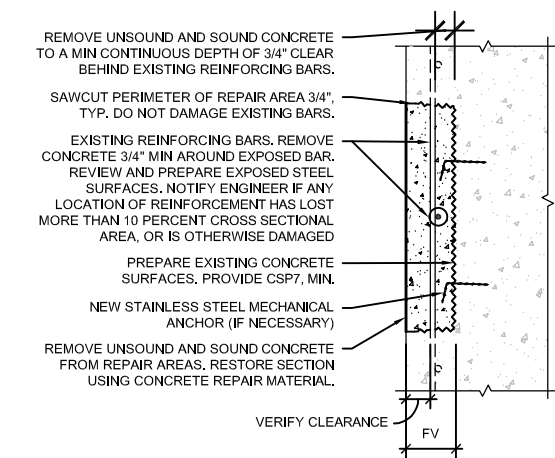
1 PARTIAL DEPTH VERTICAL REPAIR  
SCALE: Not to Scale

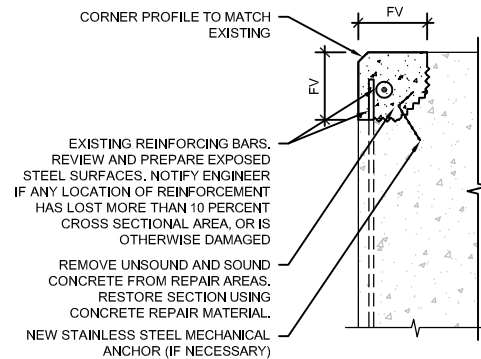
2 CORNER REPAIR  
SCALE: Not to Scale

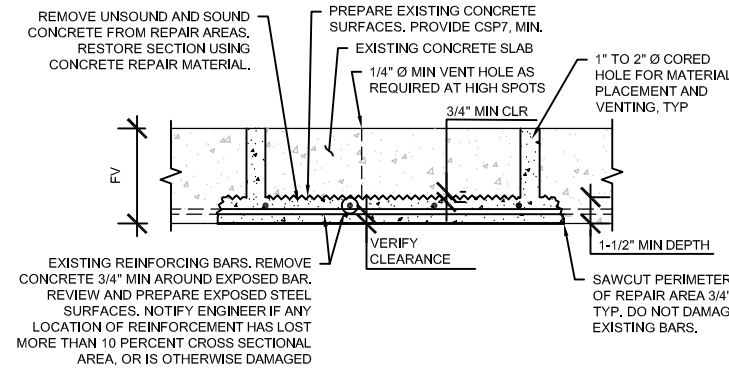
3 OVERHEAD REPAIR  
SCALE: Not to Scale

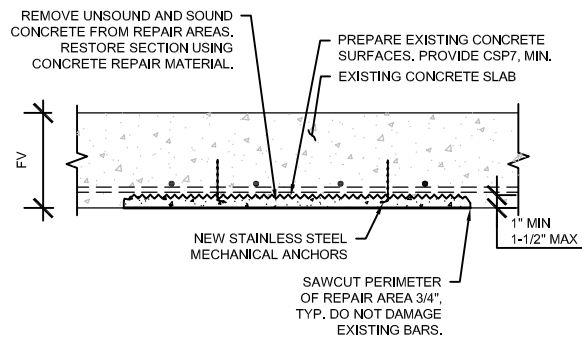
4 SHALLOW OVERHEAD REPAIR  
SCALE: Not to Scale

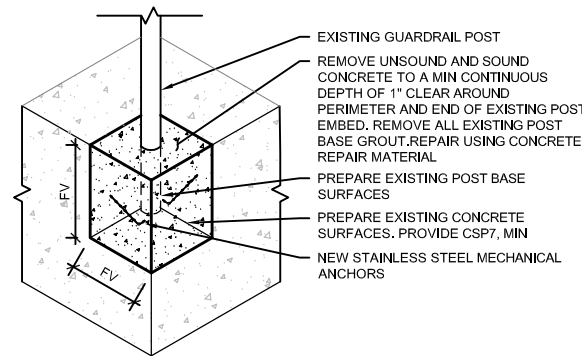
5 GUARDRAIL POST REPAIR AT AERATION BASIN  
SCALE: Not to Scale

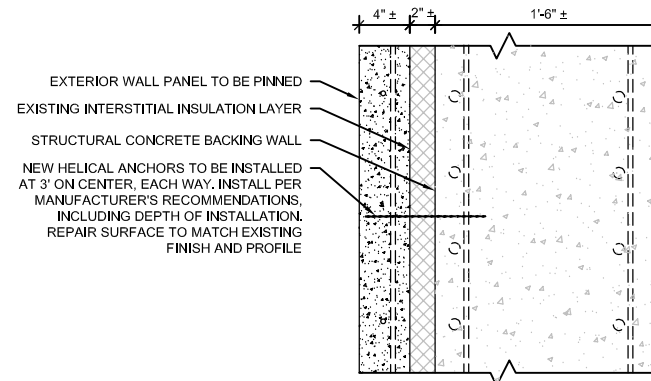
6 SUPPLEMENTAL ANCHORAGE AT ANAEROBIC DIGESTER PANELS  
SCALE: Not to Scale

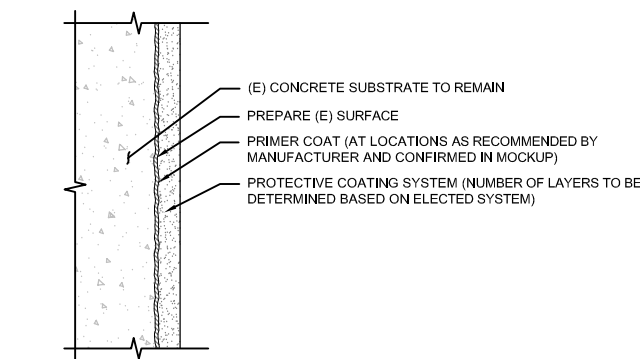
7 PROTECTIVE COATING SYSTEM  
SCALE: Not to Scale
