City of Grand Junction
Orchard Mesa Pool Improvements Study

November 26, 2018 FINAL

Introduction

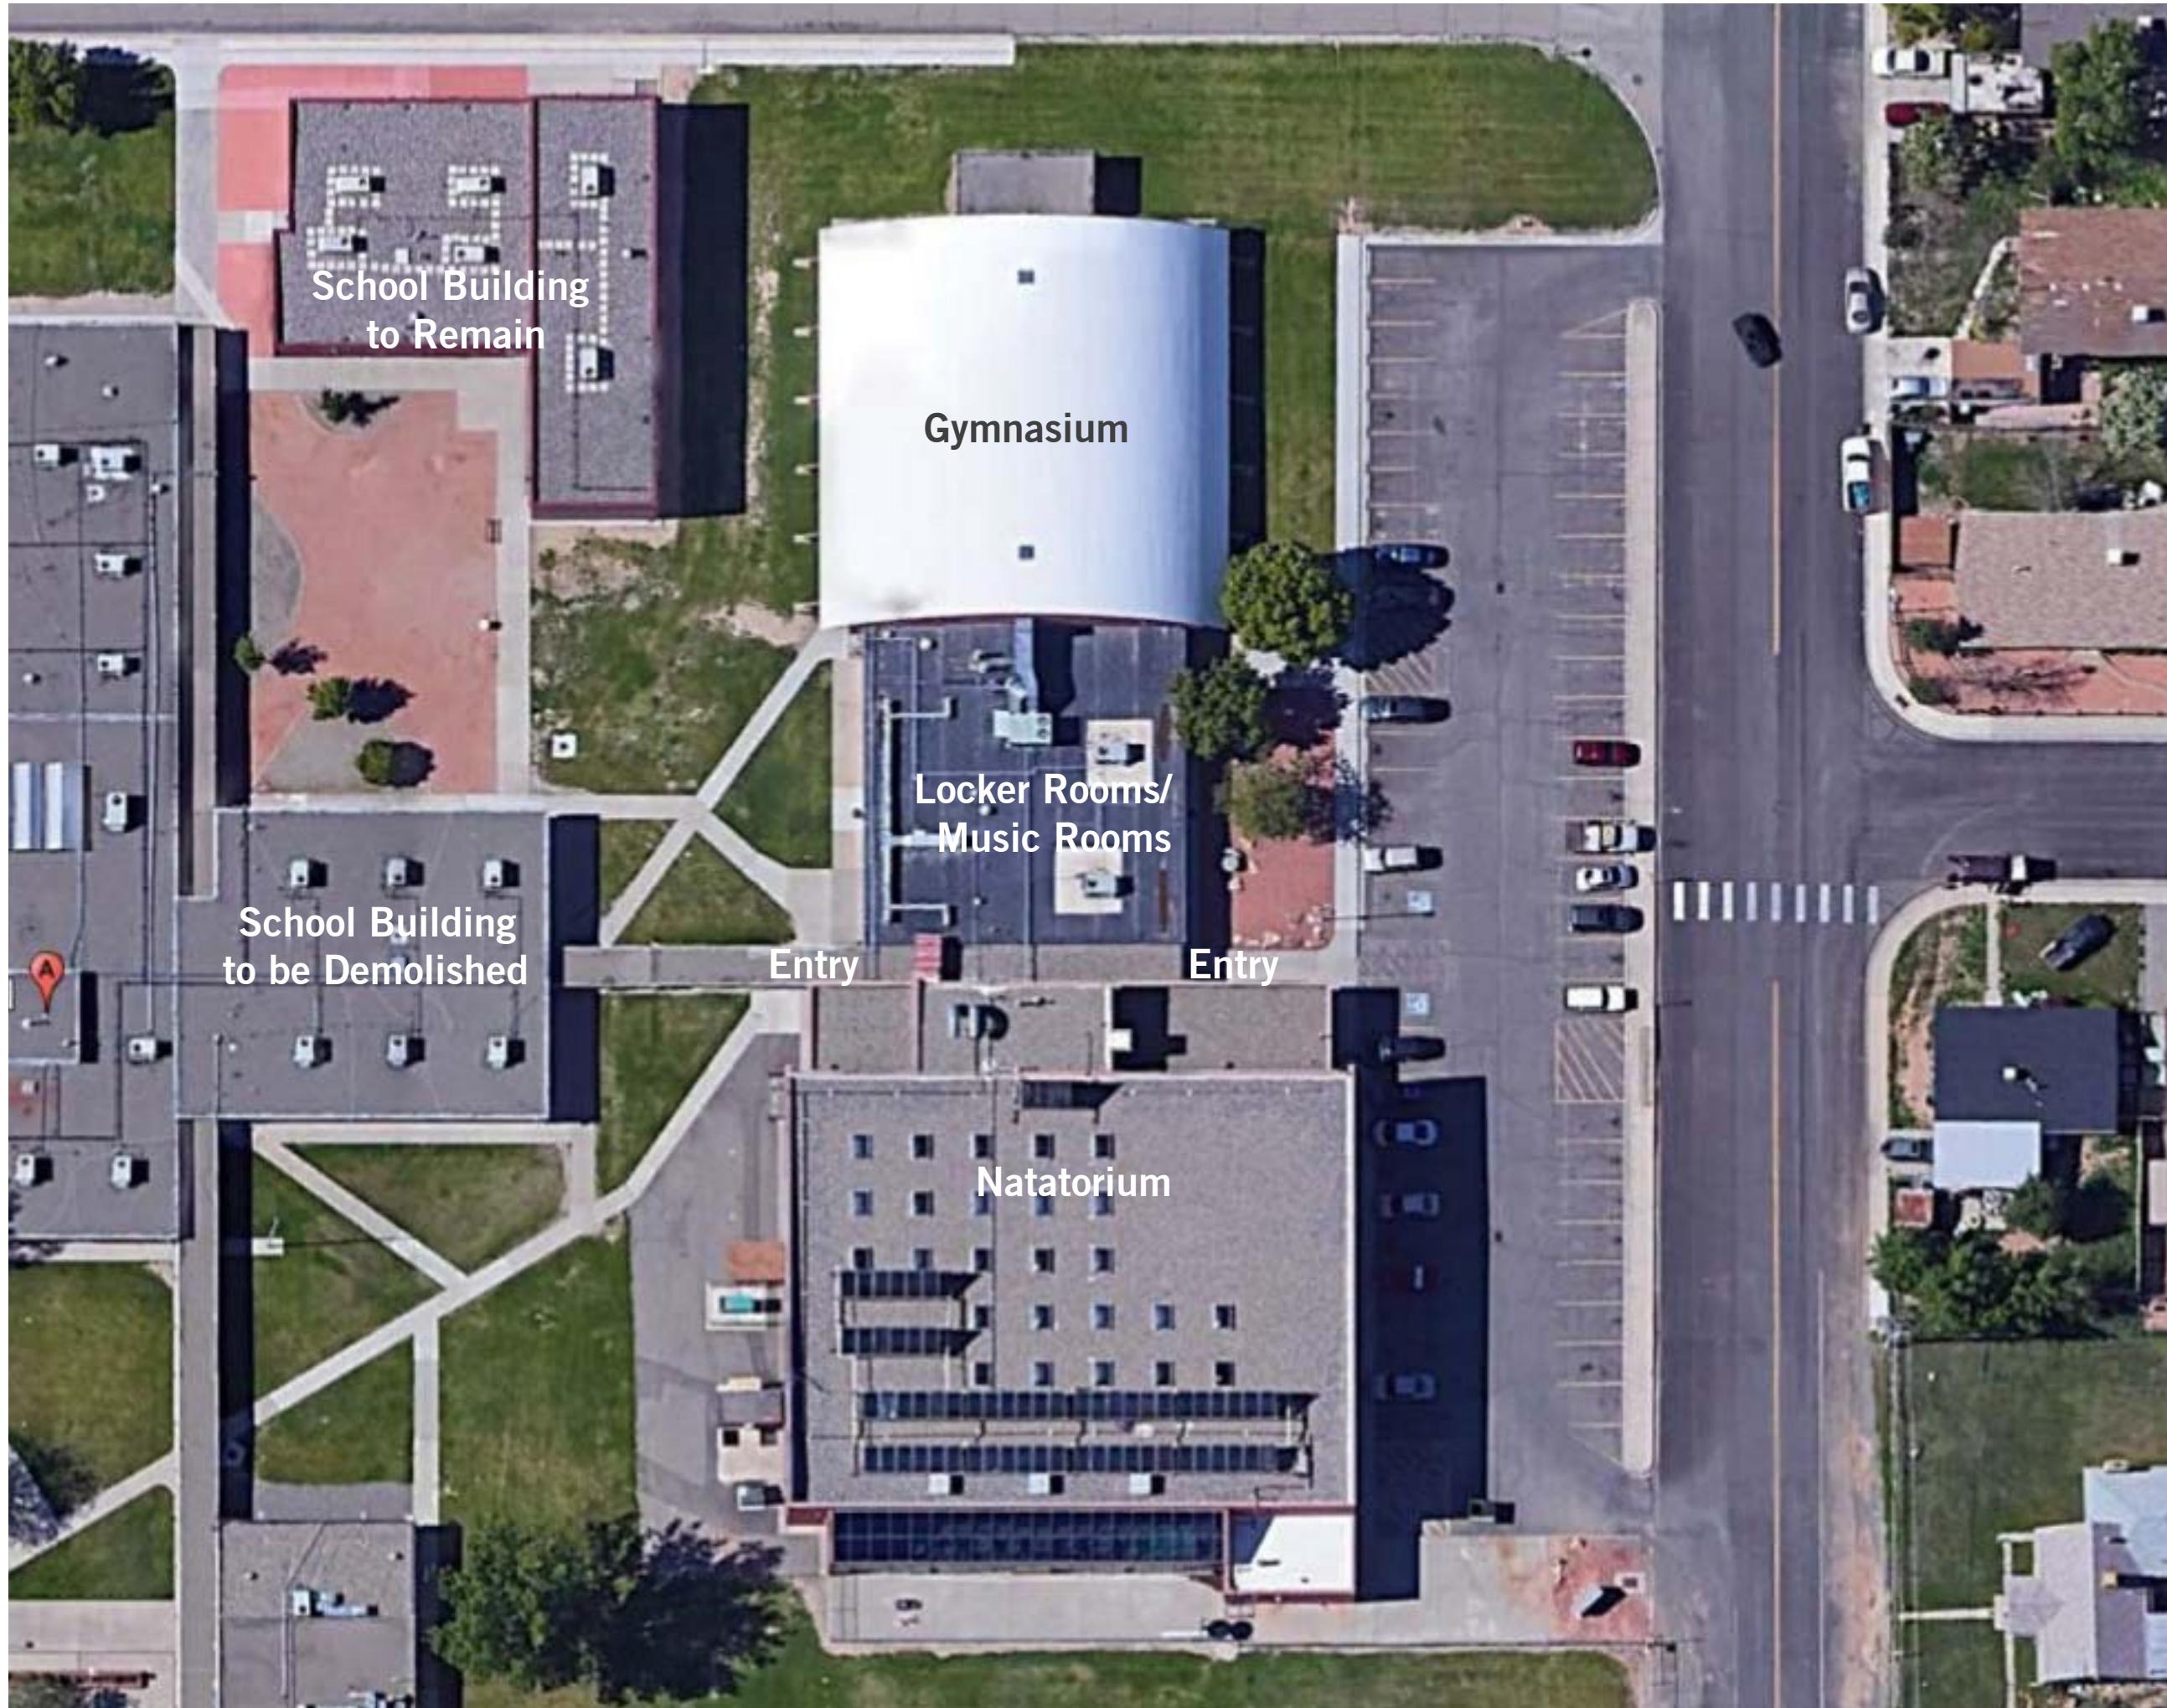
Executive Summary

School Building
to Remain

Gymnasium

Locker Rooms/
Music Rooms

School Building
to be Demolished

Natatorium
