Phase I
Environmental Site Assessment
225 S. 2nd Street
Grand Junction, Colorado

Avant Project Number: 9047-1
July 30, 2015

Phase I Environmental Site Assessment 225 S. 2nd Street Grand Junction, Colorado

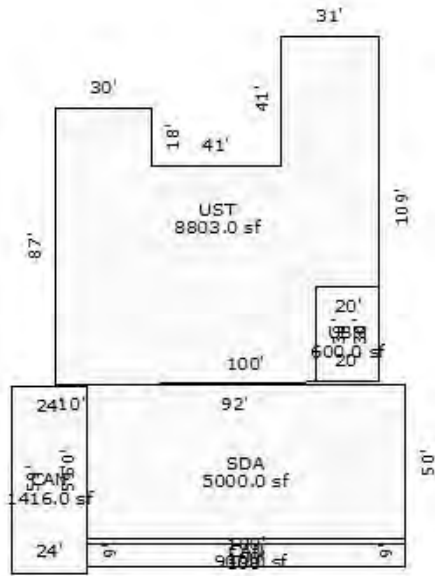
Building Description

Building #:	R064110COM1.1431710222729	Stories:	1
Units:	1	Quality:	AVERAGE QUALITY
Heated Sq. Ft.:	5000	Frame:	MASONRY
Building Use:	(2212)MERCHANDISING	Exterior Wall:	CONCRETE BLOCK
Model Desc.:	Commercial	Interior Wall:	DRYWALL
Style:	COMMERCIAL INDUSTRIAL	Roof Struct.:	FLAT
Actual Year Built:	1948	Roof Cover:	BUILT UP T & G
Effective Year Built:	1990	Air Cond:	ROOF TOP AIR
Architectural Desc.:	LG SHOP/OFFICE	Heat Fuel:	GAS
Rooms:		Heat Type:	FORCED AIR HEAT
Bedrooms:		Comm. Wall Ht.:	16
Bathrooms:	Commercial-No Bath	Comm. Fixtures:	7

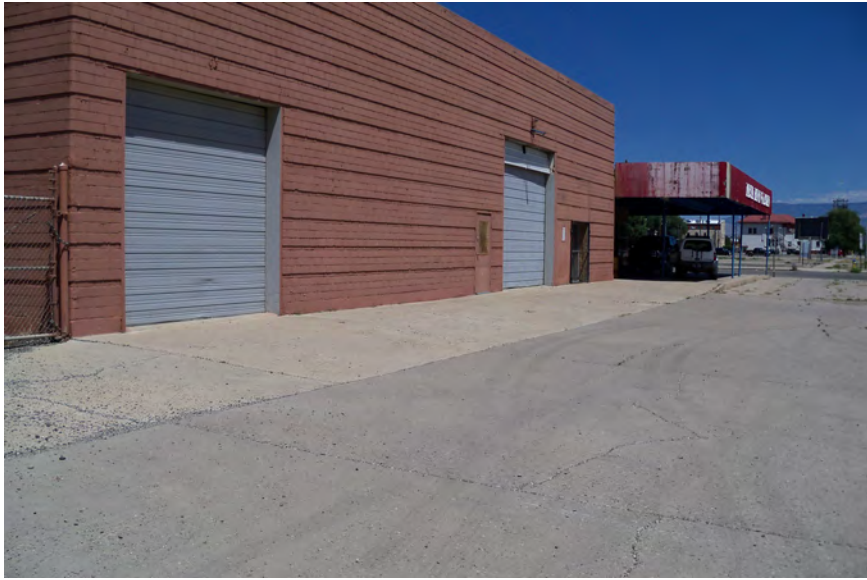
South side of business

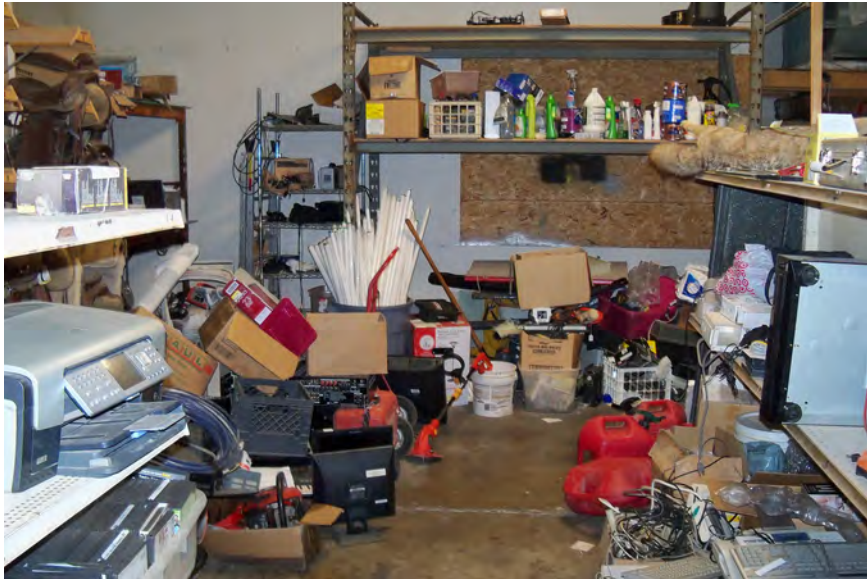
- The Site has historically been used as a pawn shop, for equipment rental, and for equipment and vehicle repair and maintenance. It currently has a large amount of pawned and used items for sale and is an active business. A thorough inspection of all floors and walls could not be conducted owing to cover by the stored materials.

Interior storage area

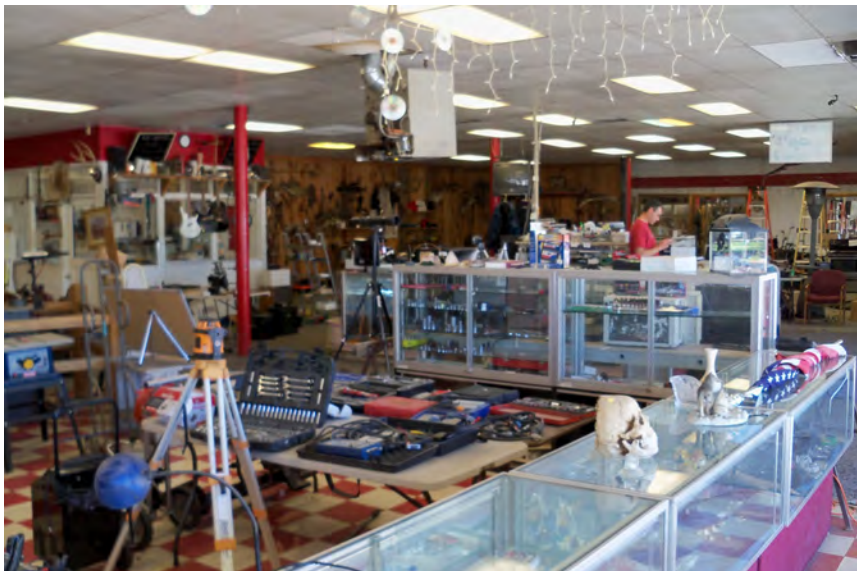
Retail area

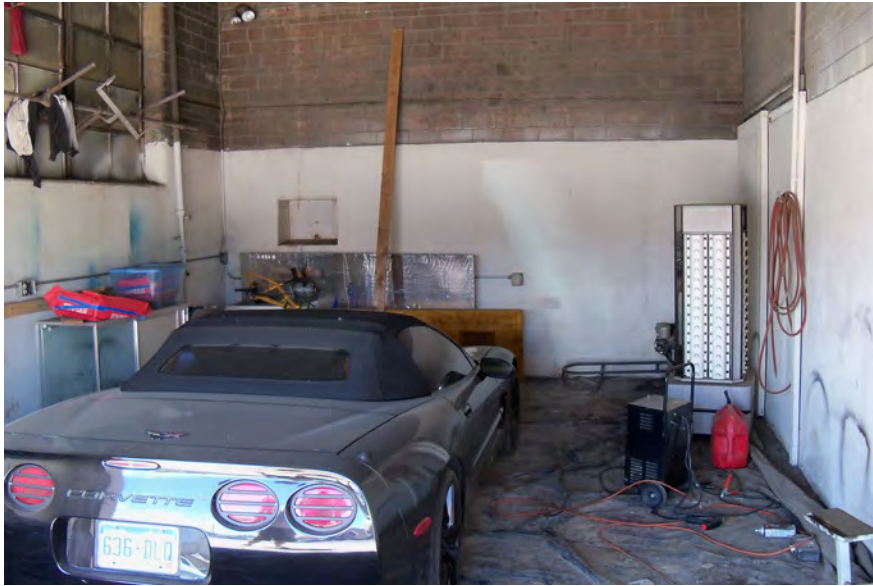
Paint booth

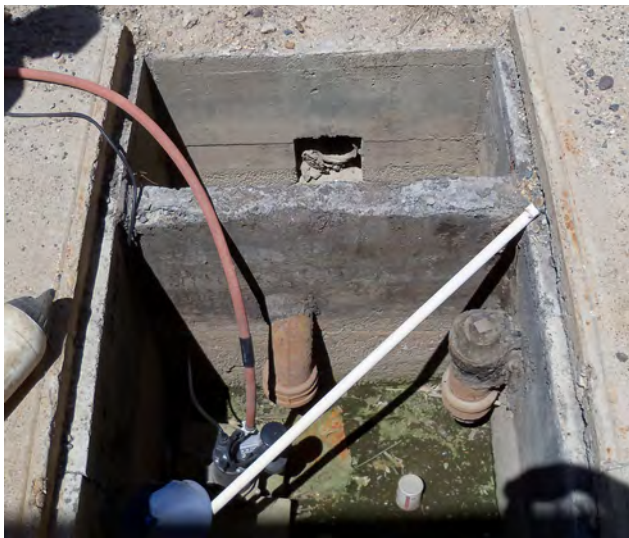
Sump or sand trap

Based on the findings of this Phase I Environmental Site Assessment (ESA), Avant recommends removing and properly disposing of all wastes, inspection and removal of contents from the sand trap, and removal of the oil-stained soil. An asbestos inspection of the structure should be conducted prior to any activities that would affect potentially asbestos-containing materials, such as remodeling or demolition. A re-inspection of the premises is recommended once all stored material is removed.

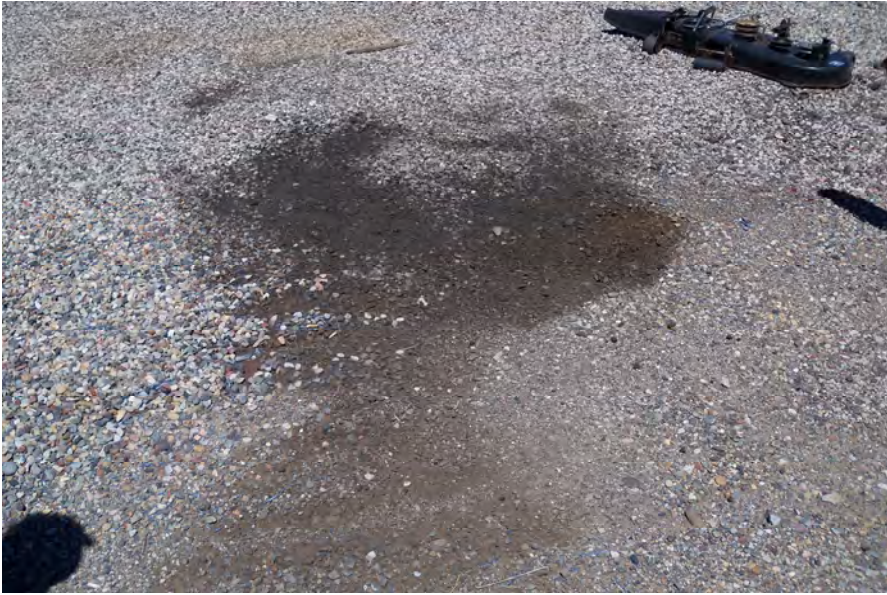
- An oil stain is present in the graveled yard; this was reported to be a hydraulic fluid leak by the Operator. It does not appear to be extensive, but should be excavated and properly disposed or otherwise remediated.

Oil stained soil in yard

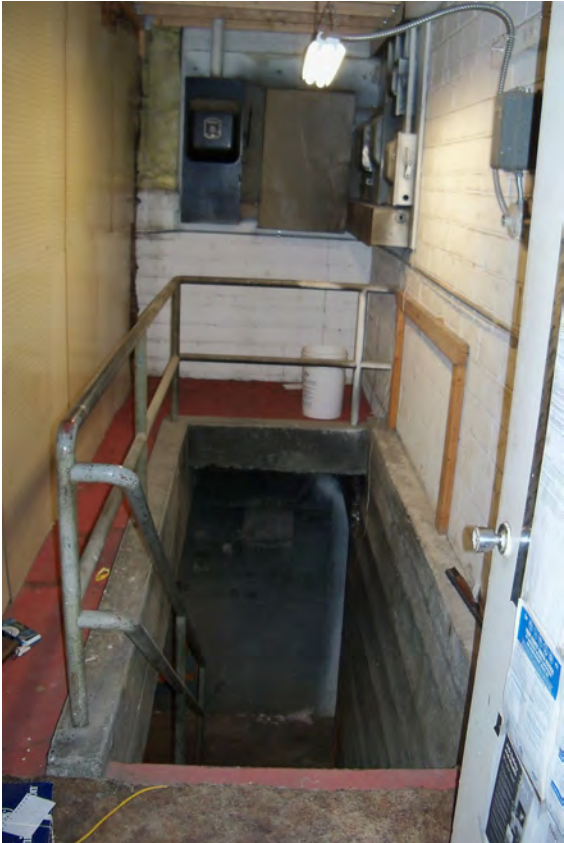
Basement access

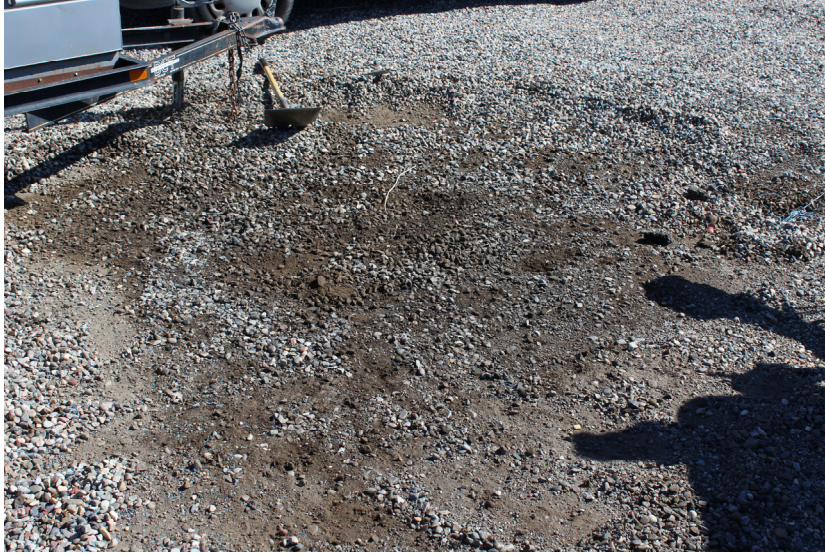
Oil stain in yard. It is about 8 feet in diameter and is underlain by broken asphalt at a depth of about 2 inches. Analytical results are consistent with a hydraulic fluid leak.

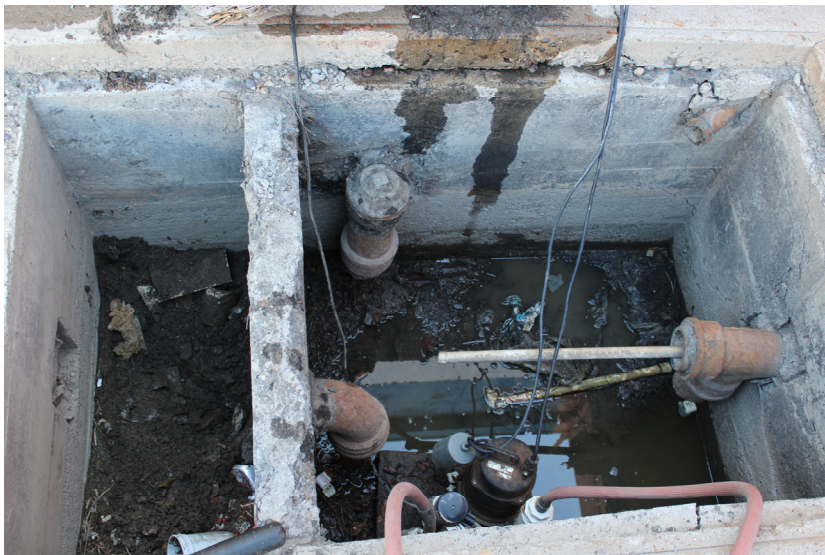
Sand trap and oil/water separator. Sump pump reportedly used by owner to remove accumulated stormwater as needed. Note water and sediment in bottom and minor cracking in top right corner and around outlet pipe.

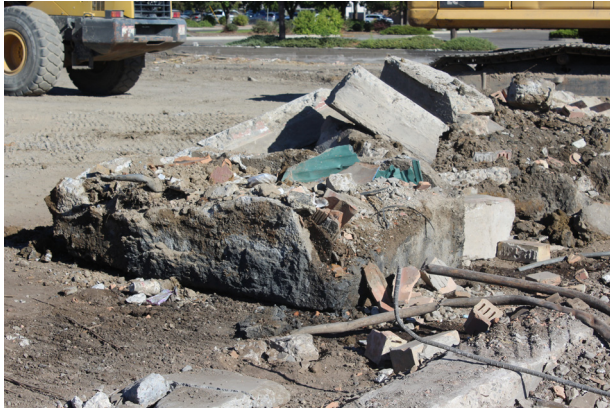
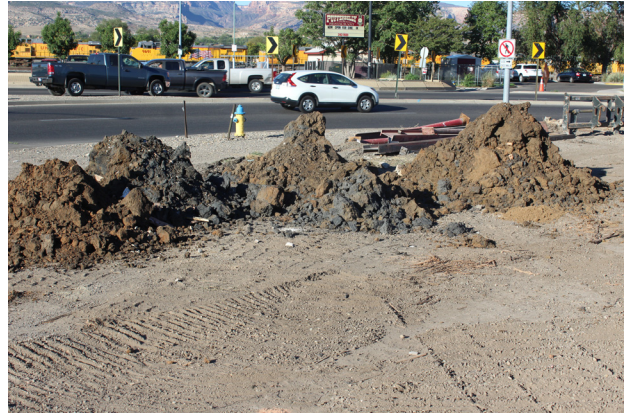
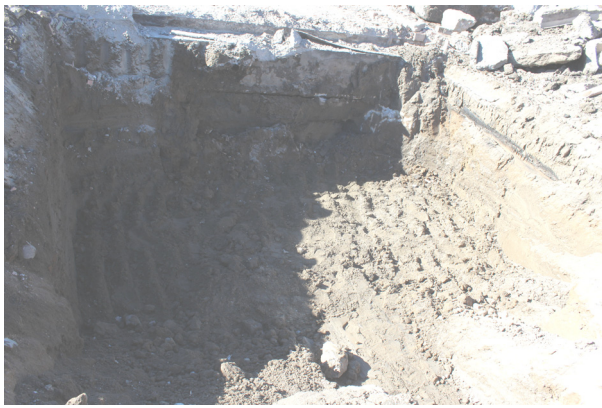
Avant Environmental Services, Inc. (Avant) observed the removal of an oil/water separator at the above-referenced property. The building was being demolished and the separator was removed under observation by Avant in order to determine if its historic use had impacted soil in the vicinity. On September 4, 2020 Avant met personnel from CW Construction and observed the removal of a buried concrete oil/water separator using a track-mounted excavator. The separator was an intact block of concrete that contained a minor amount of water that had entered it during a recent rainstorm. Soil in the vicinity had an odor of petroleum or solvents and a seam of dark staining was visible adjacent to the separator extending to the south and west. The operator removed this stained soil and stockpiled it on the project site. Avant used a photo-ionizing detector (PID) equipped with a 10.6 electron-volt lamp to measure volatile organic compounds in ambient air, air adjacent to the stained soil, and in headspace of soil. The PID measured 11 to 15 parts per million (ppm) volatile organic compounds (VOCs) in air adjacent to the soil. Head space was measured by placing stained soil into a Ziploc bag, sealing the bag, warming the soil, and measuring the air within the bag. These results ranged from 380 to 4,000 ppm. All visibly-impacted soil was removed from the area around the separator, resulting in an excavation that was about 12 feet by 15 feet and about 4.5 feet deep (see photo).

Photos showing oil/water separator (top left), stained soil stockpile (above) and final excavation (left)

Avant obtained a soil sample from six inches deep beneath the center of the excavation and another from the most visibly-stained soil within the stockpile. Samples were placed into laboratory-provided glass jars with Teflon septa, labeled, placed on ice, recorded on a chain of custody form, and shipped via overnight courier to Pace Analytical Laboratories of Mt. Juliet, Tennessee. Samples were analyzed for VOCs using EPA Method 8260. Results show no detections of any regulated VOC. As such, the soil may remain on site.
