Grand Junction Urban Trails Committee Special Workshop

Meeting Date: October 23, 2024
Prepared By: Henry Brown, Mobility Planner

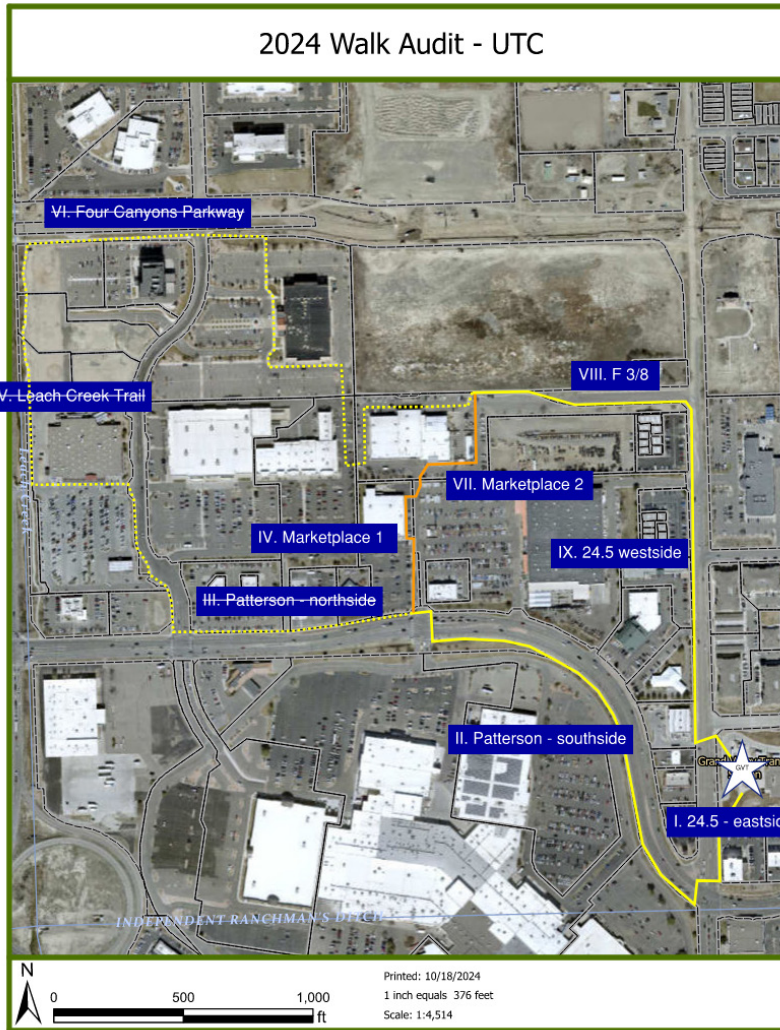
Fig. 1 (left). The Northwest GJ Walk Audit route consisted of six segments and focused on the survey area between GVT West and Home Depot and other commercial parcels. The dashed yellow line represents the proposed route, while the orange line shows the bypass that was taken instead due to a lack of time.
