**URBAN TRAILS COMMITTEE AGENDA
CITY HALL AUDITORIUM, 250 N 5th STREET**

Grand Junction Urban Trails Committee

Special Workshop – Winter Walk Audit – 2/12/2025

EXECUTIVE SUMMARY

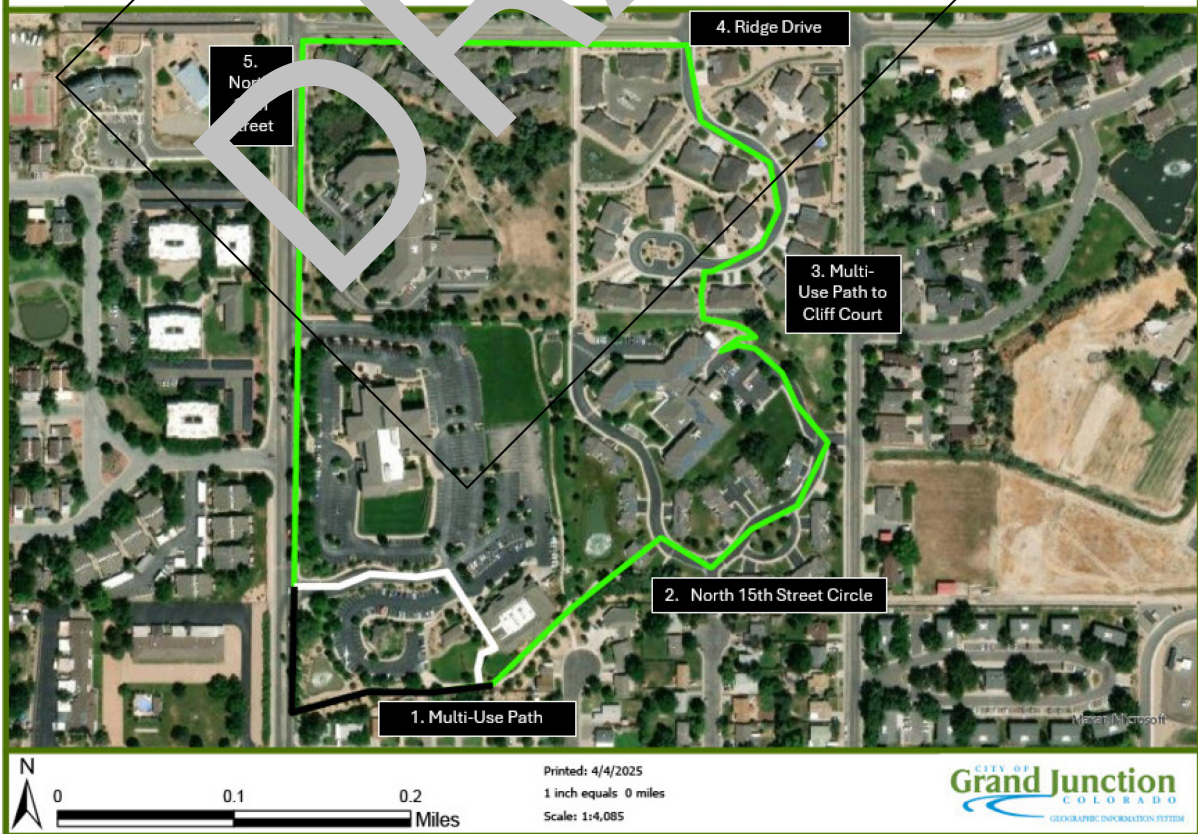
2025 Winter Walk Audit - Route 2

Auditors of Route 2 observed very few other pedestrians on the route, along with very clean paths but relatively poor lighting. Participants agreed that the crosswalks near 12th Street were poorly marked, while interior crosswalks were well-marked. The two bus stops along the route were observed to offer some amenities for transit users. The tree cover was sufficient, and landscaping was not observed to be encroaching on sidewalks. Overall, Route 2 auditors found themselves to be a relatively safe distance from moving cars.

Route 2 Segments	Configuration	Perceived/ Estimated* PLOTS
1. Multi-Use Path	Wide, low-stress detached paths with good tree cover. Lighting along the path is deficient. Could use a railing on the south side to prevent people from falling into the drainage way.	1.5

2. North 15 th Street Circle	Low stress. No lighting along the sidewalks other than the ones attached to the houses.	1.5
3. Multi-Use Path to Cliff Court	Low stress and better lighting. The crosswalk across Cliff Court that connects to the path along the drainage way could be marked.	1*

4. Ridge Drive	Deficient lighting. Good use of railings on the south side.	2.5*
5. North 12 th Street	Decently wide paths but with deficient lighting. The lamp post in the middle of the crosswalk across 12 th near Lakeside Drive is not working and there should be a better way to alert drivers of crossing pedestrians (i.e. a flashing beacon).	2.5*

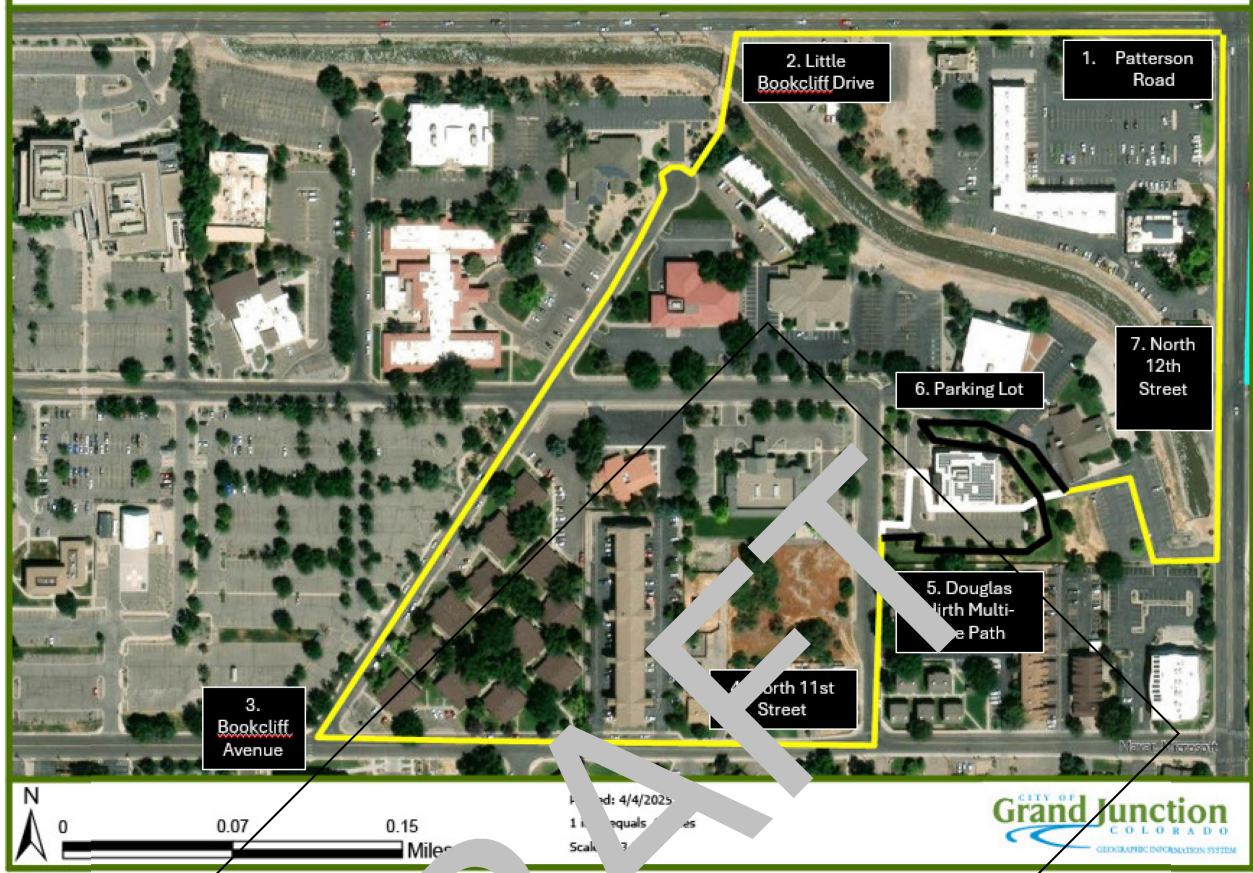
2025 Winter Walk Audit - Route 5

Route 5 participants only observed other sidewalk users near Patterson Road and 12th Street. The amount of debris present varied across the segments, with Bookcliff Avenue found to be cleanest. The same was true for lighting, with North 11th Street in particular receiving poor marks. Auditors found most crosswalks were not well marked, particularly on Little Bookcliff Drive and North 11th Street. Participants did not feel that all signalized crossings at the Patterson Road/North 12th Street intersection provided enough time for a safe crossing. The sufficiency of tree shade varied across segments, with the best on Little Bookcliff Drive and the poorest on 12th Street. The only bus stops observed, on 12th Street, had mixed opinions on its accessibility and amenities for transit users. Landscaping was encroaching onto the sidewalk on North 11th Street, but in good condition elsewhere. Participants felt moderately safe throughout the southern part of the route, but not along Patterson Road nor North 12th Street.

Route 5 Segments	Configuration	Perceived PLOTS
1. Patterson Road	Sidewalk felt very exposed to vehicular traffic with little room for error. Driveway conflicts were of a variable nature, some communicating “pedestrian area” and some communicating “intersection.” There was evidence of historical tactile pads in places where none remain today. The connection to Little Bookcliff felt like a secret passageway, “if you know you know.”	3.2

2. Little Bookcliff Drive	Significantly quieter, more of a neighborhood feel. However, crossing distances felt particularly unnecessarily long, and curb ramps were not well-aligned to crossings.	1.5

3. Bookcliff Avenue	Sidewalk wound around driveways and parking pods, where a truck was significantly overhanging the walkway. Driveway conflicts were again of various styles, some comfortable; some steep.	1.5

4. North 11 th Street	Overhanging branches could use a trim. With no crossing marked near the route’s right turn, the group attempted a midblock crossing when the way looked clear but ended up jogging when a vehicle turned the corner.	2.5

5. Douglas Hirth Multi-Use Trail	Due to landscaping, the pedestrian connection (north of the driveway) was hidden, another secret passageway. The group entered via the driveway instead and progressed along the walkway until it ended, crossed through landscaping down a small embankment, and through a dark and desolate parking lot to navigate back to 12 th Street.	2.3

6. Parking Lot		
7. North 12 th Street	Similar to Patterson Road with a high level of exposure and little room for error. Driveways feel more like intersections than sidewalks, have unnecessary crossing length and out-of-path travel.	3.3
