Geotechnical Investigation Forrest Glen Subdivision North and East of F 1/2 Road and 29 Road Grand Junction, Colorado

Environmental Investigation Forrest Glen Subdivision North and East of F 1/2 Road and 29 Road Grand Junction, Colorado

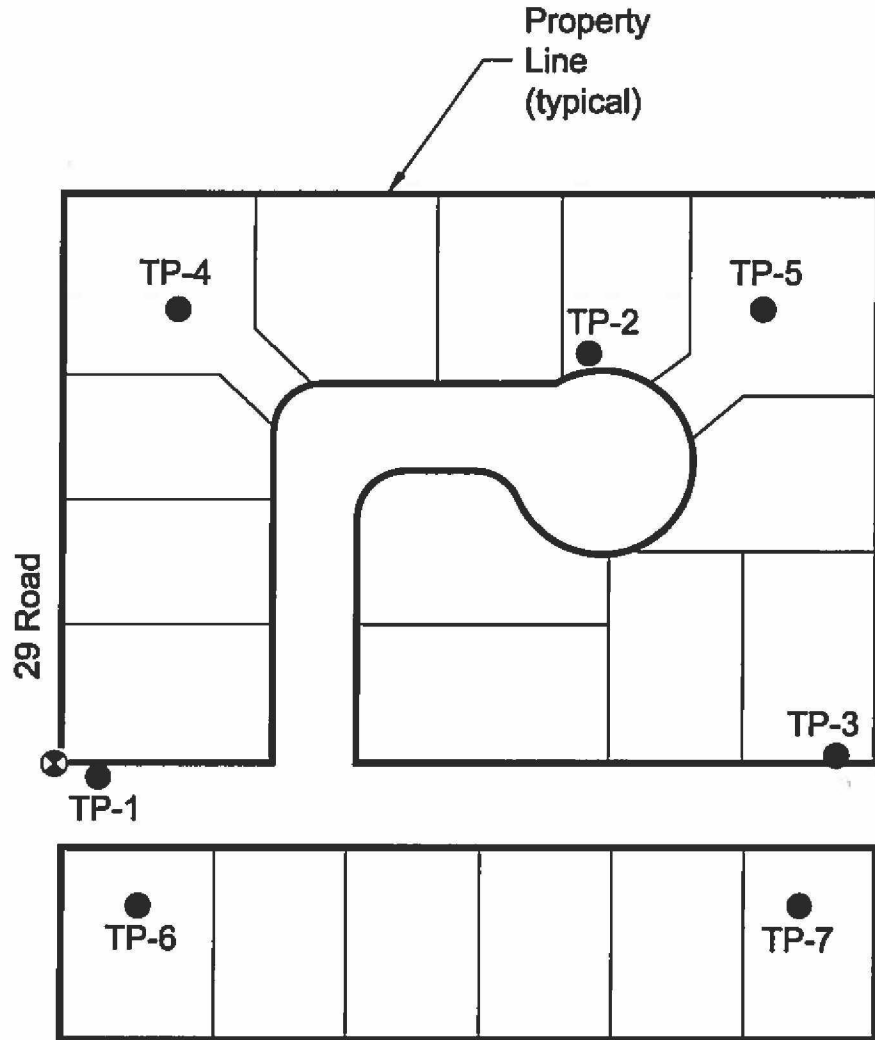
- Indicates location of exploratory test pit.
- ⊗ TBM: Corner of water meter cover in South West portion of site. Datum= 100.0'

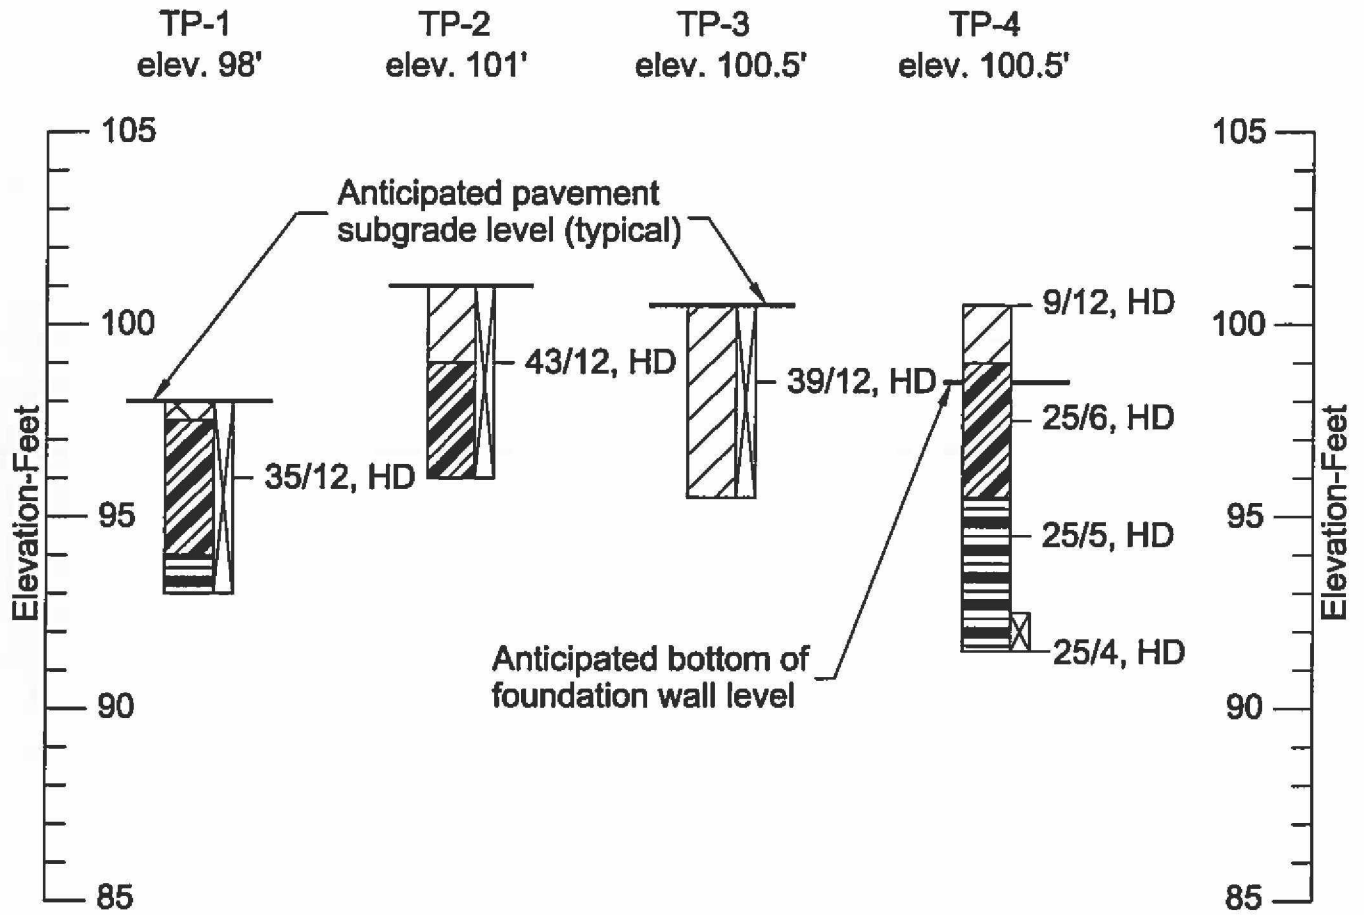
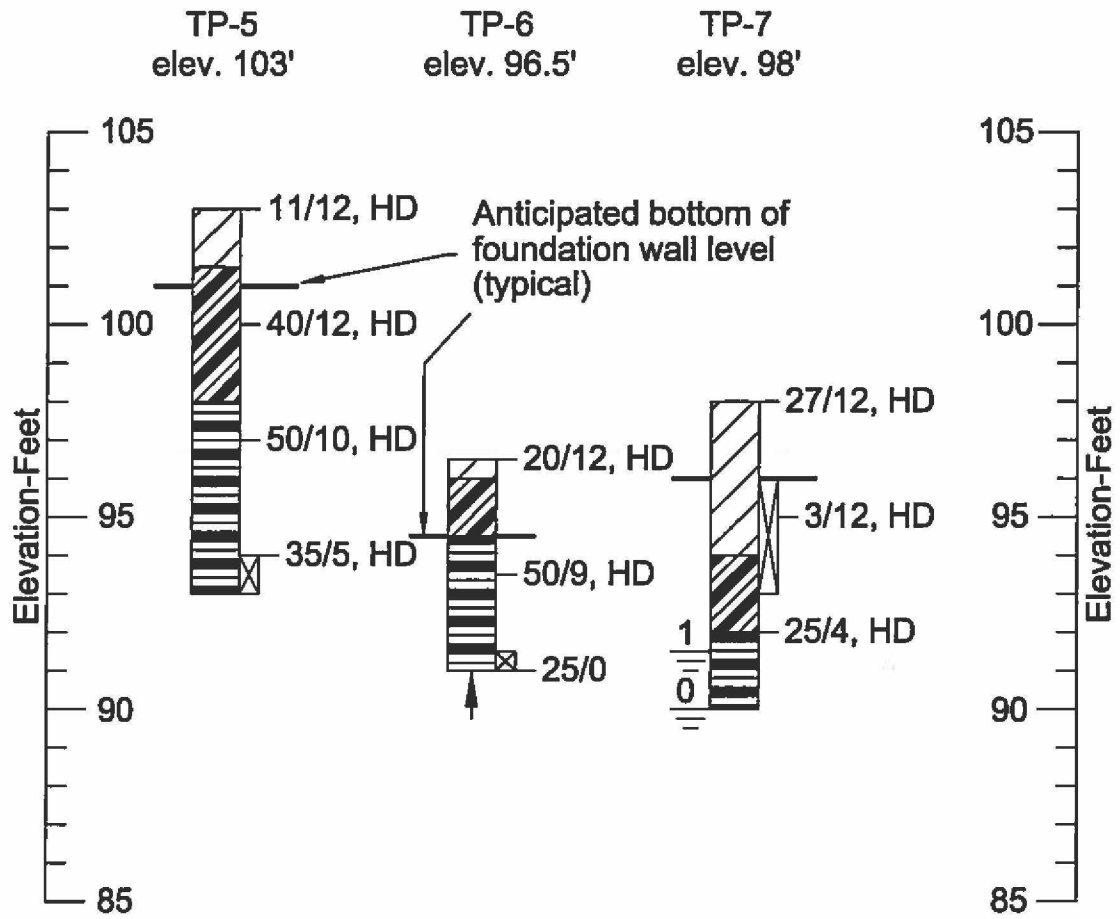
Legend of Logs of Exploratory Test Pits

Existing fill material, variable, gravel and sand, dry, tan, gray

Clay, very soft to very stiff, dry to moist, tan, brown, gray (CL,CH)

Extremely weathered shale, clayey, very stiff to medium hard, dry to moist, brown, gray, layered, fractured, sulfates noted

Shale, medium hard to hard, dry to moist, brown, gray, fractured, layered

1. Test pits were excavated and observed December 2, 2002.
2. Elevations of borings were determined using an automatic level and the temporary benchmark (TBM) shown on Fig. 2.
3. These logs are subject to the explanations, limitations and conclusions as contained in this report.

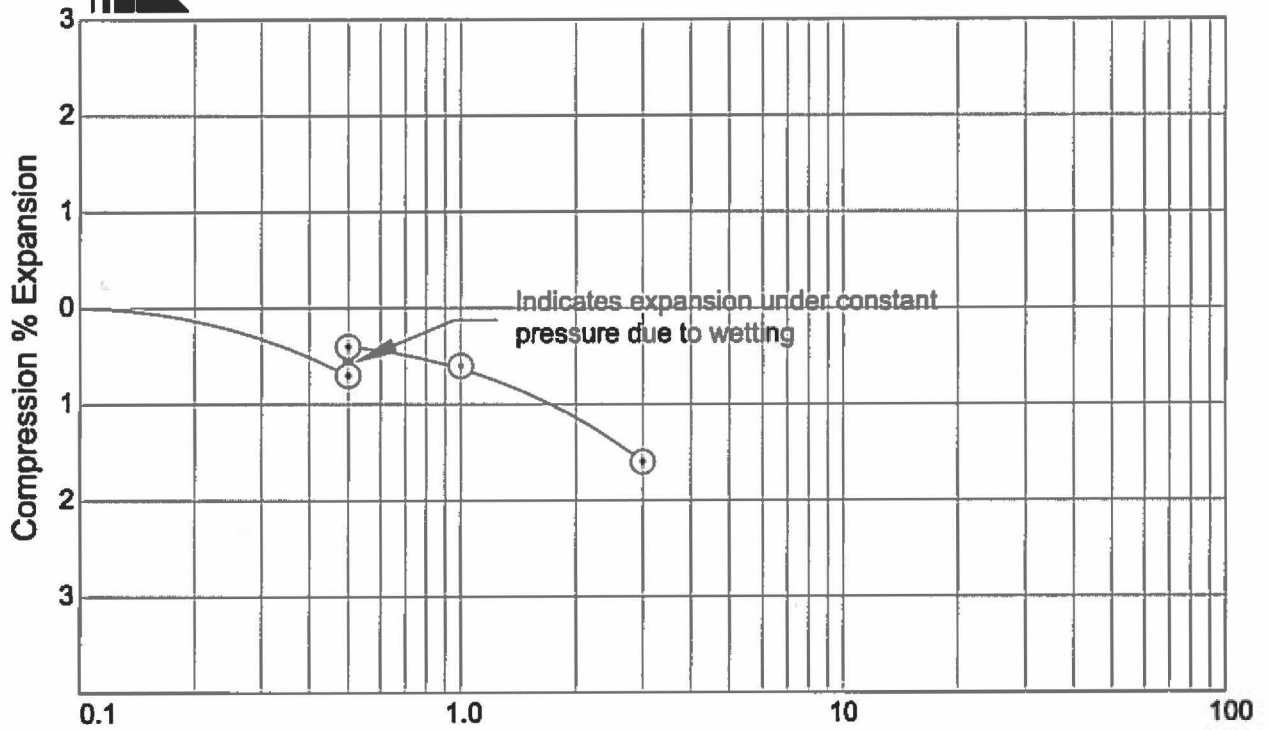
Sample of: Extremely Weathered Shale
From: TP-4 @ 3 feet depth

Dry Unit Weight= 116 PCF
Moisture Content= 14.7 %

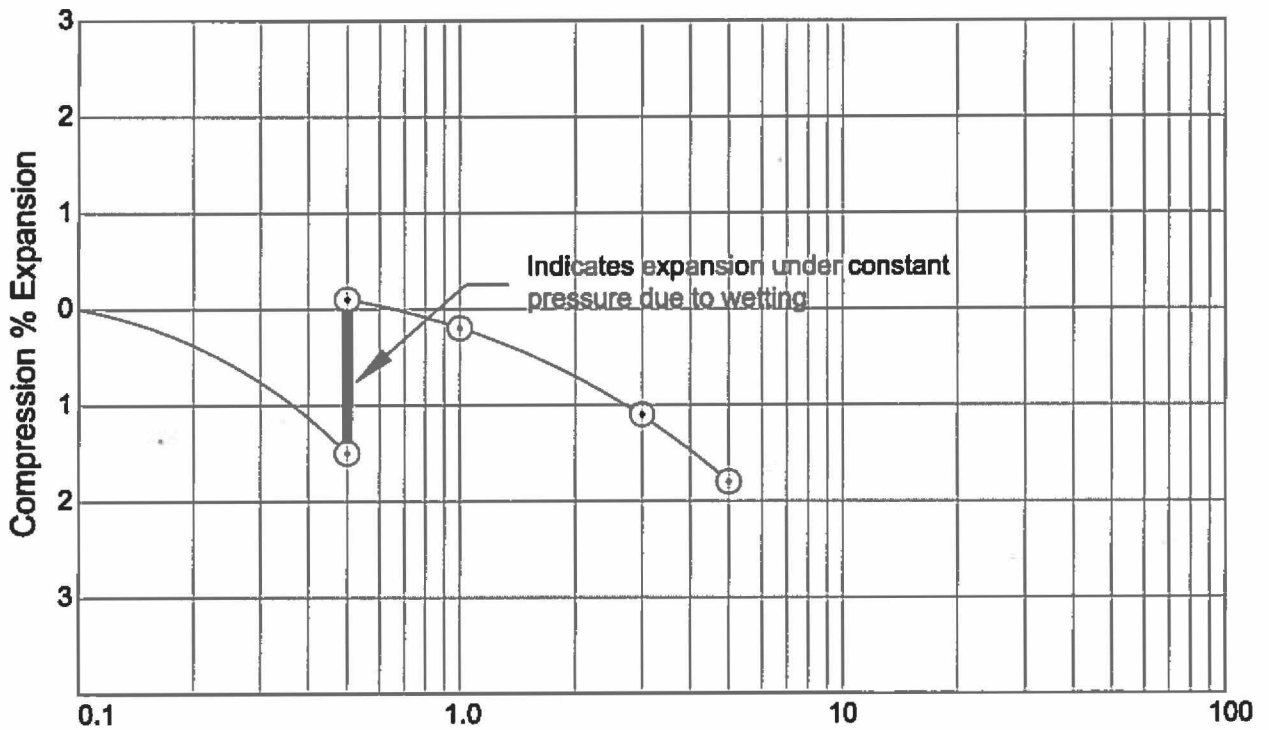
Sample of: Extremely Weathered Shale
From: TP-5 @ 3 feet depth

Dry Unit Weight= 111 PCF
Moisture Content= 18.8 %

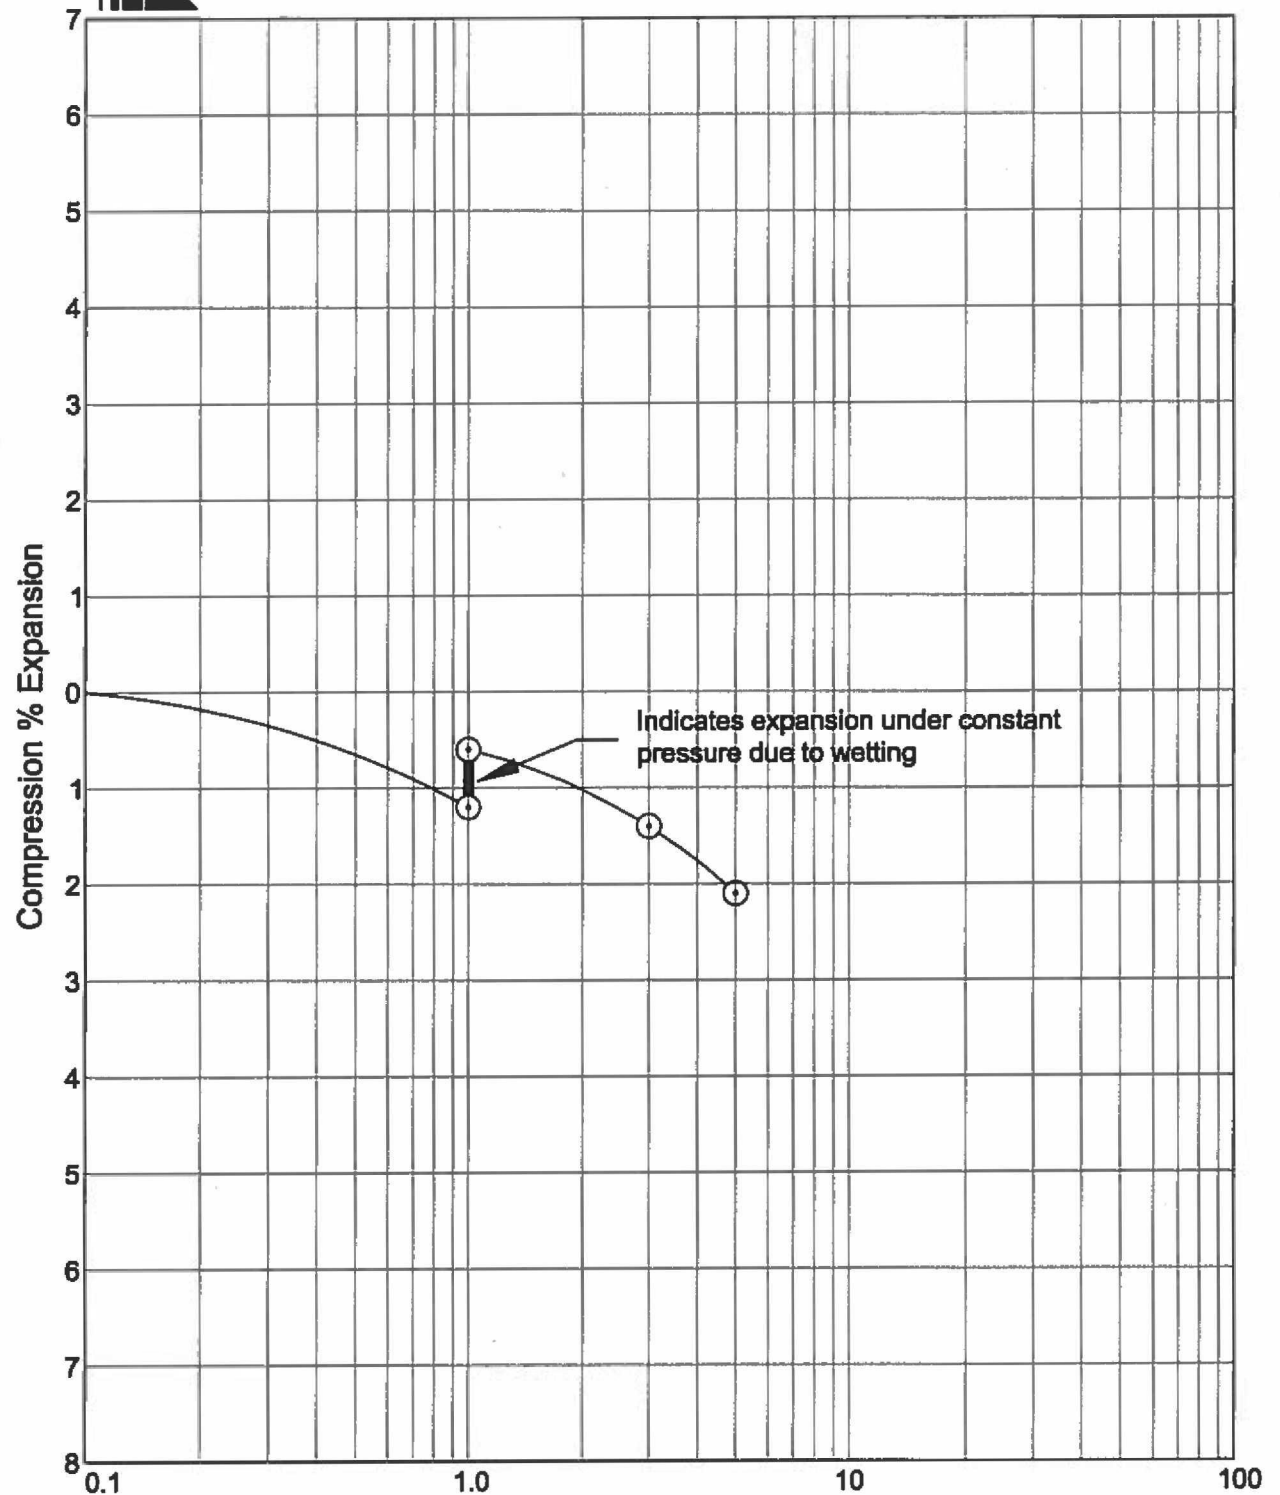
Sample of: Shale, clayey
From: TP-7 @ 6 feet depth

Dry Unit Weight= 113 PCF
Moisture Content= 14.1 %

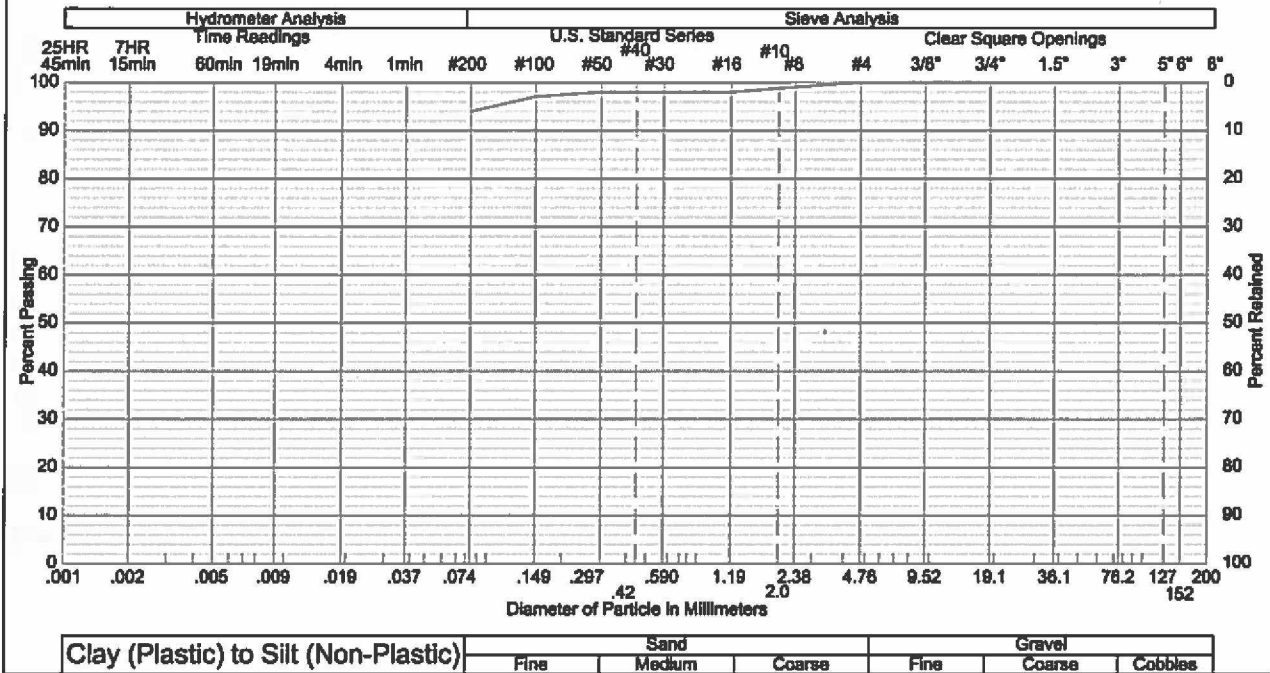
Sample of: Clay, extremely weathered shale and shale
 From: TP-1 and 2 @ 0 to 5 feet, bulk combined

Gravel: 0 %
 Silt & Clay: 94 %
 Plasticity Index: 18

Sand: 6 %
 Liquid Limit: 42

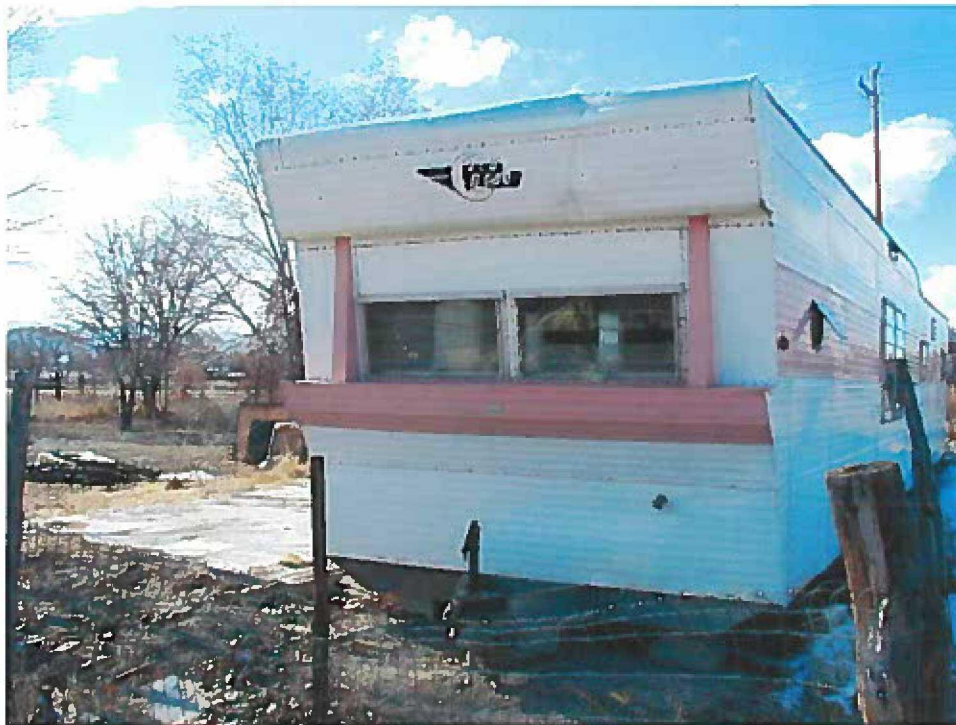
Photograph 1 – Mobile Home. View to the west-southwest.

At the time of our investigation, the subject site was occupied by a mobile home and vacant land (Appendix B, Photographs 1 and 2). The mobile home was reported to be served by municipal water, natural gas, and electric power. We were informed by the Site Owner, Mr. Max Sneddon, that domestic waste was directed to an on-site leach field.

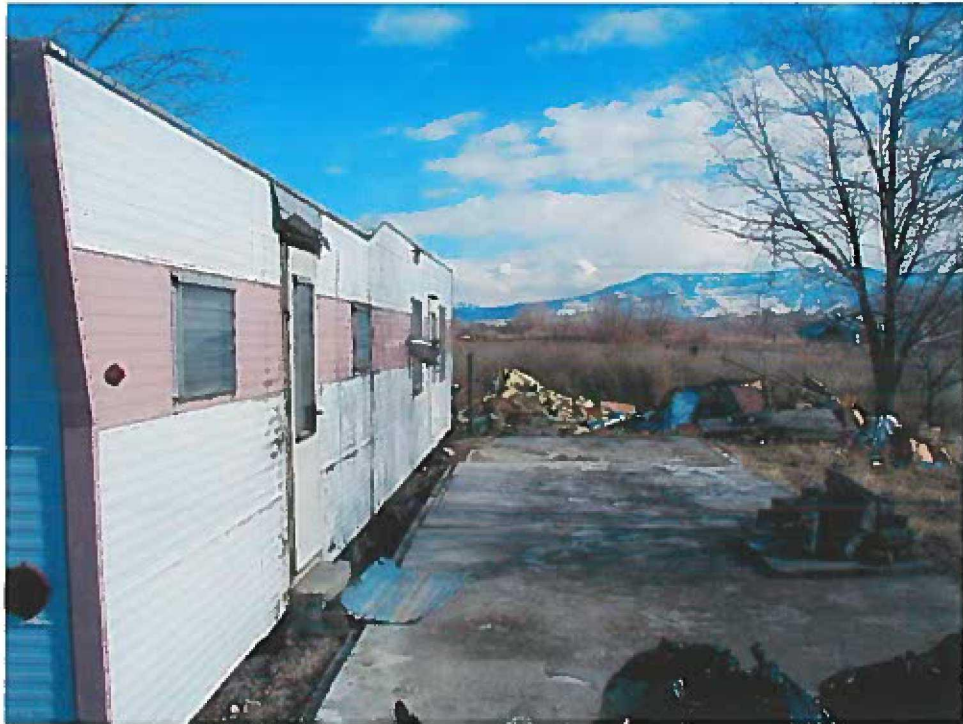
Photograph 3 – Mobile Home. View to the east. Note construction debris.

Surface vegetation included weeds and grasses. We observed construction debris (Appendix B, Photograph 3). We did not smell noxious odors or observe staining on the ground during the site visit. We noted north/south furrows across the field. An irrigation canal was located south of the subject site and near the south property line in the western portion of the site. The canal was approximately 6 to 8 feet in depth and no water was flowing at the time of site visit (Appendix B, Photograph 4). A barbed-wire fence surrounded the subject site. The ground surface on site had a very gentle slope to the south. No recognized environmental conditions were observed on the subject site.

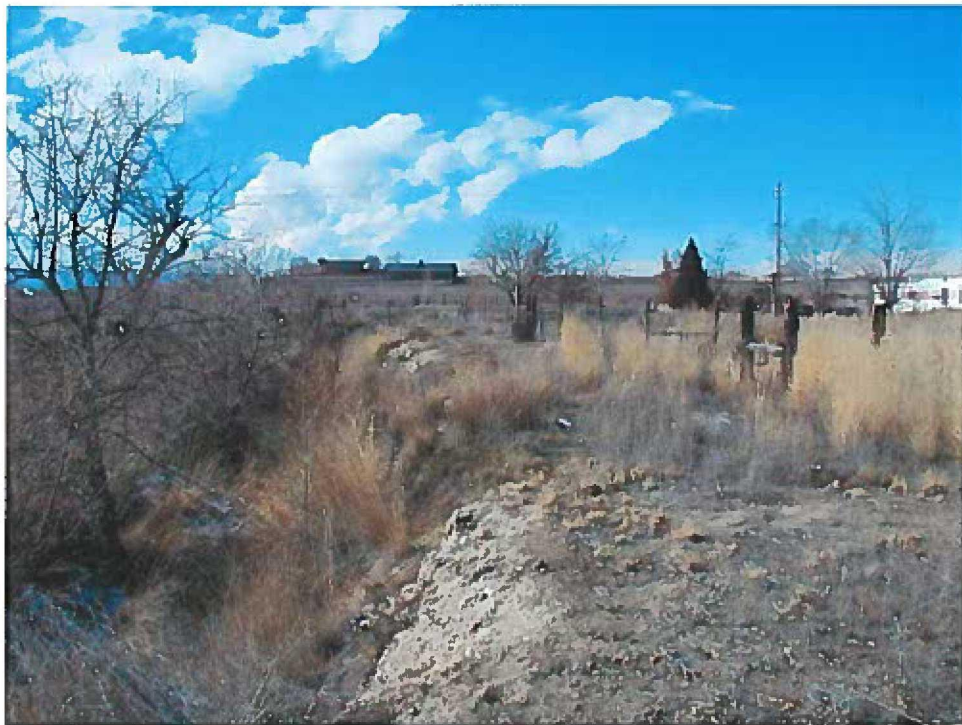
Photograph 4 – Irrigation Canal. View to the west.

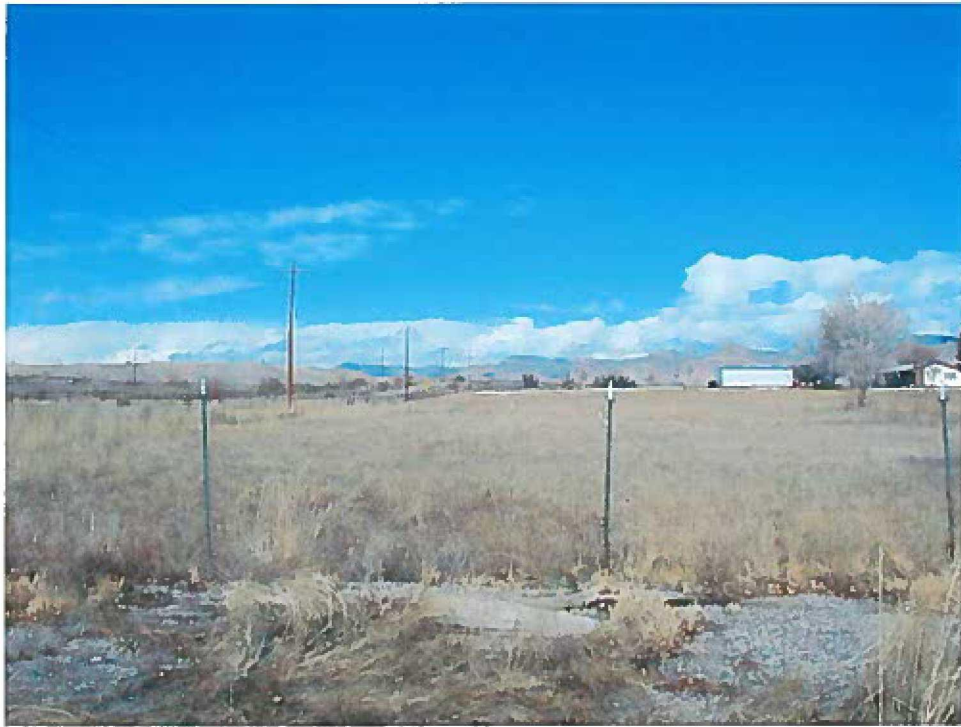
Photograph 5 – Subject site and vacant land adjoining the site to the north.

The surrounding areas were generally flat, sloping down toward the southwest at a gradient of approximately 1 to 3 percent (USGS). Agricultural land adjoined the subject site to the north (Appendix B, Photograph 5), east, and south (Appendix B,

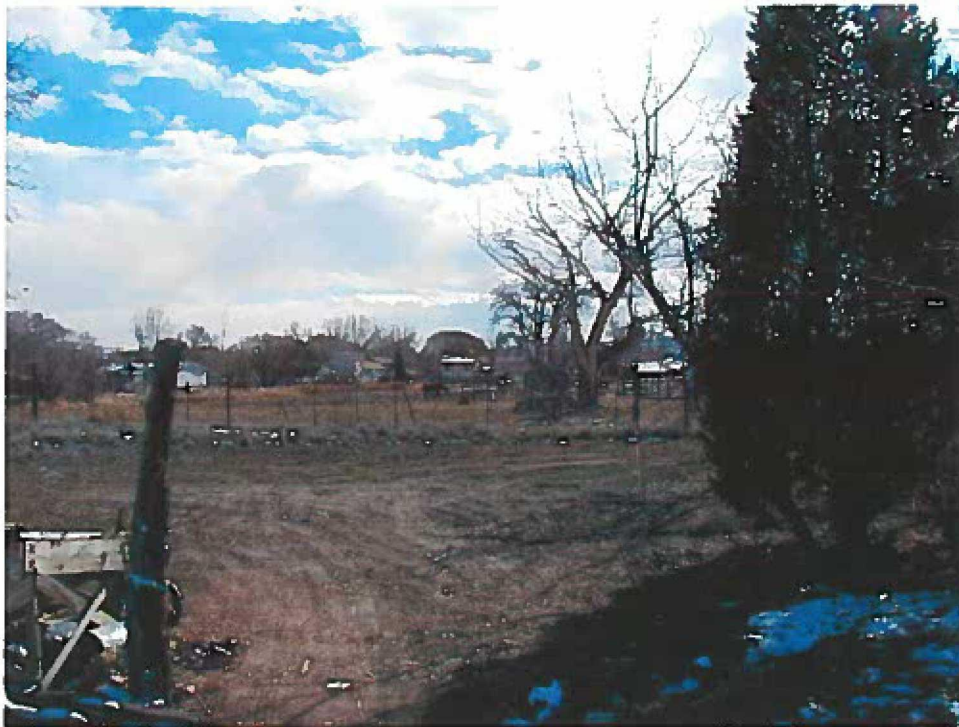
Photograph 6 – Subject Site. View to the south.

Photograph 6). Adjoining the subject site to the west was 29 Road and agricultural land.
