Architectural Inventory Form

1. Resource number: 5ME.14590
2. Temporary resource number: 1217.FIFT
3. County: Mesa
4. City: Grand Junction
5. Historic building name: n/a
6. Current building name: n/a
7. Building address: 1217 N. 15th Street
8. Owner name and address: Morse Living Trust
1018 Twining Ave San Diego, CA 92154-2559

47. Photograph numbers: Roll # 5 Frame # 37 and Roll # 16 Frame # 15
Negatives filed at: City of Grand Junction Planning Dept.
48. Report title: Grand Junction Phase 3 Survey 49. Date(s): March 2005
50. Recorder(s): Suzannah Reid, Patrick Duffield and Lydia Herron
51. Organization: Reid Architects, Inc.
52. Address: PO Box 1303 Aspen, Colorado 81612
53. Phone number(s): 970 920 9225

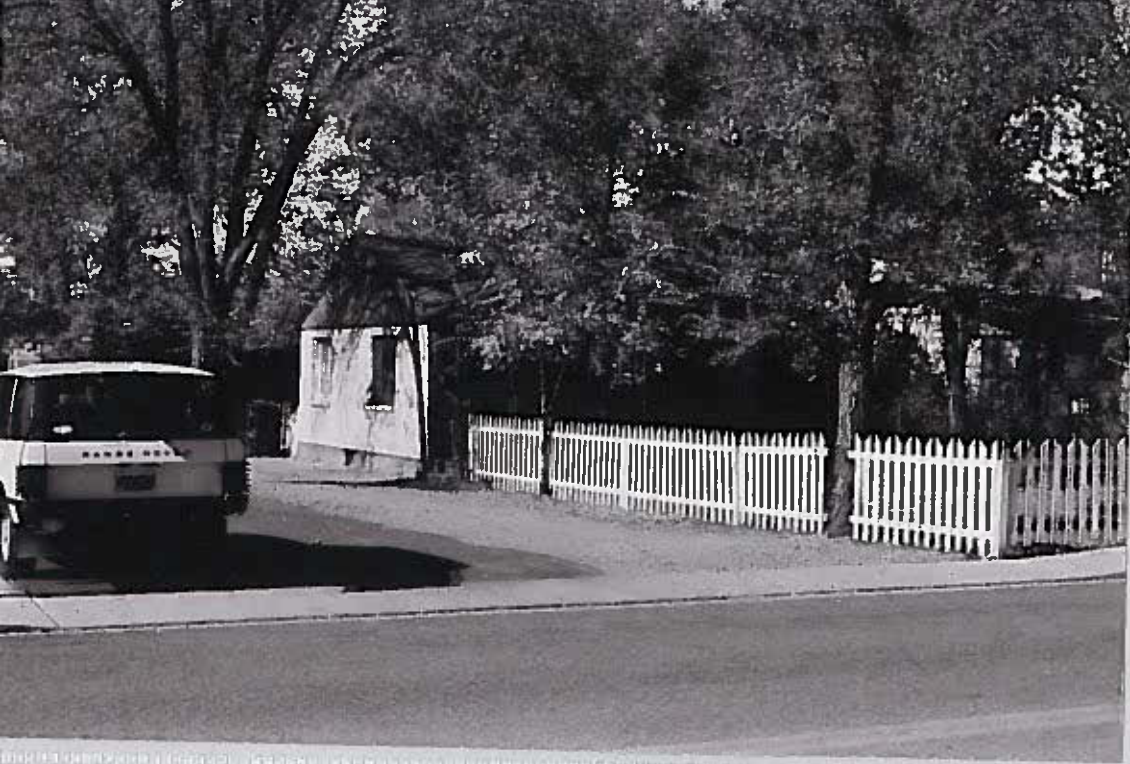
Roll # 5 Frame # 37

21. General architectural description: This is a very simple side gable masonry house. The ridge runs north/south and the main façade faces east. The entry door is located to the left side of the main façade and has two pairs of casement windows with a two over four muntin pattern. The window openings have radiused masonry corners. A front gable porch roof extends to the east off the main façade and is supported by pairs of square wood posts, one in each corner. The porch roof has vertical siding with scalloped ends in the gable end, and it covers a concrete patio area. The south side has two similar window units equally distributed and the gable end is infilled with vertical siding. A brick chimney sits on the rear slope of the roof.

Looking northwest

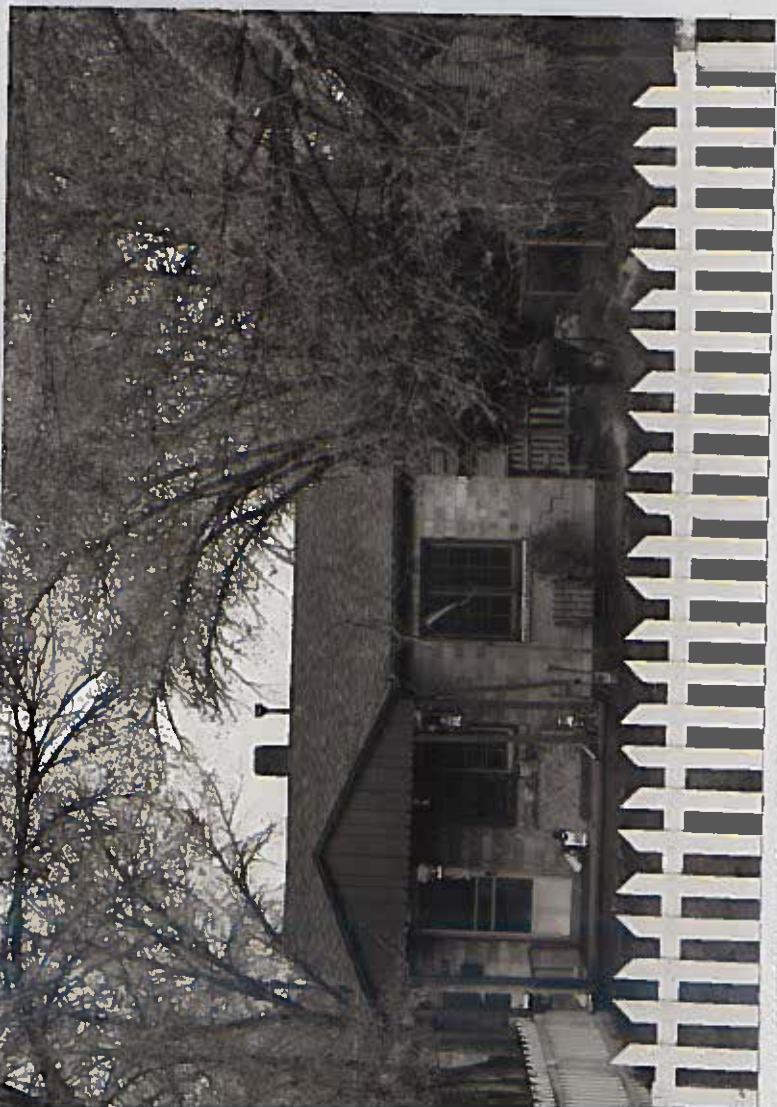
Roll # 16 Frame # 15

Looking west
