COLORADO CULTURAL RESOURCE SURVEY

Architectural Inventory Form

1. Resource number: 5ME.14673
2. Temporary resource number: 1347.ORB
3. County: Mesa
4. City: Grand Junction
5. Historic building name: n/a
6. Current building name: n/a
7. Building address: 1347 Orchard Ave.
8. Owner name and address: Clover Properties LLC
2486 H Ct Grand Junction, CO 81505-9613

48. Report title: Grand Junction Phase 3 Survey 49. Date(s): March 2005

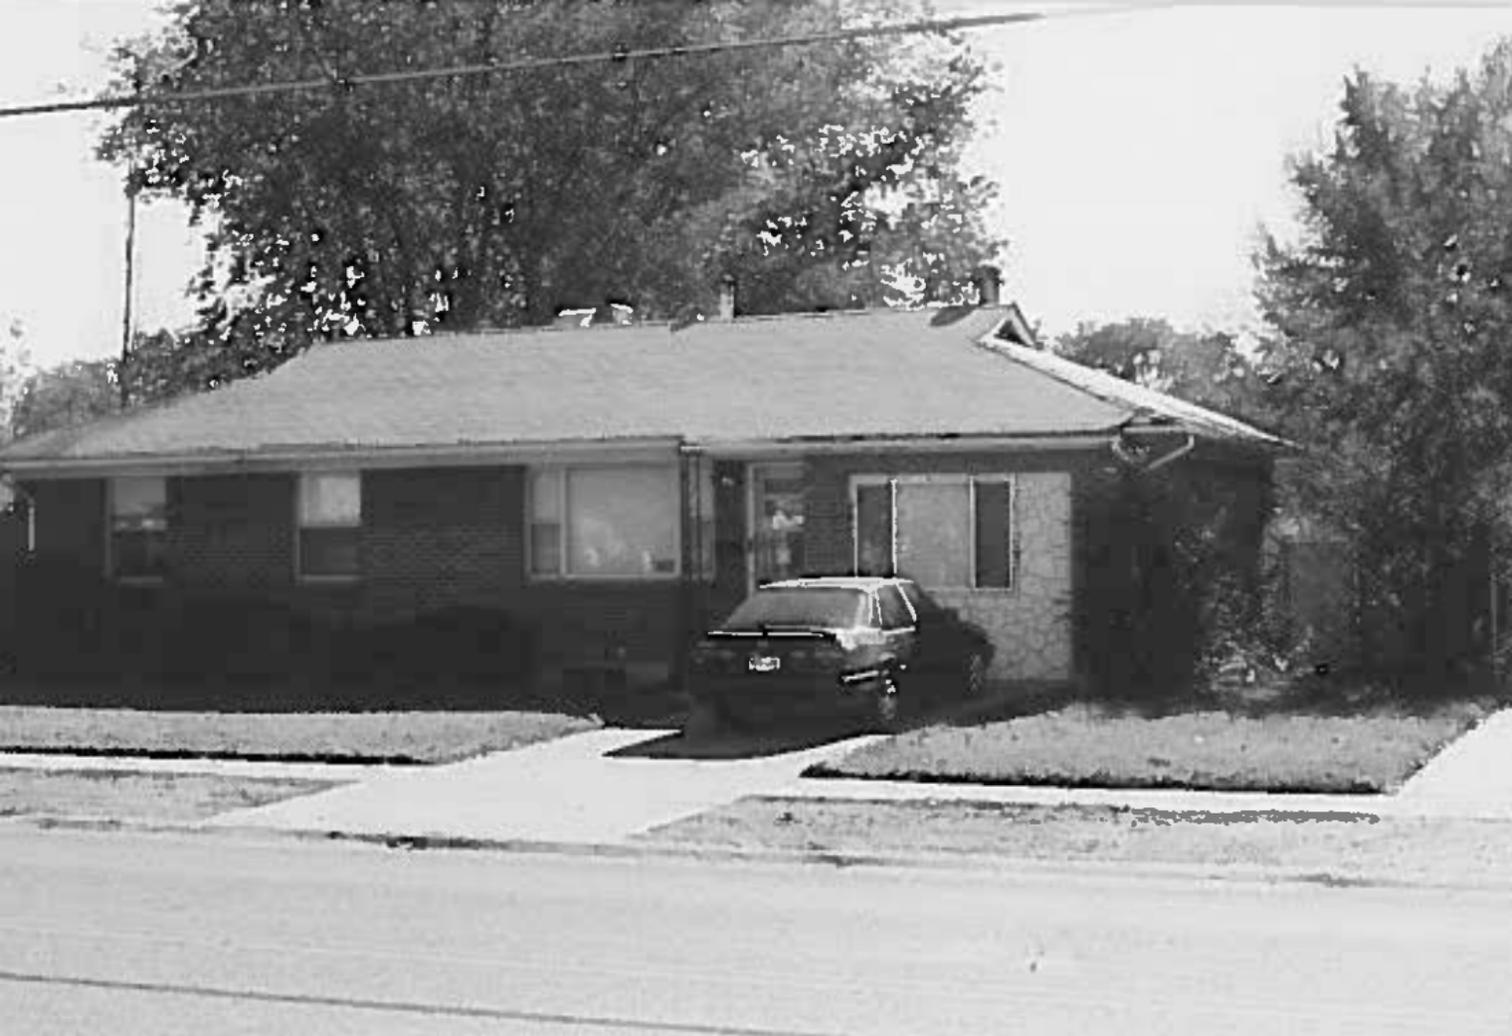
Roll # 6 Frame # 27

21. General architectural description: This is a simple rectangular masonry house. The hipped roof has a moderate overhang on all sides and small gables are revealed at the ends of the ridge. The roof has an extended plane over the entry door, which also covers a projection in the main wall plane. The projecting section of wall has a picture window with vertical side units to each side. The window is in a field of plaster with a stone pattern that infills a former single car garage door opening. The entry door sits under the roof extension to the left of the projecting wall. Adjacent to the entry door is a picture window with double hungs on each side. The remainder of the wall has a single double hung centered between the picture window and another double hung near the corner. The small cantilevered portion of the roof at the entry is supported by a thin metal support. The east side has two double hungs distributed equally along the wall. A wood trim board runs along the head of the windows, separating the brick field from the soffit of the roof. A shed roof porch is attached to the rear of the building.

Looking south
