# Architectural Inventory Form

1. Resource number: 5ME.14674
2. Temporary resource number: 1357.ORG
3. County: Mesa
4. City: Grand Junction
5. Historic building name: n/a
6. Current building name: n/a
7. Building address: 1357 Orchard Ave.
8. Owner name and address: Dennis J Svaldi  
677 24 1/2 Rd Grand Junction, CO 81505-1246

48. Report title: Grand Junction Phase 3 Survey 49. Date(s): March 2005

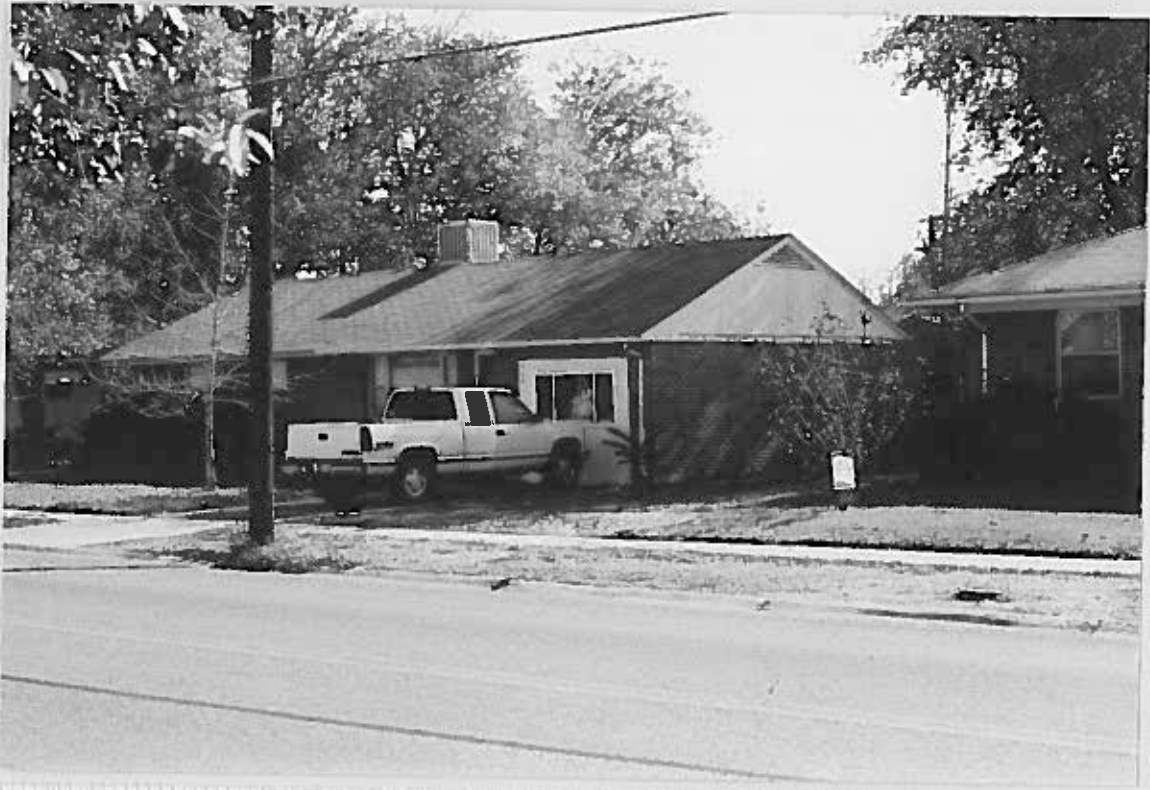
Roll # 6 Frame # 28

21. General architectural description: This is a simple rectangular brick house with a side gable roof. The ridge runs east/west and the principal façade faces north. The roof has minimal overhangs on the gable ends and a larger overhang on the main façade. The overhang is increased at the entry door and principal window by a small extension of the roof plane. At the far west end the wall steps forward returning the extended overhang to a normal depth. This projecting section of wall has a picture window flanked by a vertical unit on each side, in a field of stucco. The stucco is framed by the size of the original brick garage door opening. The main entry is located to the left of the projection, on the main wall. Adjacent to the left is a picture window with a double hung on each side. The remainder of the façade has two double hung windows relatively evenly spaced on the façade. The east wall has two double hungs near the center and the gable end is infilled with vertical siding; a triangular vent is located in the peak. The base of the wall has small horizontal vents and a band of wood separates the top of the brick wall from the overhang soffit.

Looking southeast

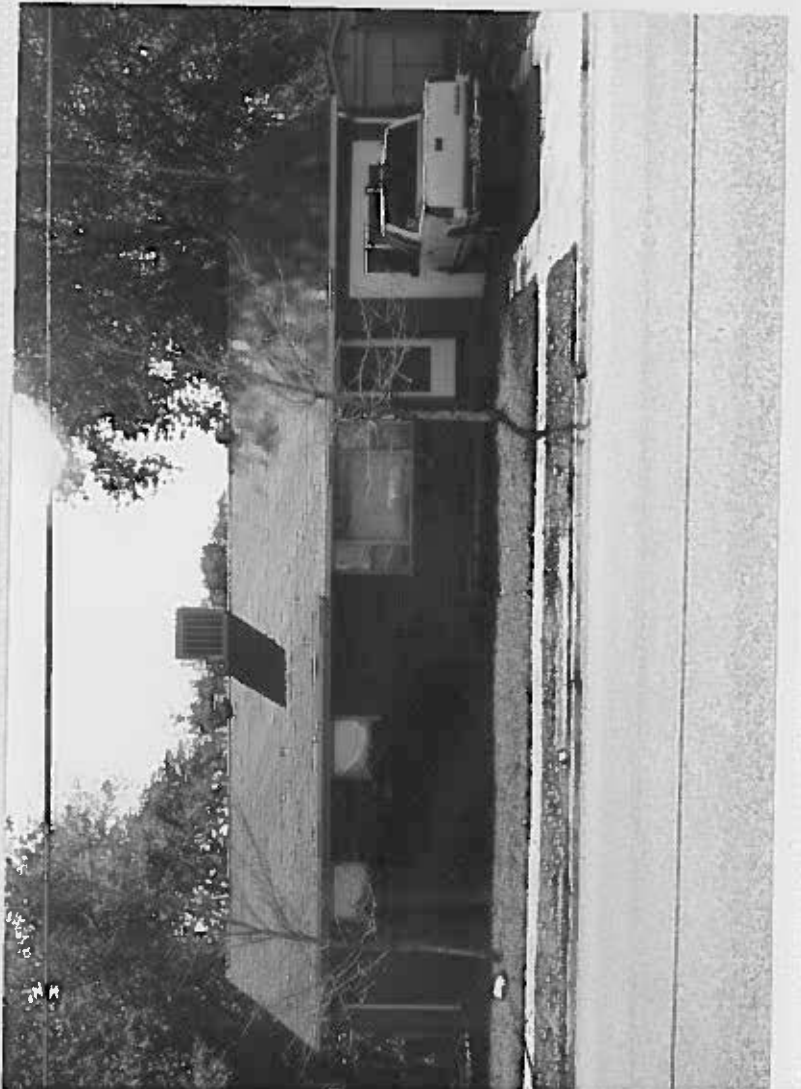
Roll # 6 Frame # 26

Looking south
