COLORADO CULTURAL RESOURCE SURVEY

Architectural Inventory Form

1. Resource number: 5ME.14641
2. Temporary resource number: 1450.ELM
3. County: Mesa
4. City: Grand Junction
5. Historic building name: n/a
6. Current building name: n/a
7. Building address: 1450 Elm Ave.
8. Owner name and address: Nick A Lobato
2489 S Broadway Grand Junction, CO 81503-2782

48. Report title: Grand Junction Phase 3 Survey 49. Date(s): March 2005
50. Recorder(s): Suzannah Reid, Patrick Duffield and Lydia Herron
51. Organization: Reid Architects, Inc.
52. Address: PO Box 1303 Aspen, Colorado 81612
53. Phone number(s): 970 920 9225

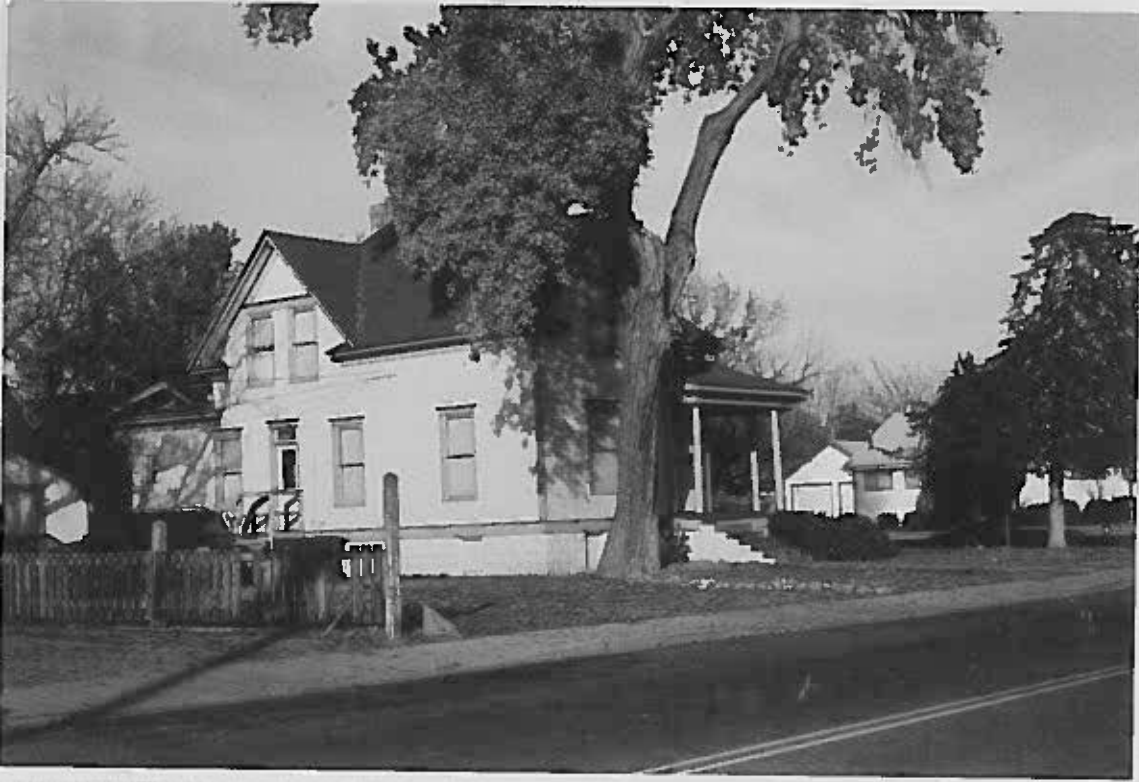
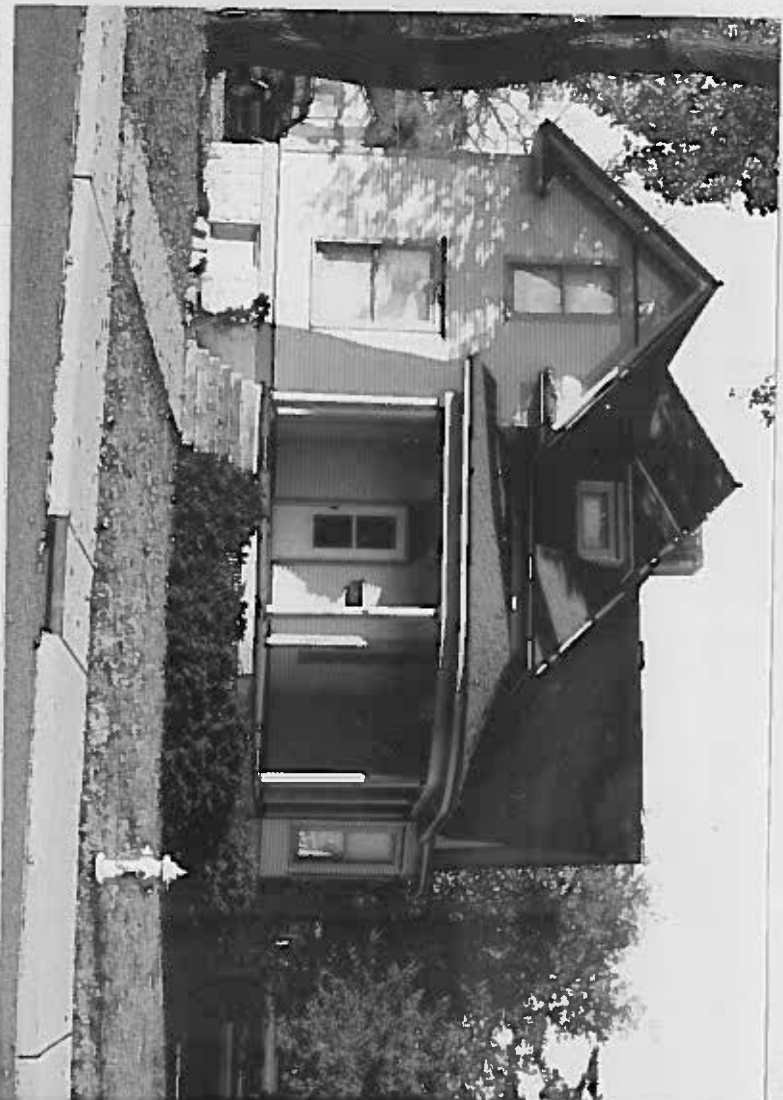
Roll # 4 Frame # 27

20. Special features (enter all that apply): Porch, Dormer, Decorative Shingles
21. General architectural description: This is a large wood framed house with complex geometry. The primary volume is a steeply pitched hipped form with secondary gable forms projecting to the south and east. The gables are approximately half the width of the hipped volume and share the west and north roof slopes of the hip respectively. The south facing façade is the principal façade with the front gable on the west and a curved porch infilling the ell created by the two perpendicular gable forms. The porch roof runs below the eave of the main hipped form. The entry door sits under the porch roof on the central volume, facing south. A single vertically proportioned double hung window sits on the east facing wall under the porch. The porch roof is supported by four Tuscan columns, one at the edge of the overhang that projects beyond the wall plane on the south, one at the start of the quarter round curve, one at the end of the curve, one in the center of the remaining space and finally a pilaster at the corner of the east facing gable. The south facing gable end has a large double hung on the main level and a narrower one on the upper level. A trim board runs across the gable at the head of the window with decorative shingles infilling the small remaining triangle. The eave ends return on the gable end creating a small cornice return on the wall. A hip roofed dormer sits on the main hip form, just above the entry door. It has a small horizontally proportioned window on its face and shares the east roof plane with the main roof. The east facing gable has a bay centered on its width on the main level. The bay has vertically proportioned double hung windows in each face, and a small hipped roof. a single double hung sits above the bay on center. The west side of the house has a gable which does not project beyond the main wall with two double hungs on the upper level, a door with transom is centered below the windows. Three other vertically proportioned double hung windows are located along the length of the façade. A one story hipped roof addition is located on the rear of the house. The house sits on an ashlar stone base with several square basement windows.

Looking northeast
