COLORADO CULTURAL RESOURCE SURVEY

**Architectural Inventory  
Form**

1. Resource number: 5ME.14776
2. Temporary resource number: 525.PIN
3. County: Mesa
4. City: Grand Junction
5. Historic building name: n/a
6. Current building name: n/a
7. Building address: 525 Pinyon Ave.
8. Owner name and address: Muriel C Miller  
525 Pinyon Ave Grand Junction, CO 81501-7431

48. Report title: Grand Junction Phase 3 Survey 49. Date(s): March 2005

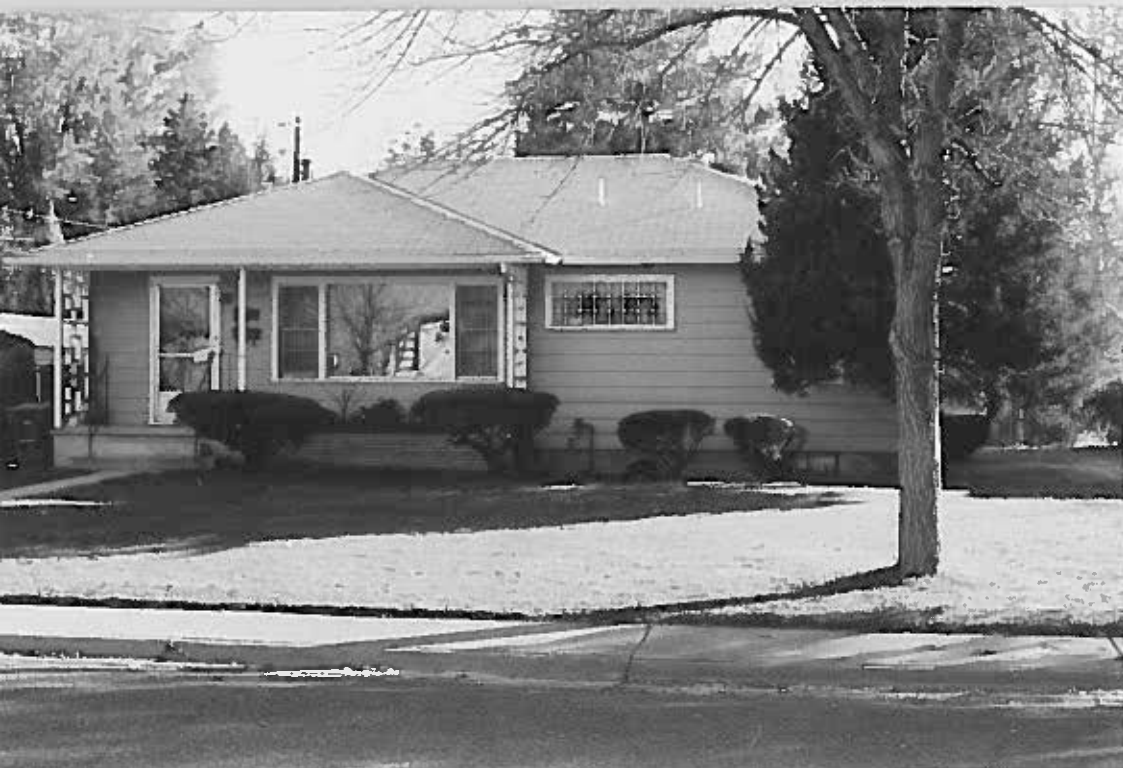
Roll # 8 Frame # 18

21. General architectural description: This is a simple wood frame house with a moderately pitched hipped roof. The ridge runs east/west and the principal façade faces north. The main entry is located on the east side of the main façade with a large picture window, flanked by double hungs, to the right. A hipped roof extends off the main roof form, creating a porch area on the left side of the façade. The porch roof is supported by decorative wood screens on either side and a single post off center to the left. The screens are a symmetrical composition of ellis and squares. To the right of the porch on the main wall is a horizontally proportioned window of glass block. At the far right, a single double hung is located near the corner. The porch floor is concrete and a brick planter runs across the area to the right of the door. A single step leads to the porch and light metal rails run to the porch returning along either side. The double hungs have a single horizontal muntin in each sash.

Looking south
