Architectural Inventory Form

1. Resource number: 5ME.14774
2. Temporary resource number: 500.PIN
3. County: Mesa
4. City: Grand Junction
5. Historic building name: n/a
6. Current building name: n/a
7. Building address: 500 Pinyon Ave.
8. Owner name and address: Mark J Ryan
500 Pinyon Ave Grand Junction, CO 81501-7432

48. Report title: Grand Junction Phase 3 Survey 49. Date(s): March 2005

5ME.14774

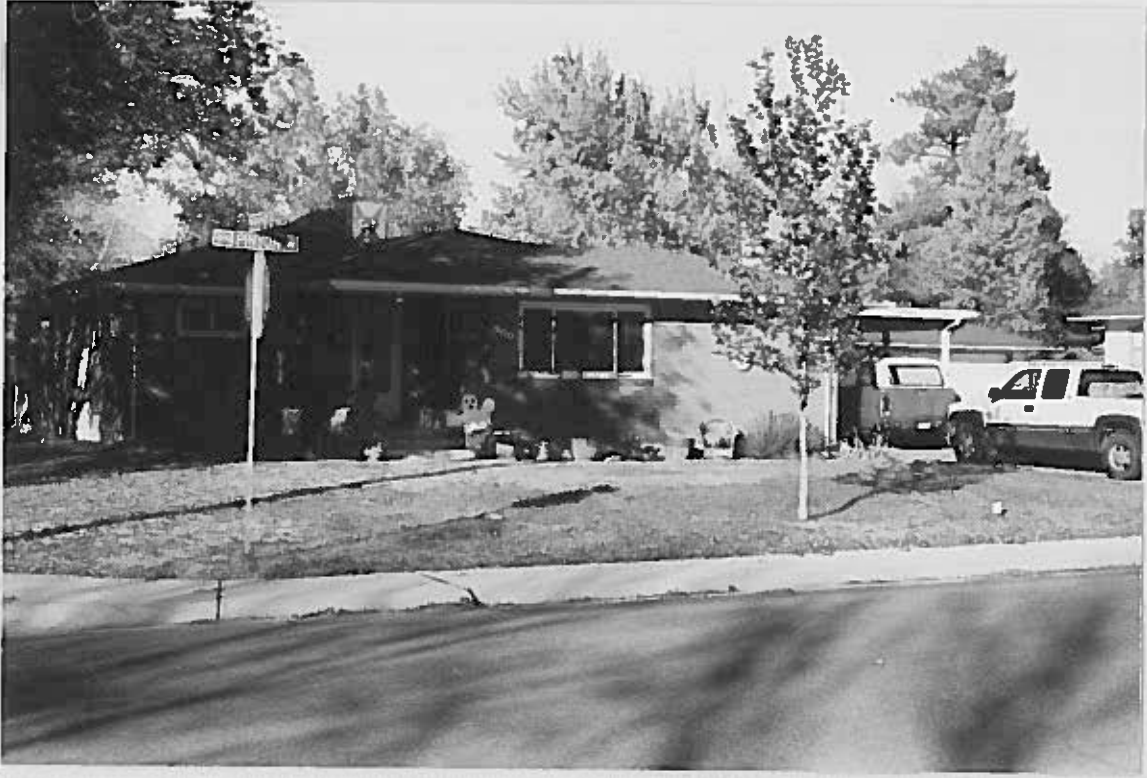
Roll # 8 Frame # 16

21. General architectural description: This is a horizontally proportioned masonry house. It is comprised of several additive volumes that stack from front to back on the site. The principal façade faces south and has a low pitched hipped roof with a short ridge running east/west. The west side of the ridge slopes up to a higher ridge that runs north/south. A picture window, flanked by casements, sits on the left side of the main wall. The main entry is set back under the main roof form into a deep recess on the west corner. The roof is supported by a pair of metal supports that sit on a low brick wall/planter, which runs along the west side of the concrete porch area. The door is off center on the back wall with a series of individual glass blocks that run vertically on the left side. The right side of the main façade has a flat roofed carport, which continues the eave line from the main roof. The carport roof is supported by three pipe columns and the back is closed. On the west side the building wall steps outward and runs to the rear of the house. This wall has a horizontally proportioned sliding window with a high sill, centered on the south face and three similar windows on the west. The main side slopes up again in this area to maintain a continuous eave line around the house. A rectangular brick chimney is applied to the east wall and runs through the carport roof. The house sits on concrete foundation with a soldier course of brick at the base of the brick wall.

Looking northeast
