COLORADO CULTURAL RESOURCE SURVEY

Architectural Inventory Form

1. Resource number: 5ME.14751
2. Temporary resource number: 535.CED
3. County: Mesa
4. City: Grand Junction
5. Historic building name: n/a
6. Current building name: n/a
7. Building address: 535 Cedar Ave.
8. Owner name and address: Birl W Worley
535 Cedar Ave Grand Junction, CO 81501-7427

47. Photograph numbers: Roll # 8 Frame # 1 see also digital image 535.CED
Negatives filed at: City of Grand Junction Planning Dept.
48. Report title: Grand Junction Phase 3 Survey 49. Date(s): March 2005
50. Recorder(s): Suzannah Reid, Patrick Duffield and Lydia Herron
51. Organization: Reid Architects, Inc.
52. Address: PO Box 1303 Aspen, Colorado 81612
53. Phone number(s): 970 920 9225

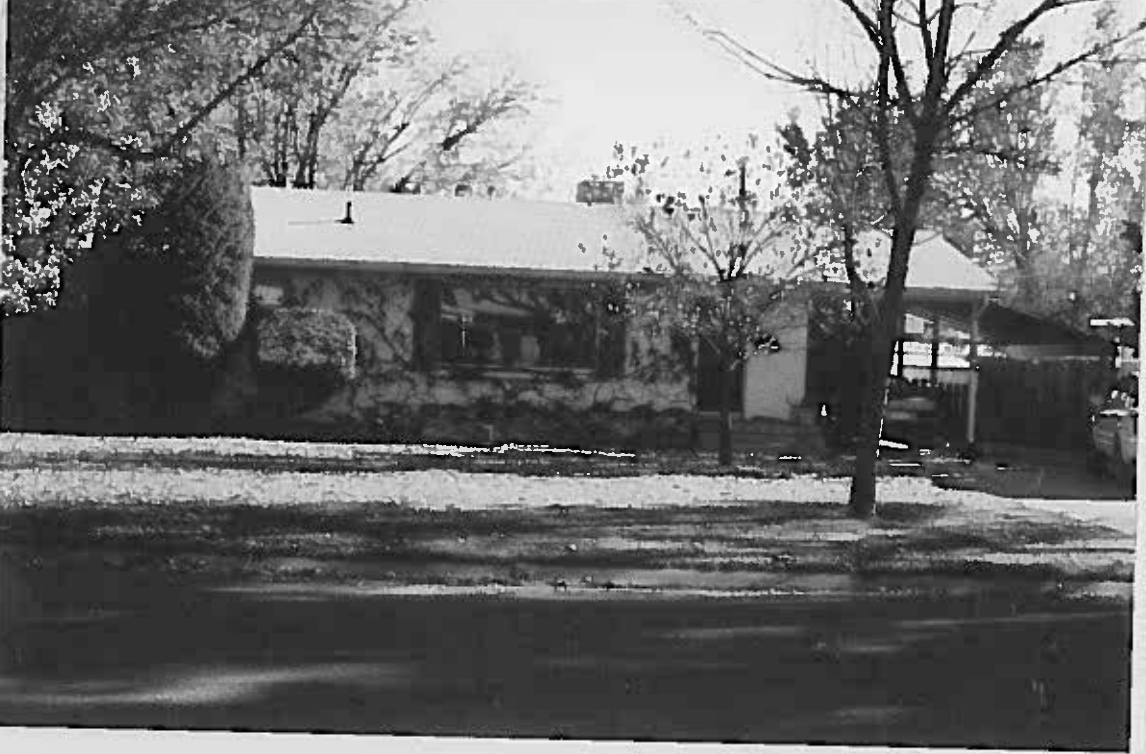
Roll # 8 Frame # 1

21. General architectural description: This is a simple primarily rectangular wood frame house with an addition on the rear. The main ridge line runs generally east/west and the principal façade faces north. The main entry sits on the right side of the main wall. A very large picture window is centered on the wall to the left between the door and a double hung window further to the left. A pair of double hungs sit on the far corner. The carport sits on the right side of the main form with a slightly lower side gable roof. The edge of the side gable is supported by three pipe columns and an additional carport space sits under a shed roof addition on the west side. The addition extends off the rear of the west side. A series of concrete steps run to a landing at the entry door and a planter extends the landing height to the left under the large window.

Looking southeast

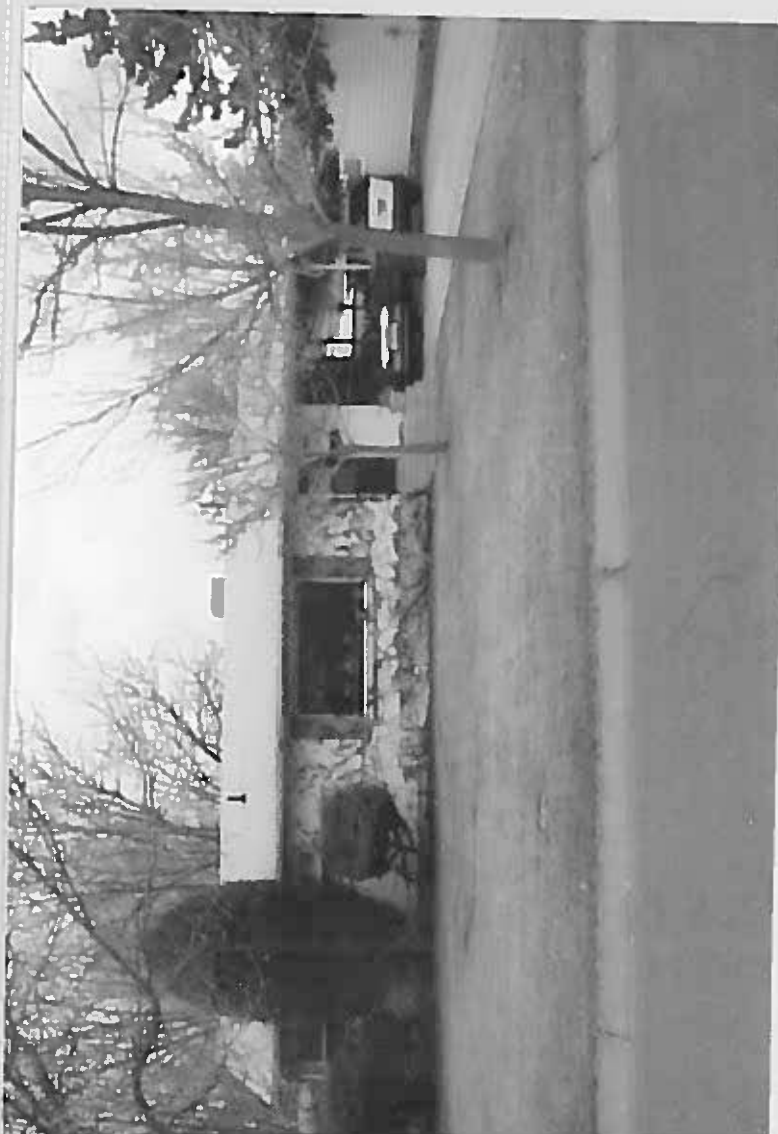
Digital Frame # 535.CED

Looking southeast
