**Architectural Inventory
Form**
1 of 4

1. Resource number: 5ME.14749
2. Temporary resource number: 525.CED
3. County: Mesa
4. City: Grand Junction
5. Historic building name: n/a
6. Current building name: n/a
7. Building address: 525 Cedar Ave.
8. Owner name and address: Kelly J Rogers
525 Cedar Ave Grand Junction, CO 81501-7427

48. Report title: Grand Junction Phase 3 Survey 49. Date(s): March 2005

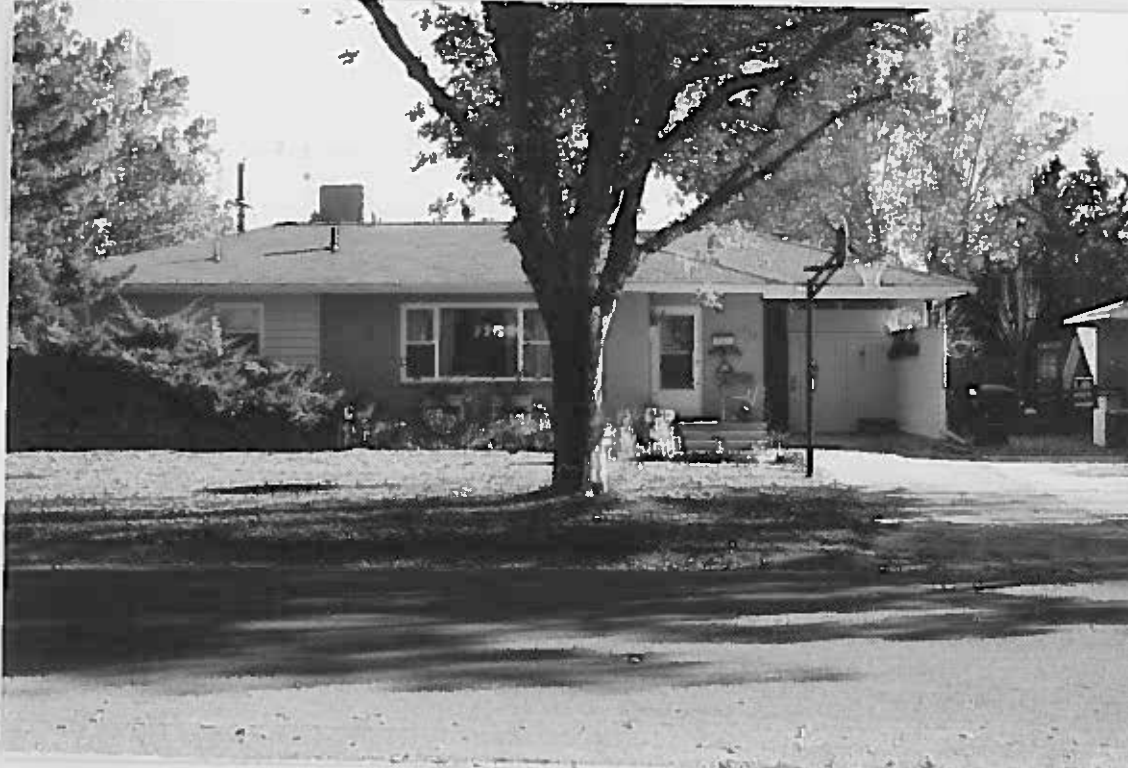
Roll # 8 Frame # 3

21. General architectural description: This is a simple wood frame house with a primary hipped roof. The hipped roof ridge runs generally east/west and the principal façade faces generally north. The principal façade is divided into two sections; the left has horizontal siding and the right is brick. The wall plane remains continuous across the material change. Two double hung windows are located to each side of the field of horizontal siding. A large picture window, flanked by double hung on each side, is centered on the brick wall. The western corner of the brick wall is recessed under the main roof form, creating an entry porch. The entry door faces the street and sits in the corner of the ell. A concrete landing infills the recess corner and three steps run to grade from the line of the main wall. The roof overhang is unsupported. A hipped roof carport is applied to the west side of the main form and sits well back from the front, creating a jog in the hipped roof ridge. The peak of the carport hip also steps up slightly, appearing as a small peak in the front roof plane. The west side of the carport roof is supported by three pipe columns which are enclosed in a wall which stops short of the eave. The rear of the carport is closed and a shallow volume extends off the rear to the south.

Looking southeast
