COLORADO CULTURAL RESOURCE SURVEY

# Architectural Inventory Form 1 of 4

| | | | | Noncontributing to eligible NR District |
|--|---|---|---|---|
| | 1. | Resource number: | 5ME.14748 | |
| | 7. | Building address: | 515 Cedar A | ve, |

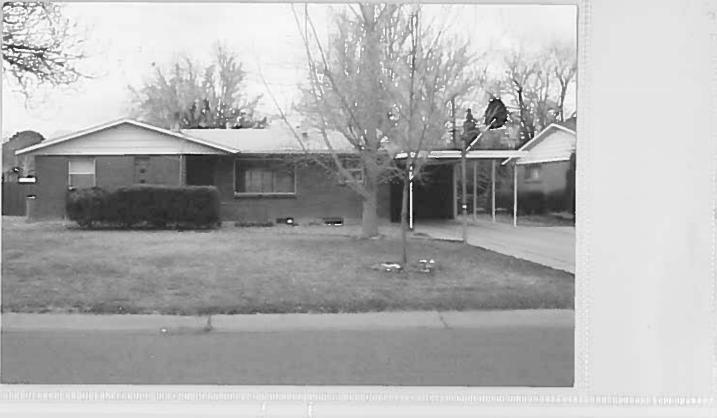
## 515 Cedar Ave.

| | 21. | . General architectural desc | ription: This is a masonry house with several additive forms. |
| | | The main side gabled form | has a ridge running generally east/west with the principal |
| | | façade facing generally no | rth. The principal façade is divided into three sections of |
| | | approximately equal size. | To the far left is a front gable projection with a cut out under |
| | | the right eave. At the cent | er is the wall of the main side gable and on the right is a flat |
| | | roofed carport, which proje | ects in front of the main wall. The front gable has a single |
| | | double hung window on the | e left and a similarly sized glass block window toward the right. |
| | | The main entry door sits ur | nder the edge of the front gable roof, in a shallow recess into |
| | | the main wall plane. A pict | ure window sits to the right on the main wall surface and a |
| | | single double hung is locat | ed on the corner. The carport, at the far right, has a solid wall |
| at the rear and both sides are supported by steel pipe columns. A low brick wall pro- | | | are supported by steel pipe columns. A low brick wall projects |
| | | from the face of the front ga | able and runs across the recessed area, creating a small porch. |
| | | The front gable, above the | eave line, is infilled with horizontal siding. Two volumes |
| | | extend off the rear on either | er side and an enclosed porch infills between them. |
