COLORADO CULTURAL RESOURCE SURVEY

Architectural Inventory Form

1. Resource number: 5ME.14533
2. Temporary resource number: 1917.THDC
3. County: Mesa
4. City: Grand Junction
5. Historic building name: n/a
6. Current building name: n/a
7. Building address: 1917 3rd Court
8. Owner name and address: Virginia Jeannette Gibson Trust
1917 N 3rd Ct Grand Junction, CO 81501-2114

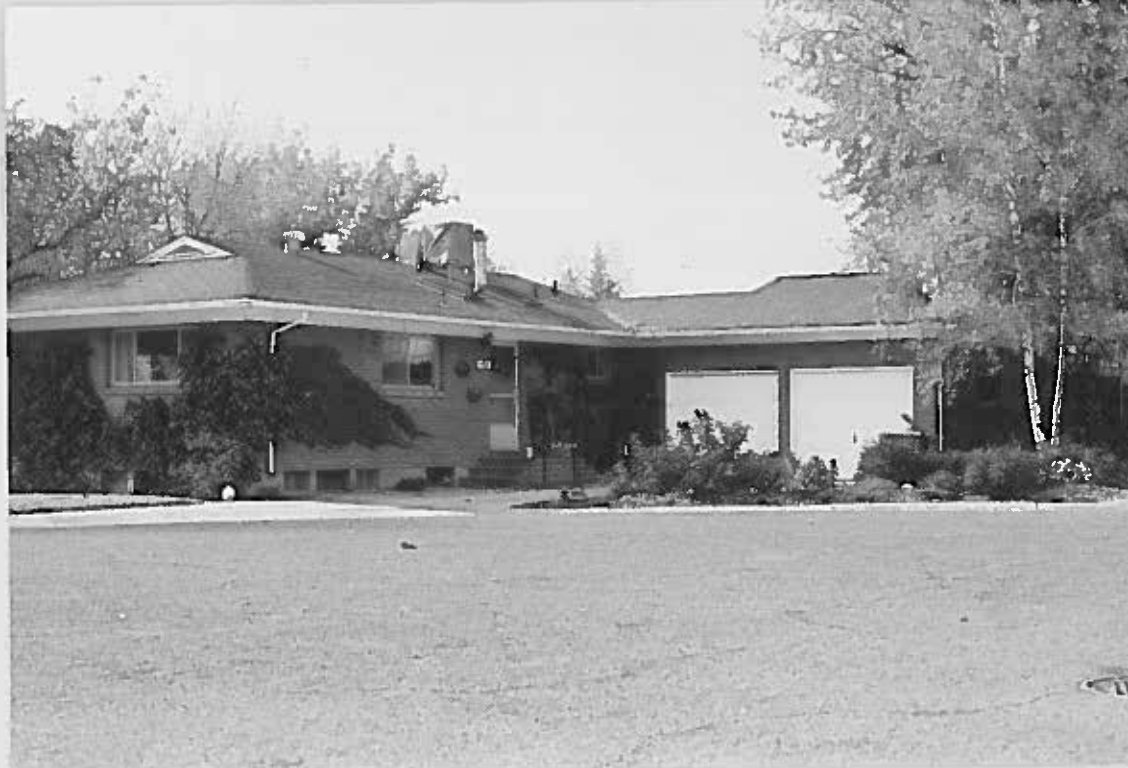
Roll # 10 Frame # 10

20. Special features (enter all that apply): Attached Garage
21. General architectural description: This is a single story brick house comprised of two basically rectangular forms. The entry to the house faces north which is perpendicular to the cul-de-sac. The majority of the house living space is located in this volume. The second volume contains a two car garage which faces the cul-de-sac to the east. The first volume has a low pitched hipped roof with moderate overhangs on all sides. Small gable ends are revealed at either end of the ridge. The single entry door is located near the center of the north wall and is raised three steps from grade. A single window opening sits to the left of the door and is comprised of an aluminum slider unit. The windows are in simple brick openings with a crown molding running the perimeter of the building under the soffit at the head of all the windows. A small window is located to the west of the entry with the same configuration as the other. The garage volume is attached to the main house at the western corner and its length extends perpendicularly to the north. The roof configuration is similar to the main house, but is somewhat exaggerated and asymmetrical. The garage has two single car doors and a simple window opening on the side. The main house has a window on the east side which is offset to the north. It has the same configuration as the window to the left of the main door. A band of windows can be seen at the basement level on both the east and north sides. They are all similar heights but vary in width. Several pieces of mechanical equipment are located on the roof above the entry as are two skylights. The brick materials are thin, horizontally proportioned units with a rusticated surface.

Looking southwest
