COLORADO CULTURAL RESOURCE SURVEY

**Architectural Inventory
Form**

1. Resource number: 5ME.14770
2. Temporary resource number: 546.ORB
3. County: Mesa
4. City: Grand Junction
5. Historic building name: n/a
6. Current building name: n/a
7. Building address: 546 Orchard Ave.
8. Owner name and address: Stacey L Robinson
546 Orchard Ave Grand Junction, CO 81501-2162

48. Report title: Grand Junction Phase 3 Survey 49. Date(s): March 2005

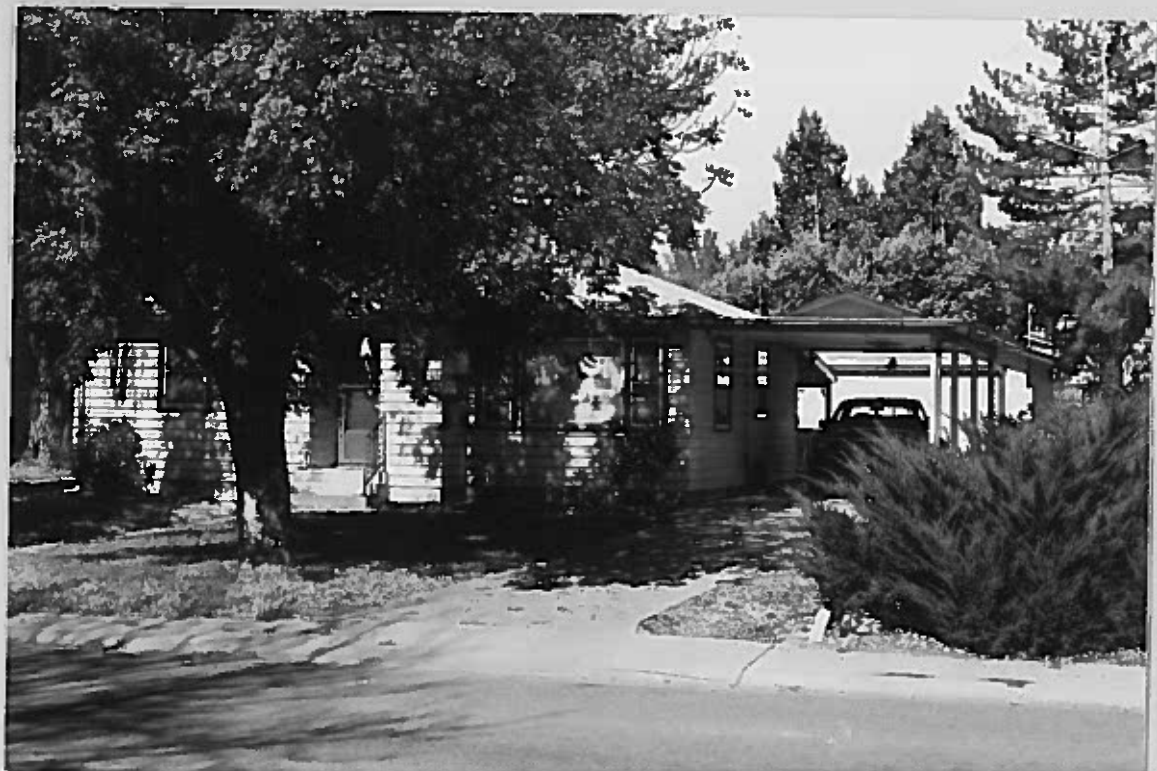
Roll # 10 Frame # 24

21. General architectural description: This is a simple wood frame house with a low pitched hipped roof. The main hipped roof form has a short ridge that runs east/west and the principal façade faces south. A lower hipped roof form projects from the west side and runs over half the width of the façade. A small double hung window sits on the face of the projecting volume, centered between the west corner and a deep recess at the right. The main entry is set in the narrow recess and the main wall plane continues for a short distance on the far side of the door. A large picture window is located on the wall of the main volume. The picture unit is flanked by narrow double hungs to each side. The flat roofed carport extends off the east side, continuing the eave line of the main hipped roof. The flat roof is supported by four thin columns on the east side. Two double hungs sit on the east wall near the center below the carport roof. The west wall has two double hungs evenly spaced along the length of the wall. A shed roof extends off the rear of the house.

43. Assessment of historic physical integrity related to significance: Alterations have somewhat impacted the integrity of the house. Siding and window replacement are in keeping with the original character. The house continues to contribute to the character of the neighborhood.
