COLORADO CULTURAL RESOURCE SURVEY

Architectural Inventory Form

1. 1	den	tification		
	1.	Resource number:	5ME.14744	
	2.	Temporary resource number:	445.CED	
	3.	County:	Mesa	
	4.	City:	Grand Junction	
	5.	Historic building name:	n/a

6.	Current building name:	n/a	
	7.	Building address:	445 Cedar Ave.	
	8.	Owner name and address:	Elizabeth B Zollner	
			445 Cedar Ave Grand Junction, CO 81501-7425

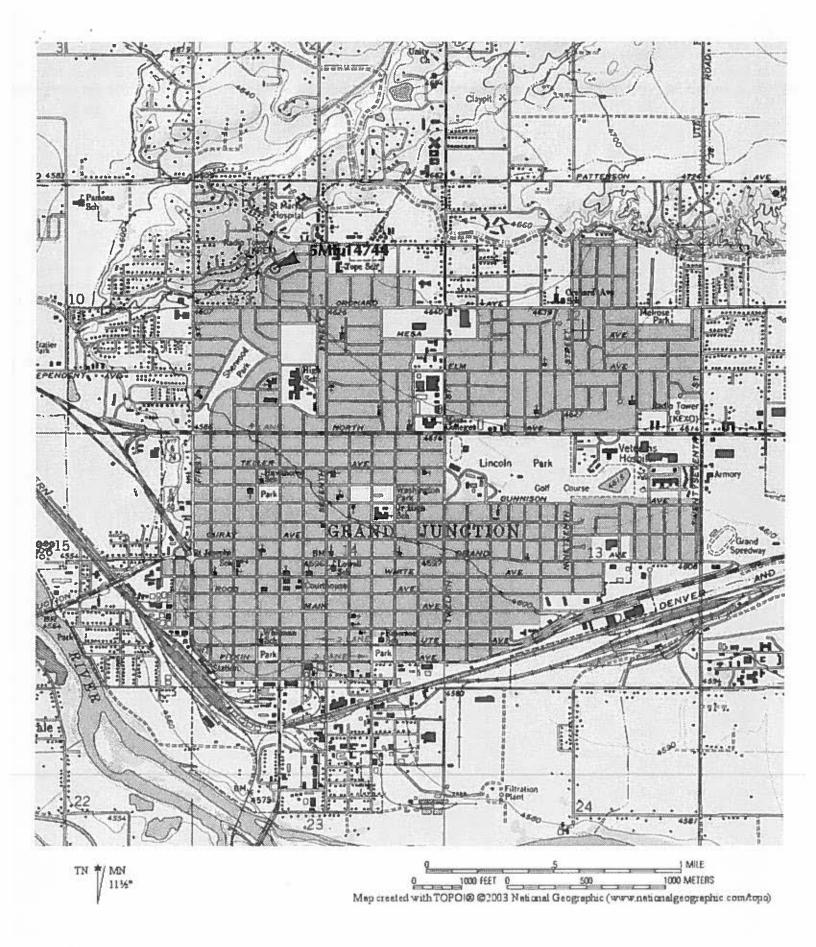
445 Cedar Ave. 5ME.14744 Roll #8 Frame #9 Looking southeast ... Grand Junction, Mesa County, CO WHF BA010A1X0N NNN-

21.	General architectural descr	ription: This is a horizontally proportioned wood frame house	
		with a moderately pitched I	hipped roof. The ridge runs generally east/west and the	
		principal façade faces gene	erally north. The main entry is located on the main façade, off	
		center to the left. A pair of	double hung windows are centered on the wall from the door	
		to the left corner. A large p	picture window, flanked by double hungs on each side, sits just	
		to the right of the door. The	e same unit is located at the far right end of the façade. All	
		windows share the same si	Il height and the heads sit just below the soffit. The roof has a	
	deep overhang on all sides. A carport is located off the right side, with its own hippe			
		roof form. The carport ridg	e is slightly lower than the main ridge. A brick chimney is	
		located on the main roof plant	ane just short of the intersection with the garage roof. A band

of wood shingles runs arou	nd the house up to the height of the window sills. Clapboard	
		style siding infills the area	above the sill height to the soffit. The carport roof is supported	
		by a wall on the west side,	which has rectangular cutout openings. The back of the	
		carport is also enclosed. T	he double hung windows have a single horizontal muntin in	
		each sash.
