COLORADO CULTURAL RESOURCE SURVEY

Architectural Inventory Form 1 of 4

1. 1	den	tification	
	1. Resource number:		5ME.14889
	2.	Temporary resource number:_	575.ORC
	3.	County:	Mesa
			Grand Junction
			n/a
	6.	Current building name:	n/a

48. Rep	ort title: Grand Junction Phase 3 Survey 49. Date(s):	March 2005	
50. Rec	order(s): Suzannah Reid, Patrick Duffield and Lydia	Herron	
51. Org	anization: Reid Architects, Inc.

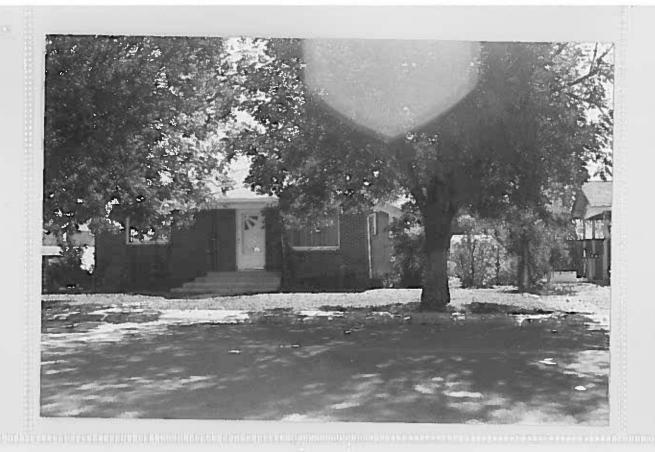
Roll #11 Frame #5

Looking south

21.	. General architectural desc	ription: This is a generally rectangular wood frame house with	
a low pitched hipped roof. The ridge runs north/south and the principal façade face			The ridge runs north/south and the principal façade faces	
		north. A small hipped root	f projects off the north side, off center to the right. It covers the	
		entry door, which sits on the	ne main wall plane. A picture window sits on the wall to the	
		right of the door. Another	picture window is located off center to the left on the remaining	
		wall. Four concrete steps	run up to the landing in front of the door. Two thin metal	
		supports run from the cond	rete landing to the corners of the hipped porch roof. A larger	
		section of hipped roof exte	nds off the east side, about halfway along the length, covering	
		the carport. The roof is su	pported by steel pipe columns. A door and several windows	
	are located on the east wall under the carport roof. The west wall has a few horizontally

proportioned windows with high sills. All the window heads sit just under the roof soffit.		
		The roof has a moderate overhang on all sides.		
	22.	Architectural style/building	type: Ranch Type
