COLORADO CULTURAL RESOURCE SURVEY

**Architectural Inventory
Form**

1. Resource number: 5ME.14873
2. Temporary resource number: 161.MES
3. County: Mesa
4. City: Grand Junction
5. Historic building name: n/a
6. Current building name: n/a
7. Building address: 161 Mesa Ave.
8. Owner name and address: Mabel J Lacy
126 Hillcrest Dr Grand Junction, CO 81501-7442

48. Report title: Grand Junction Phase 3 Survey 49. Date(s): March 2005

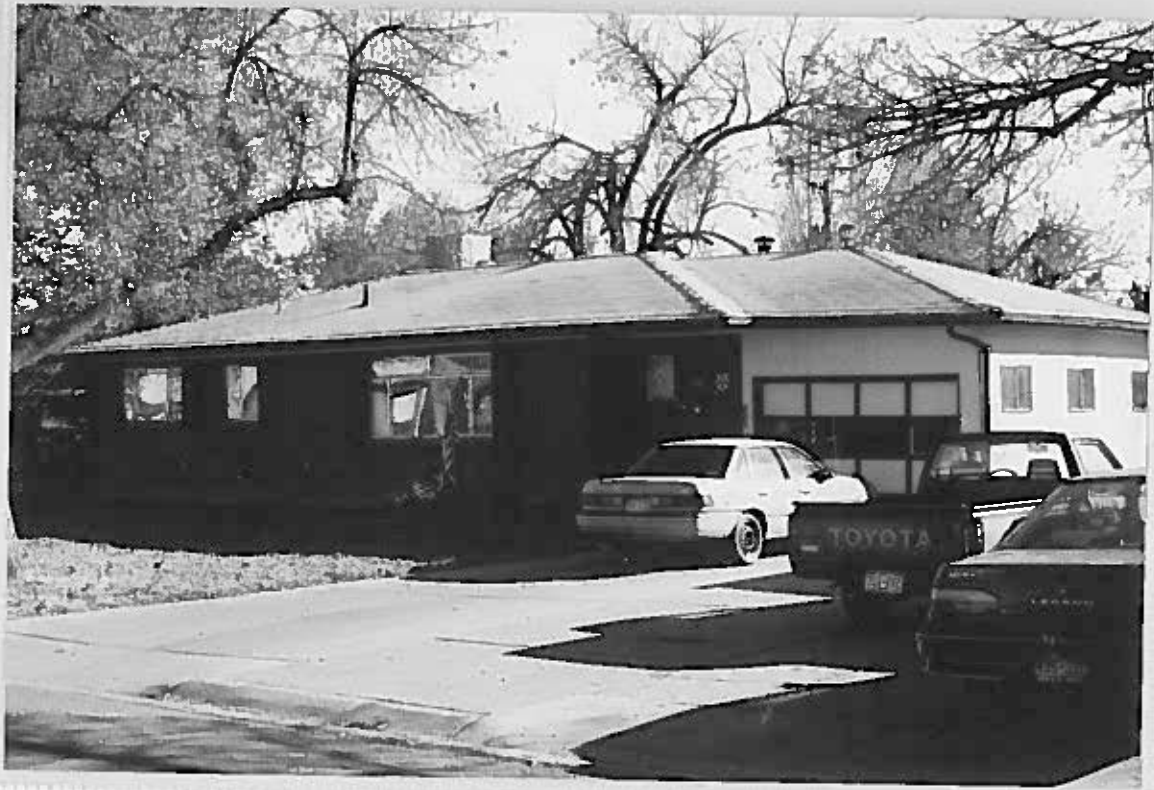
Roll # 12 Frame # 22

21. General architectural description: This is a long horizontally proportioned house with a moderately pitched hipped roof. The ridge runs east/west and the principal façade faces north. The house is comprised of two volumes; the main house and a smaller hipped roof extension off the west side. The extension has a lower ridge and the eave is set back from the main eave; the roof shares the north roof plane with the main volume. The entry door is located in a shallow recess on the western corner of the main volume. A picture window, flanked by casements, is located to the east of the entry, on the main wall plane. A pair of casements and another picture window combination sit on the far east wall near the corner. The north wall of the smaller hipped roof section aligns with the entry recess wall and continues to the west. A single car garage door is centered on the wall, which is sided with vertical plywood siding. The siding begins at the jog in the roof and butts up to the main brick wall plane. A series of small horizontally proportioned windows run along the west side. A large enclosed porch extends off the rear.

161 Mesa Ave

Looking southeast
