Architectural Inventory Form

1. Resource number: 5ME.14846
2. Temporary resource number: 1800.THD
3. County: Mesa
4. City: Grand Junction
5. Historic building name: n/a
6. Current building name: n/a
7. Building address: 1800 N. 3rd Street
8. Owner name and address: Scott C Roberts
1800 N 3rd St Grand Junction, CO 81501-2110

47. Photograph numbers: Roll # 13 Frame # 19 also digital image 1800.THD
Negatives filed at: City of Grand Junction Planning Dept.
48. Report title: Grand Junction Phase 3 Survey 49. Date(s): March 2005
50. Recorder(s): Suzannah Reid, Patrick Duffield and Lydia Herron
51. Organization: Reid Architects, Inc.
52. Address: PO Box 1303 Aspen, Colorado 81612
53. Phone number(s): 970 920 9225

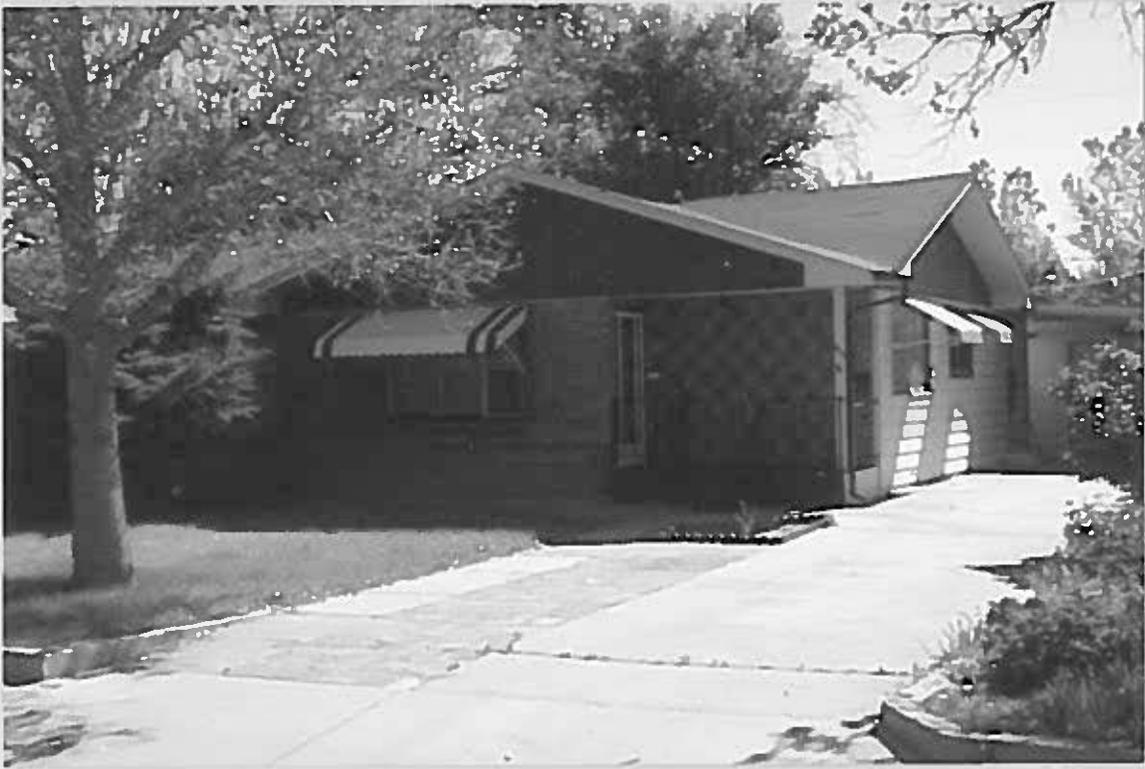
Digital Frame # 1800.THD

21. General architectural description: This is a compact wood frame house with a low pitched cross gable roof. The main façade faces west and the front gable spans 3/4 of the width of the façade. The front gable has a single picture window, flanked by double hungs, in the center of the wall and the wall is faced with brick up to the eave line. Above the eave line the gable end is infilled with vertical siding. The right side of the front gable is recessed back to the side gable wall. The main entry is located on the south facing wall of the recess. A concrete porch area infills the recess to the south façade and the corner of the roof is supported by a single square post. The west facing wall of the recess is faced with brick in a basket weave pattern of three horizontal units and three vertical units. The pattern fills the whole wall surface and wraps around to the south wall as well. The main front gable wall also has various patterns in the brick face. A double row of headers in a stack bond pattern runs along the window jambs and a rowlock course runs across the wall just below the window sill. The wall on the far side of the front gable is set back and the wall finish turns to horizontal siding. A double hung window sits on the far north corner of the wall. The south side of the house also has horizontal siding up to the eave line and vertical in the gable end. A pair of double hungs are located on the west corner and another smaller pair sits near the center of the wall. A shed roof carport attaches to the south wall beyond the side gable and a becomes a porch on the rear of the house. A single car garage is attached to the rear of the carport.

Looking east
