COLORADO CULTURAL RESOURCE SURVEY

## Architectural Inventory Form

1.	Resource number:	_5ME.14854
2.	Temporary resource number:_	101.ELM
3.	County:	Mesa
4.	City:	Grand Junction
5.	Historic building name:	n/a
6.	Current building name:	n/a
7.	Building address:	101 Elm Ave.
8.	Owner name and address:	Delroy Charlesworth
		101 Elm Ave Grand Junction, CO 81501-2127

- 47. Photograph numbers: <u>Roll # 12</u> Frame # 10 Negatives filed at: <u>City of Grand Junction Planning Dept.</u>
- 48. Report title: Grand Junction Phase 3 Survey 49. Date(s): March 2005

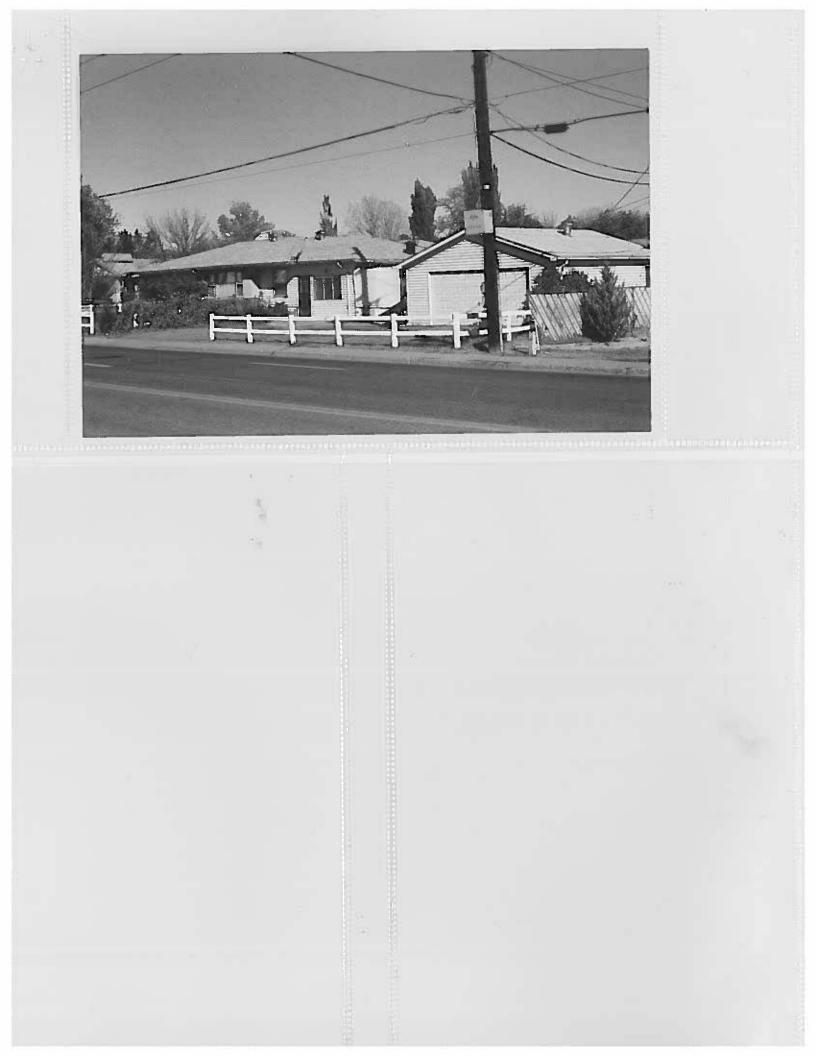
-5ME.14854 101 Elm Ave. Roll # 12 Frame # 10 Looking southeast Grand Junction, Mesa County, CO WHF BA010A1X0N NNN 0 5647 002910 011 share 54574 CONTRACTORS OF STREETING TO BE THE REAL PROPERTY OF A DESCRIPTION OF A DES 1

- 21. General architectural description: <u>This is a long rectangular wood frame house with a low pitched hipped roof. The main ridge runs east/west and the principal façade faces south. Centered on the length of the main wall is a brick projection with a large picture window, flanked by double hungs. To the left of the projection is the main entry door. A low brick planter begins on the far side of the concrete landing at the door and runs west to the end of the main wall. The planter is set flush with the face of the brick projection. A single double hung window is located on the southwest corner and a similar unit sits around the corner on the west wall. A single double hung, a door and a group of three casements sit on the main wall to the right of the brick projection. The roof eave remains constant across the façade, creating a varied overhang. The south hipped roof plane jogs back in a line with the secondary door. The brick projection has a band of contrasting brick which runs across the wall from the window sill down to the grade.</u>

43. Assessment of historic physical integrity related to significance: <u>Alterations have had a</u> <u>serious impact on the integrity of the house.</u>
