COLORADO CULTURAL RESOURCE SURVEY

Architectural Inventory Form

1. Resource number: 5ME.14670
2. Temporary resource number: 1354.MES
3. County: Mesa
4. City: Grand Junction
5. Historic building name: n/a
6. Current building name: n/a
7. Building address: 1354 Mesa Ave.
8. Owner name and address: Kelly S Corn
2486 H CT Grand Junction, CO 81505-9613

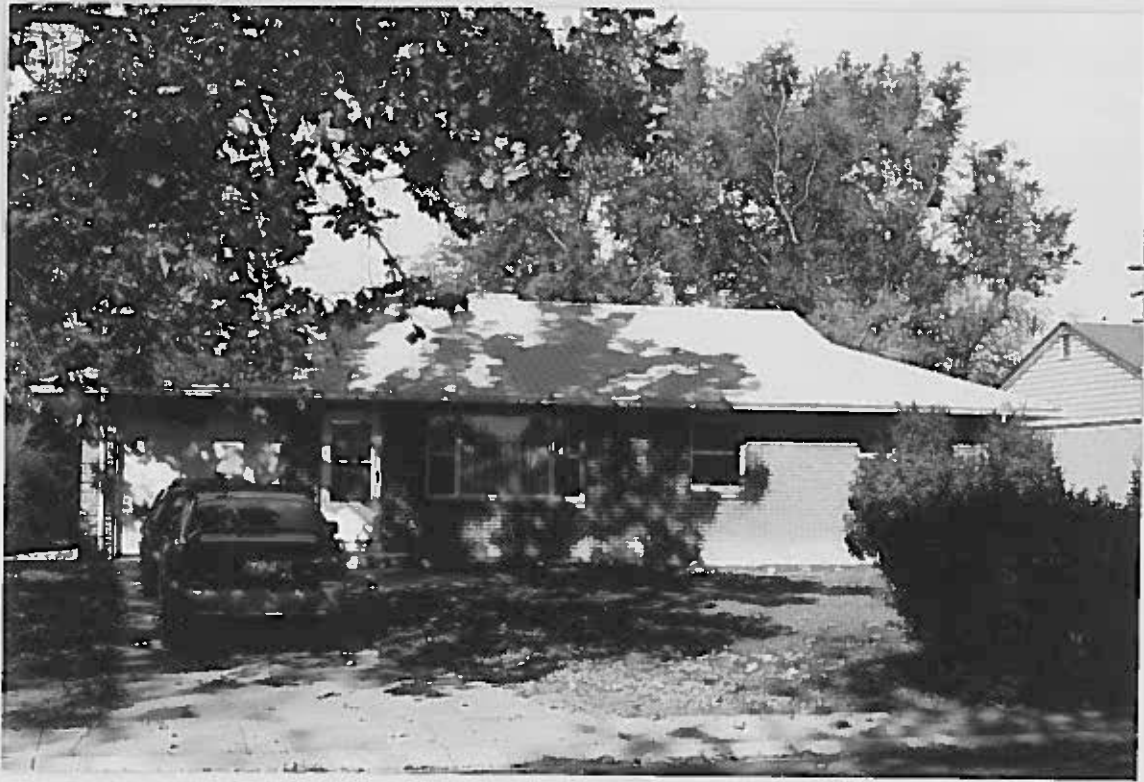
5ME.14670 1354 Mesa Ave.
Roll # 2 Frame # 35
Looking north
Grand Junction, Mesa County, CO

21. General architectural description: This is a simple rectangular house. The hipped roof has a large overhang on all sides and small gables revealed at the ends of the ridge. The ridge runs east/west and the principal façade faces south. A single car garage door is located on the west end of the façade with the main entry adjacent to the right. A picture window flanked by vertical units sits to the right of the door and a single window is centered on the remaining wall between the picture window and the pair of windows that sit near the east end. The windows have a single horizontal muntin. A shed roof porch extends off the rear.

43. Assessment of historic physical integrity related to significance: The alterations to the windows have moderately impacted the integrity.
