COLORADO CULTURAL RESOURCE SURVEY

Architectural Inventory Form

1. Resource number: 5ME.14605
2. Temporary resource number: 1315.SIXT
3. County: Mesa
4. City: Grand Junction
5. Historic building name: n/a
6. Current building name: n/a
7. Building address: 1315 N. 16th Street
8. Owner name and address: Edith Woodring
2862 Grand Falls Dr Grand Junction, CO 81501-6888

48. Report title: Grand Junction Phase 3 Survey 49. Date(s): March 2005

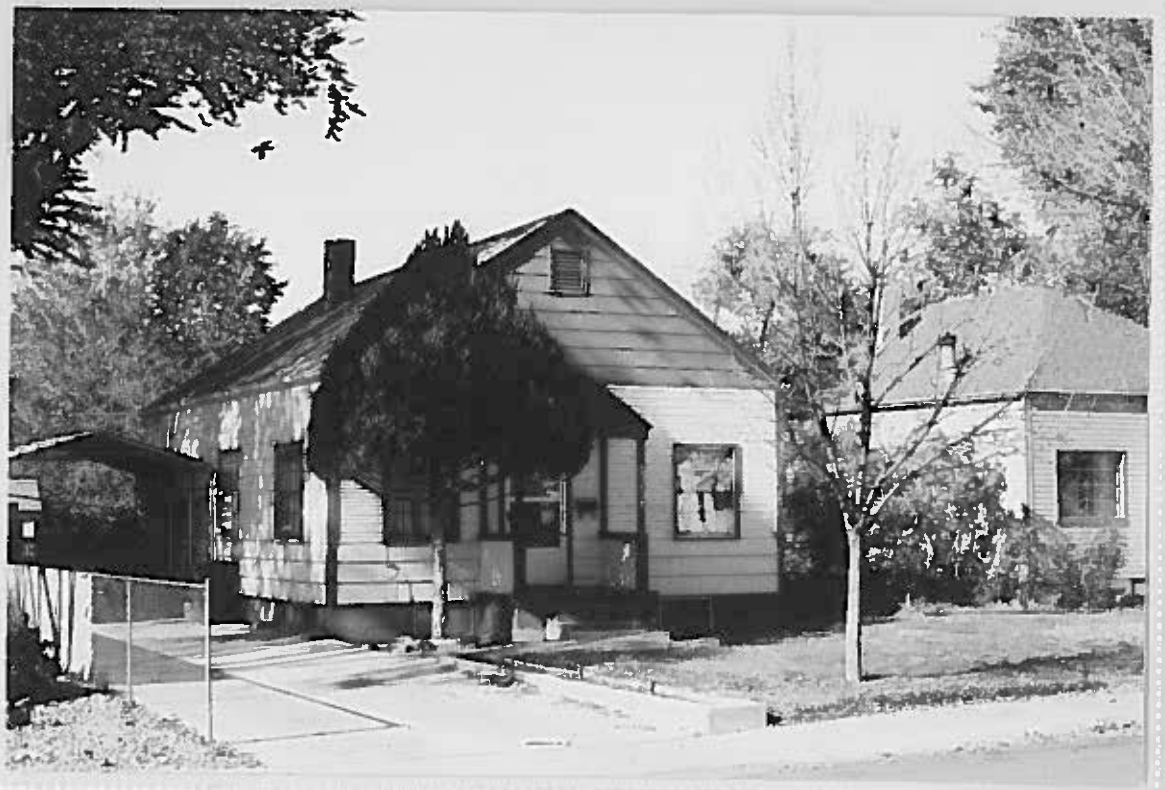
Roll # 5 Frame # 25

21. General architectural description: This is a simple rectangular wood frame house with a medium pitched front gabled roof. The ridge runs east/west and the principal façade faces east. A small front gable roof is applied to the main wall just off center to the south, over the entry door. The roof is supported by single square wood columns on the corners. Pilaster supports the roof at the wall. The columns support a shallow entablature with an infilled pediment above. A low wall runs between the front column and the main wall on each side. A wide double hung sits to each side of the entry, centered on the remaining wall. The double hungs are wood with a four over two muntin pattern. Similar double hungs are located on the sides. The narrow clapboard siding extends to the eave line and the large gable end is infilled with composition shingles. Patches of composition shingles can also be seen on areas of the main walls. The house sits on a concrete foundation and small basement windows can be seen that correspond to the main level window locations. A brick chimney is located on the south slope of the roof.

43. Assessment of historic physical integrity related to significance: The form of the building is intact, though some of the original materials and details have been lost. Integrity has been seriously compromised.
