COLORADO CULTURAL RESOURCE SURVEY

Architectural Inventory Form

1. Resource number: _____ 5ME.14693 2. Temporary resource number: 1274.TEX 3. County: Mesa 4. City: Grand Junction 5. Historic building name: n/a 6. Current building name: n/a 7. Building address: _____ 1274 Texas Ave. 8. Owner name and address: Juanita L Tomasi 1274 Texas Ave Grand Junction, CO 81501-7638

- 48. Report title: Grand Junction Phase 3 Survey 49. Date(s): March 2005
- 50. Recorder(s): Suzannah Reid, Patrick Duffield and Lydia Herron
- 51. Organization: Reid Architects, Inc.
- 52. Address: PO Box 1303 Aspen, Colorado 81612
- 53. Phone number(s): 970 920 9225

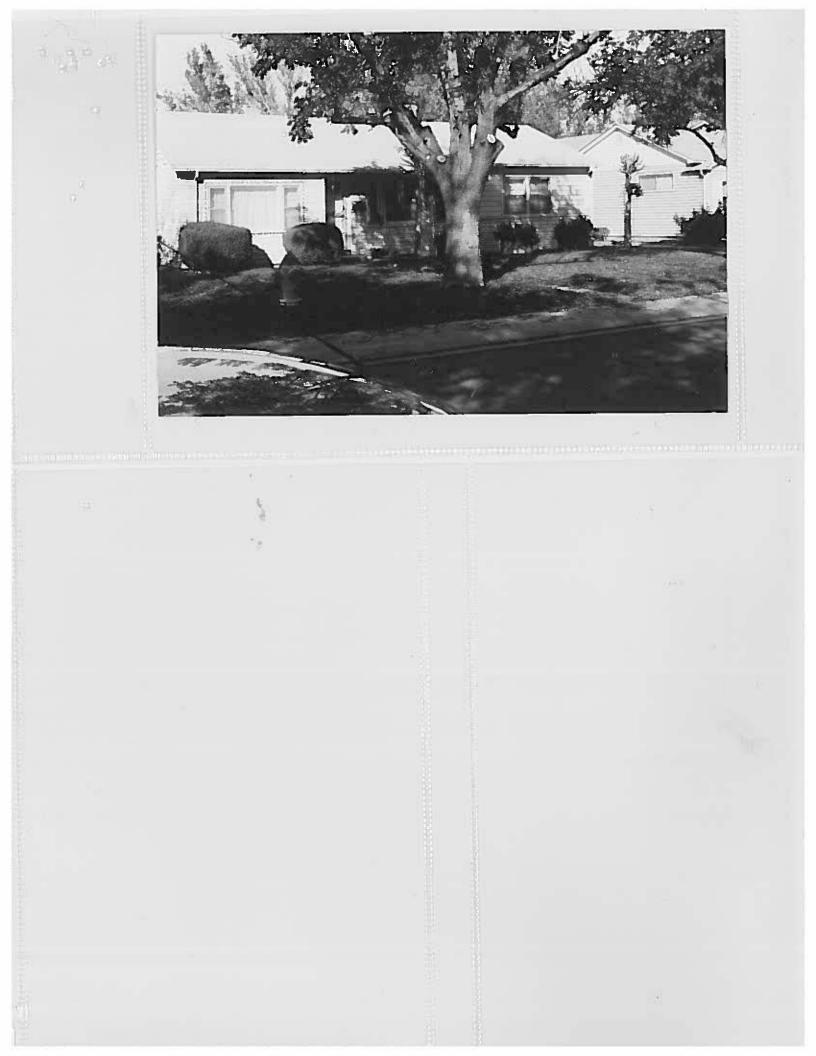
1274 Texas Ave. 5ME.14693 Roll # 3 Frame # 29 Looking northeast Grand Junction, Mesa County, CO WHF BA010A1X0N NNN 0 5871 002924 030 share 57807 η. * 1

- 21. General architectural description: This is a rectangular wood frame house with a side gable roof. The main ridge runs east/west and the principal facade faces south. The roof has minimal overhangs on the eave ends and a deeper variable overhang on the principal facade. The variation is a result of a combination of areas of extended roof plane and wall projections below. At the west side the wall projects forward of the main facade and has a large picture window flanked by double hungs, centered on its length. The main entry door is located adjacent to the east side wall of the projection; the eave line remains continuous, creating a deep overhang at the door and adjacent picture window. The picture window to the east has a narrow double hung to each side; to the east of the window the roof returns to a smaller overhang, A pair of double hungs are centered on the remainder of the wall. The double hung windows have a single horizontal muntin in each sash. A band of stone veneer runs across the facade at the window sills on the east and steps up at the entry door continuing the full height around the projection and on to the west side. Two double hung windows are located on the east side near the center. A front gable carport sits at the rear of the east wall, and a low pitched gable addition extends the west wall to the south.
