COLORADO CULTURAL RESOURCE SURVEY

Architectural Inventory Form

1. Resource number: 5ME.14789
2. Temporary resource number: 540.WAL
3. County: Mesa
4. City: Grand Junction
5. Historic building name: n/a
6. Current building name: n/a
7. Building address: 540 Walnut Ave.
8. Owner name and address: Robert T Crowell
540 Walnut Ave Grand Junction, CO 81501-7438

48. Report title: Grand Junction Phase 3 Survey 49. Date(s): March 2005

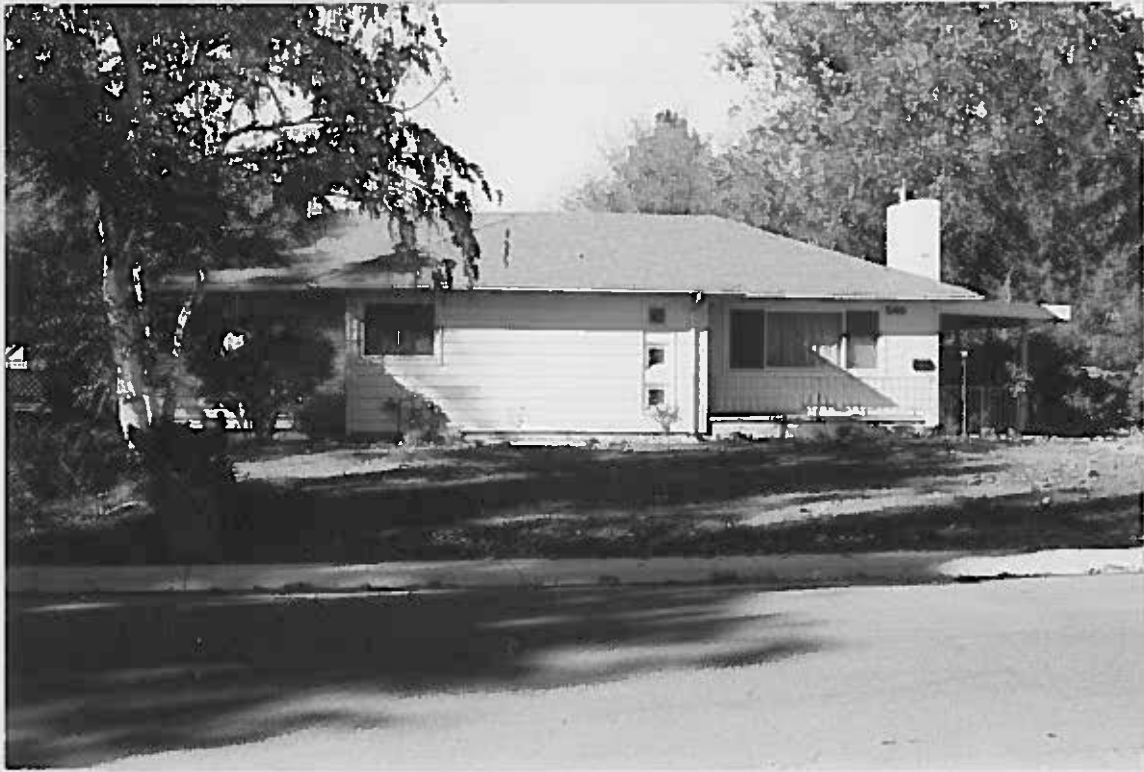
Roll #7 Frame #13

21. General architectural description: This is a horizontally proportioned, wood frame house with a moderately pitched hipped roof. The main ridge runs generally east/west and the principal façade faces south. The principal façade is divided by a central hipped roof projection. A single slider window is located on the face of the projection, on the left corner and a vertical row of three small square windows is located on the right. To the left of the projection, another slider window is located on the far corner. On the right side of the projecting volume is a large picture window, flanked by casements on each side. The main entry door is located on the east wall of the projection and a concrete walkway runs along the main volume wall to the east. A thin metal rail runs along the top of a low wall at the edge of the walkway. A shed roof carport is attached to the east side of the main façade. The roof is supported by several pipe columns. A large rectangular chimney is applied to the east façade and appear on the wall surface under the carport roof. A series of additions extend off the rear of the house.

43. Assessment of historic physical integrity related to significance: The window replacement has altered original opening proportions and window types. Along with other alterations, the integrity has been seriously compromised. The building no longer contributes to the character of the neighborhood.

Looking northwest

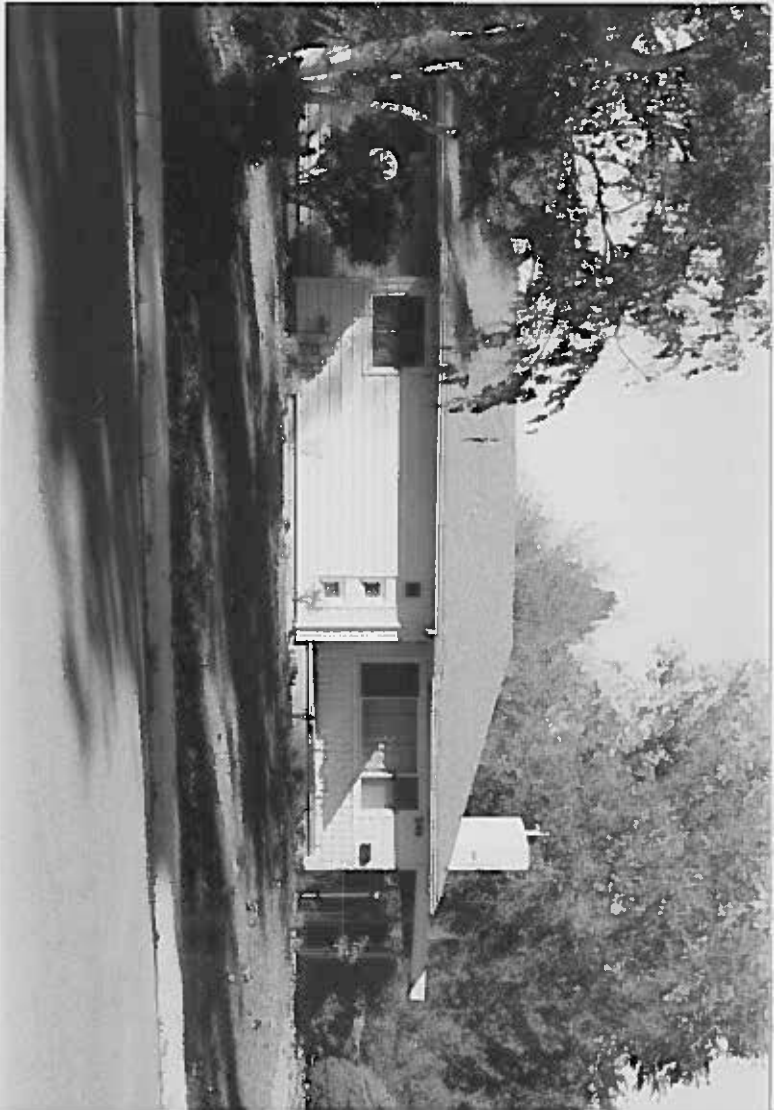
Roll #7 Frame #12

Looking northwest
