COLORADO CULTURAL RESOURCE SURVEY

Architectural Inventory Form

1. Resource number: 5ME.14937
2. Temporary resource number: 3046.ER
3. County: Mesa
4. City: Grand Junction
5. Historic building name: n/a
6. Current building name: n/a
7. Building address: 3046 E Road
8. Owner name and address: Robert D Ross
3046 E Rd Grand Junction, CO 81504-5716

Map created with TOPO!® ©2003 National Geographic (www.nationalgeographic.com/topo)

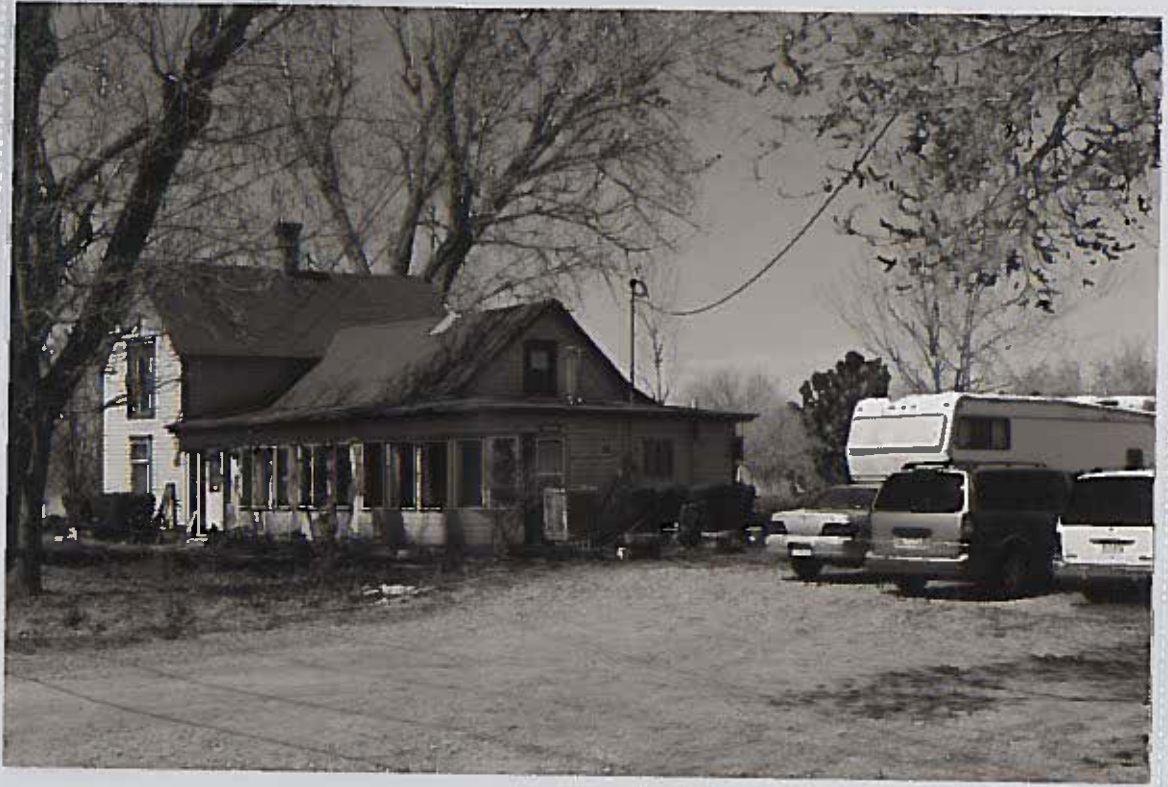
Roll # 15 Frame # 21

21. General architectural description: This is a one and one half story wood frame house. The house is comprised of two main sections; the one and one half story front gable on the west and a one story side wing that extends to the east. The front gable ridge runs north/south and the principal façade faces south. The front gable has a pair of vertically proportioned double hung windows on the upper level and a single narrower vertically proportioned double hung window on the main level. The side wing runs approximately three times the width of the front gable and has an enclosed shed roof porch that runs the length of the wing and wraps around to the east end of the side wing. The porch has an entry door with side lights directly adjacent to the front gable form and then a series of picture window units flanked by casements, that run the length of the wall. The window all share the same head and sill heights. The window units are separated by wood columns that imply the spacing of the original porch posts. The porch roof and wall enclosure are radiused around the corner and the window pattern continues down the east end to a door that is off center to the left. The side wing has a symmetrical gable with shed roofs to either side. A single vertically proportioned double hung window sits in the east gable end. The west side of the one and one half story section has a series of vertically proportioned double hung windows along its length. A brick chimney sits on the ridge of the tall front gable, near the center.

Looking northwest
