Architectural Inventory Form

1. Resource number: 5ME.14936
2. Temporary resource number: 3062.ER
3. County: Mesa
4. City: Grand Junction
5. Historic building name: n/a
6. Current building name: n/a
7. Building address: 3062 E Road
8. Owner name and address: The Bishop of Pueblo
1001 N Grand Ave Pueblo, CO 81003-2915

48. Report title: Grand Junction Phase 3 Survey 49. Date(s): October 2005

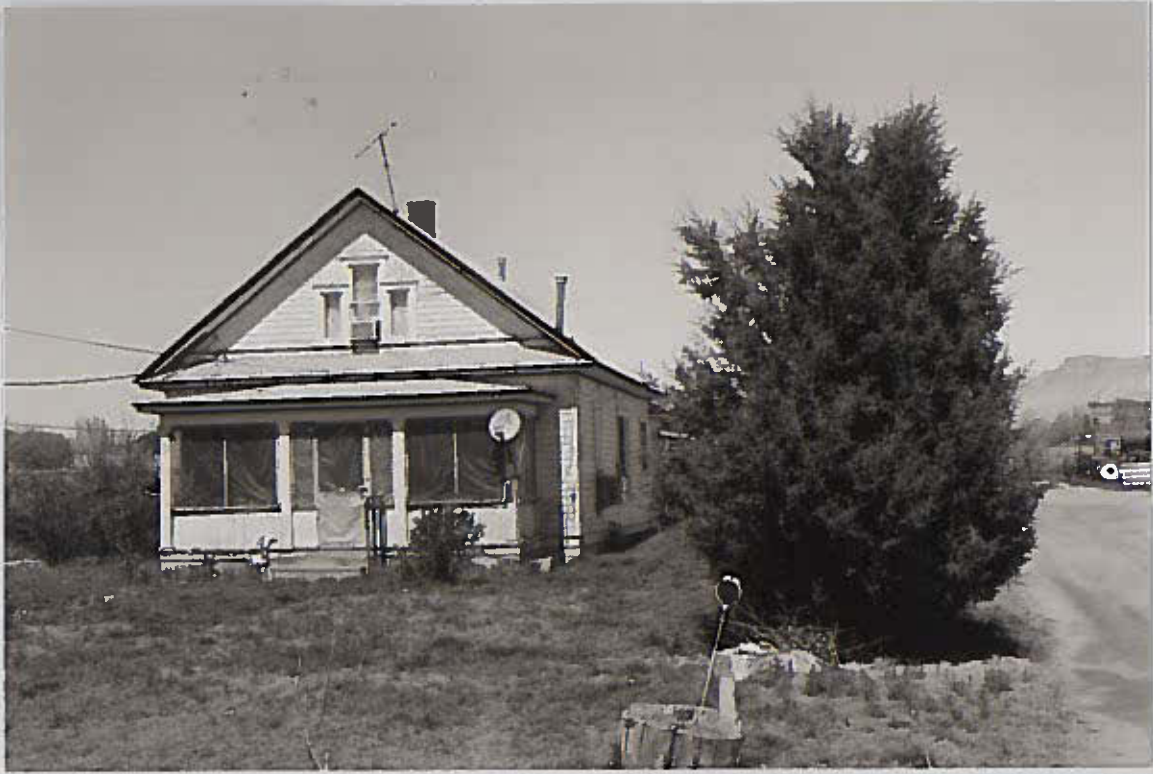
Roll # 15 Frame # 17

21. General architectural description: This is a simple rectangular wood frame house with a front gable roof. The ridge of the roof runs north/south and the principal façade faces south. A hipped roof porch is applied to the front of the principal façade. The porch roof is supported by four equally spaced square wood posts with detailing at the base and capital. The posts support a shallow entablature and the roof has a small overhang with crown molding on the edge. A low wall infills the area between the posts and wood framed screens sit on the wall and run to the entablature. An entry door is centered on the porch and has a wood frame that matches the screen frames. The main eave line returns across the façade above the porch roof and a narrow vertically proportioned double hung window is centered in the pediment. Two smaller vertically proportioned fixed glass windows flank the central double hung. The windows are trimmed together with a simple crown across the top of the head trim. Two vertically proportioned double hung windows are located on the west side wall, one near the front and the other near the center of the building. The east side wall has a similar pattern and a low pitched shed addition extends off the rear of the house. The small brick chimney sits on the main ridge near the center point.

Looking north
