**Architectural Inventory
Form**
1 of 4

1. Resource number: 5ME.2839
2. Temporary resource number: 3070.DR
3. County: Mesa
4. City: Grand Junction
5. Historic building name: n/a
6. Current building name: n/a
7. Building address: 3070 D Road
8. Owner name and address: Rodney C Shepard
3070 D Rd Grand Junction, CO 81504-8625

48. Report title: Grand Junction Phase 3 Survey 49. Date(s): October 2005

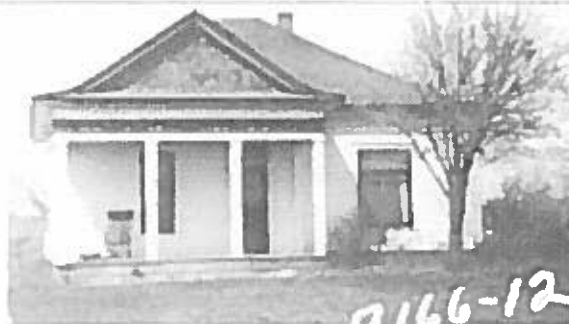
*Photo from Mesa County Assessor
Date unknown*

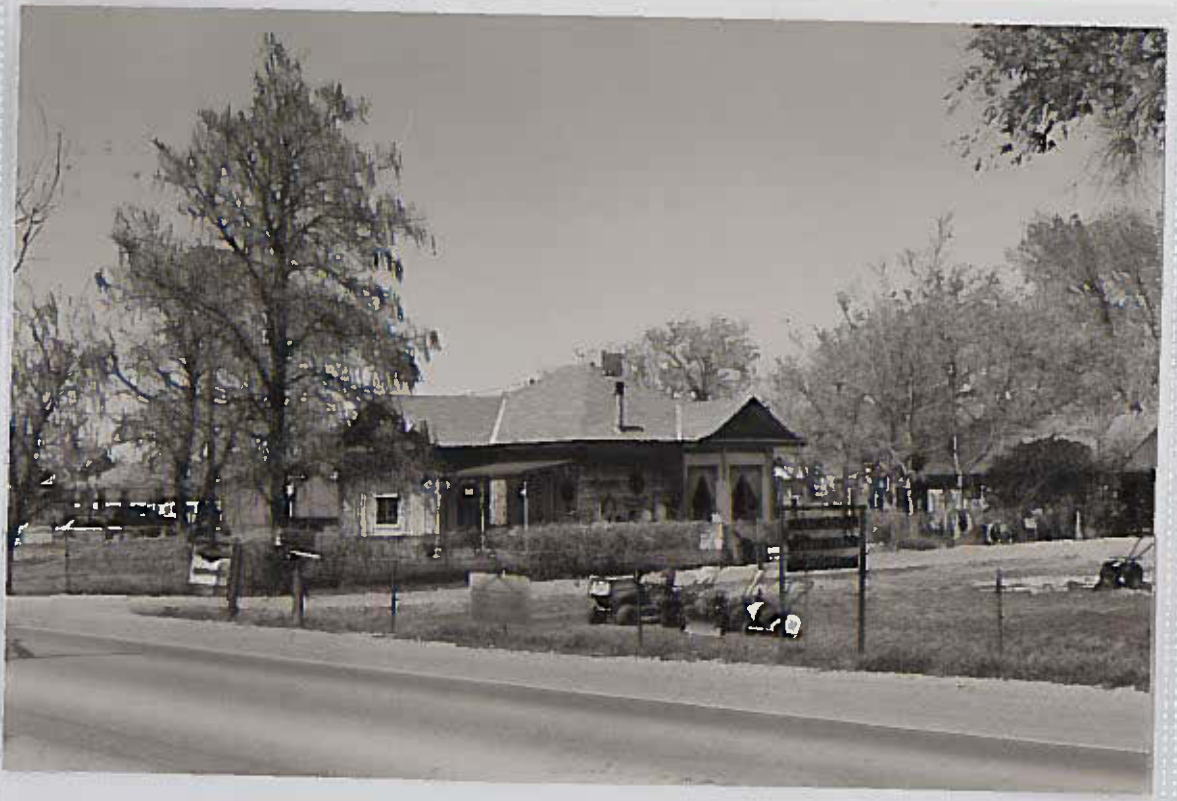
Roll # 15 Frame # 15

20. Special features (enter all that apply): Flared Eave, Porch, Chimney
21. General architectural description: This is a simple one story house with a moderately pitched hipped roof. The hipped roof covers the almost square plan of the primary volume and lower gables project off the hip to the south and east. The main hipped roof has a short ridge running east/west and the principal façade faces south. The principal façade is has a small projecting gabled roof volume on the left and a shed roof porch on the right. The western roof plane of the small gable is continuous with the western plane of the hipped roof. The roof has a moderate overhang and the small gables have flared eaves. The gable has a central pair of windows and a small vent window in the gable end. The eave line returns across the gable end creating a pediment and continuing the moderate overhang across the gable end. The entry door is located on the side wall of the projecting gable facing east. A large picture window opening sits on the south facing wall under the porch. The porch roof is supported by turned posts. A small bay is located on the right side of the east elevation. The bay is topped by a small gable roof, whose north plane is continuous with the main hipped roof plane. The bay has 45° sides and a central panel, each with similarly sized vertically proportioned openings with fixed glass windows. The front bay has wood vertical siding and the main volume has horizontal wood siding. The siding has a clear finish on it. The bay is the only painted section of the house. The asphalt roof has a series of vents and a swamp cooler on the rear slope of the main roof.

Looking northwest

43. Assessment of historic physical integrity related to significance: Alterations have had a substantial impact on the integrity of the house. The loss of original materials, windows, porch and detailing has resulted in a considerable loss of original character.
