# Architectural Inventory Form

1. Resource number: 5ME.1895
2. Temporary resource number: 2990.DHR
3. County: Mesa
4. City: Grand Junction
5. Historic building name: n/a
6. Current building name: n/a
7. Building address: 2990 D.5 Road
8. Owner name and address: Darren M Davidson  
2139 N 12th Street STE 10 PMB 9233  
Grand Junction, CO 81501-2910

47. Photograph numbers: Roll # 15 Frame # 13  
Negatives filed at: City of Grand Junction Planning Dept.
48. Report title: Grand Junction Phase 3 Survey 49. Date(s): October 2005
50. Recorder(s): Suzannah Reid, Patrick Duffield and Lydia Herron
51. Organization: Reid Architects, Inc.
52. Address: PO Box 1303 Aspen, Colorado 81612
53. Phone number(s): 970 920 9225

*Phase Three Historic Survey*

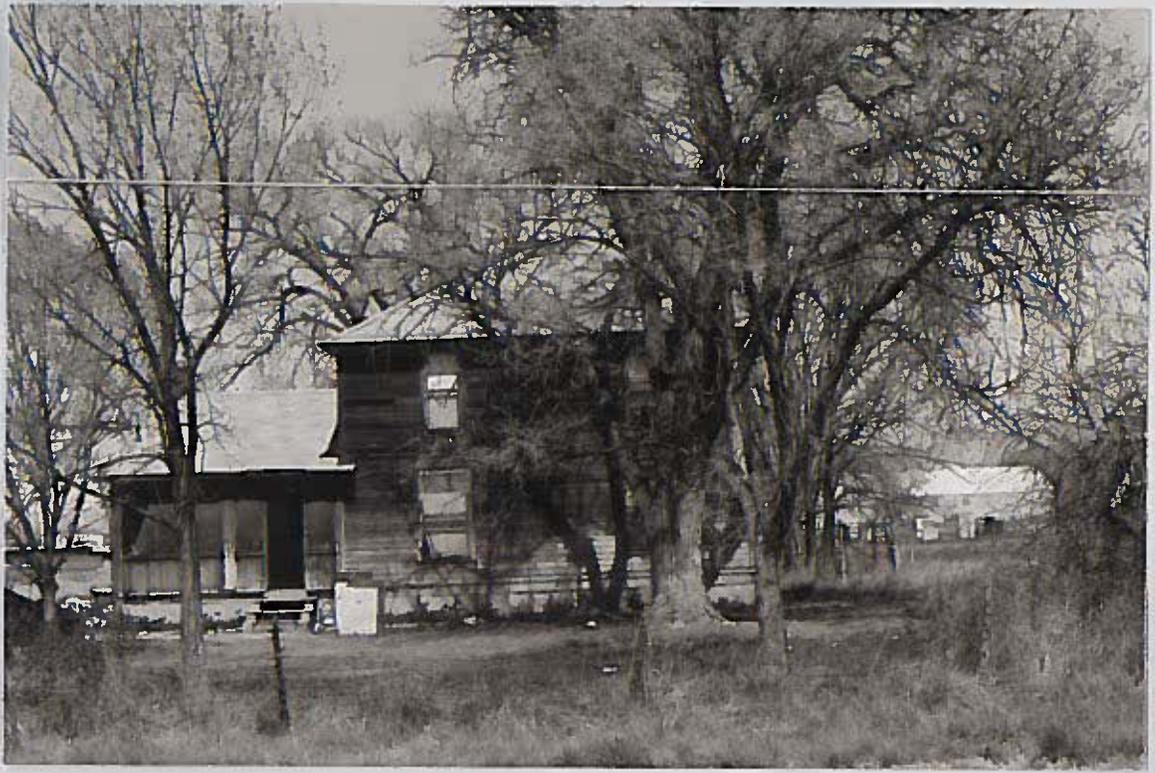
5ME.1895

20. Special features (enter all that apply): Porch, Chimney
21. General architectural description: This is a large two story wood frame house with a moderately pitched hipped roof. A short ridge runs east/west and the principal façade faces south. The two story main volume has a one story gable wing applied to the west side. The side wing has an enclosed porch under a shed roof on the south side. The shed roof is supported by three square wood posts with some detailing at the capital and base. The porch posts are in line with the face of the main two story section of the house, and the space between the posts is infilled with a low panel of vertical siding with screens above. The entry to the porch is centered on the right hand column bay, and consists of a simple wood frame opening in the screen. The front door is located on the south wall on the left hand side of the porch. Three wood steps run from grade to the porch level and the whole house sits on a concrete foundation. The two story south wall has four vertically proportioned double hung windows; two on the main level and two slightly narrow units directly above. The east side has a similar arrangement. A brick chimney sits at the west end of the side gable wing.

43. Assessment of historic physical integrity related to significance: The house has suffered some deterioration of materials. The integrity has been moderately compromised by this and the porch enclosure.
